Water Velocities: Bachelor Hatton

General Observations: Bachelor Hatton

1999 Underwater Video Images: Bachelor Hatton

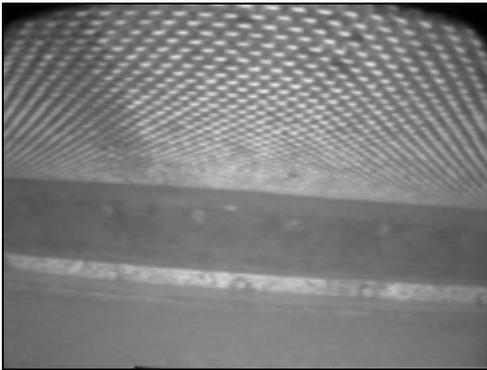
Bachelor Hatton: AVG

Screen Site	Date (Tape #)	Location (screen # & VCR counter)	VCR Counter	Notes	Photos	Descriptor
Bachelor Hatton	5/12/99 (1)	1 0:00:34	0:01:01	small pile of sand	0:02:15	AVG
		2 0:03:42	0:05:08	large gap in corner, also along seam	0:05:08	G1

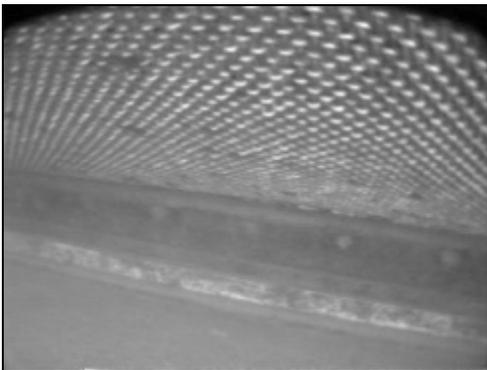
0:05:34	possible gaping along seam	0:05:35	G2
		3 0:07:30	0:08:14	sticks in corner and along drum	0:09:00	D1
			0:09:33	sand & sticks piled up to seam

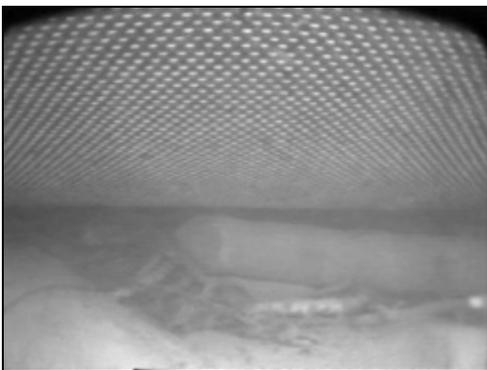
D3

0:13:35	sticks coming up over seal to drum	0:13:32	D3, D4	
	Bypass 0:15:11	0:15:21	sand & stick piles	0:15:46	D5	
Bachelor Hatton	7/15/99 (2)	1 1:16:04				
		2 1:17:54	1:18:20	gap in corner		
		3 1:21:11	1:23:15	gaping from corner to middle
