Water Velocities: Ellensburg Mill

1997 Photos: Ellensburg Mill

1999 Underwater Video: Ellensburg Mill

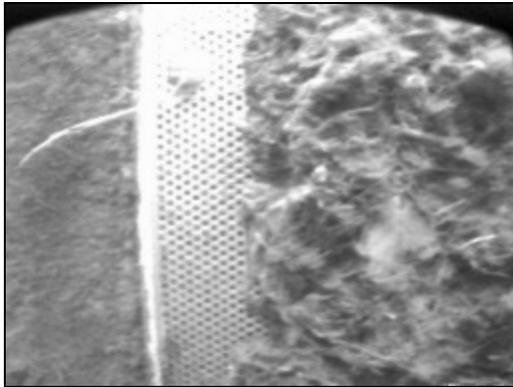
Screen Site	Date (Tape #)	Location (screen # & VCR counter)	VCR Counter	Notes	Photos	Descriptor
Ellensburg Mill	5/19/99 (2)	1 0:07:12	0:07:15	full of leaf litter, loose caulking?	0:07:20	D1
		2 0:12:34	0:09:17 0:13:20 0:13:39	large sediment/leaf pile plants growing full of leaf litter	0:09:36	D2
		3 0:15:24	0:16:00 0:17:17	sticks against panel debris	0:16:01	D3
		Bypass 0:17:34	0:17:36	full of sticks and debris		
			0:18:19	large log and debris	0:18:22	D4
Ellensburg Mill	7/23/99 (3)	1 1:13:11		elodea throughout whole forebay		
		2 1:17:13				
		3 1:22:41	1:23:28	caulking oozed out		
		Bypass 1:25:16	1:26:04	lots of debris and leaf litter
