Water Velocities: Glead

General Observations

1997 Photos: Glead

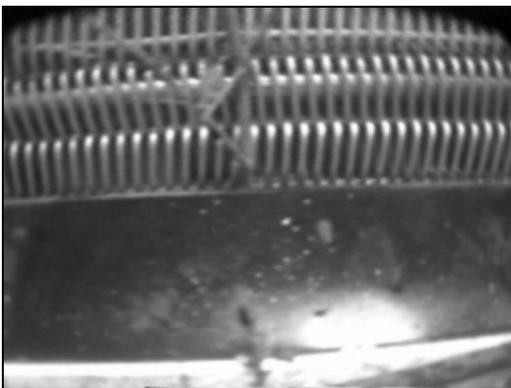
Screen Site	Date (Tape #)	Location (screen # & VCR counter)	VCR Counter	Notes	Photos	Descriptor
Gleed	5/14/99 (1)	1 1:21:09	1:22:46	sticks, twig in screen	1:22:47 1:25:47	D1 AVG
		2 1:24:38				
		3 1:26:50	1:26:51	sticks at top of screen		
		4 1:29:16
