Water Velocities: Lindsey

General Observations: Lindsey

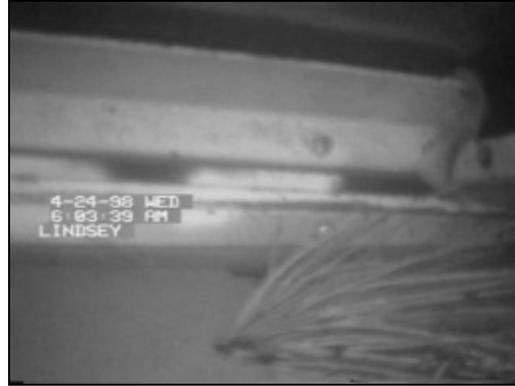
Caulking

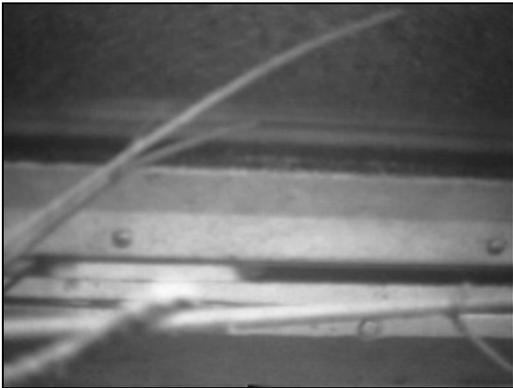
Caulking

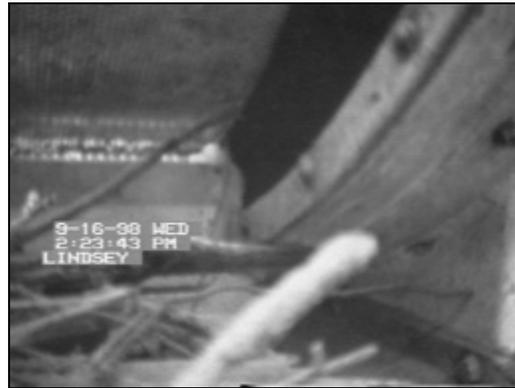
Tiny gap?

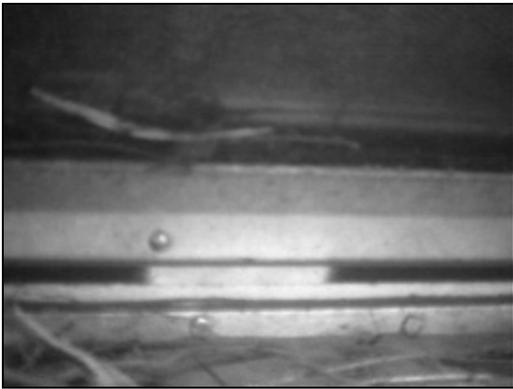
Caulking

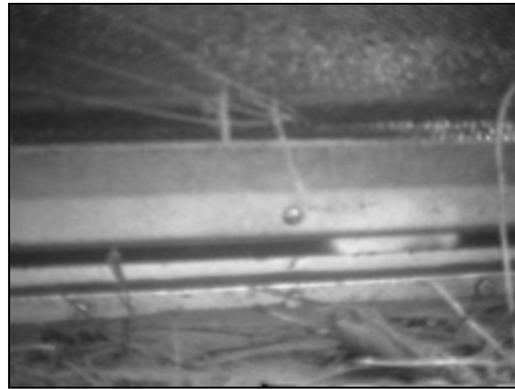
Caulking

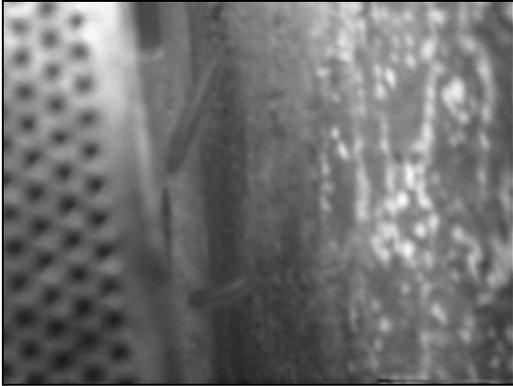
Small Fish

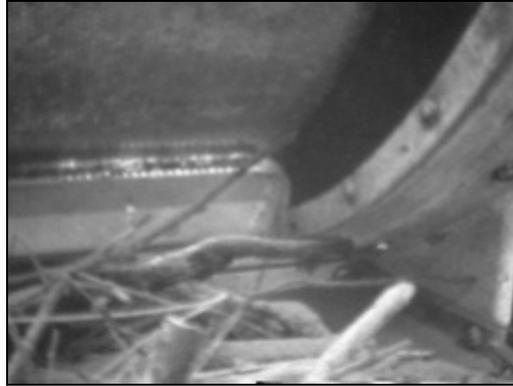
light through a tiny gap?

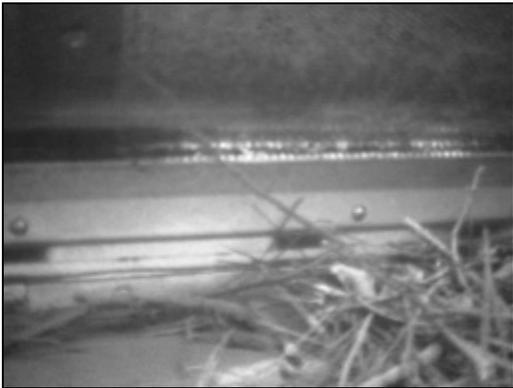
light through a tiny gap?
