Lower WIP - May 12, 1999

General Observations: Lower WIP

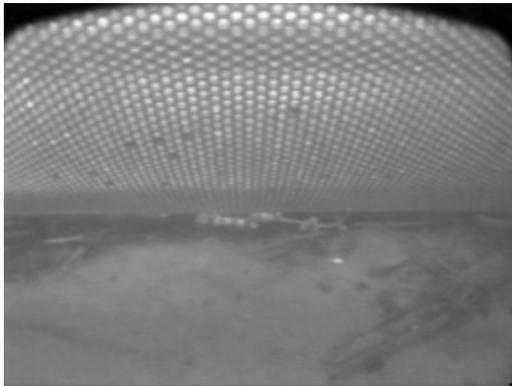
Screen Site	Date (Tape #)	Location (screen # & VCR counter)	VCR Counter	Notes	Photos	Descriptor
Lower WIP	5/12/99 (1)	1 0:29:49	0:30:11	sand covering seal, some sticks debris pile on top of sand in corner	0:30:35	AVG
		2 0:31:15	0:30:45			
			0:31:32	sand and debris sand up to seal	0:31:52	S1
			0:32:04	pop can	0:32:04	T1
Lower WIP	8/4/99 (4)	1 0:19:50	0:20:05	debris in corner debris and sediment up over seal woody debris in corner		
			0:20:26			
			0:21:14			
		2 0:21:46	0:22:16	debris and sand piles, not covering screen		
			0.015671296	fish in aftbay
