Water Velocities: Naches Selah

General Observations: Naches Selah

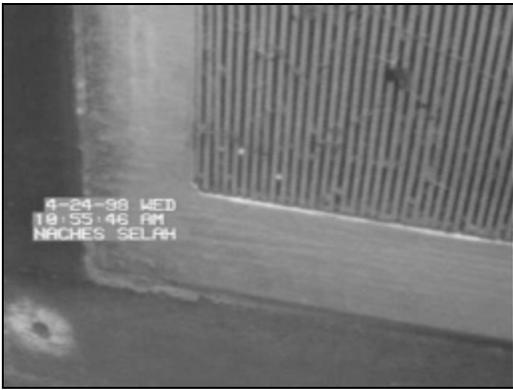
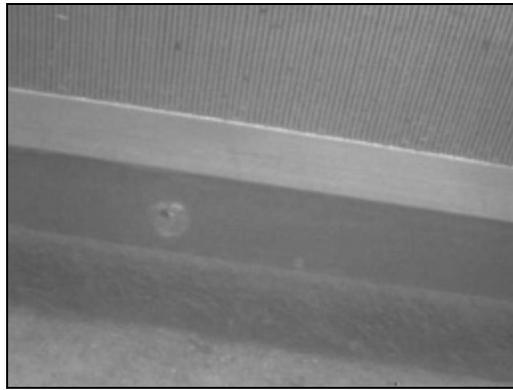
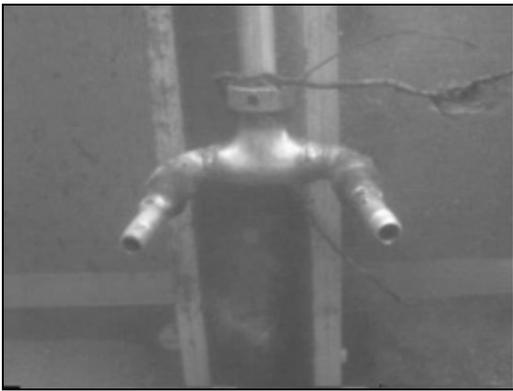
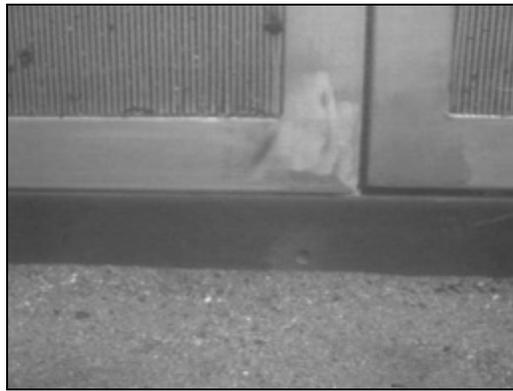
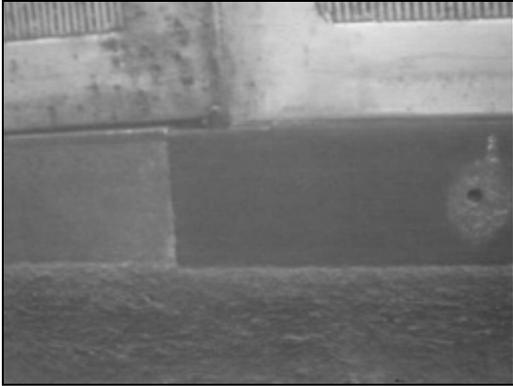
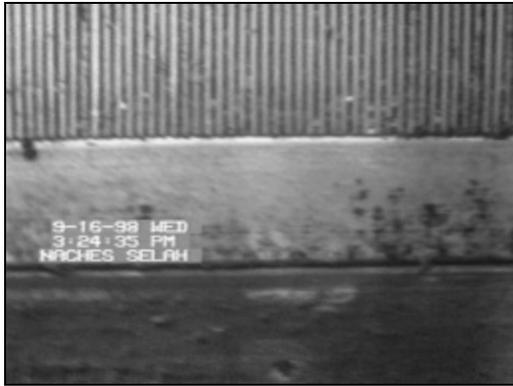
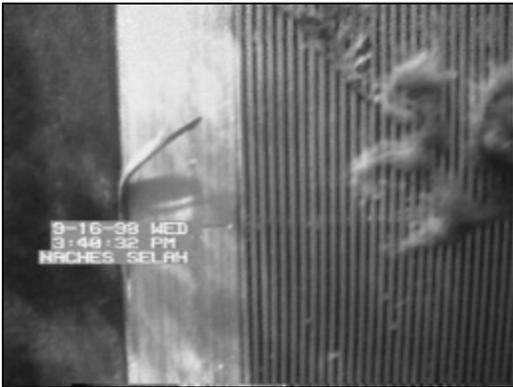
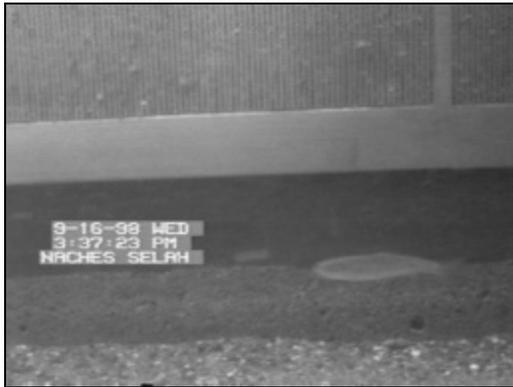
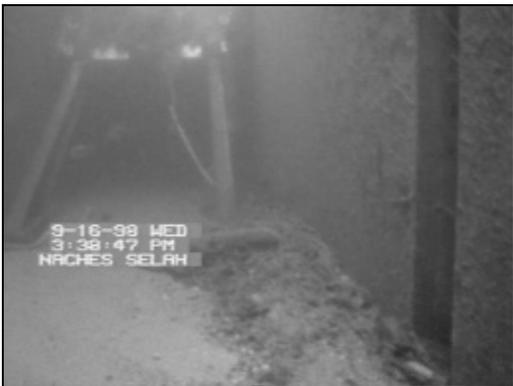
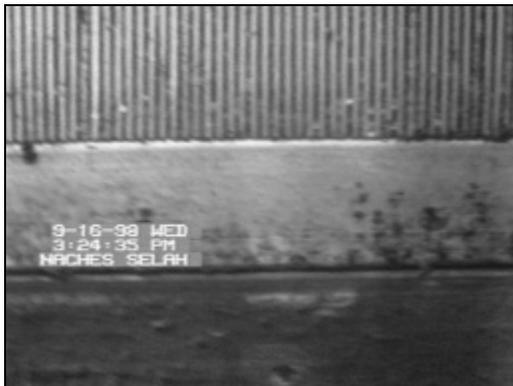
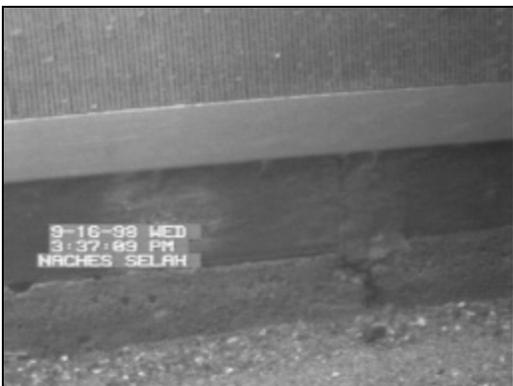
1998 Photos: Naches Selah

Comments			potential gap at panel 3; fish in front of panel 6	A crew was working here yesterday and clearing out lots of silt (5/11/98).	We saw an attachment on the cleaning brush for the "bubbler". Looks like they fit an airhose to a pipe that extends to the bottom of the screen and blasts silt out of the way.	Jeff said he saw lots of fish inside the bypass. Cory observed 1 little fish on the wrong side of the screen. Fish on video (?) in bypass.	Several 2-4" trout in forebay, one also near trashrack.	Missing caulking at 2&3, 3&4, 4&5. Brush not touching whole way, grass/leaves on screen.

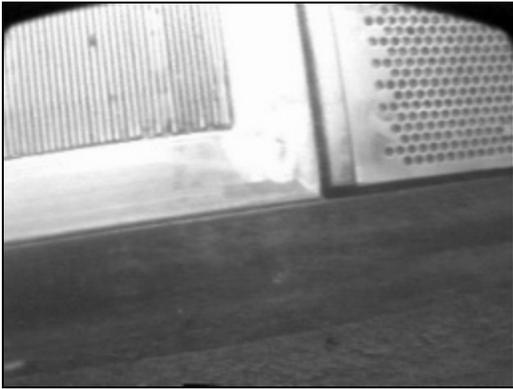
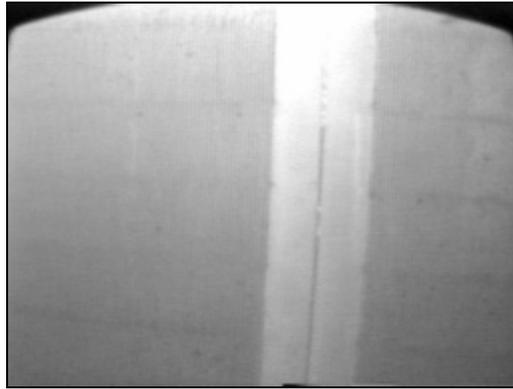
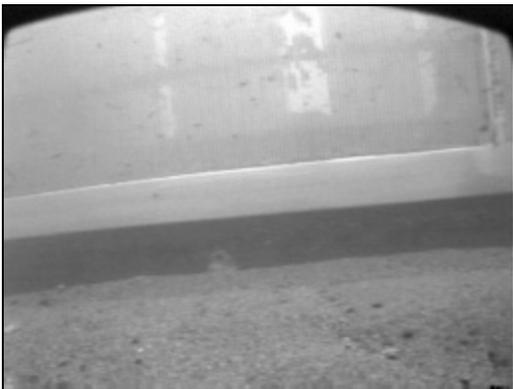
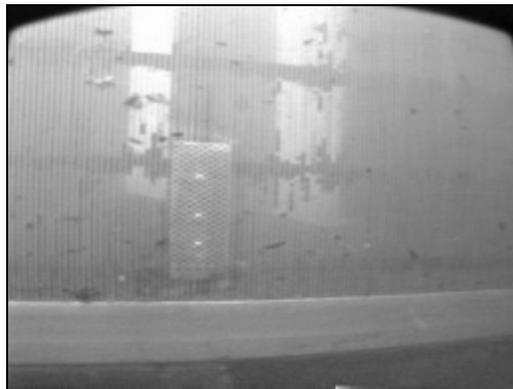
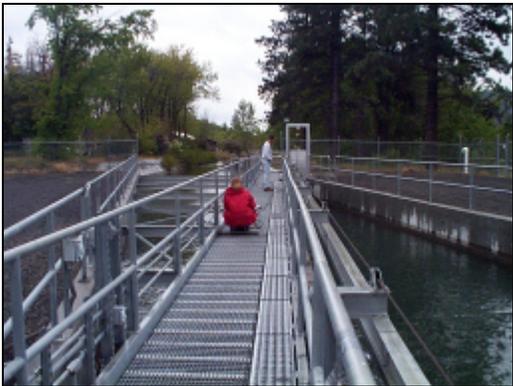
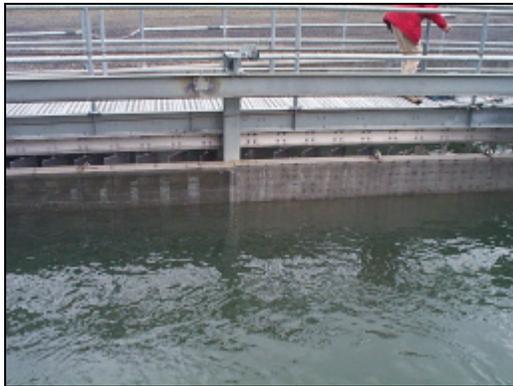
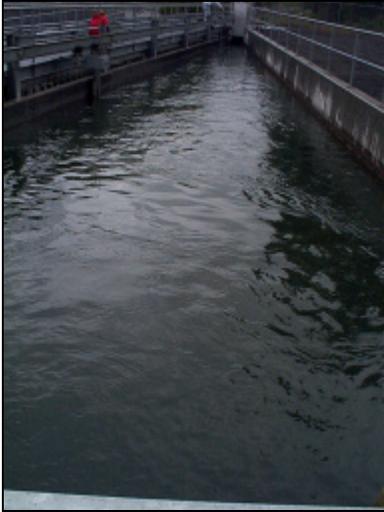
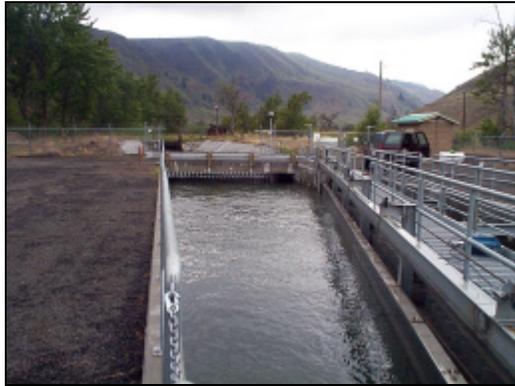
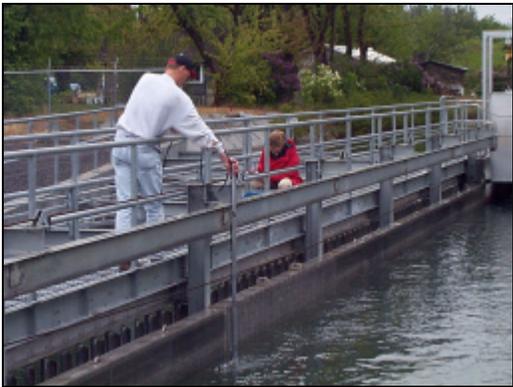
1999 Photos: Naches Selah

1:56:29	looks like screen has wear in corner	1:56:42	C1
		3					
		1:56:44		1:56:44	perfect plate screen		
		4					
		1:58:13		1:58:53	sediment pile	1:58:53	S1
		5			sediment pile

1:59:14		1:59:25	throughout (4")		
				2:00:54	patch on lower screen	2:00:54	R1
6							
2:01:10							
Bypass							
2:01:43							
			2:02:47, 52	missing seal 5 & 6

2:03:06	missing seal 4 & 5	2:03:08	C2	
			2:03:18	doesn't seem to have caulking 3 & 4			
			2:03:44	missing seal 1 & 2			
Naches Selah	8/4/99 (4)	1
