General Observations: New Cascade

1997 Photos: New Cascade

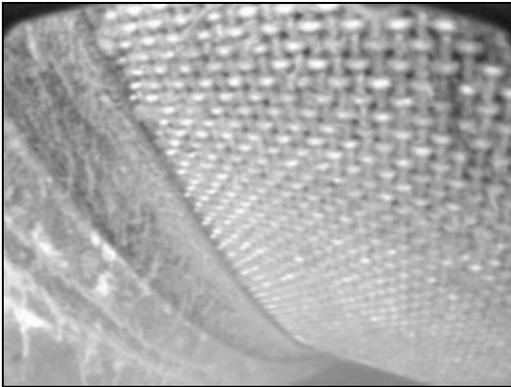
Screen Site	Date (Tape #)	Location (screen # & VCR counter)	VCR Counter	Notes	Photos	Descriptor	
New Cascade	5/20/99 (2)	1	0:19:18	0:19:40	screen covered in algae (screen not on)	0:19:40	D1

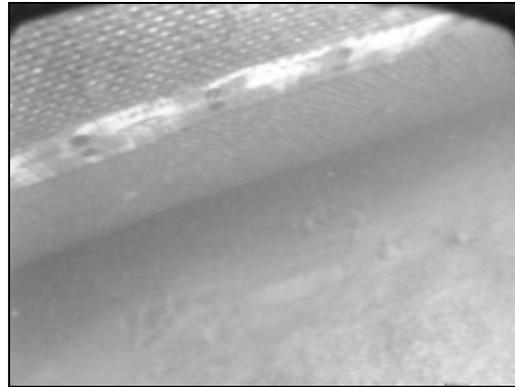
0:20:38	sediment covering all the way past seal		
				0:21:12	across screen	0:20:52	S1
		2	0:22:02	0:22:33	sticks at corner		
				0:23:29	sand at seal all the way across		
		3	0:24:12	0:24:52	sand up and over seal

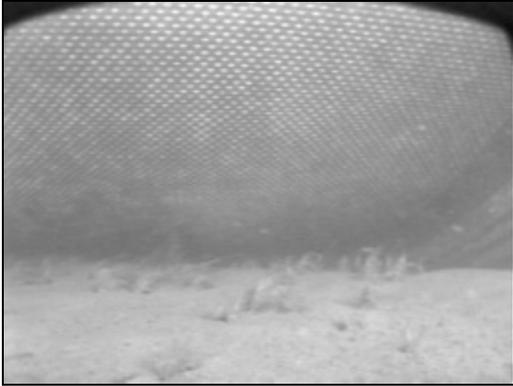
0:25:58	sand and plant growth	0:25:56	AVG
		4	0:26:34	0:27:14	sand and plant up and over seal		
				0:28:22	sand piling across large tumble weed-like things in front of screen	0:28:23	D2
		5	0:29:16	0:30:04	sand piling across brush pile		
		6	0:32:11	0:33:11

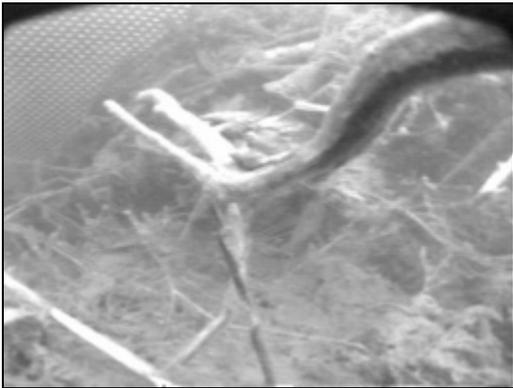
0:33:31	sediment pile across large brush pile in corner	0:33:32	D3
		7	0:34:28	0:34:55	sticks at corner		
				0:35:15	sand and plants, brush throughout		
8	0:36:14	0:36:38	seals look worn	0:36:40	C1
