Water Velocities: Snipes Allen

General Observations: Snipes Allen

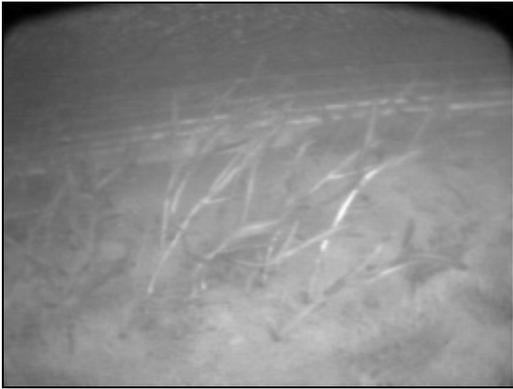
Screen Site	Date (Tape #)	Location (screen # & VCR counter)	VCR Counter	Notes	Photos	Descriptor		
Snipes Allen	5/14/99 (1)	1	0:57:27	0:57:57	silty bottom, plants growing across bottom	0:58:04	P1 S1	
		2	1:00:23	1:00:53		0:58:50		
		Bypass	1:04:43	1:01:13	1:01:16	branch & twig pile	1:01:16	D1
				1:03:56	1:04:03	large log	1:04:03	D2
Snipes Allen	8/4/99 (4)	1	0:14:07	0:15:17	sediment building up in middle			
		2	0:16:09	0:18:42				can in corner
		Bypass	0:19:22
