Water Velocities: Taylor

General Observations: Taylor

1997 Photos: Taylor

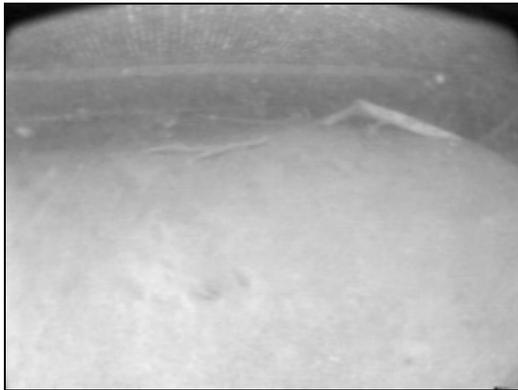
Screen Site	Date (Tape #)	Location (screen # & VCR counter)	VCR Counter	Notes	Photos	Descriptor
Taylor	5/19/99 (2)	1 0:00:04	0:00:28	sand pile and debris sand up to seal all the way across, large branch	0:00:35	S1
			0:00:42			
		2 0:01:42	0:01:59	gap in corner	0:02:12	G1
			0:02:33	sand up to seal all the way across, branch branches and sand piling up	0:03:14	S2
		Bypass 0:03:42 Forebay 0:05:30	0:04:58	some sand on bottom		
			0:05:30	fish	0:06:41	F1
