# Water Velocities: Toppenish Pump

General Observations: Toppenish Pump

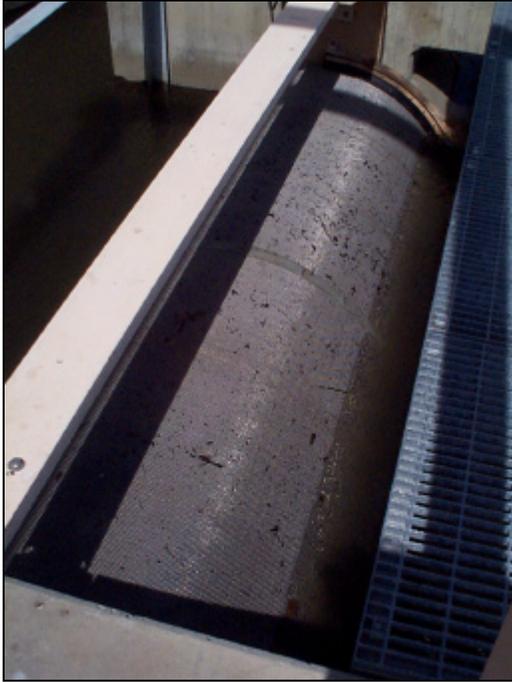
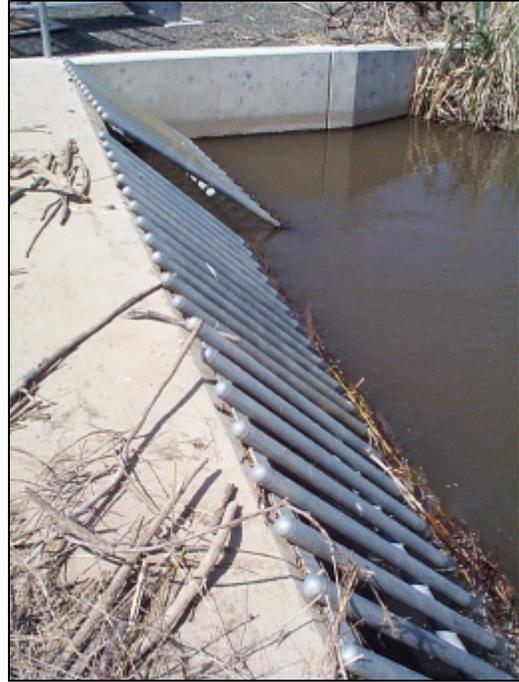
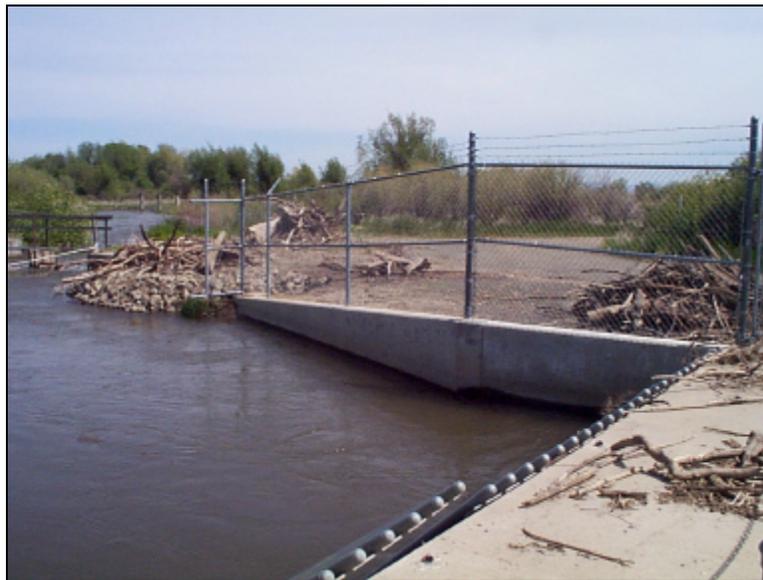
1999 Photos: Toppenish Pump

Screen Site	Date (Tape #)	Location (screen # & VCR counter)	VCR Counter	Notes	Photos	Descriptor
Toppenish Pump	7/22/99	<b>Battery Failure so Notes Only</b>				
		1	0:00	sediment and sticks build up in middle possible gap in side seal		
		2	3:00	sticks in the downstream corner sediment over seal in upstream end		
		3	3:59	logs and sticks in downstream corner sediment covering seal		
		4	5:57	sticks in both corners twigs in downstream corner		
		5	6:56	brush pile in upstream corner		
		6	9:58	lots of sticks in downstream corner		
		Bypass	12:02
