Water Velocities: Union Gap

General Observations: Union Gap

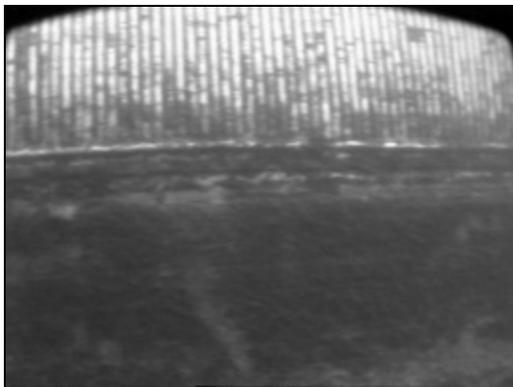
Screen Site	Date (Tape #)	Location (screen # & VCR counter)	VCR Counter	Notes	Photos	Descriptor
Union Gap	5/13/99 (1)	1 0:32:22	0:32:23	algae growth on seams, some small debris on screen	0:32:32	P1
		2 0:34:33	0:32:58	algae growth on seams, some small debris on screen *Notes: caulking between 2/3 & 3/4 & end 4 may be missing looks to be loose caulking at bottom of 2 & 3 screen.	0:35:57	C1
		3 0:36:03	0:36:12	leaf debris on screen	0:36:35	AVG
		4 0:37:29	0:38:13	sand cover and leaf debris on screen		
		Bypass 0:39:19	0:40:46	looking at patch on screen	0:41:11	R1
Union Gap	7/14/99 (2)	1 1:09:02	1:09:10	algae growth on bottom of screen	*no picture upstream seal; too much debris	
		2 1:10:24	1:11:15	loose caulking		
		3 1:11:49	1:12:35	missing caulking		
		4 1:13:13	1:14:04	debris on screen		
		Bypass 1:14:52
