Water Velocities: Upper WIP

General Observations: Upper WIP

1999 Underwater Video: Upper WIP

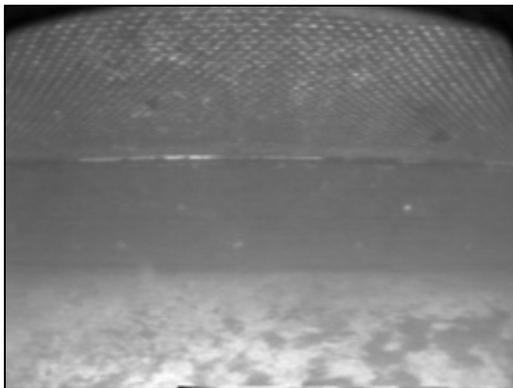
Screen Site	Date (Tape #)	Location (screen # & VCR counter)	VCR Counter	Notes	Photos	Descriptor		
Upper WIP	5/12/99 (1)	1 0:16:09	0:17:25 0:18:01	small sand pile at corner	0:19:13	G1		
		2 0:20:43	0:18:47 0:21:56	possible gap gap?; some possible reflection from 30 inches in to corner				
		3 0:23:34	0:25:24	very small gap?				
				small sediment pile

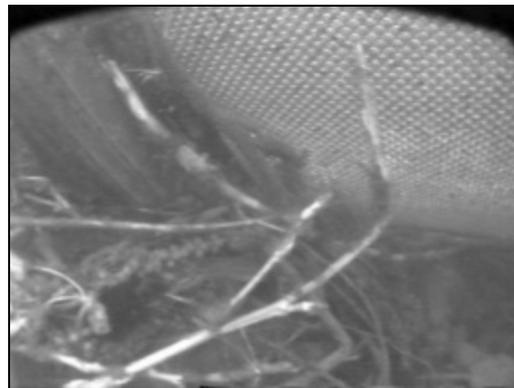
0:26:26	large sand pile and sticks start and go to corner; can't see seal			0:26:40	S1
			0:26:47	large sticks, over seal and drum			0:27:07	D1
			0:27:09	large stick pile in corner				
		4 0:27:51	0:28:19 0:29:00	stick & sand piles across sand covering seals			0:29:03	S2
Upper WIP	7/15/99 (2)	1 1:30:02	1:30:13	gapping in screen sand up to seal,				
		2 1:31:05	1:31:46 1:33:20	possible gap in corner debris up to screen				
		3 1:34:26	1:35:34	large log, debris across screen				
		4 1:37:04	1:38:33	log and debris in corner, debris across screen				
		Bypass 1:39:15	1:40:14	wooden boards in place of weir
