PNNL-14246

# Final Project Report G-Plus Windshield Coatings

## **G-Plus Windshield Coatings**

Dean Matson (PNNL)  
Kuaku Koram (PPG)

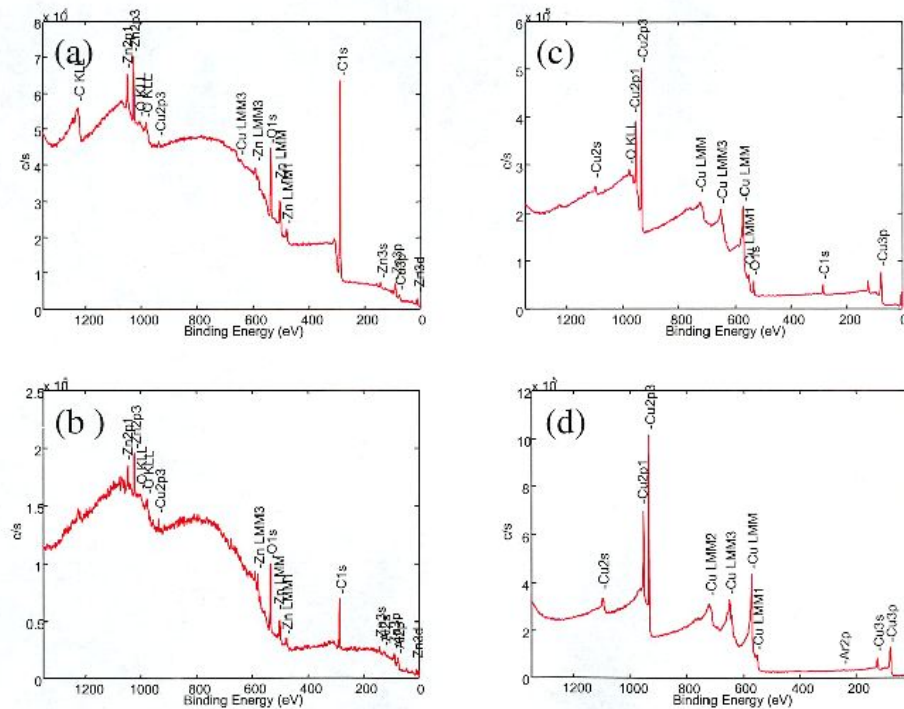
The accompanying XPS spectra (Figure 1) show the effect of selected solvent and abrasive treatments on the surface composition of the copper busbar material. Figure 1d shows the results of removing the surface layers of material by argon ion sputtering to expose the underlying copper material. These results confirm that the carbon and zinc components detected are surface “contaminants” and that the bulk copper material of the busbar is relatively pure.

Figure 1. XPS spectra of busbar material with different surface treatments: (a) as received, (b) after ultrasonic baths in hexane, acetone, and isopropyl alcohol (15 minutes each), (c) after 600 grit silicon carbide paper rub, (d) after removal of roughly 14 nanometers of surface material by argon ion sputtering.

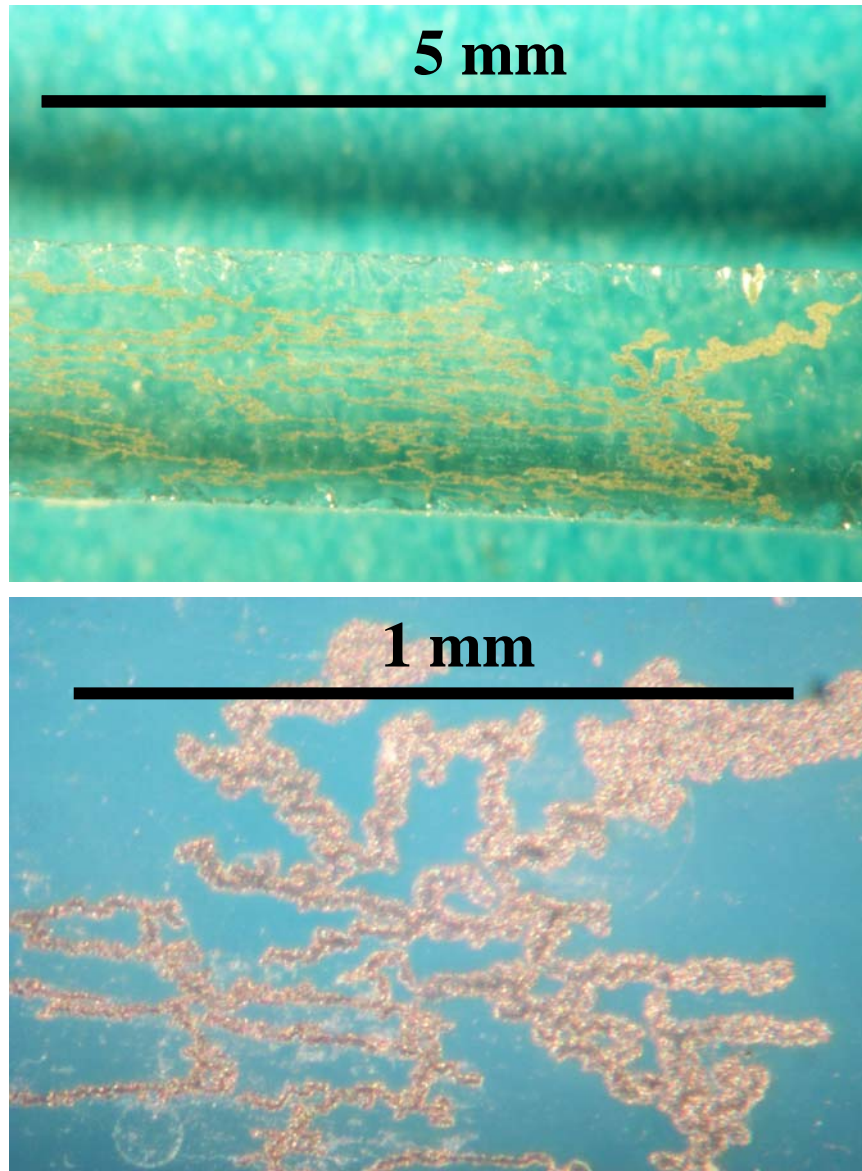
Microscopic analyses, both optical and electron, were performed on the failed laminated busbar/Sungate coating to help ascertain the failure mechanism. Optical analysis of the dark lines present between the busbar material and the Sungate coating in the failed sample of laminated windshield suggested an arc-like process was responsible for the formation of these features (Figure 2).

*Figure 2. Reflective optical micrographs of lines present at the interface between the copper busbar and the Sungate coating in a failed laminated windshield sample.*

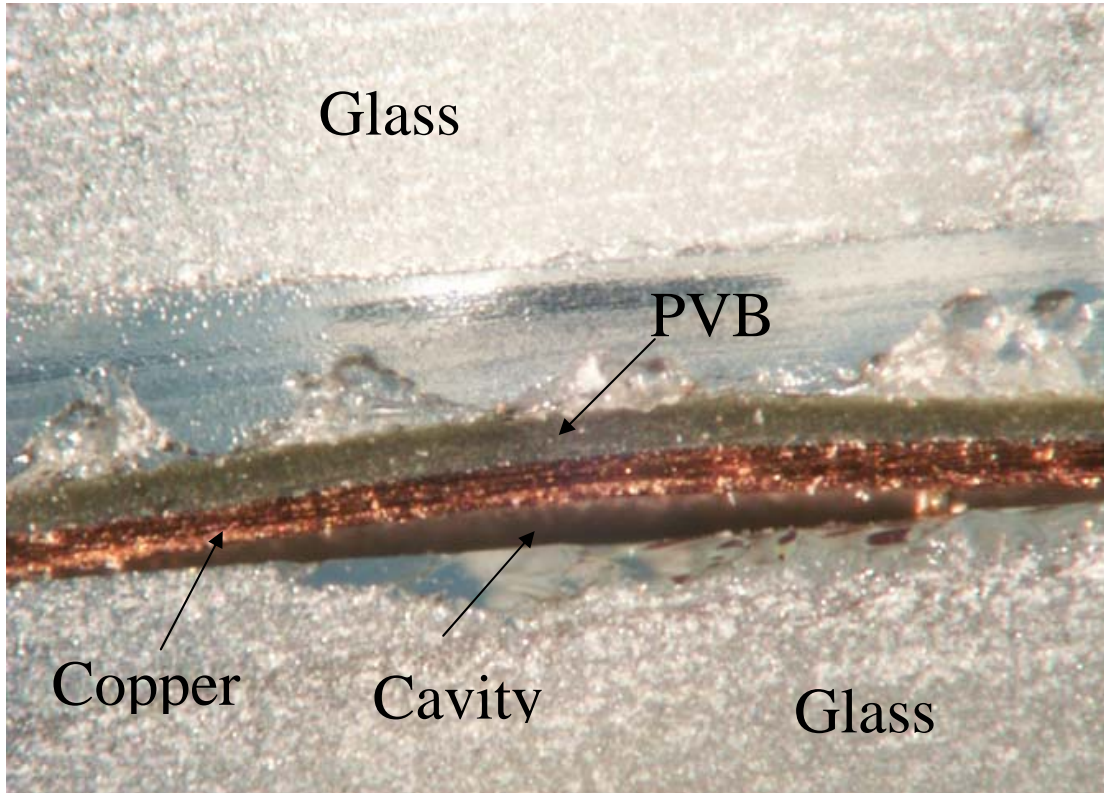
An optical micrograph was also taken of a cross section made of an area of the failed laminated sample that did not contain the fine black lines or “tracks”. Visual inspection of the area prior to sectioning suggested that the copper may have been in poor contact with the Sungate coating at that point due, perhaps, to a slight wrinkle in the busbar

material. The cross sectional analysis confirmed that there was a gap between the copper and underlying glass in that area (Figure 3). Application of the 42V driving voltage across a small air-filled gap would provide the conditions needed to initiate a discharge ( $\sim 2.6 \times 10^6$  V/m, see Y. P. Raizer, *Gas Discharge Physics*, Springer, 1997). Such a discharge could be self-propagating since it generates localized high temperatures which, in turn, would produce more gas-phase species in the cavity.

*Figure 3. Reflective optical micrograph showing a cross section of the copper/Sungate coating interface in an area of the failed sample showing no lines such as those shown in Figure 2.*

Failure of the PPG busbar/Sungate coating interface appears related to a discharge phenomenon that severely reduces the area of surface contact between the coating and busbar. The discharge is most likely initiated across an air gap incorporated into the laminate during assembly and bonding, and may be associated with wrinkles in the busbar material. The discharge appears to be self-propagating once initiated, affecting large areas of the busbar/coating interface. The presence of an apparent organic sealing layer on the surface of at least some of the copper busbar material may compound this problem through the production of gaseous organic species during the initial and subsequent discharges. This would act to maintain a relatively high pressure in the void area between the busbar and coating as the void volume grows as a result of the discharge process. The problem may be reduced by laminating the glass components under a vacuum (eliminating air in any gaps formed by irregularities in the busbar) or under an atmosphere not as conducive to discharge formation. Unfortunately, these conditions may not be easily achieved under manufacturing conditions. An alternative solution may be to reduce wrinkle formation in the busbar by automating the process of applying the busbar material to the PVB surface prior to lamination.

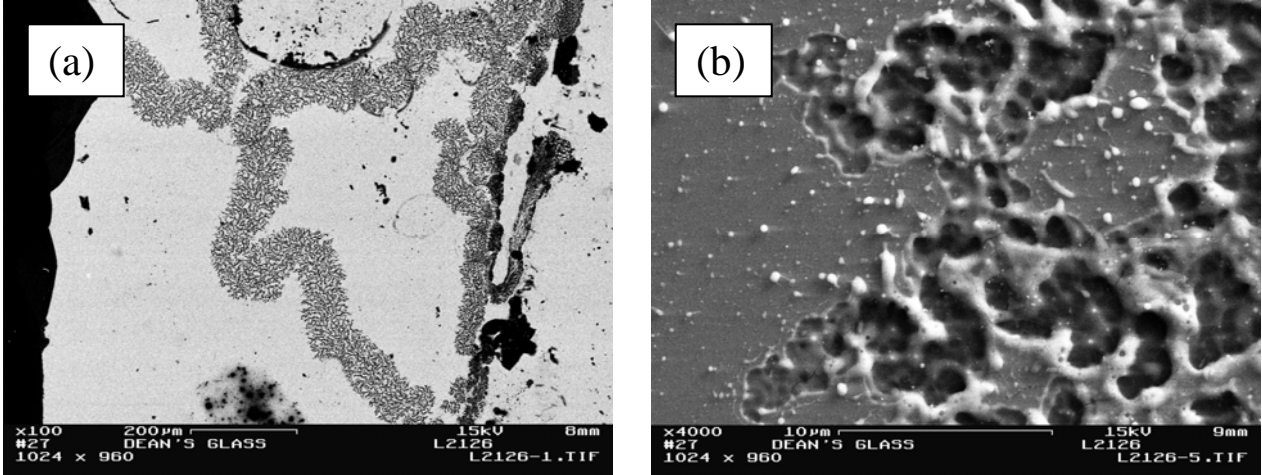
Scanning electron microscopic analysis of the “tracks” in the Sungate coating in the failed busbar/coating interface confirmed that an arc or arc-like process produced these features. Low magnification SEM micrographs of the lines (Figure 4a) indicated that they consist of a pattern of subfeatures in a fractal-like array. A higher magnification micrograph (Figure 4b) indicates that these smaller features are a series of interconnected pits, as might be expected to be formed by a continuous arcing process. Energy dispersive x-ray elemental mapping performed on the tracked samples while in the SEM instrument (Figure 5) showed that the major elements found in the pitted areas to be silicon and oxygen. This indicates that the pitting extends completely through the Sungate coating and into the underlying windshield glass.

Figure 4. SEM micrographs of “track” features on Sungate coating under the busbar in a failed sample of laminated windshield at increasing magnification.

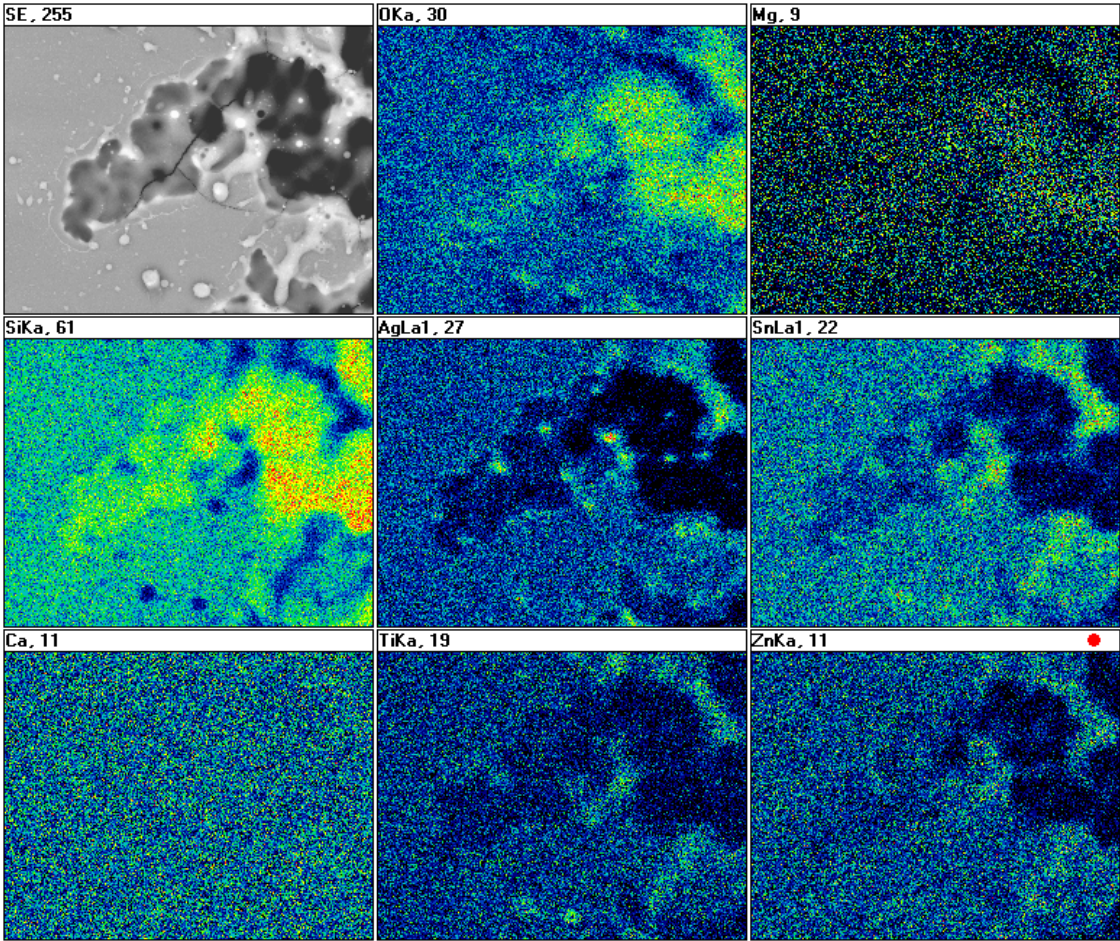
Figure 5. SEM image (top left) of pit area in damaged busbar/coating laminated sample and the corresponding EDX elemental maps for that image area.

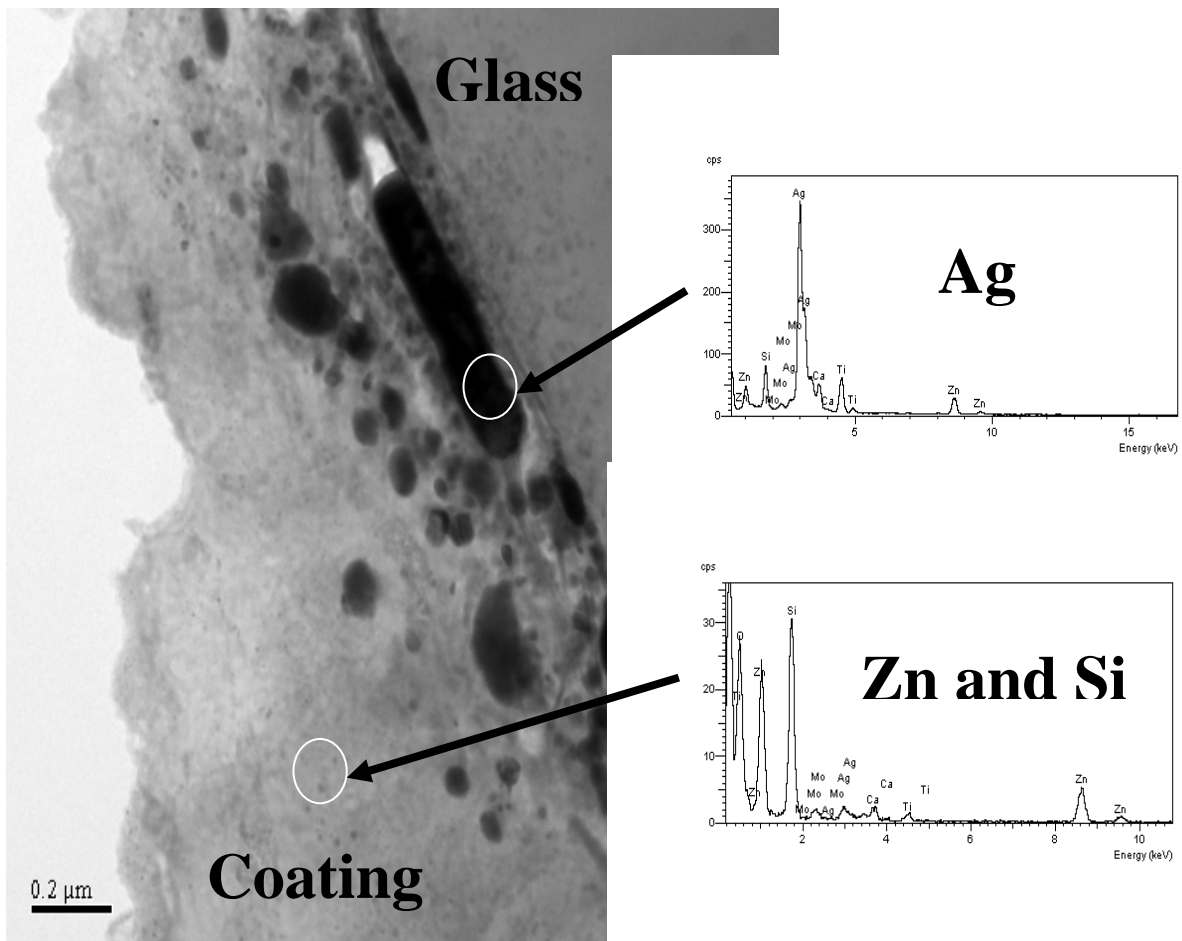
We had hoped to be able to perform TEM analysis on the busbar/coating interface to gain insight into the current transport mechanism between the copper and the conductive layers of the Sungate coating. However, because of poor adhesion between the copper and the glass coating, it was not possible to prepare an acceptable TEM section for this purpose. Some TEM analyses were performed on cross sections of just the coating on glass from the failed laminated sample. The results of these studies suggested that the silver, which is believed to act as the conductive layer in the Sungate coating, becomes discontinuous in the areas in which arcing has occurred. This effect is seen in the attached micrograph (Figure 6), in which silver was found to be segregated into pockets. This may help account for the lack of continuity between the busbar and coating after failure.

Figure 6. TEM micrograph of the glass/coating interface from failed (pitted) laminate.
