**Ultrasonic Examination of Double-Shell Tank 241-AW-102
Knuckle Region
Examination Completed February 2003**

AF Pardini
GJ Posakony

March 2003

Pacific Northwest National Laboratory
Richland, Washington 99352

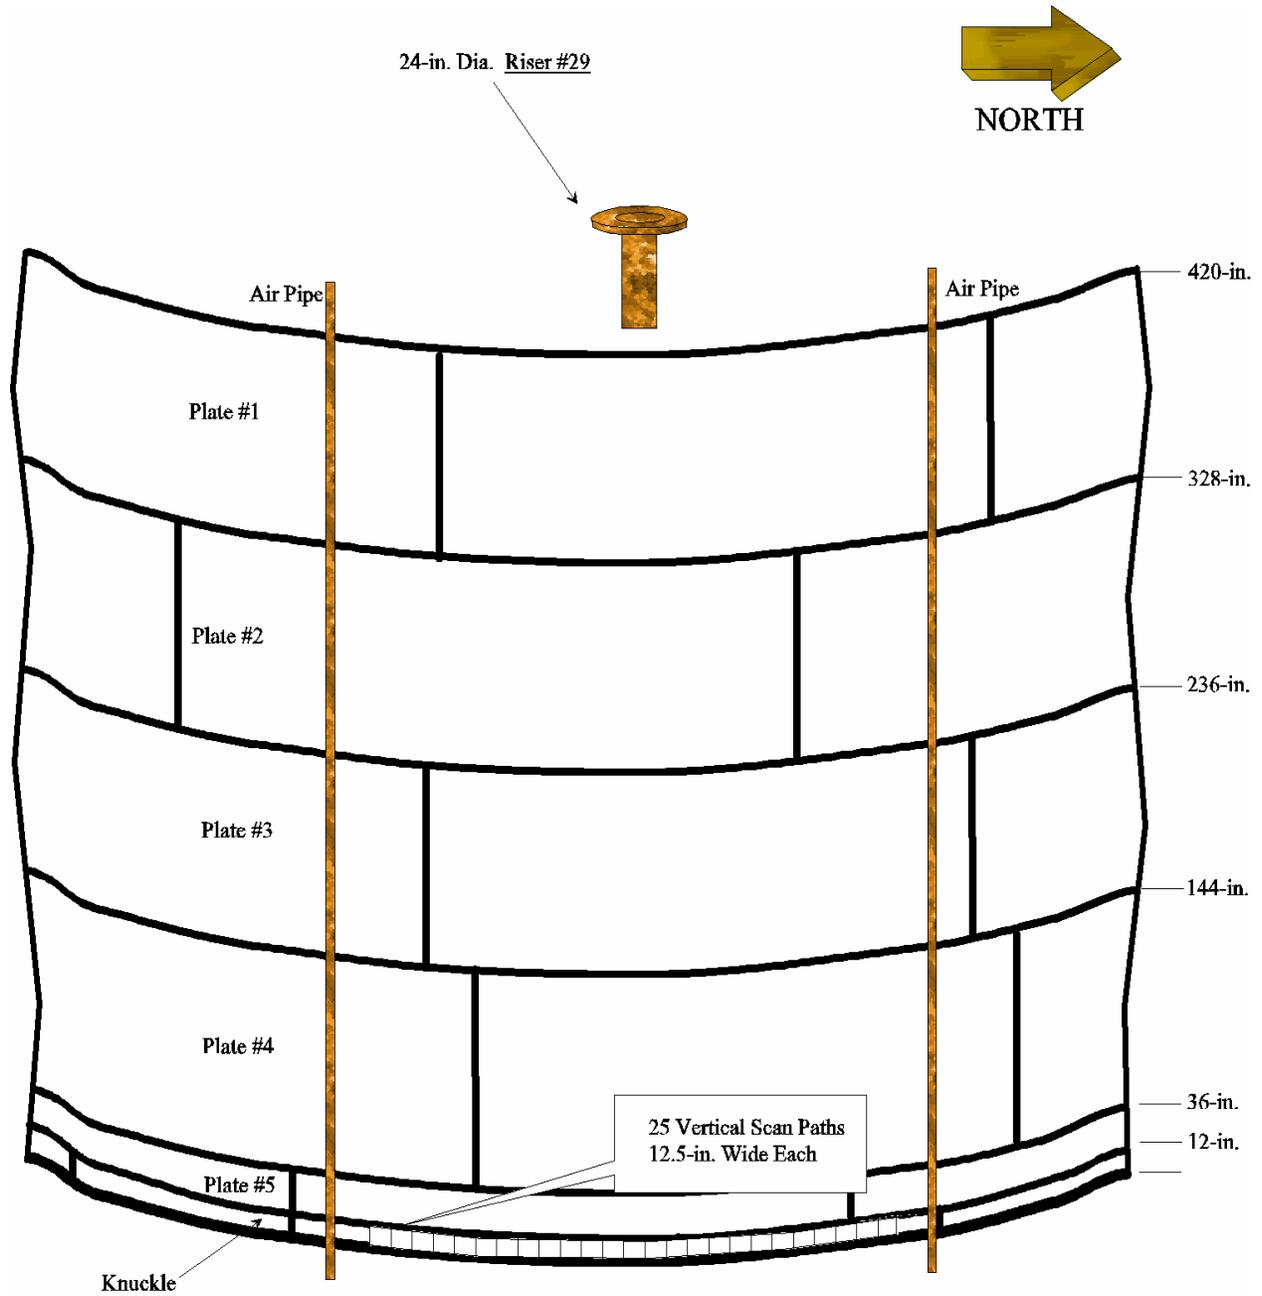
Figure 4.2 Sketch of Knuckle Inspection Scan Paths on Tank 241-AW-102

Figure 4.2 describes the area on the primary wall knuckle of Tank 241-AW-102 that was ultrasonically examined.

The examination consisted of 25 individual scans, each being 12.5 in. in width (circumferential direction). The crawler was moved around the circumference in 10-in. increments, thereby providing for a 2.5-in overlap during data acquisition. The total amount of knuckle scanned was approximately 250 in. measured circumferentially around the tank. The data was displayed in a C-scan (plan) view and provided an image of the entire knuckle, from upper knuckle weld to lower knuckle weld, inclusive of the predicted high-stress region. Further analysis was performed on selected data files by PNNL using the SAFT analysis algorithm to verify position of the lower knuckle weld.

The results of the examination of Tank 241-AW-102 indicated no circumferential cracking was present anywhere in the knuckle region between the upper knuckle weld and the lower knuckle weld over the approximately 250 circumferential inches scanned.
