**Pacific Northwest  
National Laboratory**

**Ultrasonic Examination of Double-Shell  
Tank 241-AP-103 Examination  
Completed April 2003**

June 2003

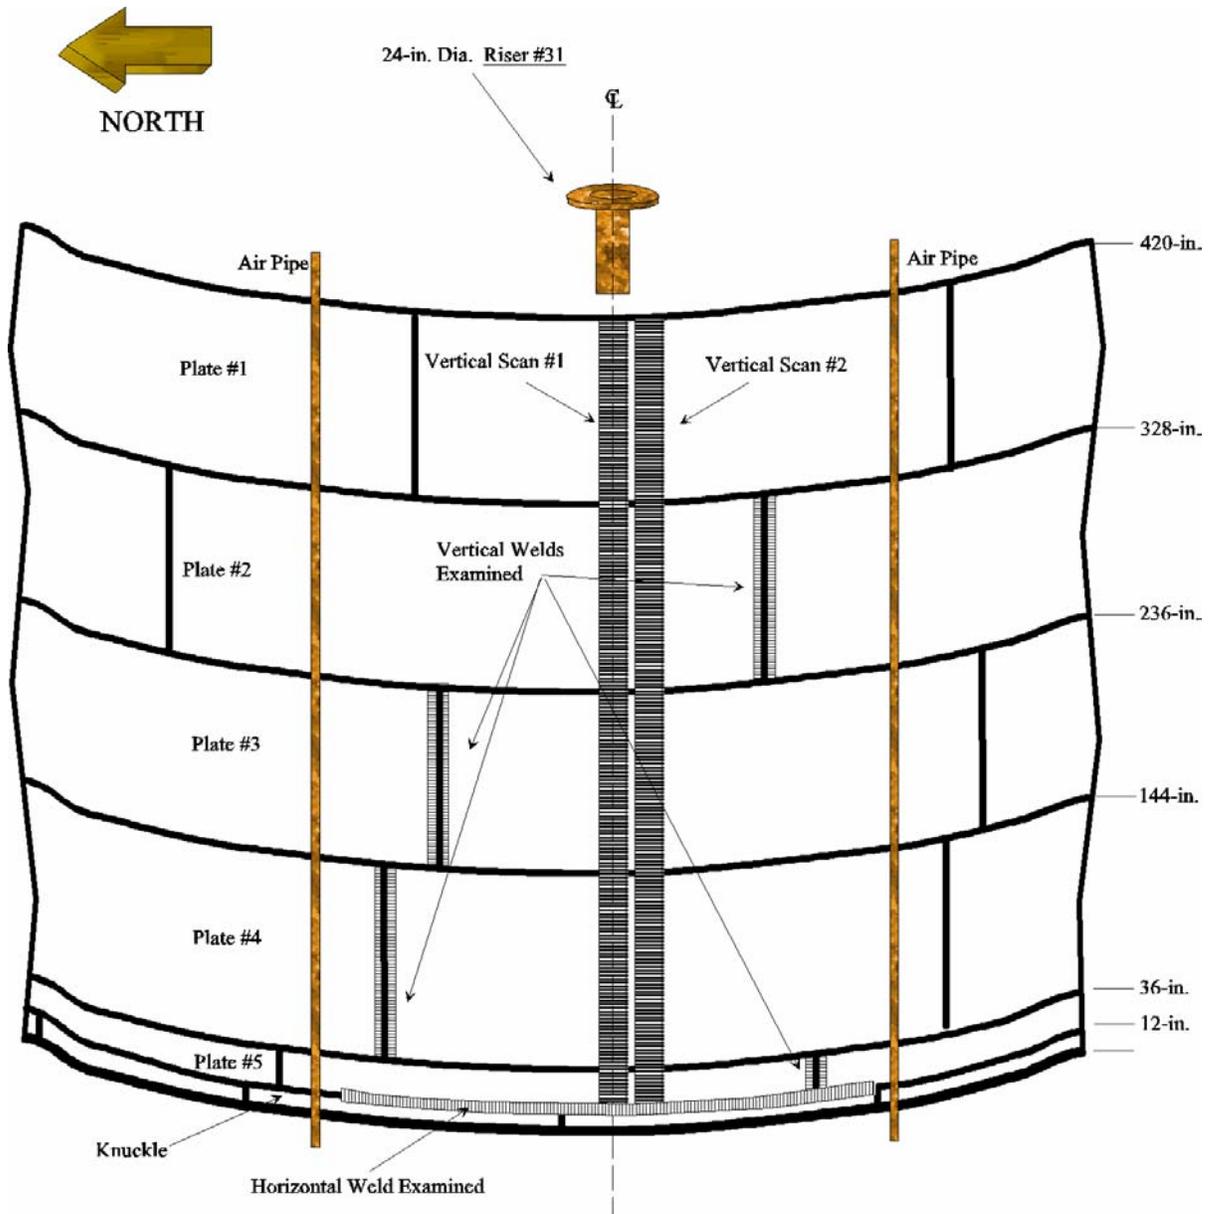
Figure 4.2. Sketch of Scan Paths on Tank 241-AP-103

Figure 4.2 describes the areas on the primary wall of Tank 241-AP-103 that were ultrasonically examined. Two 15-in.-wide vertical scan paths were performed on Plates #1, #2, #3, #4, and #5 below the entrance to Riser 31. Vertical weld HAZ examinations were done on Plates #2, #3, #4, and #5, and the horizontal weld HAZ examination was done on the transition Plate #5 to knuckle weld.

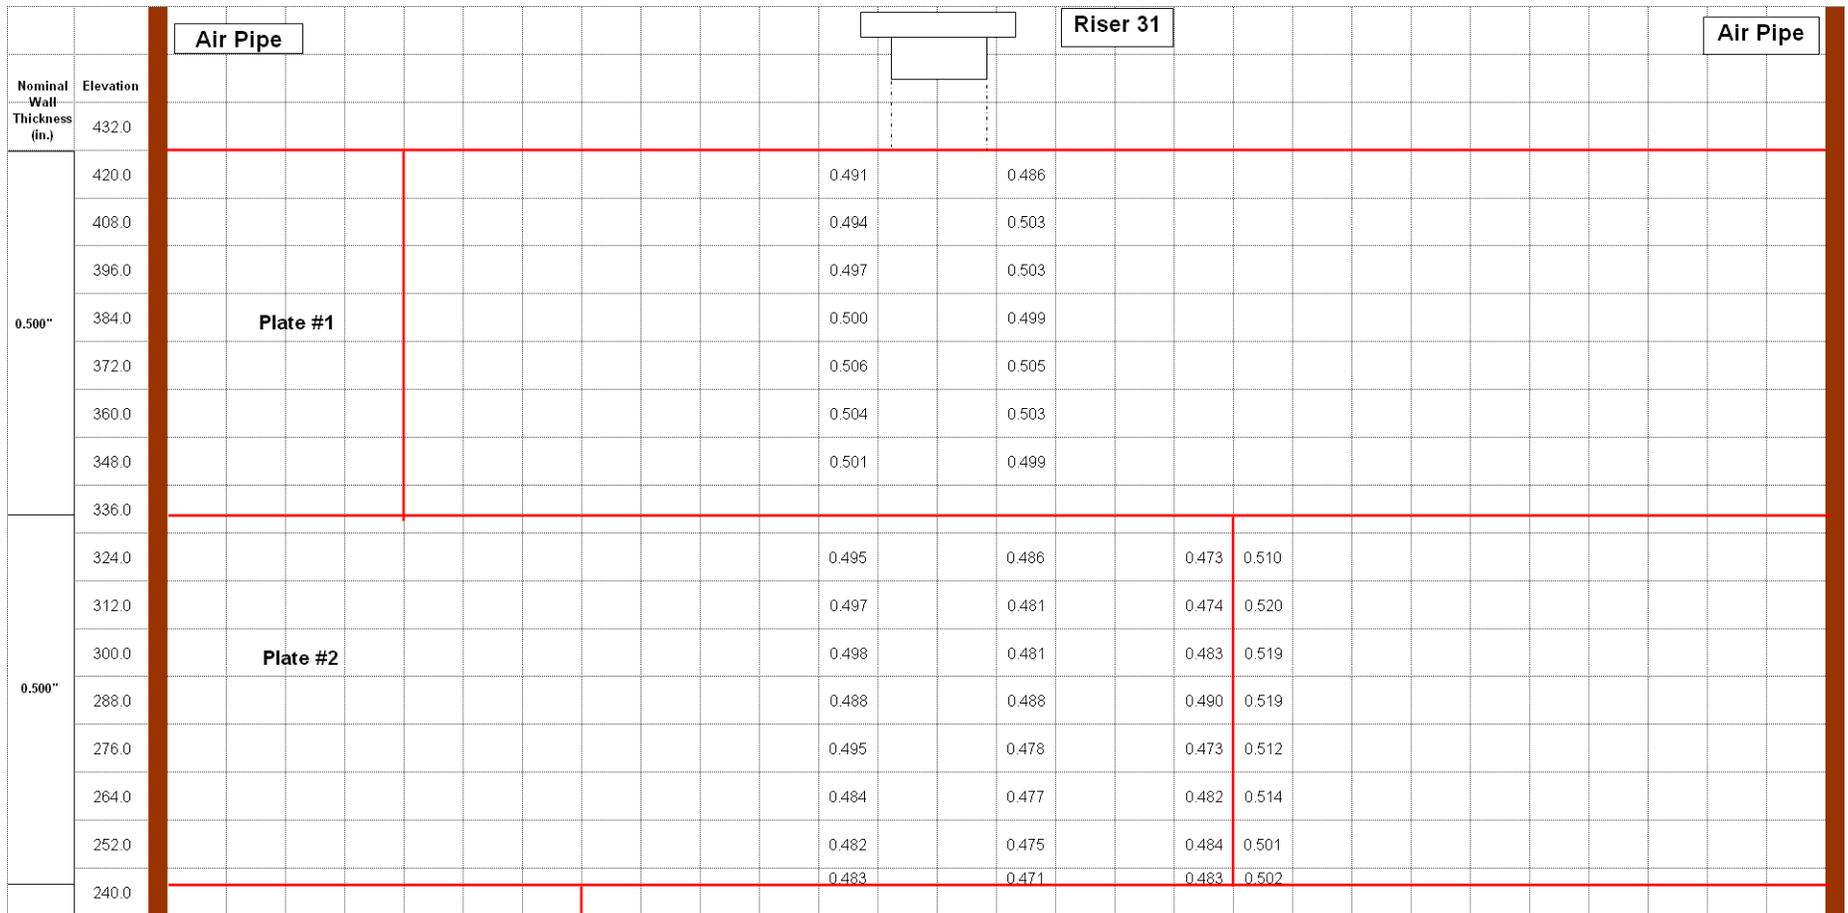
Figure 5.1. UT Data from Tank 241-AP-103

Figures 5.1 and 5.2 show the wall thickness examination results for the primary tank wall and the HAZs of both vertical and horizontal welds. The examination consisted of two vertical paths beneath the 24-in. diameter riser. Vertical scan #1 was 15-in. wide on Plates #1, #2, #3, #4, and #5 and started directly below the centerline of the 24-in. riser. Vertical scan #2 was adjacent to vertical scan #1 and was also 15-in. wide on Plates #1, #2, #3, #4, and #5. The HAZs of vertical welds in Plates #2, #3, #4, and #5 were examined and the HAZ in the horizontal weld between Plate #5 and the knuckle section was also examined. Areas in the figures that show two measurements in the same box are the result of the vertical scan paths overlapping the horizontal HAZ scan paths. Figures 5.1 and 5.2 display the minimum readings taken in each 15-in. wide by 12-in. long area of the scan. In the overlapping areas, both minimum readings from each of vertical and horizontal scan paths are given. The highlighted area in Plate #4 shows where the O.D. gouge was reported. The highlighted area in Plate #5 shows where the linear indication that is being further investigated was reported.

Two 15-in.-wide scan paths were performed on Plates #1, #2, #3, #4, and #5. The plates were examined for wall thinning, pitting, and cracks oriented vertically on the primary tank wall. The results indicated that the minimum thicknesses in the areas scanned with nominal thickness of 0.500-in. were as follows; Plate #1 was 0.486-in. and Plate #2 was 0.471-in. The nominal thickness in Plate #3 is 0.5625-in. and the minimum thickness in this area was 0.550-in. The nominal thickness in Plate #4 is 0.750-in. and the minimum thickness in this area was 0.737-in. The nominal thickness in Plate #5 is 0.875-in. and the minimum thickness in this area was 0.866-in. There were no areas of wall thinning that exceeded the reportable level of 10% of the nominal thickness. No pitting or vertical crack-like indications were detected in Plates #1, #2, #3, #4, or #5.

The HAZ of vertical welds in Plates #2, #3, #4, and #5 were examined for wall thinning, pitting and cracks oriented either perpendicular or parallel to the weld. The results indicated that the minimum thicknesses in the weld areas scanned were as follows: The nominal thickness of Plate #2 is 0.500-in. and the minimum thickness in this weld area was 0.473-in. The nominal thickness in Plate #3 is 0.5625-in. and the minimum thickness in this weld area was 0.541-in. The nominal thickness in Plate #4 is 0.750-in. and the minimum thickness in this weld area was 0.737-in. The nominal thickness in Plate #5 is 0.875-in. and the minimum thickness in this weld area was 0.844-in. There were no areas of wall thinning that exceeded the reportable level of 10% of the nominal thickness. No pitting or crack-like indications were detected in the weld areas in Plates #2 and #3. In Plate #4, an outside diameter (O.D.) indication was noted and was reported as a gouge. This indication was not considered a crack-like indication and did not originate on the inside diameter of the primary tank. The indication is located on the north side of the vertical weld in Plate #4 near the bottom of the plate. The gouge was reported as 1.42-in. in length and less than 0.100-in. in depth. In Plate #5, a linear indication 2.92-in. long was reported as an indeterminate indication. This indication is located approximately 6-in. below the horizontal weld between Plate #4 and Plate #5 and adjacent to (north) the vertical weld. This indication is being investigated and the results will be reported in a later document.

The HAZ of the horizontal weld between Plate #5 and the tank knuckle was examined for wall thinning, pitting and cracks oriented either perpendicular or parallel to the weld. The results indicated that the minimum thickness in the weld area with nominal thickness of 0.875-in. on Plate #5 was 0.838-in. The minimum thickness in the weld area with nominal thickness of 0.9375-in. on the knuckle was 0.887-in. There were no areas of wall thinning that exceeded the reportable level of 10% of the nominal thickness. No pitting or crack-like indications were detected in the weld areas on Plate #5 side or on the knuckle side of the horizontal weld.
