**Pacific Northwest  
National Laboratory**

**Ultrasonic Examination of Double-Shell  
Tank 241-SY-103 Examination  
Completed February 2004**

A.F. Pardini  
G.J. Posakony

February 2004

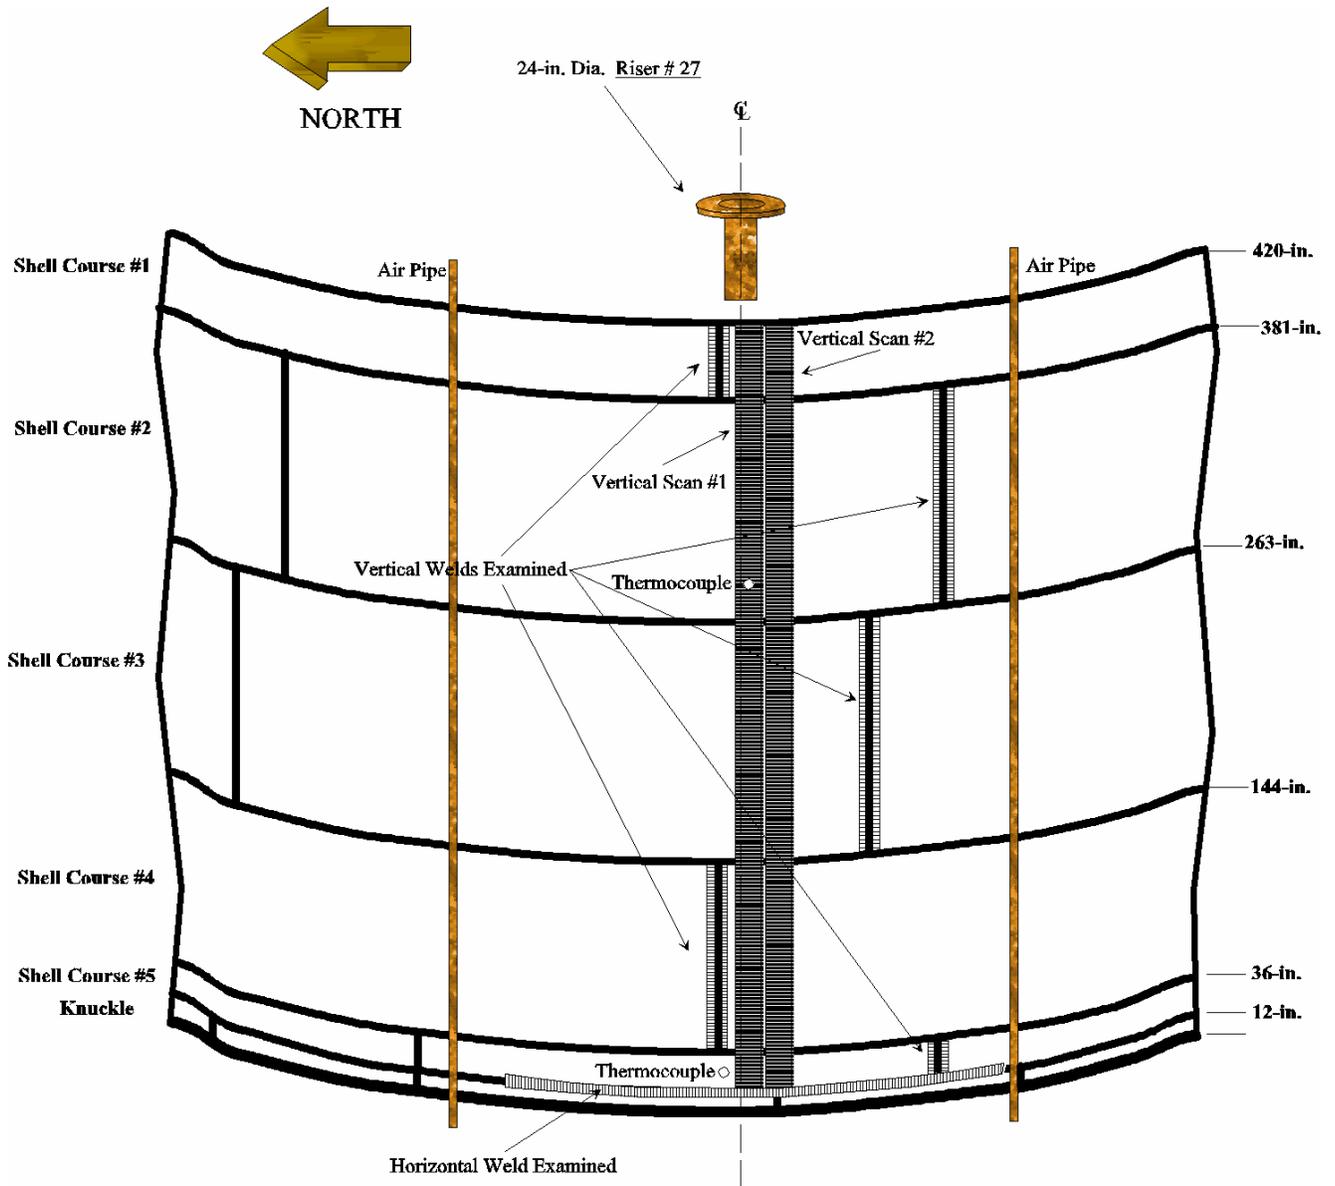
Figure 4.2. Sketch of Scan Paths on Tank 241-SY-103

Figure 4.2 describes the areas on the primary wall of Tank 241-SY-103 that were ultrasonically examined. Two 15-in.-wide vertical scan paths were performed on shell courses #1, #2, #3, #4, and #5 below the entrance to Riser 27. Vertical weld HAZ examinations were done on shell courses #1, #2, #3, #4, and #5, and the horizontal weld HAZ examination was done on the transition shell course #5 to knuckle weld.

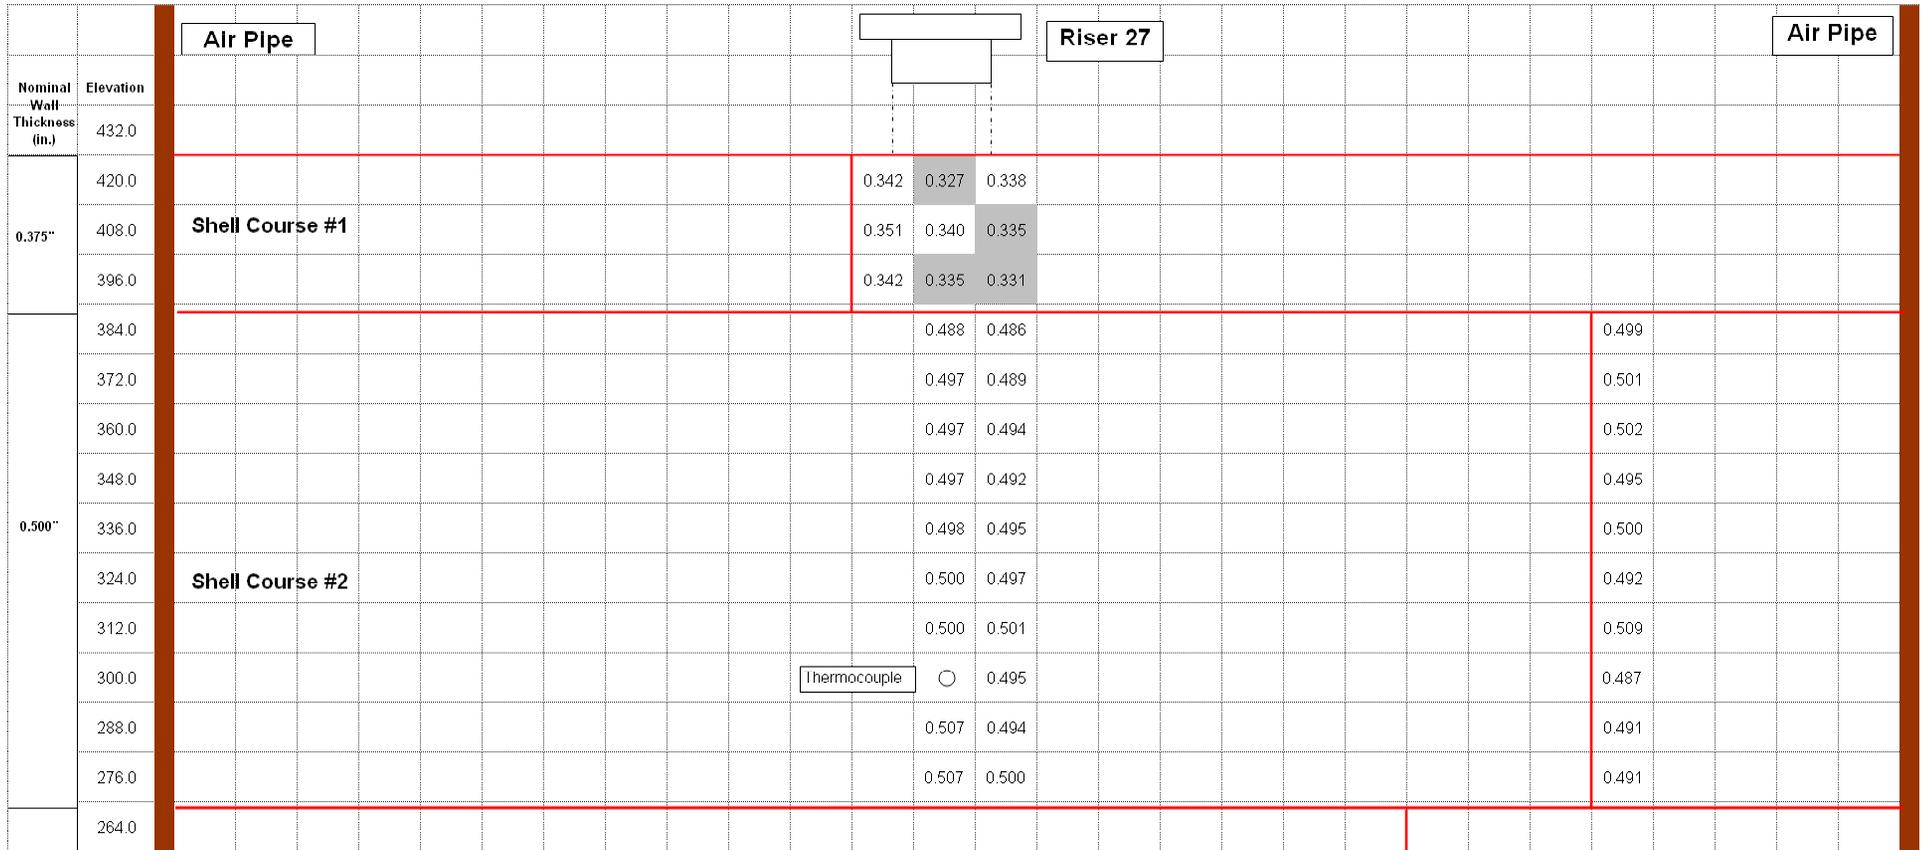
Figure 5.1. UT Data from Tank 241-SY-103

Figures 5.1 and 5.2 show the wall thickness examination results for the primary tank wall and the HAZs of both vertical and horizontal welds. The examination consisted of two vertical paths beneath the 24-in. diameter riser. Vertical scan #1 was 15-in. wide on shell courses #1, #2, #3, #4, and #5 and started below the centerline of the 24-in. riser. Vertical scan #2 was adjacent to vertical scan #1 and was also 15-in. wide on shell courses #1, #2, #3, #4, and #5. The HAZs of vertical welds in shell courses #1, #2, #3, #4, and #5 were examined and the HAZ in the horizontal weld between shell course #5 and the knuckle section was also examined. Areas in the figures that show two measurements in the same box are the result of the vertical scan paths overlapping the horizontal HAZ scan paths. Figures 5.1 and 5.2 display the minimum readings taken in each 15-in. wide by 12-in. long area of the scan. In the overlapping areas, both minimum readings from each of vertical and horizontal scan paths are given. The highlighted areas in shell course #1 show minimum wall thickness exceeded the reportable level of 10% of the nominal thickness.

Two 15-in.-wide scan paths were performed on shell courses #1, #2, #3, #4, and #5. The shell courses were examined for wall thinning, pitting, and cracks oriented vertically on the primary tank wall. The results indicated that the nominal thickness in shell course #1 was 0.375-in. and the minimum thickness was 0.327-in. The minimum thicknesses in the areas scanned with nominal thickness of 0.500-in. were as follows; shell course #2 was 0.486-in. and shell course #3 was 0.461-in. The nominal thickness in shell course #4 is 0.750-in. and the minimum thickness in this area was 0.708-in. The nominal thickness in shell course #5 is 0.875-in. and the minimum thickness in this area was 0.890-in. There were 4 areas of wall thinning that exceeded the reportable level of 10% of the nominal thickness. These areas were all located in shell course #1. No pitting or vertical crack-like indications were detected in shell courses #1, #2, #3, #4, or #5.

The HAZ of vertical welds in shell courses #1, #2, #3, #4, and #5 were examined for wall thinning, pitting and cracks oriented either perpendicular or parallel to the weld. The results indicated that the minimum thicknesses in the weld areas scanned were as follows: The nominal thickness of shell course #1 is 0.375-in. and the minimum thickness in this weld area was 0.342-in. The nominal thickness of shell course #2 is 0.500-in. and the minimum thickness in this weld area was 0.487-in. The nominal thickness in shell course #3 is 0.500-in. and the minimum thickness in this weld area was 0.486-in. The nominal thickness in shell course #4 is 0.750-in. and the minimum thickness in this weld area was 0.720-in. The nominal thickness in shell course #5 is 0.875-in. and the minimum thickness in this weld area was 0.887-in. There were no areas of wall thinning that exceeded the reportable level of 10% of the nominal thickness. No pitting or crack-like indications were detected in the weld HAZ areas in shell courses #1, #2, #3, #4, and #5.

The HAZ of the horizontal weld between shell course #5 and the tank knuckle was examined for wall thinning, pitting and cracks oriented either perpendicular or parallel to the weld. The results indicated that the minimum thickness in the weld area with nominal thickness of 0.875-in. on shell course #5 was 0.887-in. The minimum thickness in the weld area with nominal thickness of 0.875-in. on the knuckle was 0.837-in. There were no areas of wall thinning that exceeded the reportable level of 10% of the

nominal thickness. No pitting or crack-like indications were detected in the weld areas on shell course #5 side or on the knuckle side of the horizontal weld.
