**Pacific Northwest
National Laboratory**

**Ultrasonic Examination of Double-Shell
Tank 241-SY-101 Examination
Completed March 2004**

A.F. Pardini
G.J. Posakony

May 2004

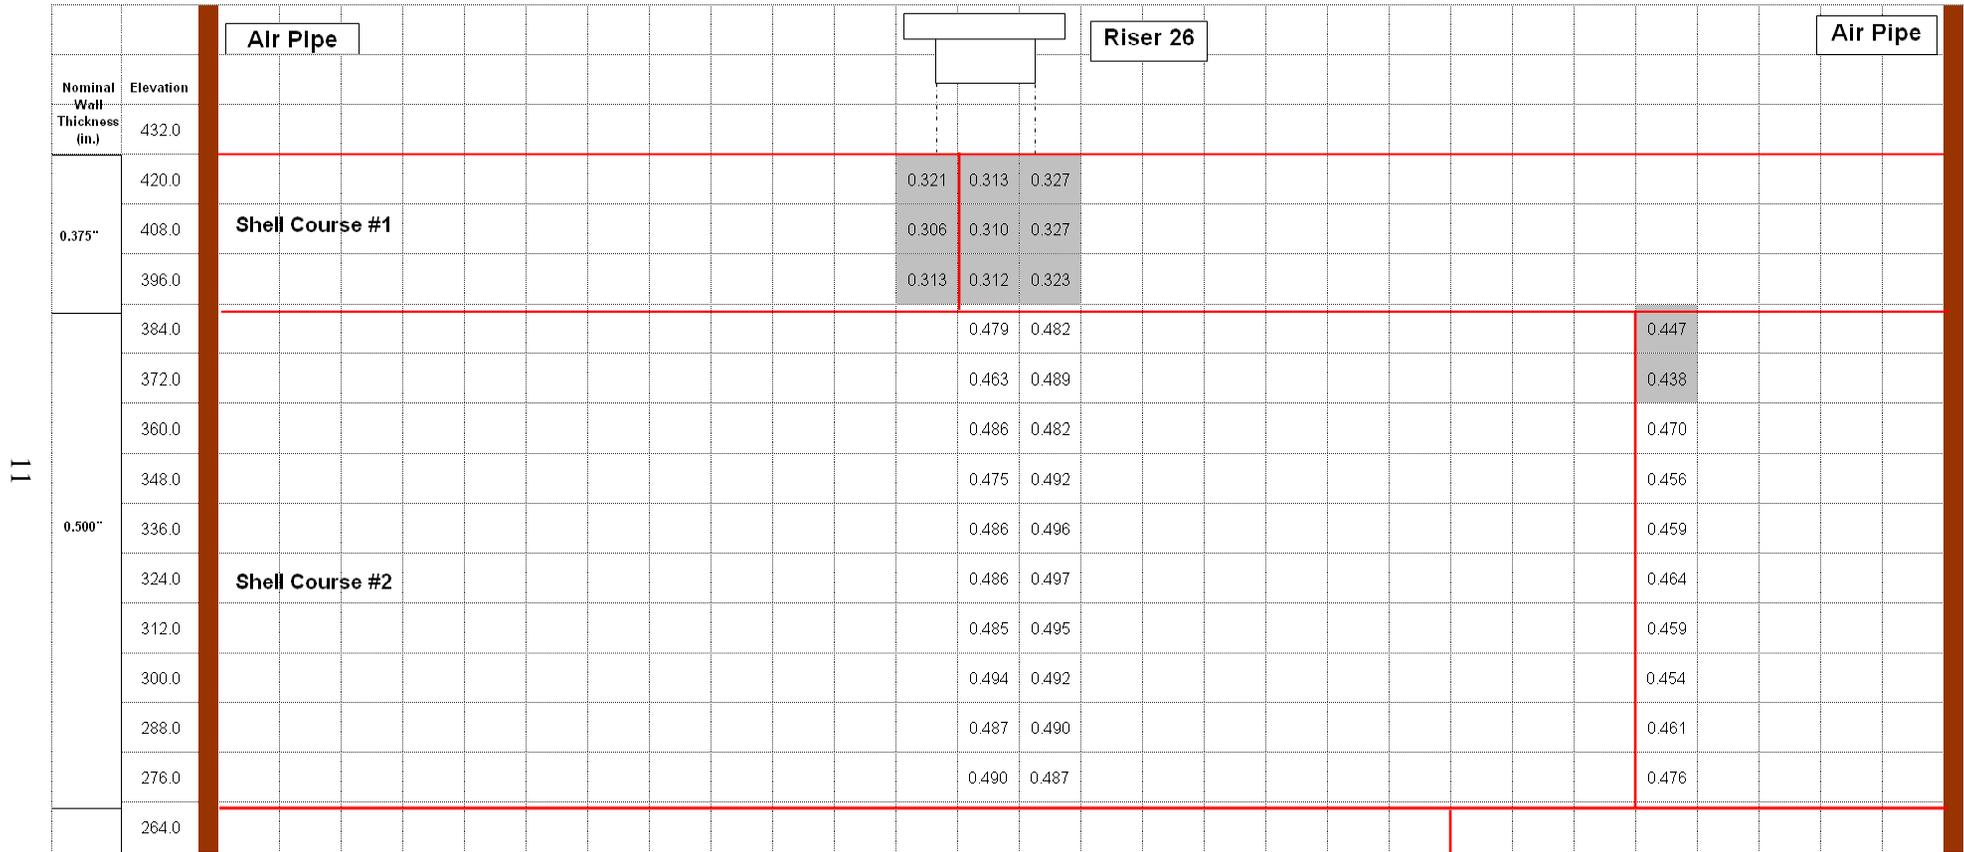
Figure 5.1. UT Data from Tank 241-SY-101

Figures 5.1 and 5.2 show the wall thickness examination results for the primary tank wall and the HAZs of both vertical and horizontal welds. The examination consisted of two vertical paths beneath the 24-in. diameter riser. Vertical path #1 was 15-in. wide on shell courses #1, #2, #3, #4, and #5 and started near the centerline of the 24-in. riser. Vertical path #2 was adjacent to vertical scan #1 (except in shell courses #1 and #4 where they were separated by a vertical weld) and was also 15-in. wide on shell courses #1, #2, #3, #4, and #5. The HAZs of vertical welds in shell courses #1, #2, #3, #4, and #5 were examined and the HAZ in the horizontal weld between shell course #5 and the knuckle section was also examined. Areas in the figures that show two measurements in the same box are the result of the vertical scan paths overlapping the horizontal HAZ scan paths. Figures 5.1 and 5.2 display the minimum readings taken in each 15-in. wide by 12-in. long area of the scan. In the overlapping areas, both minimum readings from each of vertical and horizontal scan paths are given. The highlighted areas in shell course #1 and #2 show minimum wall thickness exceeded the reportable level of 10% of the nominal thickness.

Two 15-in.-wide scan paths were performed on shell courses #1, #2, #3, #4, and #5. The shell courses were examined for wall thinning, pitting, and cracks oriented vertically on the primary tank wall. The results indicated that the nominal thickness in shell course #1 was 0.375-in. and the minimum measured thickness was 0.306-in. The minimum measured thicknesses in the areas scanned with nominal thickness of 0.500-in. were as follows; shell course #2 was 0.463-in. and shell course #3 was 0.485-in. The nominal thickness in shell course #4 is 0.750-in. and the minimum measured thickness in this area was 0.713-in. The nominal thickness in shell course #5 is 0.875-in. and the minimum measured thickness in this area was 0.897-in. There were 6 areas of wall thinning that exceeded the reportable level of 10% of the nominal thickness. These areas were all located in shell course #1. No pitting or vertical crack-like indications were detected in shell courses #1, #2, #3, #4, or #5.

The HAZ of vertical welds in shell courses #1, #2, #3, #4, and #5 were examined for wall thinning, pitting and cracks oriented either perpendicular or parallel to the weld. The results indicated that the minimum measured thicknesses in the weld areas scanned were as follows: The nominal thickness of shell course #1 is 0.375-in. and the minimum measured thickness in this weld area was 0.310-in. The nominal thickness of shell course #2 is 0.500-in. and the minimum measured thickness in this weld area was 0.438-in. The nominal thickness in shell course #3 is 0.500-in. and the minimum measured thickness in this weld area was 0.478-in. The nominal thickness in shell course #4 is 0.750-in. and the minimum measured thickness in this weld area was 0.705-in. The nominal thickness in shell course #5 is 0.875-in. and the minimum measured thickness in this weld area was 0.858-in. There were 3 areas of wall thinning that exceeded the reportable level of 10% of the nominal thickness in the HAZ of the vertical weld in shell course #1. There were 2 areas of wall thinning that exceeded the reportable level of 10% of the nominal thickness in the HAZ of the vertical weld in shell course #2. No pitting or crack-like indications were detected in the weld HAZ areas in shell courses #1, #2, #3, #4, and #5.

The HAZ of the horizontal weld between shell course #5 and the tank knuckle was examined for wall thinning, pitting and cracks oriented either perpendicular or parallel to the weld. The results indicated that the minimum measured thickness in the weld area with nominal thickness of 0.875-in. on shell course #5 was 0.855-in. The minimum measured thickness in the weld area with nominal thickness of 0.875-in. on the knuckle was 0.828-in. There were no areas of wall thinning that exceeded the reportable level of 10% of the nominal thickness. No pitting or crack-like indications were detected in the weld areas on the shell course #5 side or on the knuckle side of the horizontal weld.

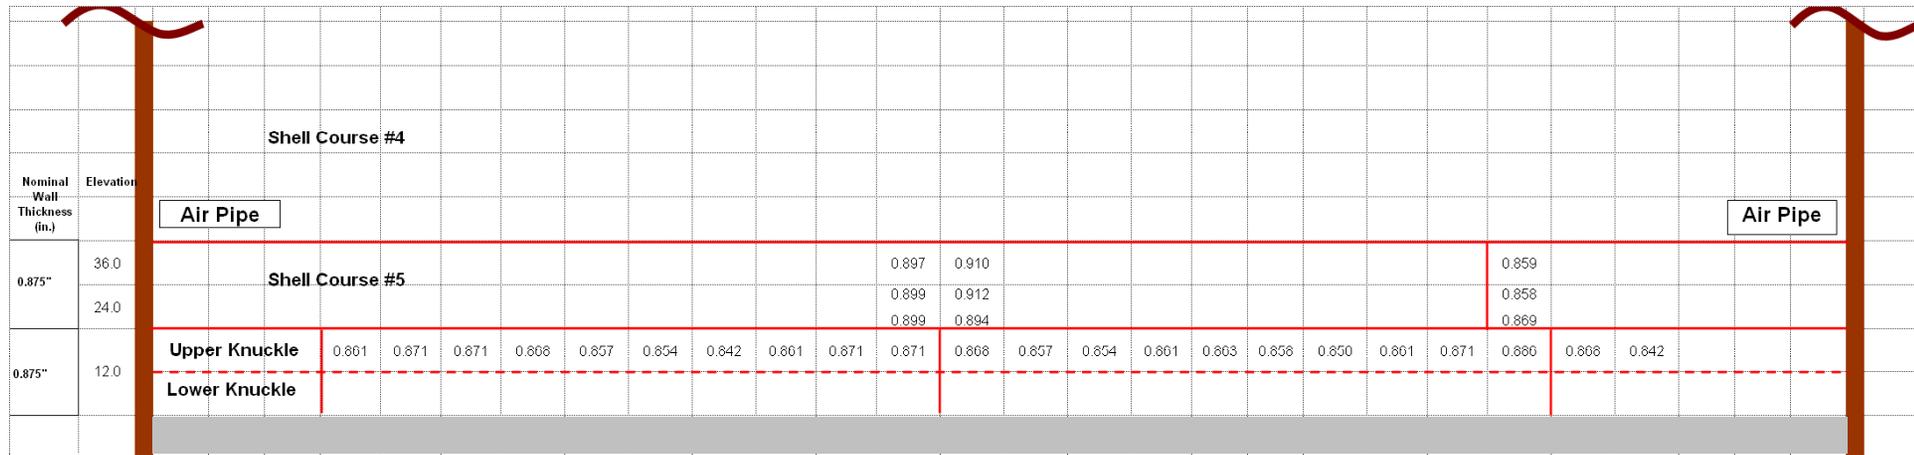
Figure 5.3 UT Data from Tank 241-SY-101 cont.

Figure 5.3 shows the examination performed on the knuckle of the primary tank wall. The readings distributed around the circumference of the tank knuckle represent the minimum reading in each 11-in. long by 12-in. wide portion extending down around the knuckle.

The upper portion of the knuckle area was scanned utilizing the Y-arm scanner attached to the AWS-5D crawler. The Y-arm scanned the transducers down around the knuckle approximately 11-in. from a starting position 1-in. down from the upper knuckle weld joining shell course #5 to the knuckle. The knuckle was examined for wall thinning, pitting, and cracks oriented circumferentially around the primary tank. The results indicated that the minimum measured thickness in the approximately 20 circumferential feet of knuckle area examined with nominal thickness of 0.875-in. was 0.842-in. There were no areas that exceeded the reportable level of 10% of the nominal thickness. No pitting or circumferentially oriented crack-like indications were detected in the upper portion of the knuckle area.
