**Pacific Northwest
National Laboratory**

**Ultrasonic Examination of Double-Shell
Tank 241-SY-102 Examination
Completed June 2004**

A.F. Pardini
G.J. Posakony

June 2004

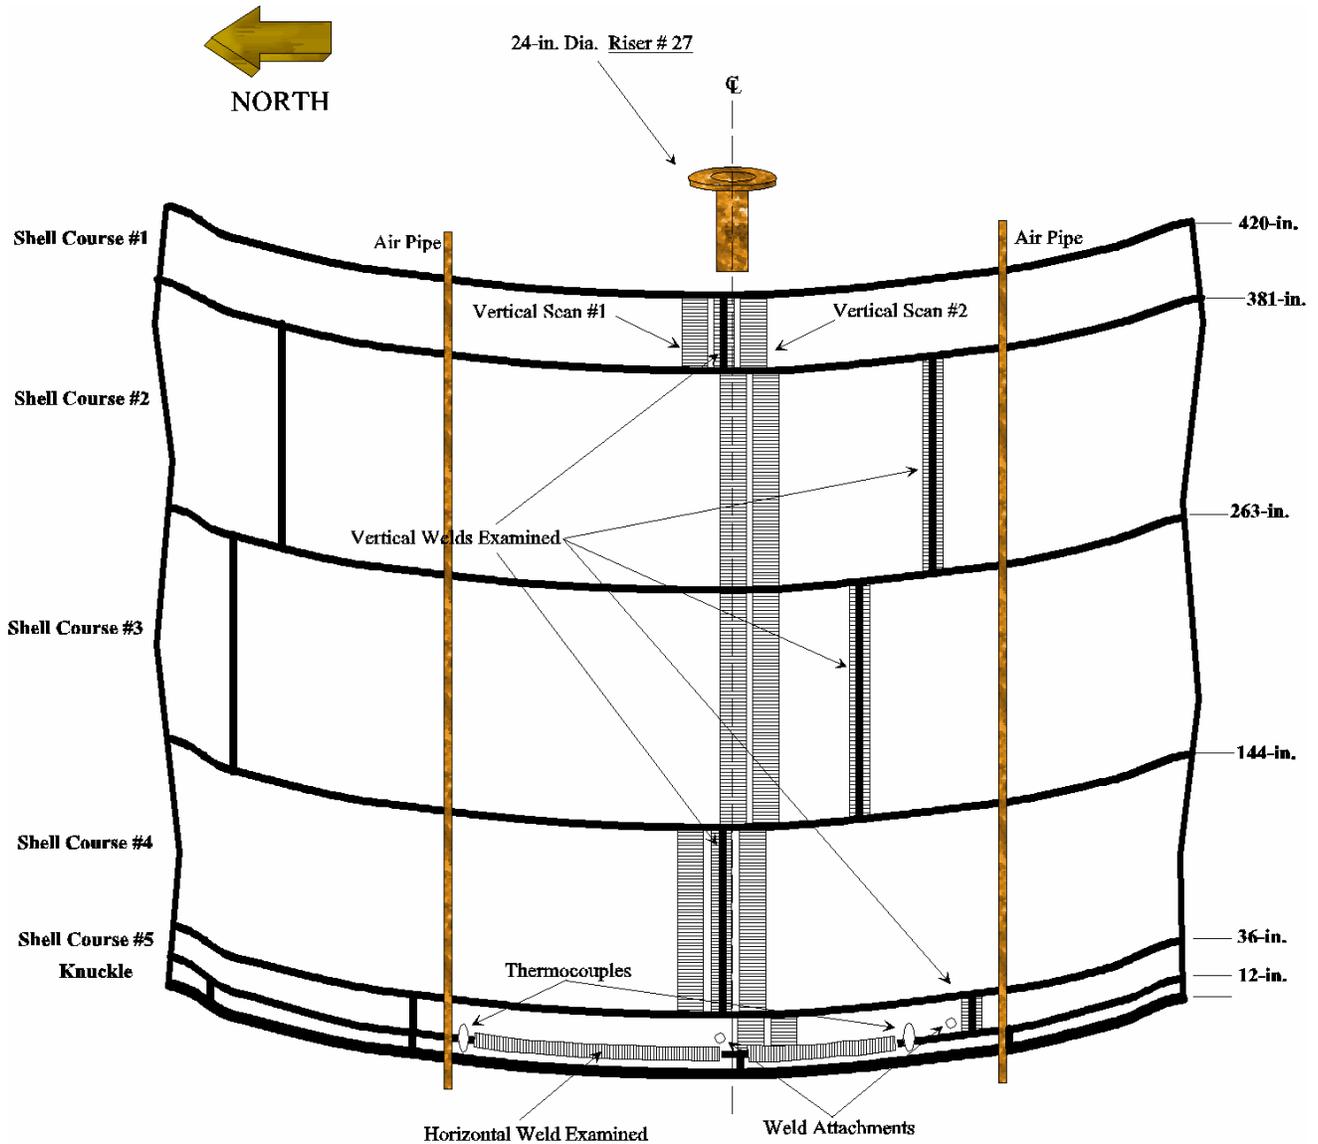
Figure 4.2. Sketch of Scan Paths on Tank 241-SY-102

Figure 4.2 describes the areas on the primary wall of Tank 241-SY-102 that were ultrasonically examined. Two 15-in.-wide vertical scan paths were performed on shell courses #1, #2, #3, #4, and #5 below the entrance to Riser 27. Vertical weld HAZ examinations were done on shell courses #1, #2, #3, #4, and #5, and the horizontal weld HAZ examination was done on the transition shell course #5 to knuckle weld.

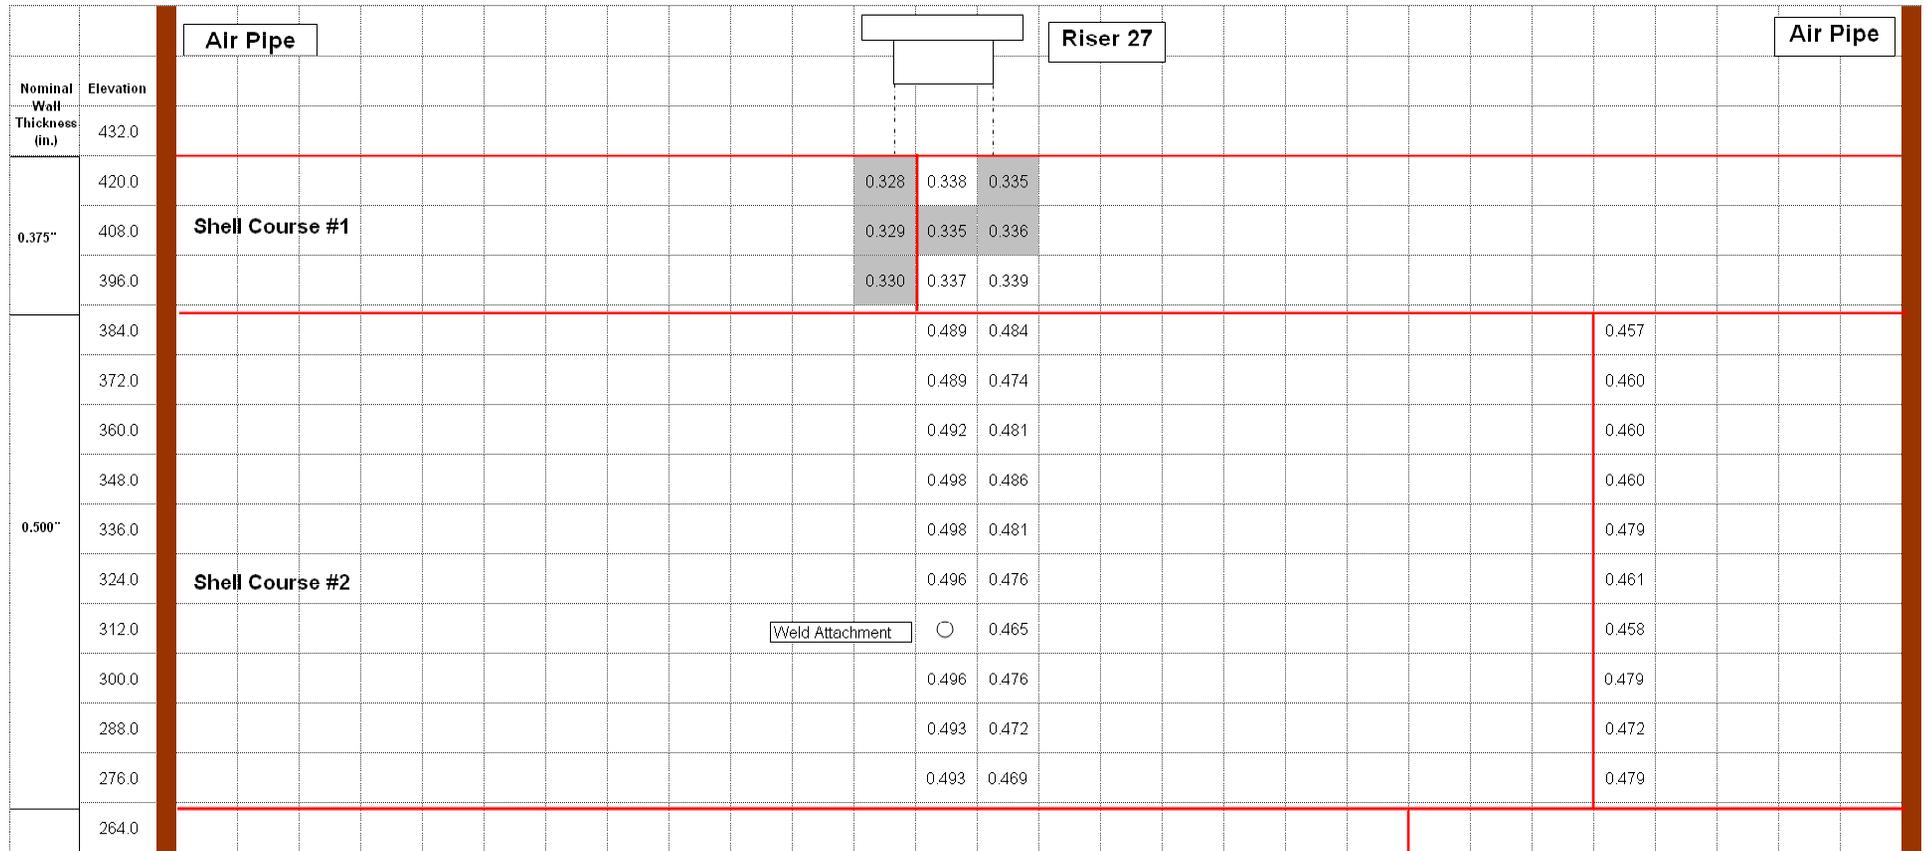
Figure 5.1. UT Data from Tank 241-SY-102

Figures 5.1 and 5.2 show the wall thickness examination results for the primary tank wall and the HAZs of both vertical and horizontal welds. The examination consisted of two vertical paths beneath the 24-in. diameter riser. Vertical scan #1 was 15-in. wide on shell courses #1, #2, #3, #4, and #5 and started near the centerline of the 24-in. riser. Vertical scan #2 was adjacent to vertical scan #1 (except in shell courses #1 and #4 where they were separated by a vertical weld) and was also 15-in. wide on shell courses #1, #2, #3, #4, and #5. The HAZs of vertical welds in shell courses #1, #2, #3, #4, and #5 were examined and the HAZ in the horizontal weld between shell course #5 and the knuckle section was also examined. Areas in the figures that show two measurements in the same box are the result of the vertical scan paths overlapping the horizontal HAZ scan paths. Figures 5.1 and 5.2 display the minimum readings taken in each 15-in. wide by 12-in. long area of the scan. In the overlapping areas, both minimum readings from each of vertical and horizontal scan paths are given. The highlighted areas in shell course #1 show minimum wall thickness exceeded the reportable level of 10% of the nominal thickness.

Two 15-in.-wide scan paths were performed on shell courses #1, #2, #3, #4, and #5. The shell courses were examined for wall thinning, pitting, and cracks oriented vertically on the primary tank wall. The results indicated that the nominal thickness in shell course #1 was 0.375-in. and the minimum thickness was 0.328-in. The minimum thicknesses in the areas scanned with nominal thickness of 0.500-in. were as follows; shell course #2 was 0.465-in. and shell course #3 was 0.477-in. The nominal thickness in shell course #4 is 0.750-in. and the minimum thickness in this area was 0.722-in. The nominal thickness in shell course #5 is 0.875-in. and the minimum thickness in this area was 0.835-in. There were 5 areas of wall thinning that exceeded the reportable level of 10% of the nominal thickness. These areas were all located in shell course #1. No pitting or vertical crack-like indications were detected in shell courses #1, #2, #3, #4, or #5.

The HAZ of vertical welds in shell courses #1, #2, #3, #4, and #5 were examined for wall thinning, pitting and cracks oriented either perpendicular or parallel to the weld. The results indicated that the minimum thicknesses in the weld areas scanned were as follows: The nominal thickness of shell course #1 is 0.375-in. and the minimum thickness in this weld area was 0.335-in. The nominal thickness of shell course #2 is 0.500-in. and the minimum thickness in this weld area was 0.457-in. The nominal thickness in shell course #3 is 0.500-in. and the minimum thickness in this weld area was 0.474-in. The nominal thickness in shell course #4 is 0.750-in. and the minimum thickness in this weld area was 0.734-in. The nominal thickness in shell course #5 is 0.875-in. and the minimum thickness in this weld area was 0.852-in. There was one area of wall thinning that exceeded the reportable level of 10% of the nominal thickness. The area was located in shell course #1. No pitting or crack-like indications were detected in the weld HAZ areas in shell courses #1, #2, #3, #4, and #5.

The HAZ of the horizontal weld between shell course #5 and the tank knuckle was examined for wall thinning, pitting and cracks oriented either perpendicular or parallel to the weld. The results indicated that the minimum thickness in the weld area with nominal thickness of 0.875-in. on shell course #5 was 0.871-in. The minimum thickness in the weld area with nominal thickness of 0.875-in. on the knuckle was 0.825-in. There were no areas of wall thinning that exceeded the reportable level of 10% of the

nominal thickness. No pitting or crack-like indications were detected in the weld areas on shell course #5 side or on the knuckle side of the horizontal weld.
