**Pacific Northwest
National Laboratory**

**Ultrasonic Examination of
Double-Shell Tank 241-AN-104
Examination Completed August 2005**

AF Pardini
GJ Posakony

September 2005

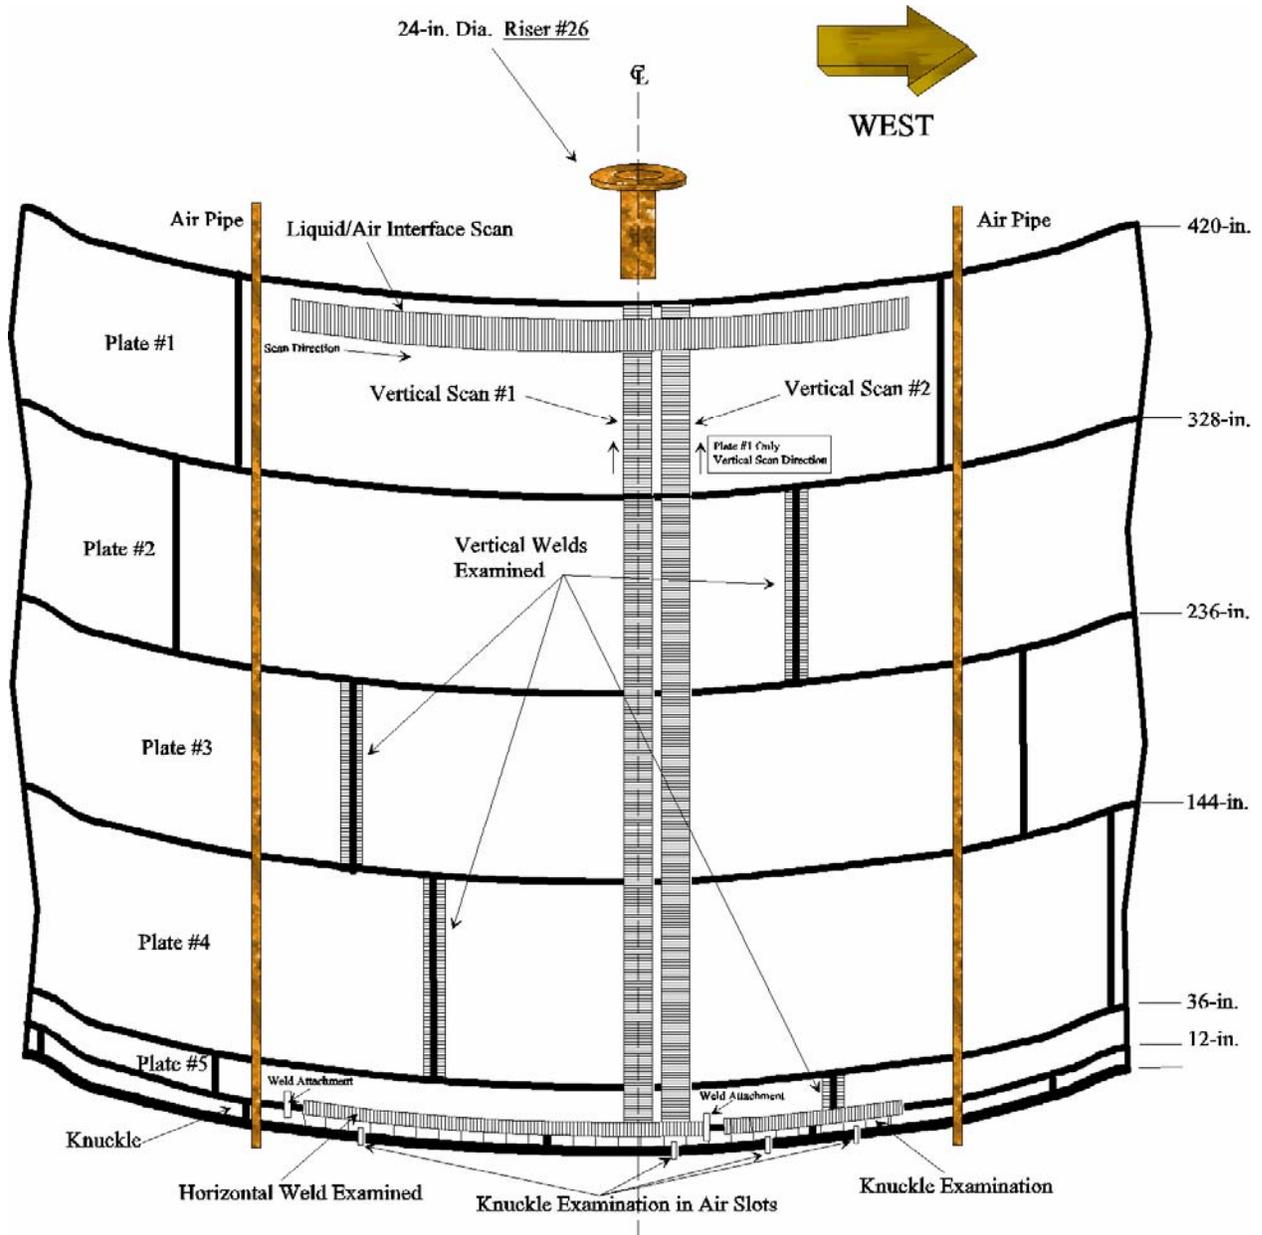
Figure 4.2. Sketch of Scan Paths on Tank 241-AN-104

Figure 4.2 describes the areas on the primary wall of Tank 241-AN-104 that were ultrasonically examined. Two 15-in.-wide (on some plates the scan was 17-in. wide) vertical scan paths were performed on Plates #1, #2, #3, #4, and #5 below the entrance to Riser 26. Vertical weld HAZ examinations were done on Plates #2, #3, #4, and #5, and the horizontal weld HAZ examination was done on the transition Plate #5 to knuckle weld. One additional horizontal scan path was performed in the liquid/air interface region on Plate #1, examination of the upper portion of the knuckle region, and 4 areas of the lower portion of the knuckle in the air slots.

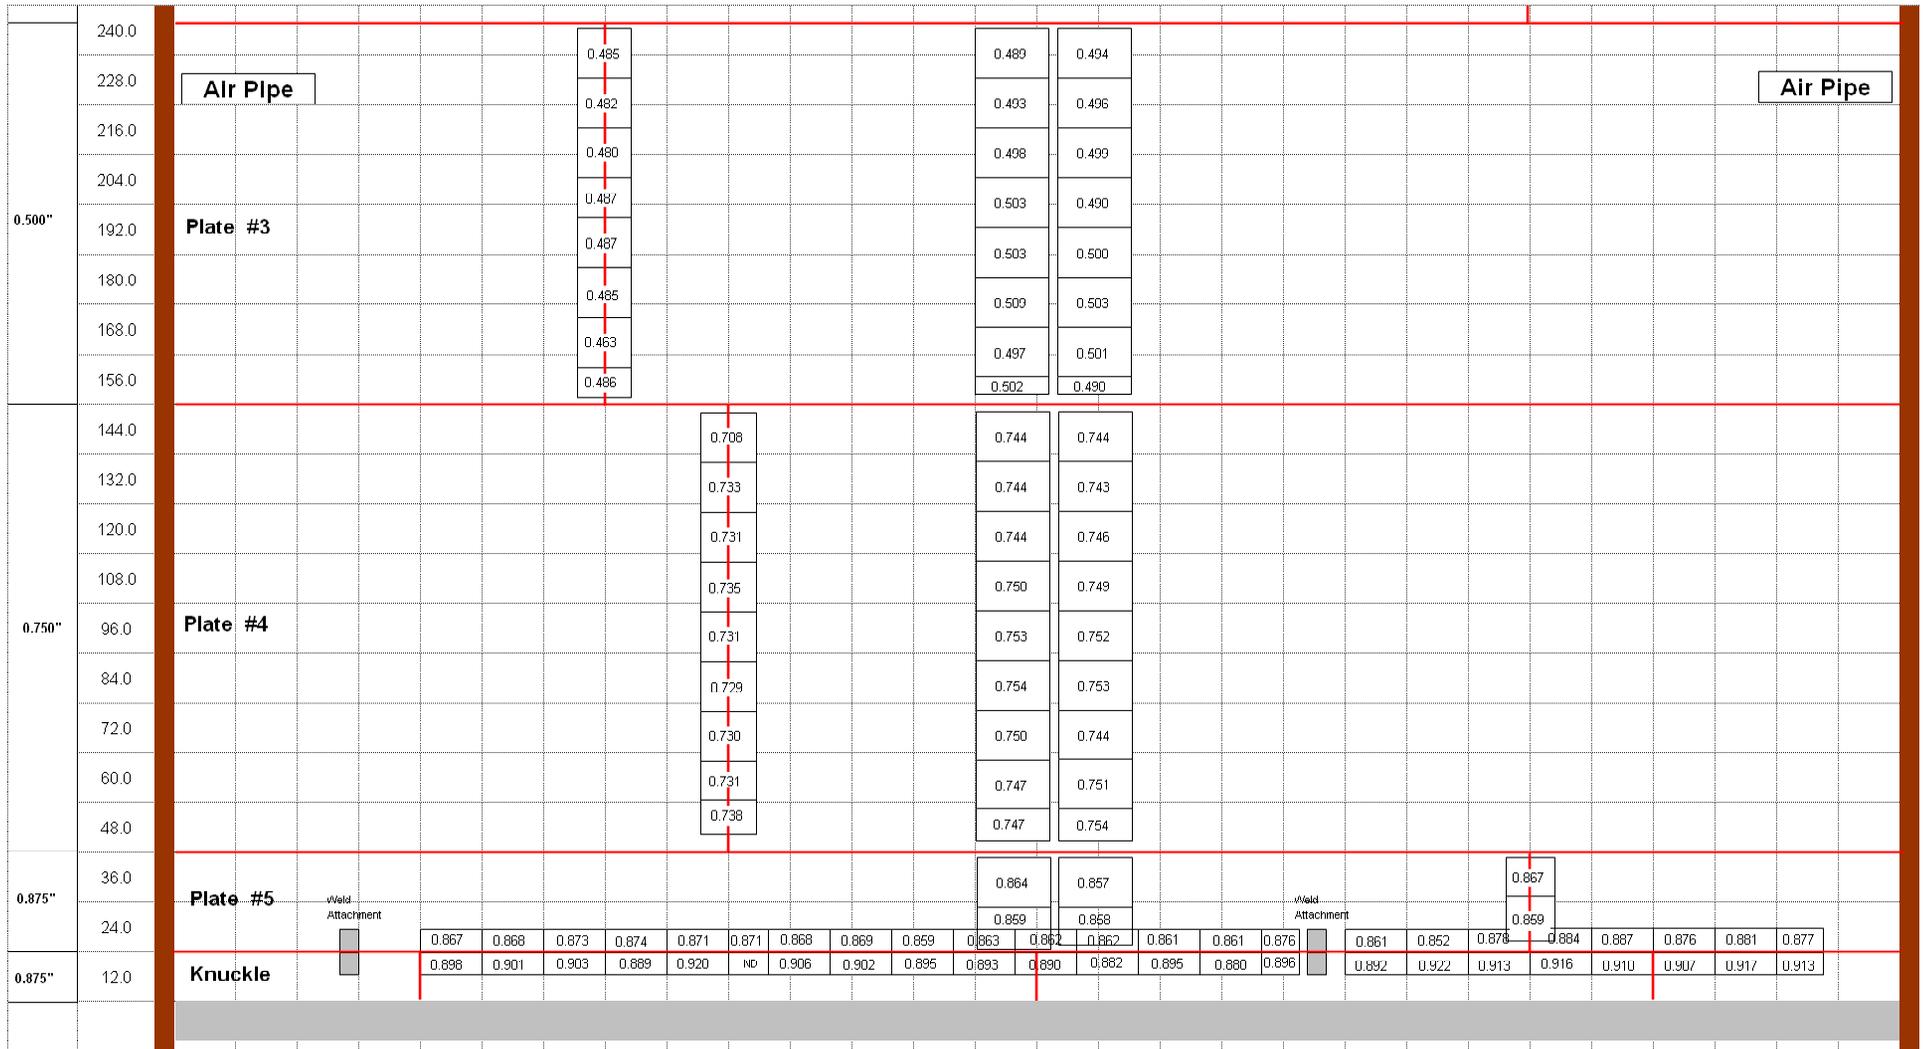
Figure 5.2. UT Data from Tank 241-AN-104 cont.

Figures 5.1 and 5.2 show the wall thickness examination results for the primary tank wall and the HAZs of both vertical and horizontal welds. The examination consisted of two vertical paths beneath the 24-in. diameter riser. Vertical scan #1 was 15-in. wide (on some plates the scan was 17-in. wide) on Plate #1, #2, #3, #4, and #5 near the centerline of the 24-in. riser. Vertical scan #2 was adjacent to vertical scan #1 and was also 15-in. wide (on some plates the scan was 17-in. wide) on Plate #1, #2, #3, #4, and #5. Vertical scans on Plate #1 were done in the upward direction due to modifications made to the crawler cable attachment. All other plates were done in the downward direction. The HAZs of vertical welds in Plates #2, #3, #4, and #5 were examined and the HAZ in the horizontal weld between Plate #5 and the knuckle section was also examined. Weld area exams include approximately 5-in. on each side of the weld. One 17-in. wide horizontal scan path on Plate #1 was performed in the liquid/air interface region. Areas in the figures that show two measurements in the same box are the result of the vertical scan paths overlapping the horizontal scan paths. Figures 5.1 and 5.2 display the minimum readings taken in each 15-in. (17-in. for some plates and the liquid/air interface horizontal scans) wide by 12-in. long area of the scan. In the overlapping areas, both minimum readings from each vertical and horizontal scan paths are given. Two areas on the horizontal weld examination had a weld attachment that limited data acquisition.

Two 15-in.-wide (on some plates the scan was 17-in. wide) scan paths were performed on Plates #1, #2, #3, #4, and #5. The plates were examined for wall thinning, pitting, and cracks oriented vertically on the primary tank wall. The results indicated that the minimum thicknesses in the areas scanned with nominal thickness of 0.500-in. were as follows; Plate #1 was 0.480-in., Plate #2 was 0.499-in., and Plate #3 was 0.489-in. The nominal thickness in Plate #4 is 0.750-in. and the minimum thickness in this area was 0.743-in. The nominal thickness in Plate #5 is 0.875-in. and the minimum thickness in this area was 0.857-in. There were no areas of wall thinning that exceeded the reportable level of 10% of the nominal thickness. No pitting or vertical crack-like indications were detected in Plates #1, #2, #3, #4, or #5.

The HAZ of vertical welds in Plates #2, #3, #4, and #5 were examined for wall thinning, pitting and cracks oriented either perpendicular or parallel to the weld. The results indicated that the minimum thicknesses in the weld areas scanned were as follows: The nominal thickness of Plate #2 is 0.500-in. and the minimum thickness in this weld area was 0.478-in. The nominal thickness in Plate #3 is 0.500-in. and the minimum thickness in this weld area was 0.463-in. The nominal thickness in Plate #4 is 0.750-in. and the minimum thickness in this weld area was 0.708-in. The nominal thickness in Plate #5 is 0.875-in. and the minimum thickness in this weld area was 0.859-in. There were no areas of wall thinning that exceeded the reportable level of 10% of the nominal thickness. No pitting or crack-like indications were detected in the weld areas in Plates #2, #3, #4, and #5.

The HAZ of the horizontal weld between Plate #5 and the tank knuckle was examined for wall thinning, pitting and cracks oriented either perpendicular or parallel to the weld. The results indicated that the minimum thickness in the weld area with nominal thickness of 0.875-in. on Plate #5 was 0.852-in. The minimum thickness in the weld area with nominal thickness of 0.875-in. on the knuckle was 0.880-in. There were no areas of wall thinning that exceeded the reportable level of 10% of the nominal thickness. No pitting or crack-like indications were detected in the weld areas on Plate #5 side or on the knuckle side of the horizontal weld.
