PNNL-17488 Rev.1

Ultrasonic Examination of Double-Shell Tank 241-AP-107 Examination Completed February 2008

September 2008

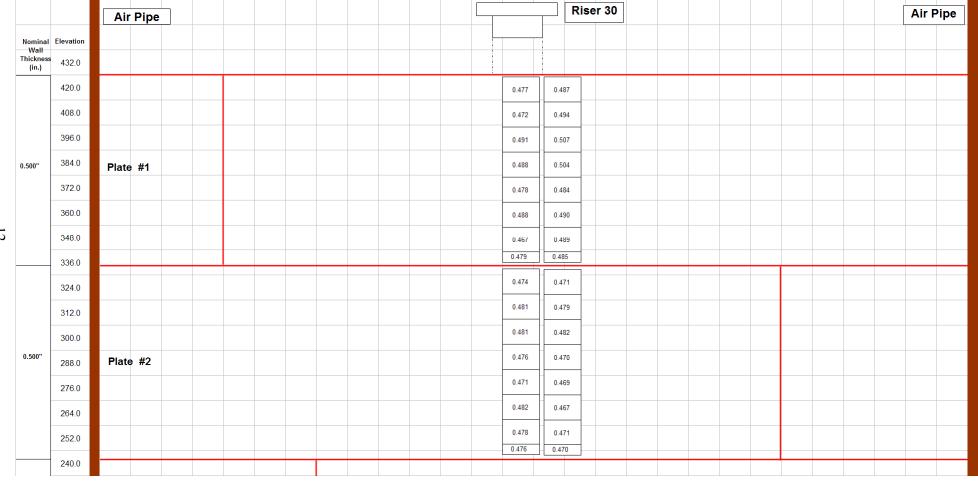
Figure 5.1. UT Data from Tank 241-AP-107 Riser 30

Figures 5.1 and 5.2 show the wall thickness examination results for the primary tank wall taken below Riser 30. The examination consisted of two vertical paths beneath the 24-in. diameter riser. Vertical scan #1 was 15-in.-wide on Plate #1, #2, #3, #4, and #5 near the centerline of the 24-in. riser. Vertical scan #2 was adjacent to vertical scan #1 and was also 15-in.-wide on Plates #1, #2, #3, #4, and #5. Vertical scans were conducted in the downward direction. Figures 5.1 and 5.2 display the minimum readings taken in each 15-in.-wide by 12-in.-long area of the scan.

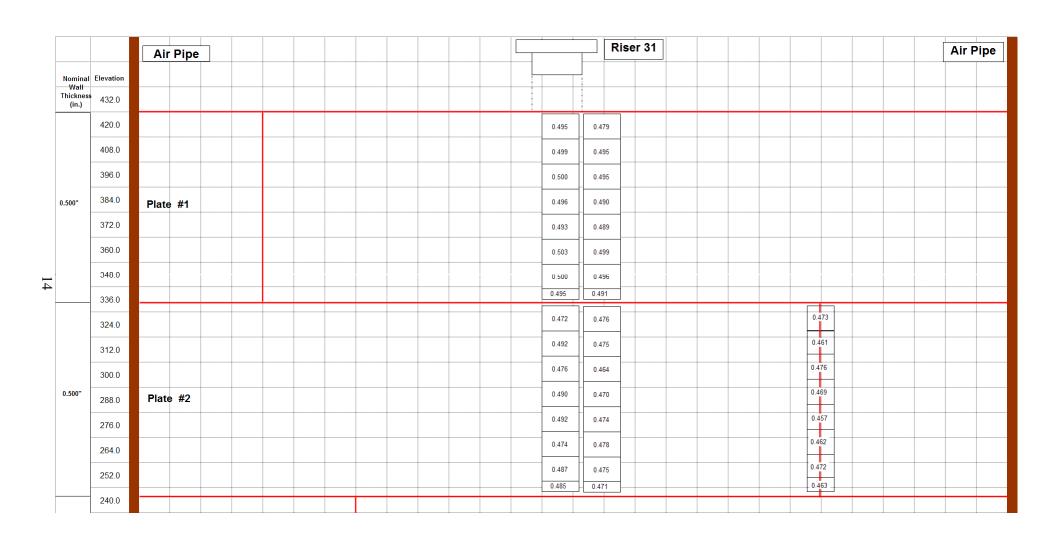
Figure 5.3. UT Data from Tank 241-AP-107 Riser 31

Figures 5.3 and 5.4 show the wall thickness examination results for the primary tank wall and the HAZs of both vertical and horizontal welds taken below Riser 31. The examination consisted of two vertical paths beneath the 24-in. diameter riser. Vertical scan #1 was 15-in.-wide on Plate #1, #2, #3, #4, and #5 near the centerline of the 24-in. riser. Vertical scan #2 was adjacent to vertical scan #1 and was also 15-in.-wide on Plates #1, #2, #3, #4, and #5. Vertical scans were conducted in the downward direction. Figures 5.3 and 5.4 display the minimum readings taken in each 15-in.-wide by 12-in.-long area of the scan. The HAZs of vertical welds in Plates #2, #3, #4, and #5 were examined and the HAZ in the horizontal weld between Plate #5 and the knuckle section was also examined. Weld area exams include approximately 5-in. on each side of the weld and figures 5.3 and 5.4 display the minimum readings taken in each 5-in.-wide by 12-in.-long area of the scan. Areas in the figures that show two measurements in the same box are the result of the vertical scan paths overlapping the horizontal scan paths. In the overlapping areas, both minimum readings from each vertical and horizontal scan paths are given.

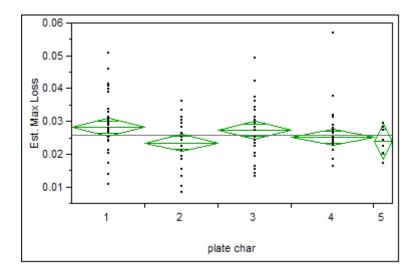
Figure 6.2. Estimated Maximum Loss by Plate

The estimated wall thickness maximum losses for Tank 241-AP-107 are shown across plates in Figure 6.2. The vertical extent of the green diamonds represents confidence intervals for the means within each plate (the widths of the diamonds reflect the number of UT measurements per plate). Statistically these means are at most only very marginally different, so for this reason it could be deemed appropriate to combine the measurements across all plates, and that is indeed done in the following for extreme value analysis, in addition to giving results for the individual plates. But the extreme value results actually depend more on the large values in the upper tails of plates' distributions than on the plate means. For this reason alternative groupings are considered; plates 1, 3, and 4 are combined since they have all the outlying larger values, and plates 2 and 5 are combined since they do not. Thus extreme value results are given for these latter groupings as well.

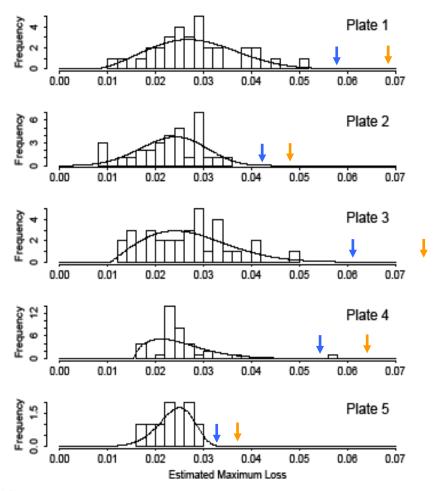
Figure 6.3. Weibull Distribution Fits to UT Maximum Wall Thickness Loss by Plate Course

The histograms in Figure 6.3 show estimated maximum wall thickness loss data for the individual plate courses. Three-parameter Weibull distributions are fit to these histograms and are shown as the smooth curves. The total surface area of a plate course, and thus the number of 15-in. by 12-in. UT images needed to 100% inspect the entire plate course is computed. The percentile of the distribution that then corresponds to the maximum expected loss among this many UT images, based on the distribution fit

The values indicated by the arrows on the histograms are the estimated worst case losses per plate course (blue, to the left) and their associated 95% confidence bounds (orange, to the right). The corresponding values are given in the table shown in Figure 6.4. Included in the table are: 1) the number of measurements, 2) the estimated extreme value loss expected for the plate course around the entire circumference of the tank, and 3) the 95% confidence bound for the extreme value loss.

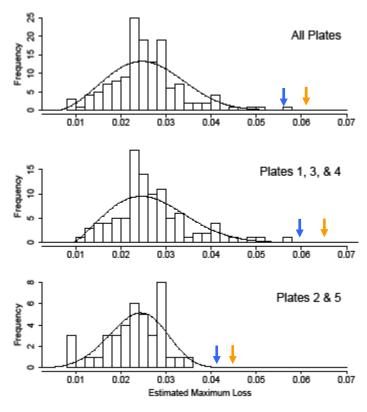
Figure 6.5. Weibull Distribution Fit to Combined UT Maximum Wall Thickness Loss

Since there is little reason to expect differences in the Plate 1,3,4 and Plate 2,5 groupings, and since little difference is shown between the individual plate distributions as well, the best estimate for this tank is probably the all plates combined case with worst case estimate 0.057-in. loss and 0.061-in bound. Recall these describe the expected worst case "measured loss" that reflects both actual wall thickness variability and measurement uncertainty. In addition recall that these losses should not be considered relative to the tank drawing nominal values, but rather relative to the estimated plate maximum values given in the table of Figure 6.1.

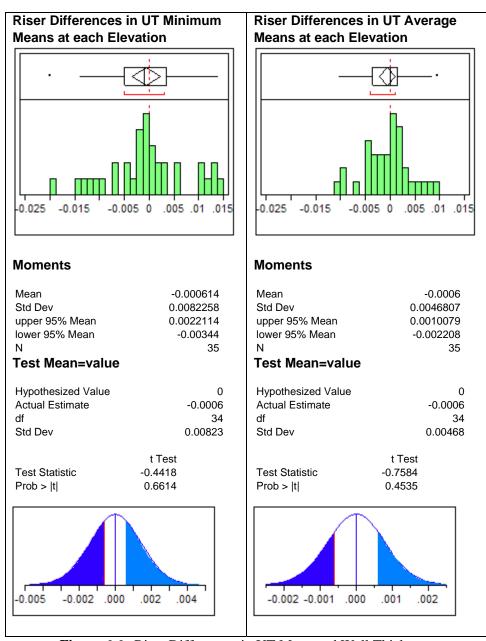
Figure 6.6. Riser Differences in UT Measured Wall Thickness

For both the UT minimum values and the UT average values no differences are indicated between risers on the average. Histograms centered at zero at the top of the figure indicate this. Note however the

greater variability in the riser differences in UT image minima than in UT image averages. Information below the histograms gives the t-test results for the differences. The blue shading in the bottom figures show how no statistical differences were observed. If statistically significant riser differences had been found, there would be very little blue area showing in those bottom figures (this will be observed in the next section on old versus new inspection results).

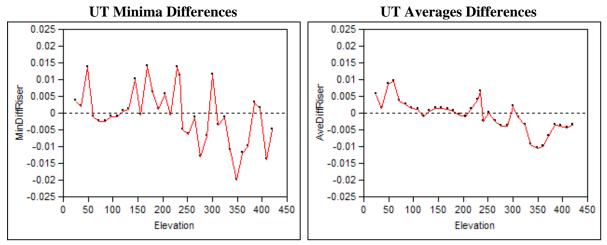
Figure 6.7. Riser 30 minus Riser 31 Differences

This riser difference result continues to suggest that UT inspections using single risers may prove sufficient. However, an interesting comparison is shown in Figure 6.7. Here the riser differences (Riser 30 minus Riser 31) are plotted by elevation. What is shown is that the measured Riser 30 wall thicknesses tended to exceed those of Riser 31 at the lower tank elevations while the opposite result held at the higher elevations. Thus on the average, as in Figure 6.6, no overall difference was indicated. No explanation for this pattern has been sought.

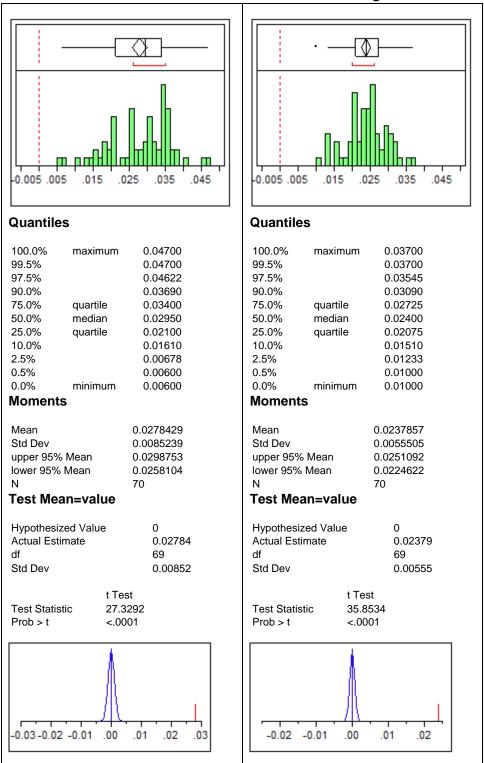
Figure 6.8. Year 2000 minus Year 2008 Differences

Figure 6.8 shows the "Old minus New" comparison by UT image. The mean difference in the 70 UT minima measurements that can be compared in this manner is about 0.028-in. For the UT average measurements this average difference is about 0.024-in. The red vertical dashed lines on the histograms at the top of the figure indicate no difference, and it can be seen that in no case was a 2008 UT image result ever less than the 2000 UT image result. T-tests are therefore strongly statistically significant as indicated by the lack of blue in the curves at the bottom figure (the opposite of the situation in the previous section on riser differences).

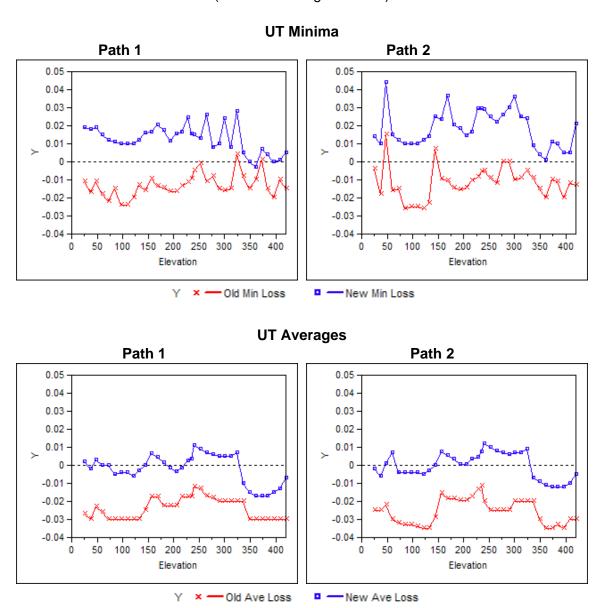
Figure 6.9. Year 2000 versus Year 2008 Measurement Paths

But even more dramatic are the results plotted in Figure 6.9. Here differences from nominal wall thickness are plotted for each path, both for the UT Minima and the UT averages as labeled on the various plots. The red curves are for year 2000, and since the losses are "nominal minus measured" wall thickness, those values being almost always negative indicate the 2000 wall thicknesses were almost always greater than the original nominal thicknesses. But for the 2008 measurements, the UT averages were right about at nominal with the losses above and below the horizontal dashed line at zero loss. The UT minima values have moved to positive values which indicate the newer measurement are below nominal.

The tracking of the paths with each other is quite remarkable, especially for the UT average values. Such consistent differences between the 2000 and 2008 results indicate one of two things, or perhaps both:

Intuitively it would seem that such consistent differences make the second reason seem the more reasonable. Special studies of UT wall thickness measurement capability have been proposed that seek to identify the source of such systematic measurement error so that it can be better controlled. This will better support comparisons of today's measurements with those taken in the future so that these UT inspections can be used to make meaningful studies of wall thickness corrosion.
