PNNL-19774

IMCOM-Southeast Region: Fort Gordon Retuning Workshop

September 2010

Executive Summary

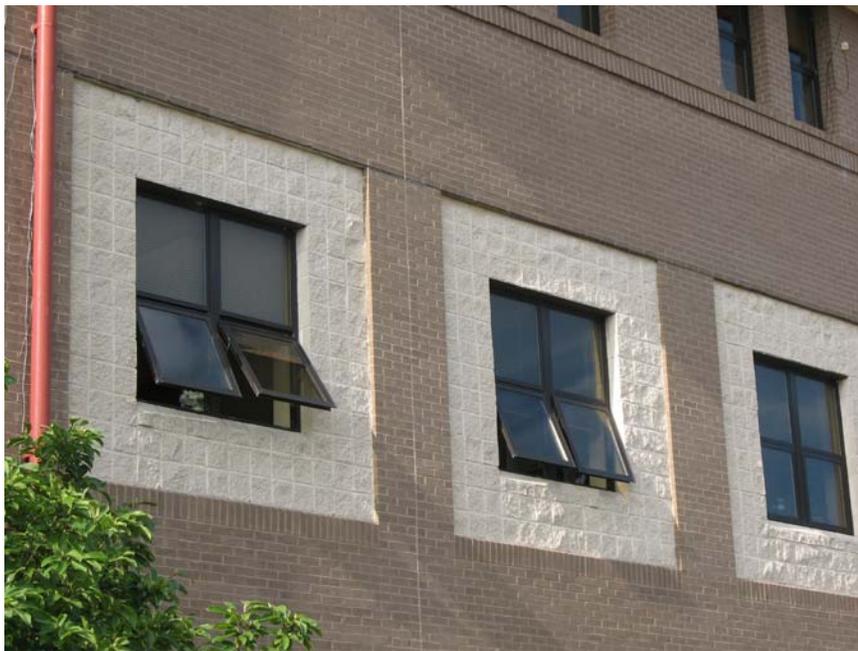
- The team found several second floor windows open during the morning walk down (see Figure 2). Occupants complained that they were cold, which indicates better space temperature control is needed.

Figure 2. Open windows at Darling Hall

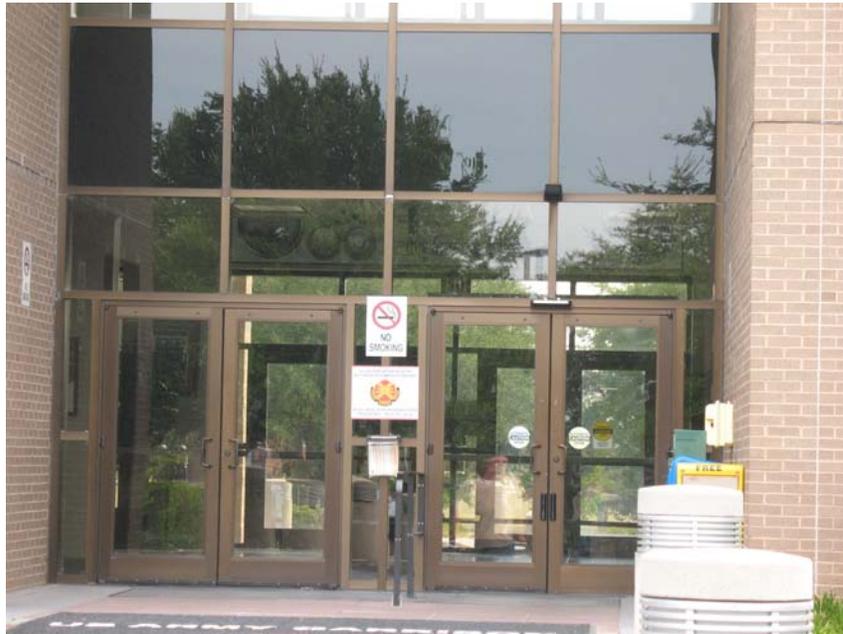
- There are many outside doors that open into the main lobby. Facility staff should look into installing vestibules or air curtains into the main lobby area to stop the waste of conditioned air and outside air infiltration.
- On the southwest side of the building, there is a set of double doors that opens into the main lobby (Figure 3). The door has an automatic sensor that opens the door as people approach. Although only one person approached the door, both double doors opened into the lobby instead of one. The door sensor is very sensitive to movement in the inside hallway, opening both double doors when someone passes by in the hall. Site staff should eliminate both double doors from opening at the same time and adjust the door sensitivity to stop nuisance door opening to the outside.

Figure 3. Double automatic doors on Darling Hall

Alternatively, handicapped door assist buttons could be added to provide automatic door function only when needed.

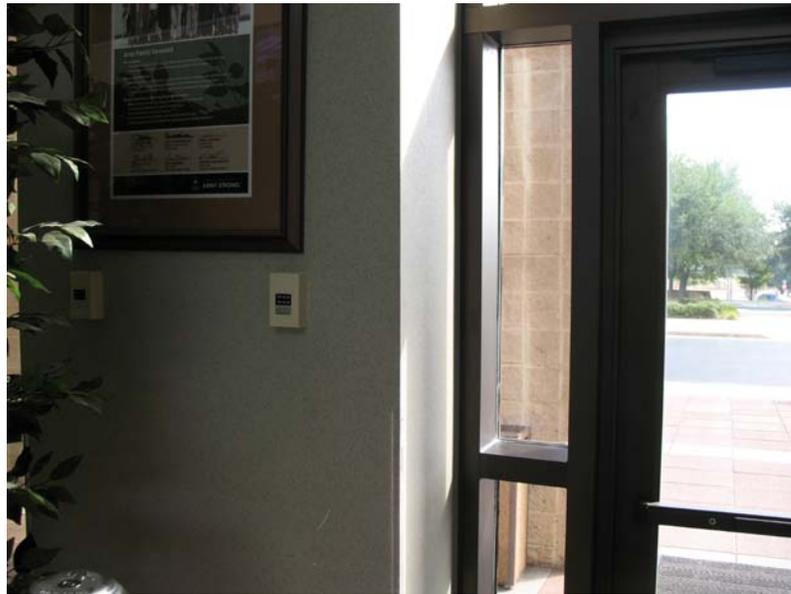
- The main lobby has a lot of glass, and it is well lit for the current use. Either provide accessible light switches so that staff can turn off lobby lights on sunny days, or install lighting controls that will dim or turn off lighting as needed.
- The team found two variable air volume (VAV) thermostats for the lobby (VAV-02-21 and VAV-02-20) mounted at the east entrance doors and on the outside wall (see Figure 4). These should be moved away from the door and off of the outside wall so that they accurately measure the indoor air temperature.

Figure 4. VAV Thermostats located near exterior door.

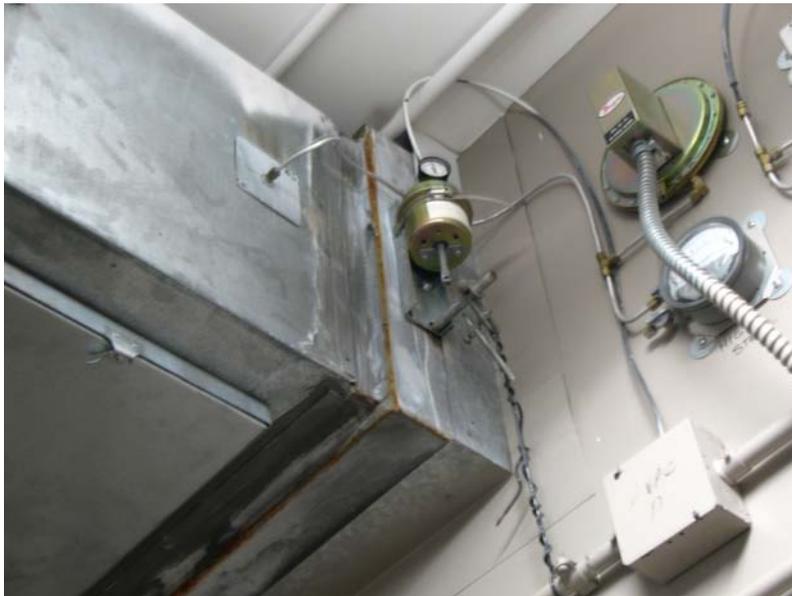
- The team noted numerous complaints on the second floor east offices that the space temperature was too hot. The team found that the VAV supply air registers were supplying reduced flow because additional air filters had been installed in the diffusers. As a test, the team removed a few of the filters, which resulted in an increase in the air flow. The filters were reinstalled later because the internally-lined duct insulation was coming loose and being blown on the occupant's desks. This was traced all the way back to the main supply fan for this zone. This is a serious performance and health problem that needs to be addressed. Each VAV box and reheat coil should be checked for obstructions.
- In the first floor east mechanical room, the team found supply and return dampers with the damper actuators disconnected and wired open (see Figure 5).

Figure 5. Dampers disconnected and wired open

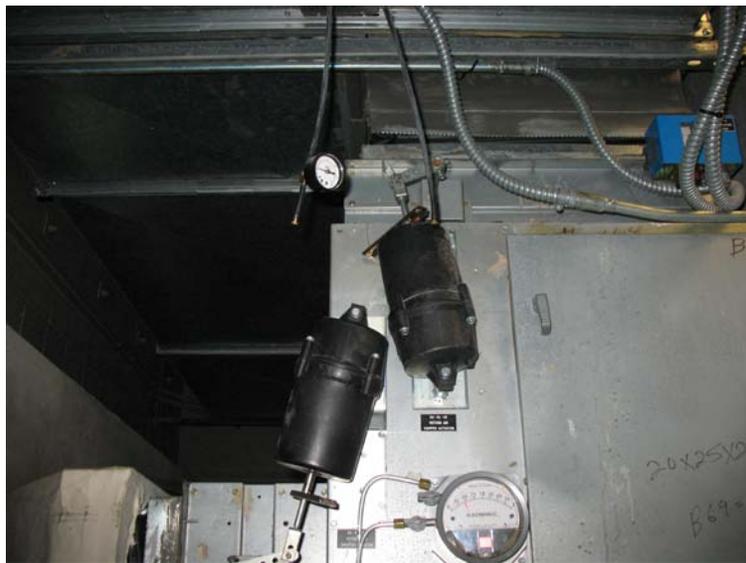
- In the second floor west mechanical room, the air handler is very noisy. The team found that the outdoor air and return air actuators are linked together, but only one damper has control air hooked to it. Like the other air handling units (AHUs), the team found that the linkage was loose, causing the shaft to slip on the clamp. Site staff need to either remove the linkage between the two actuators and supply the same control signal to both actuators or remove one of the actuators and leave them hooked together. This AHU is set up for 100% return air because of the slipping on the damper shaft (see Figure 6).

Figure 6. Disconnected damper actuators

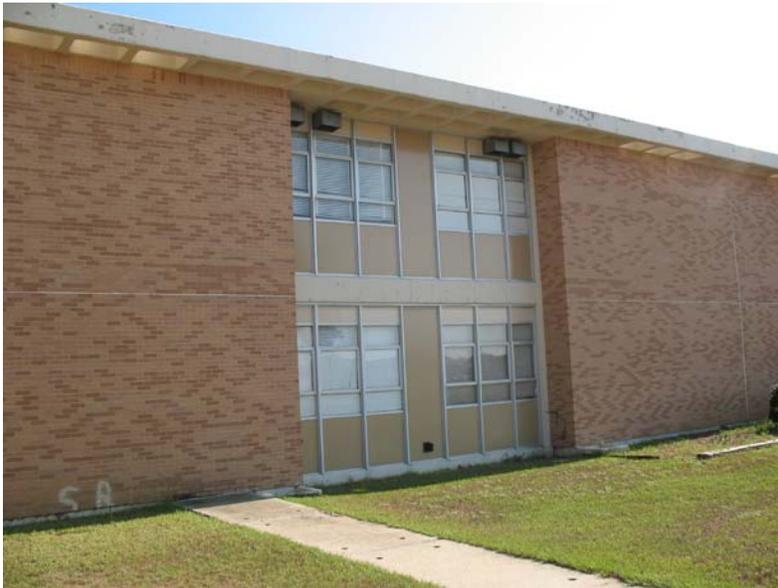
- The team found all windows and doors were single pane glass or Plexiglas (see Figure 7). This facility has a substantial amount of square footage in glass. These should be replaced with newer energy-efficient windows and doors.

Figure 7. Saltzman Hall Exterior
