Characterization of Fish Passage Conditions through a Francis Turbine, Spillway, and Regulating Outlet at Detroit Dam, Oregon, Using Sensor Fish, 2009

Final Report

JP Duncan
TJ Carlson

May 2011

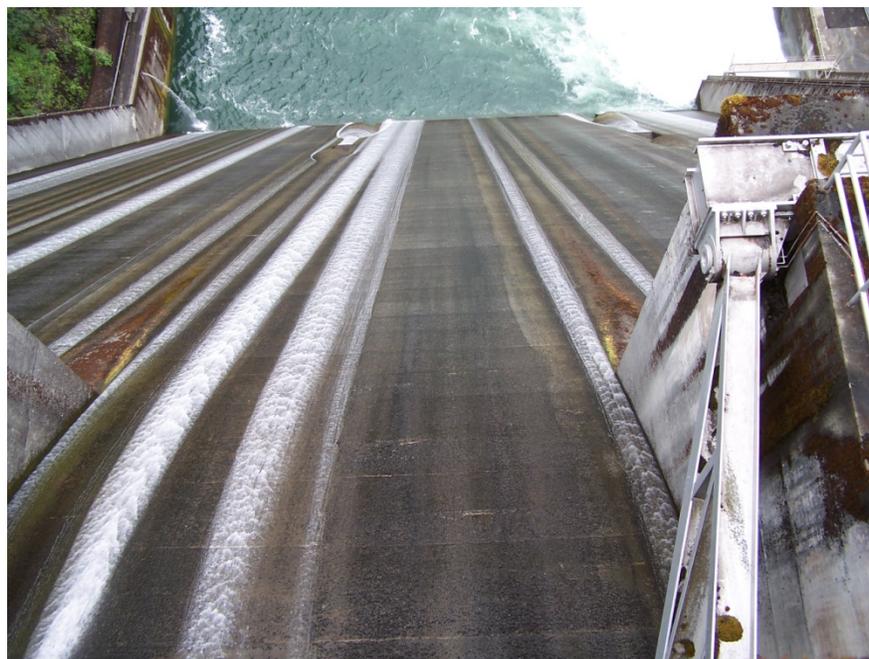
Figure 4.1. Spillbay 3 at Detroit Dam showing the rough, irregular concrete surface.

Spillbay 3 and Spillbay 6 were evaluated at two spillgate openings. The height and slope of the spillway chute contribute to deleterious exposure conditions observed during the study. Detroit Dam, completed in 1953, is slowly deteriorating due to age. The concrete surface of the spillway is rough from weathering (Figure 4.1), and the descending flow is irregular (Figure 4.2)—conditions that probably incrementally worsened spillway passage conditions.

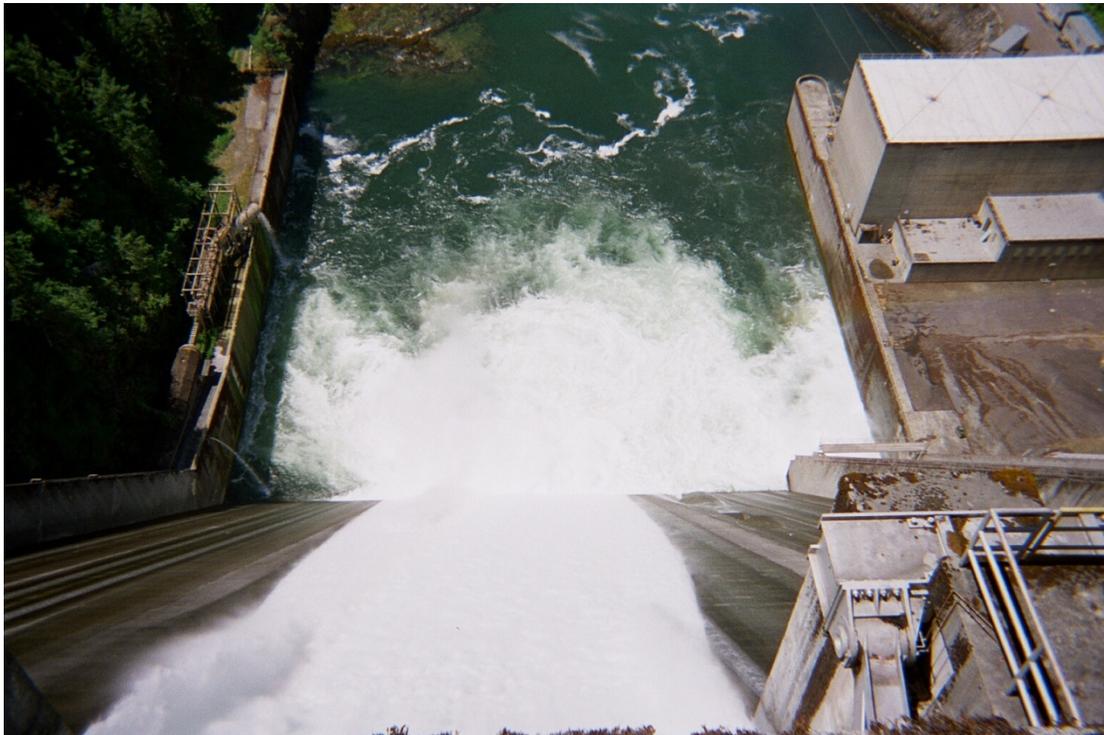
In Spillbay 3, the unconfined spillway discharge spread rapidly once past the structure supporting the tainter gate hinge assemblies (Figure 4.3). In contrast, Spillbay 6 was confined from the tainter gate through stilling basin entry (Figure 4.2). Spillway flow velocities were estimated to exceed 150 fps before plunging into the stilling basin. Sensor Fish were often carried to depths of over 30 ft with spillway discharge, at times striking rocks or other unidentified objects as they were carried in turbulent flow through the stilling basin.

Figure 4.3. Flow through Spillbay 3, 1.5-ft gate opening (1560 cfs discharge) spreads to adjoining spillbays.

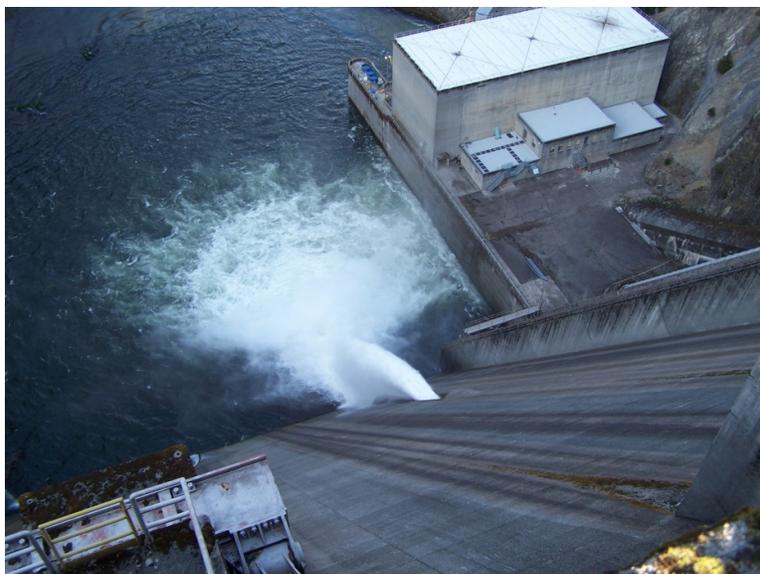
Figure 4.8. Regulating outlet discharge at Detroit Dam when the control gate was open 1 ft.

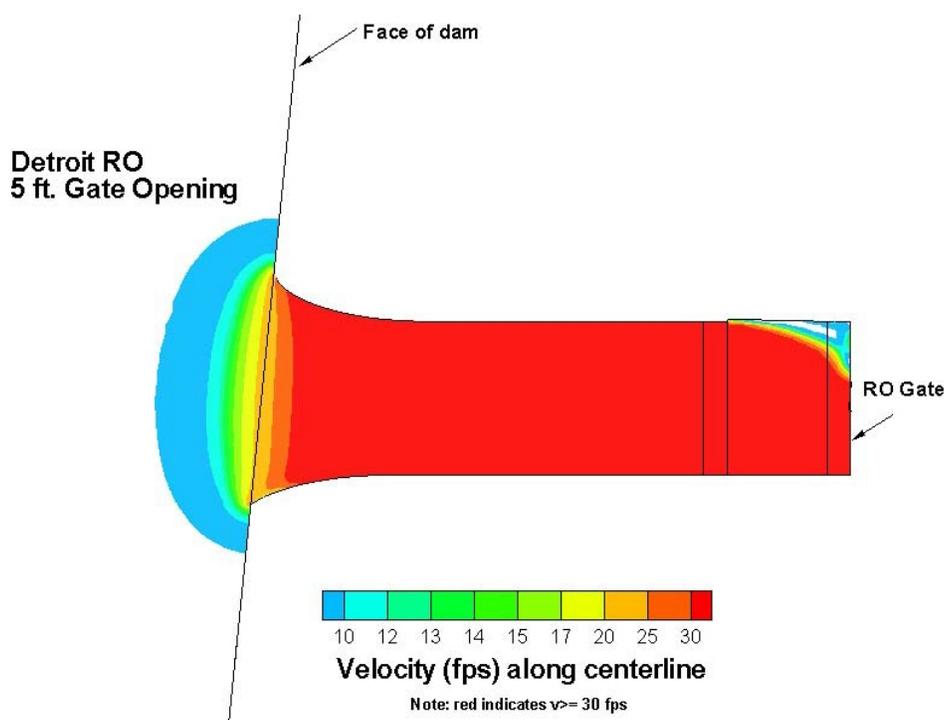
Computational fluid dynamics modeling of flow through the RO conduit when the control gate was open 5 ft is shown in Figure 4.10. At this gate setting, RO discharge was approximately 1900 cfs when the forebay elevation was 1450 ft MSL. The mean forebay elevation for the study was approximately 1441 ft MSL, which corresponds to a discharge of approximately 1800 cfs at a 5-ft control gate opening. The CFD model estimates flow velocity at 18 fps at the entrance to the RO for the 5-ft gate opening. The flow rapidly accelerates to more than 30 fps a short distance into the RO conduit.

Figure 4.10. Computational fluid dynamics estimate of water velocity through the RO when the control gate was open 5 ft (Phillips 2010¹).

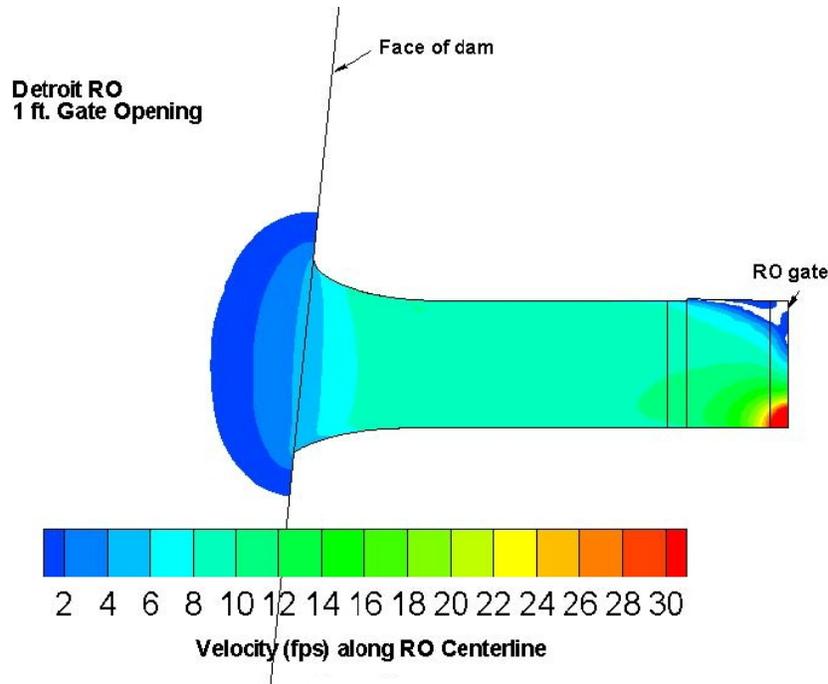
Computational fluid dynamics estimates of water velocity through the RO conduit when the control gate was open 1 ft are shown in Figure 4.12. In contrast with that for the 5-ft gate opening, there is a significant increase in water velocity from 10 to 30 fps immediately upstream of the control gate. The average acceleration magnitude of the Sensor Fish during passage under the control gate at an opening of 1 ft was nearly 4 times that observed during passage when the gate was open 5 ft. During passage under the 1-ft open gate, flow becomes supercritical; depth of flow decreases as water velocity increases. There is a rapid decrease in pressure from that in the conduit to atmospheric in the partially filled conduit downstream of the control gate. Immediately after gate passage, there is a hydraulic jump in the flow, followed by a reduction in water velocity, as the flow becomes subcritical and exits the RO conduit into

the spillway stilling basin. The turbulent flow combined with the shallow depth of flow immediately downstream of the control gate were probably the main factors that contributed to the high rate of Sensor Fish collisions observed in this region. Approximately 71% of the Sensor Fish that passed through the RO when the control gate was open 1 ft experienced a collision event immediately following gate passage. No similar collision events were observed for any of the Sensor Fish that passed through the RO when the control gate was open 5 ft.

Figure 4.12. Computational fluid dynamics estimate of water velocity through the RO when the control gate was open 1 ft (Phillips 2010¹).
