**Pacific Northwest
National Laboratory**

Operated by Battelle for the
U.S. Department of Energy

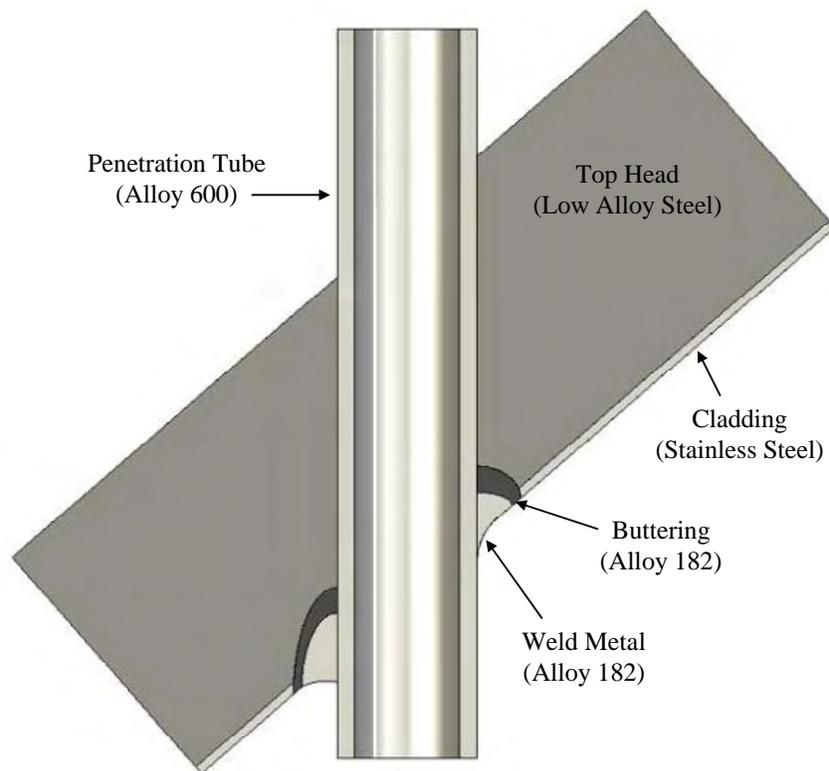
Figure 1.1. Control Rod Drive Mechanism Penetration-Nozzle Assembly

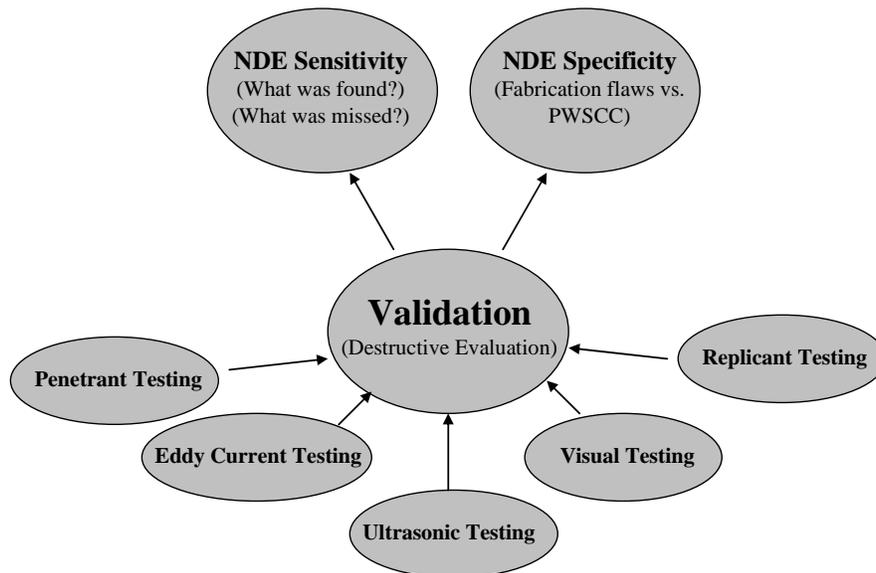
Figure 1.2. NDE Studies of CRDM Nozzle Assemblies Removed from Service

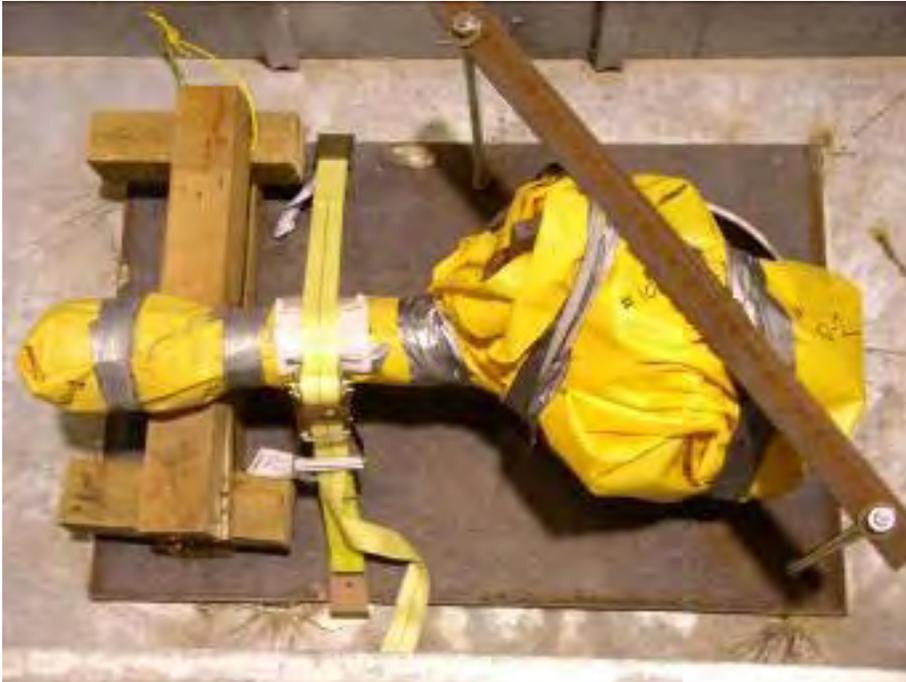
Figure 1.3. CRDM Penetration-Nozzle Assembly As Received at PNNL

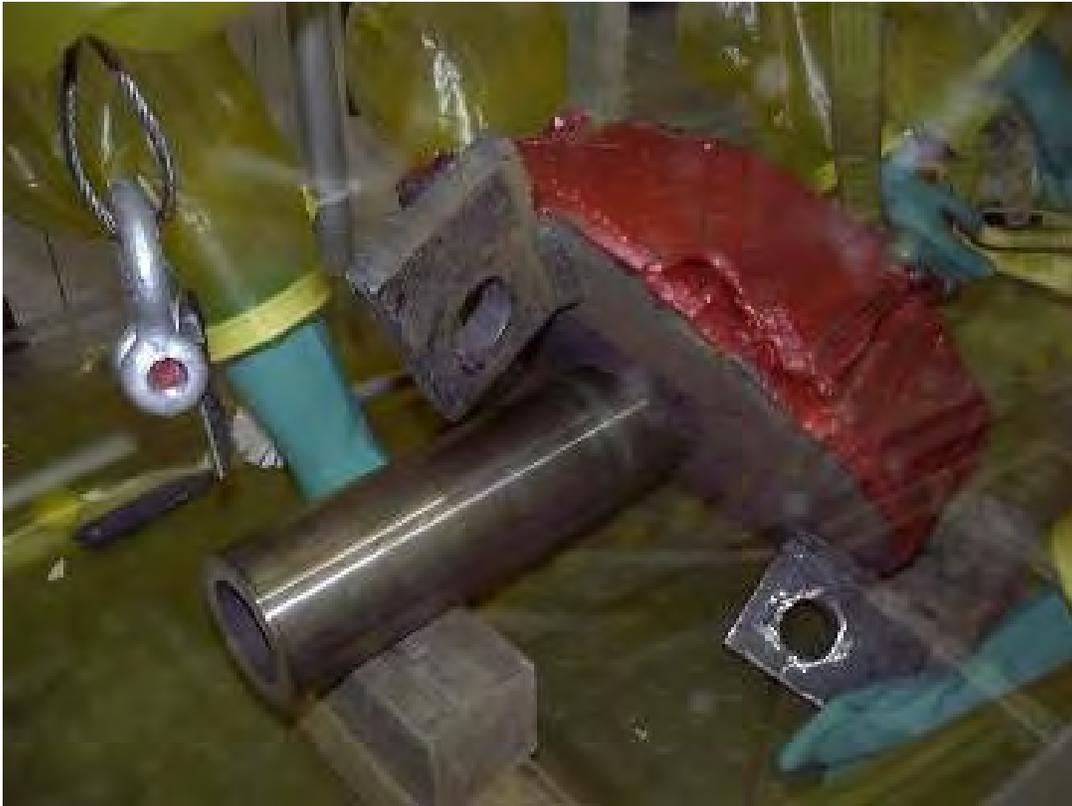
Figure 2.1. CRDM Penetration-Nozzle Assembly in Glove Box

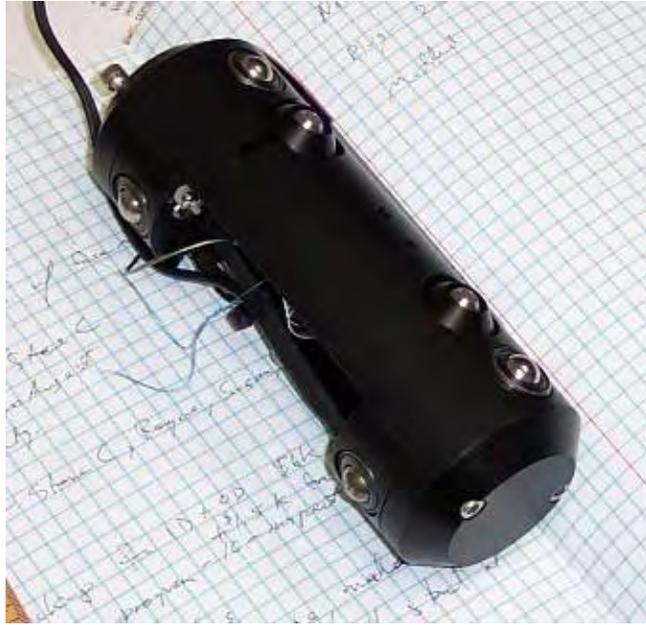
Figure 3.5. Redesigned Probe Assembly, Showing Roller Bearings and Both Sensors

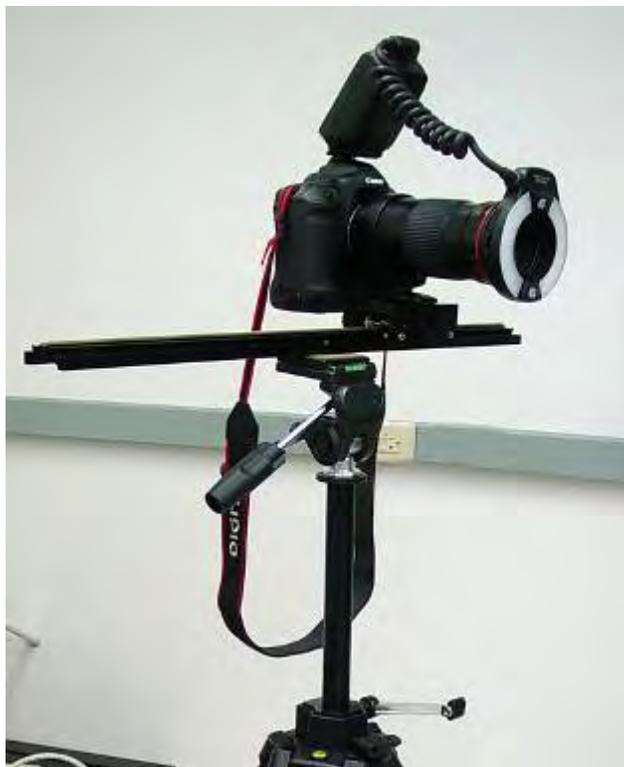
Figure 3.12. High-Resolution Camera Mounted on a Slide Bar and Tripod

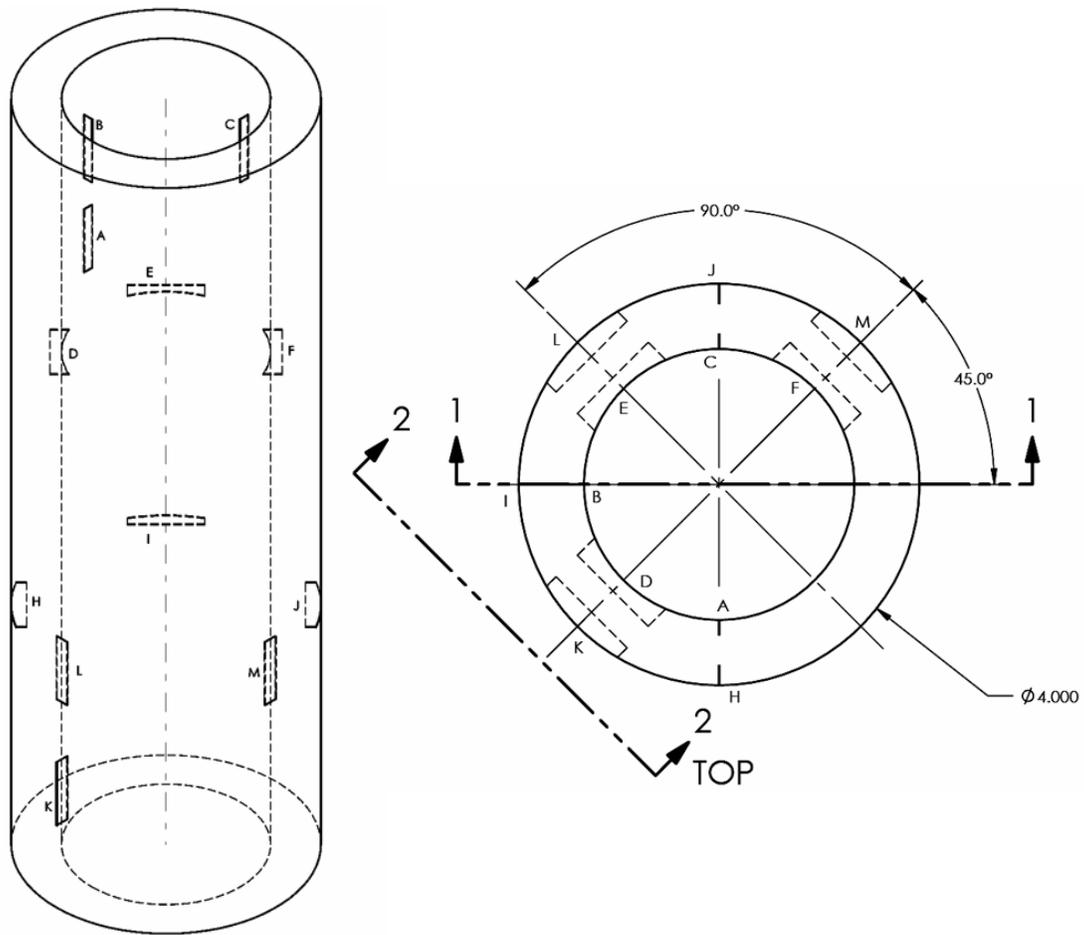
Figure 4.1. Penetration Tube Calibration Standard Isometric and Top View

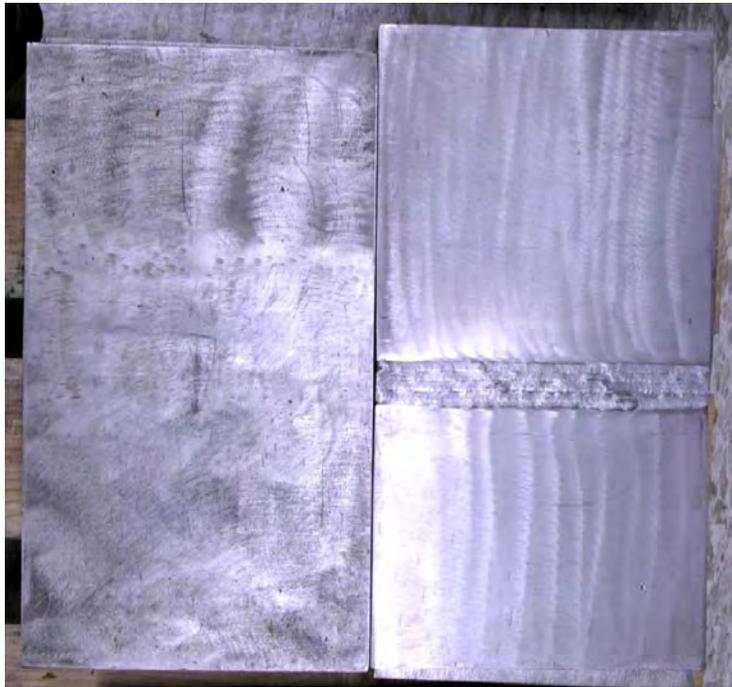
Figure 4.3. Two Cracked Stainless Steel Samples Used To Test Visual Testing Procedures and Equipment Using Replicas

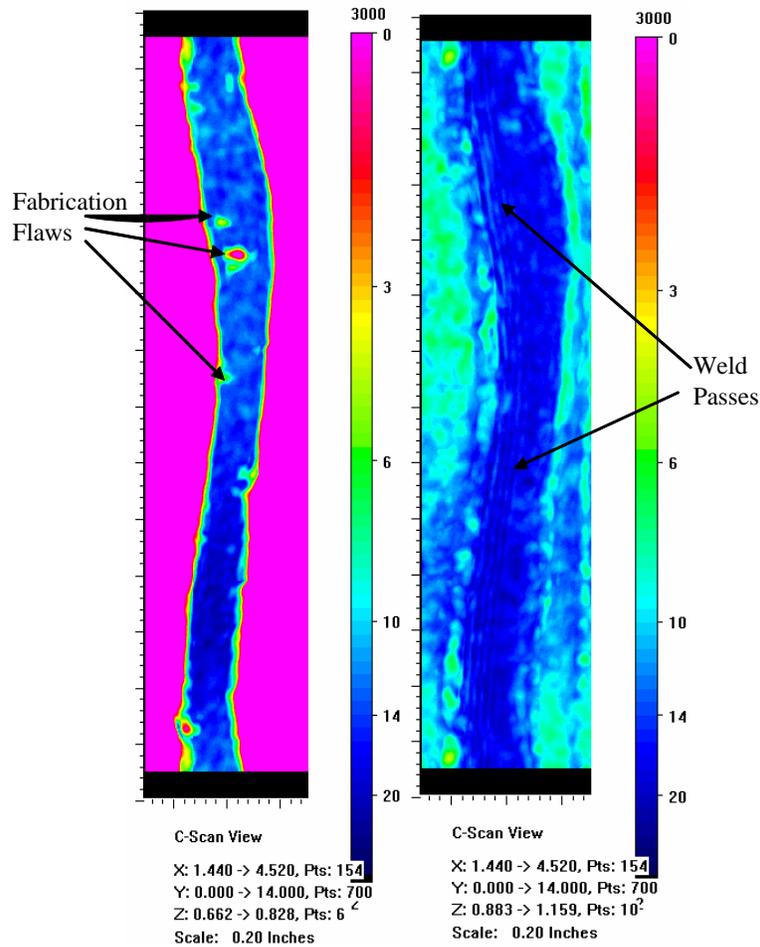
Figure 4.12. Ultrasonic Testing Responses for 2.25-MHz in Midland Control Rod Drive Mechanism. The first image shows the fusion zone of the weld where fabrication flaws were detected. The second image shows the J-groove weld area where the individual weld passes were detected.

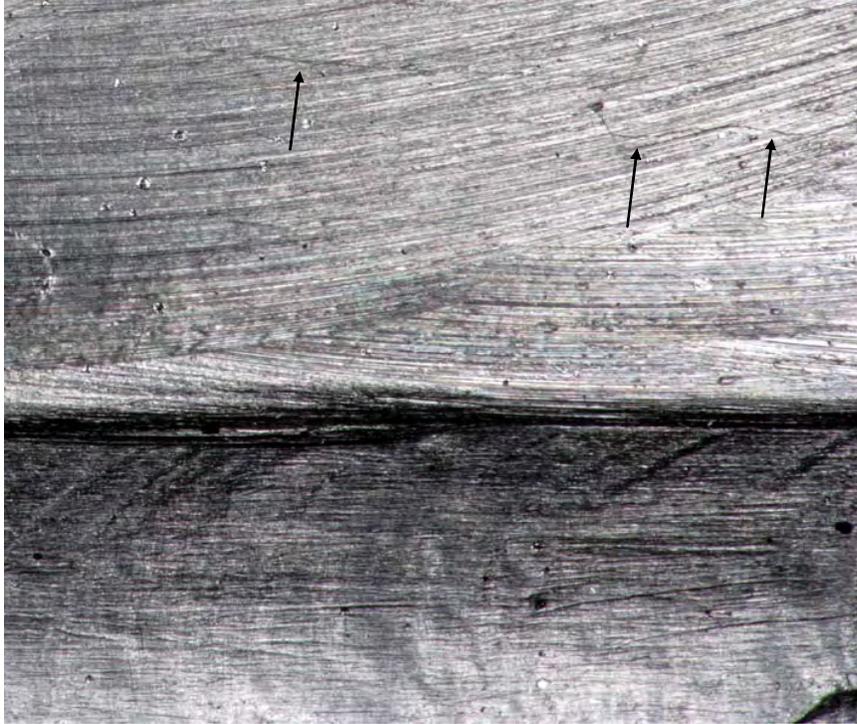
Figure 4.13. Narrow Crack Ranging 10–25 μm (0.0004–0.001 in.) Wide on a Machined Surface. The crack is easy to see when it cuts across machining marks and is difficult to see when it follows the marks.

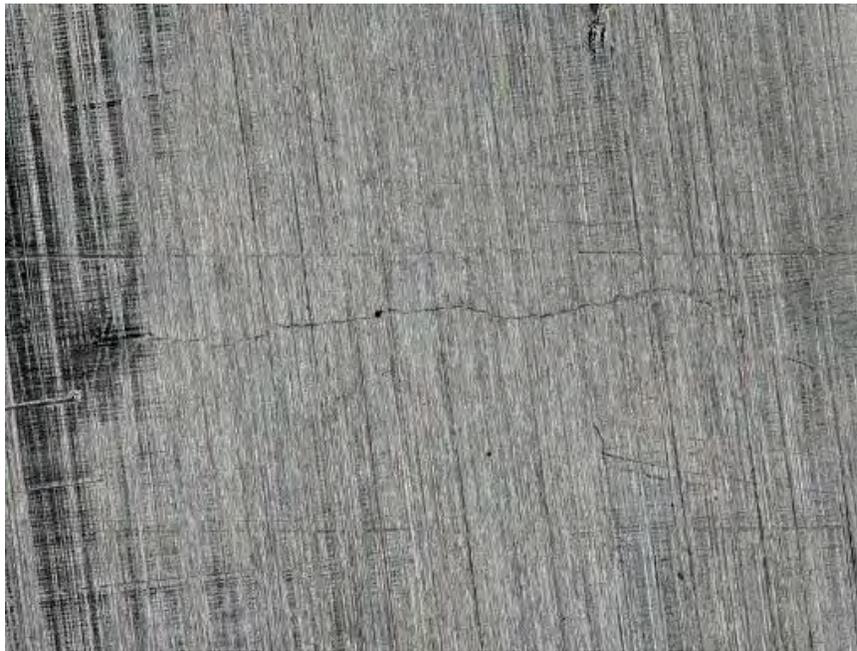
Figure 4.14. A Crack 28 μm (0.001 in.) Wide Cutting Perpendicularly Across Machining Marks

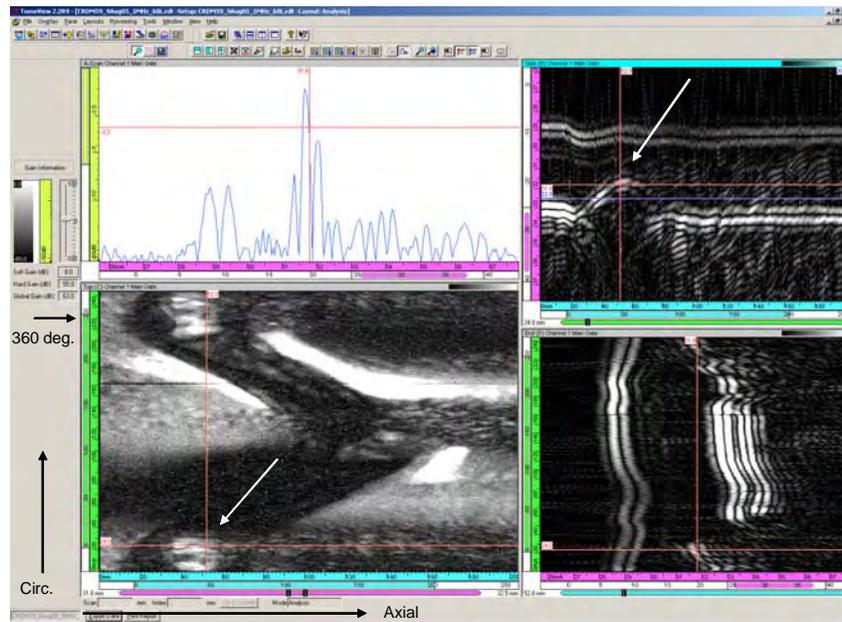
Figure 5.3. Nozzle 59 Weld Repair Intrusion Indication Detected with Time-of-Flight Diffraction at 24 mm (0.95 in.) CCW, 52 mm (2 in.) Axial, with a -5.6 -dB Response. The axial and circumferential axes are also noted. One revolution (360 degrees) was represented by 224 mm (8.8 in.) circumferentially.

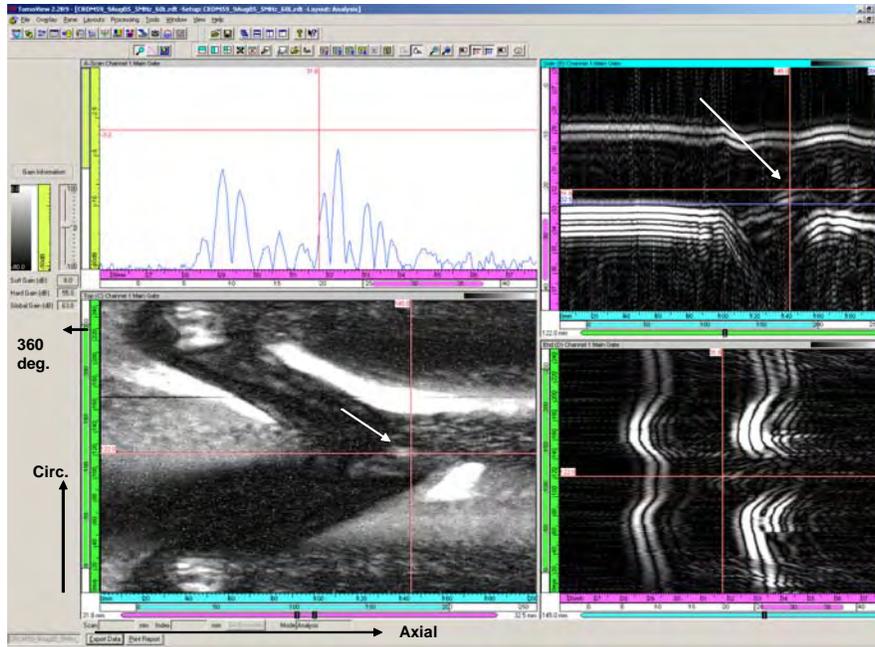
Figure 5.4. Nozzle 59 Weld Repair Intrusion Indication Detected with Time-of-Flight Diffraction at 122 mm (4.8 in.) CCW, 145 mm (5.7 in.) Axial, with a -7 -dB Response

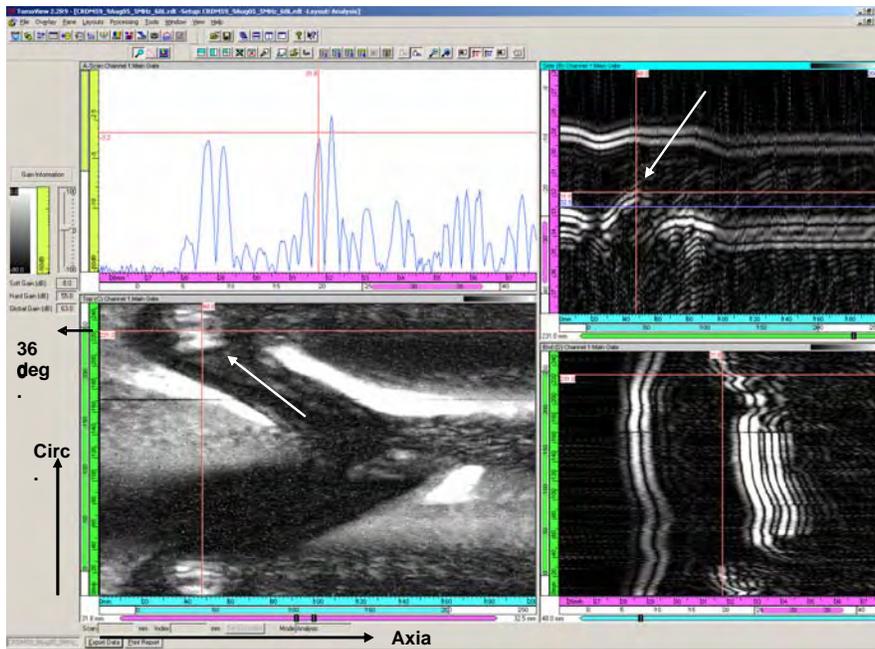
Figure 5.5. Nozzle 59 Weld Repair Intrusion Indication Detected with Time-of-Flight Diffraction at 231 mm (9.1 in.) CCW, 48 mm (1.9 in.) Axial, with a -5.7 - to -6.8 -dB Response

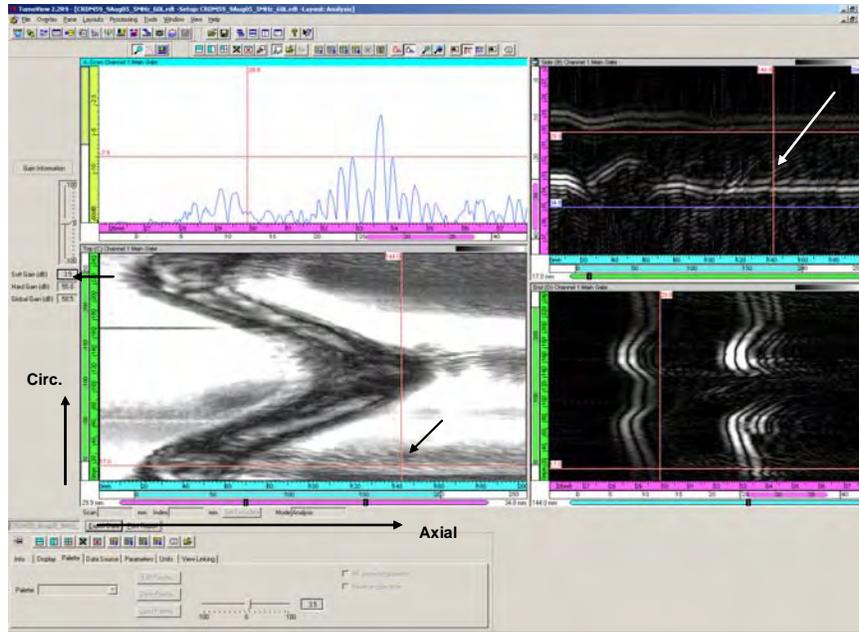
Figure 5.6. TOFD Nozzle 59, 5-MHz Typical Indication. The indication is at 17 mm (0.67 in.) CCW, 144 mm (5.7 in.) axial, with a response of -7.5 dB.

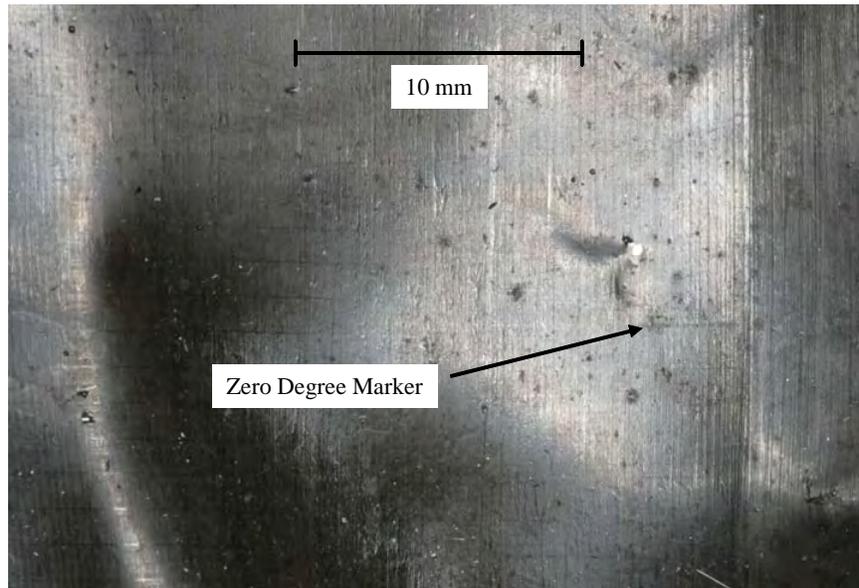
Figure 5.13. Zero-Degree Marker and Wetted End of Penetration Tube Imaged Using Replicant

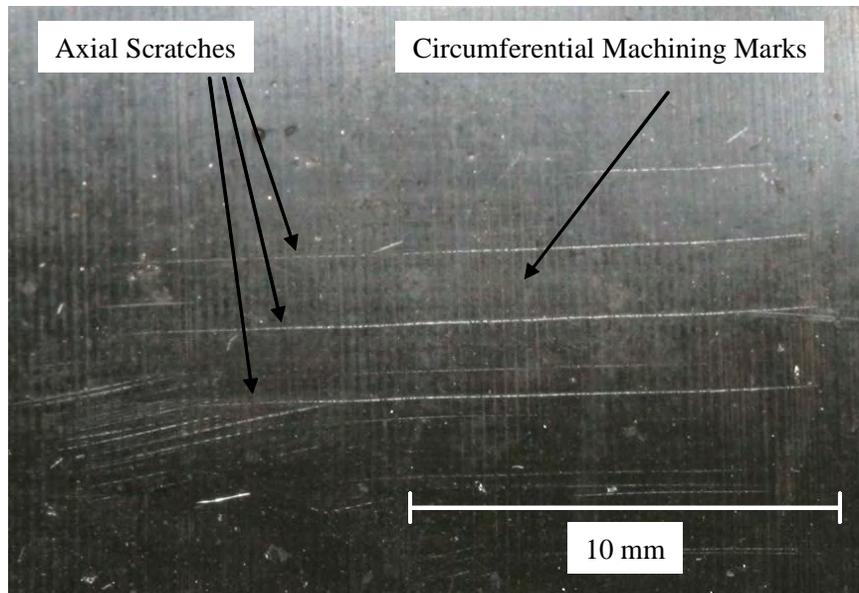
Figure 5.14. Machining Marks and Axial Scratch-Like Indications on the Interior of the Penetration Tube in Nozzle 59

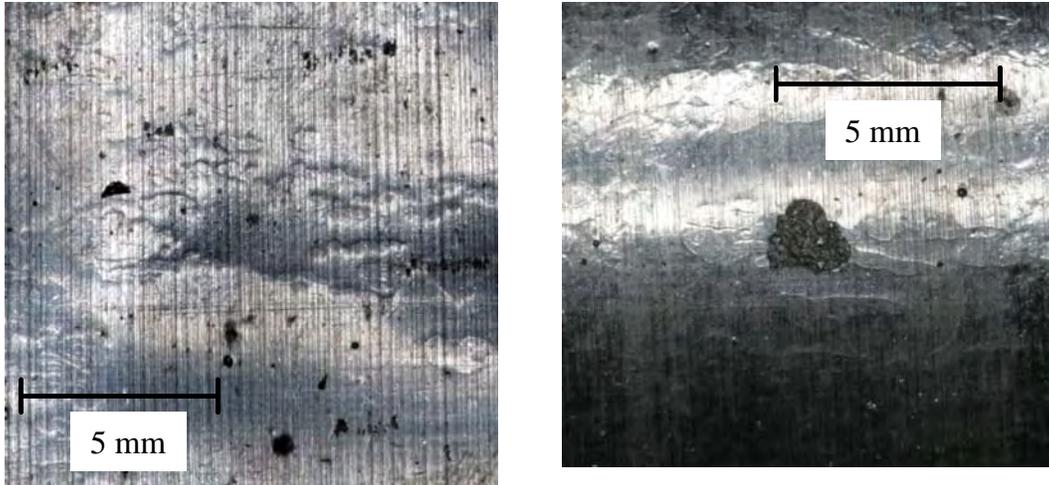
Figure 5.15. Pit-Like Indications and a Rough Patch Imaged Using High-Resolution Photographs of the Replicated Surface. The pit-like indications are located throughout the tube, while the rough patch is located at close to 180 degrees and 200 mm (7.9 in.) axially.

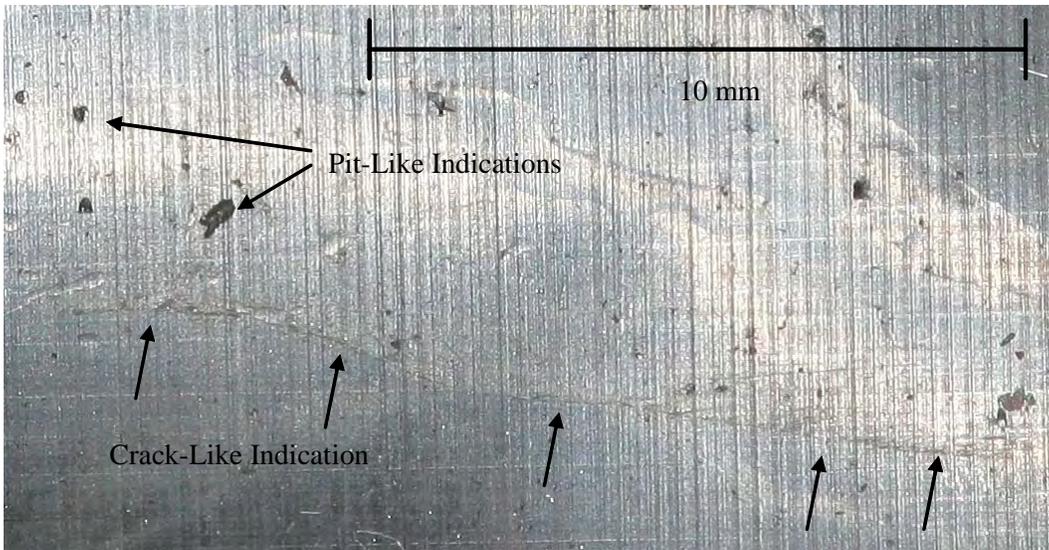
Figure 5.16. Crack-Like Indication Located at 315 Degrees Clockwise Rotation and 140 mm (5.1 in.) Axially in the Penetration Tube

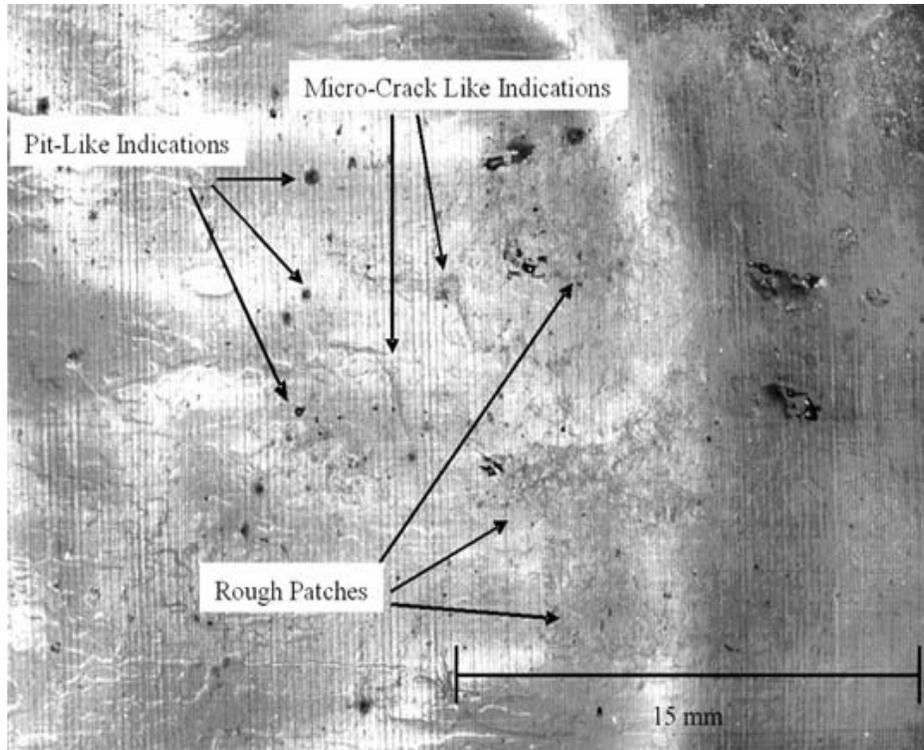
Figure 5.17. Rough Section and Possible Micro-Cracks in the Penetration Tube Interior

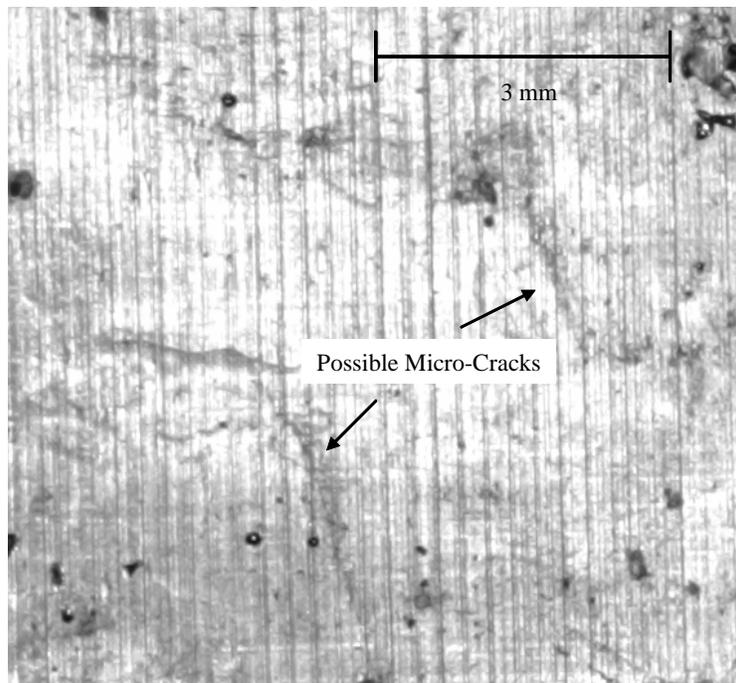
Figure 5.18. Micro-Crack-Like Indications in the Penetration Tube of Nozzle 59

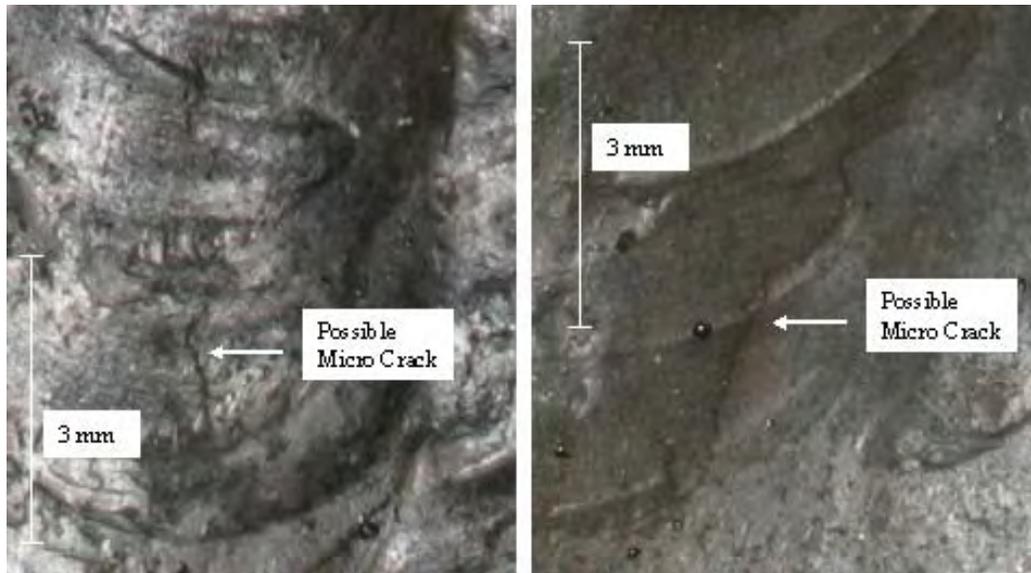
Figure 5.19. Small Crack-Like Indications near 120 Degrees in the J-Groove Weld

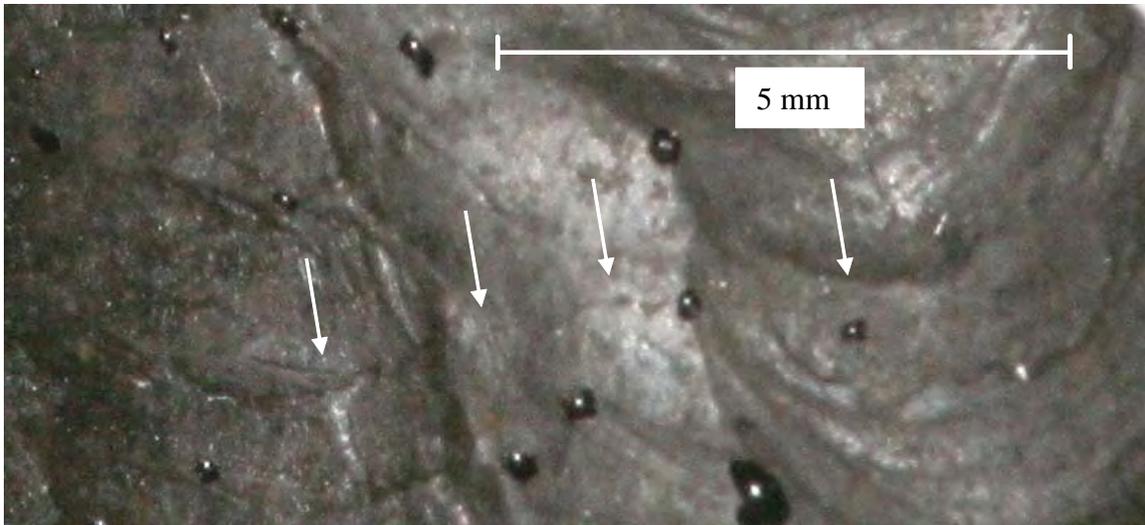
Figure 5.20. Crack-Like Indication in the J-Groove Weld of Nozzle 59 at 225 Degrees

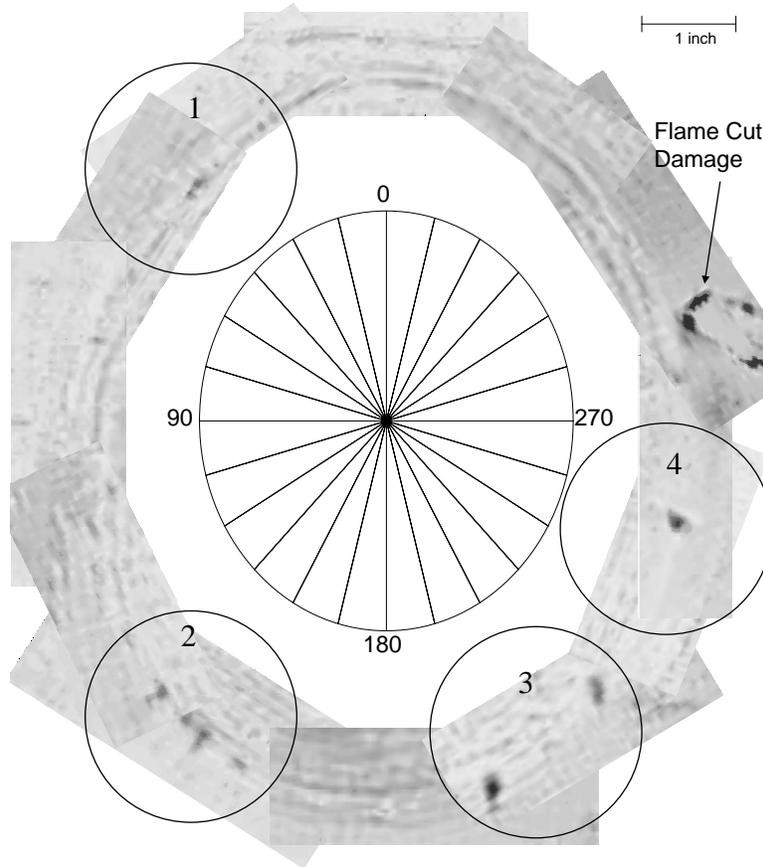
Figure 5.23. Eddy Current Results for 0-Degree Scan of the J-Groove Weld of Nozzle 31. Four areas of interest were found at close to 60, 150, 215, and 270 degrees.

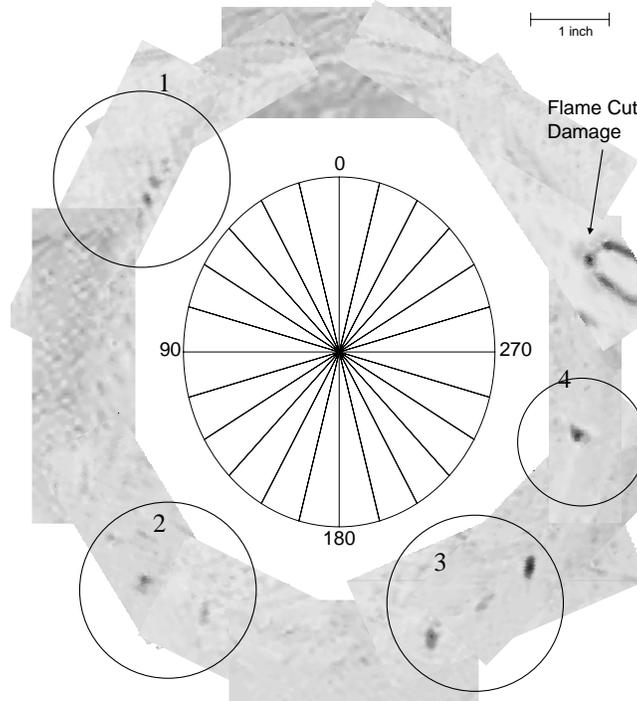
Figure 5.24. Eddy Current Results for 45-Degree Scan of the J-Groove Weld of Nozzle 31. Four areas of interest were found at close to 60, 150, 215, and 270 degrees.

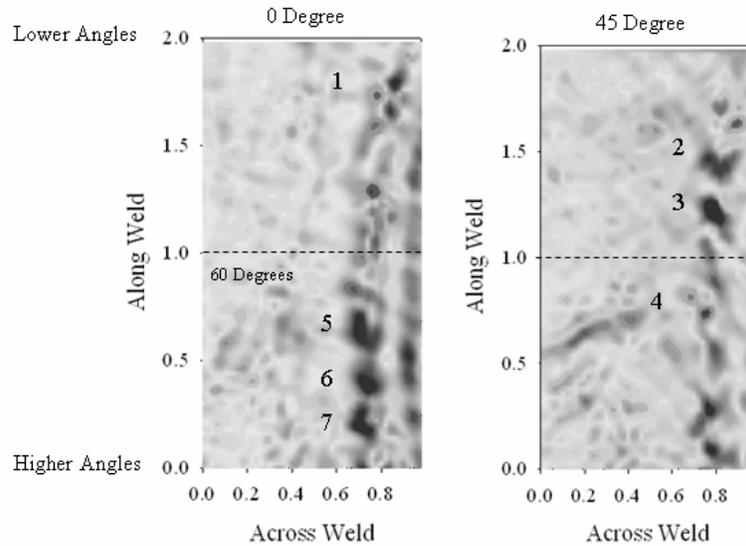
Figure 5.25. 0- and 45-Degree Scans Centered on 60 Degrees on the J-Groove Weld of Nozzle 31

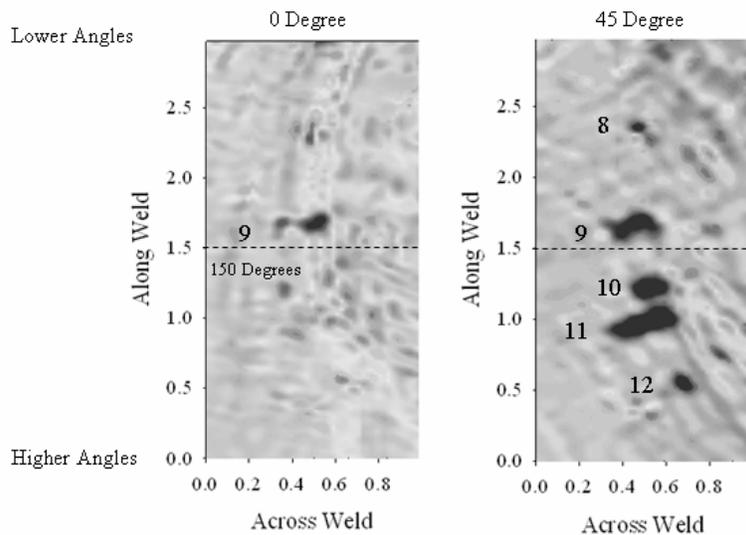
Figure 5.26. 0- and 45-Degree Scans Centered on 150 Degrees on the J-Groove Weld of Nozzle 31

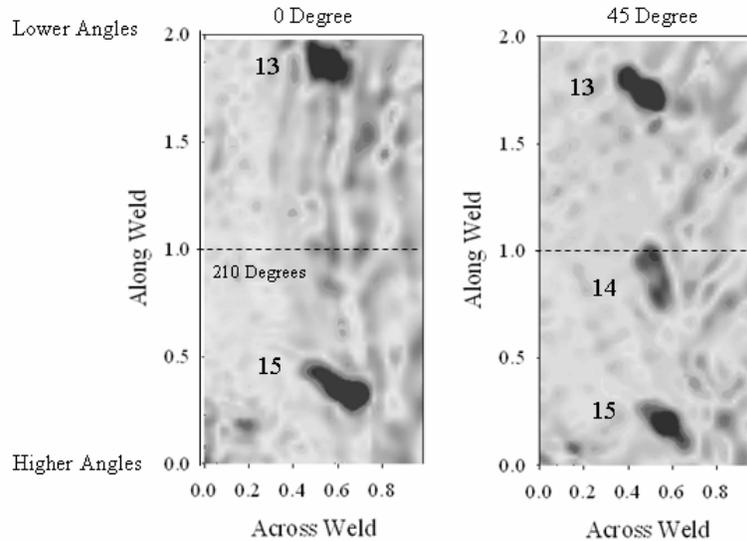
Figure 5.27. 0- and 45-Degree Scans Centered on 210 Degrees on the J-Groove Weld of Nozzle 31

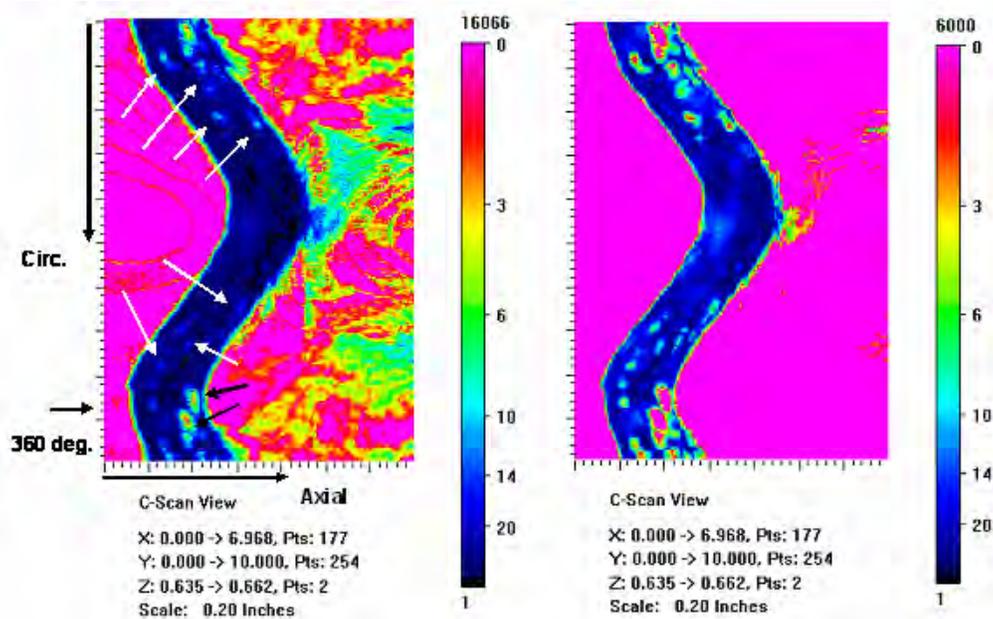
Figure 5.34. Nozzle 31, 5-MHz Immersion Data Showing Indications in the J-Groove Weld Material at Two Different Displayed Amplitude Settings

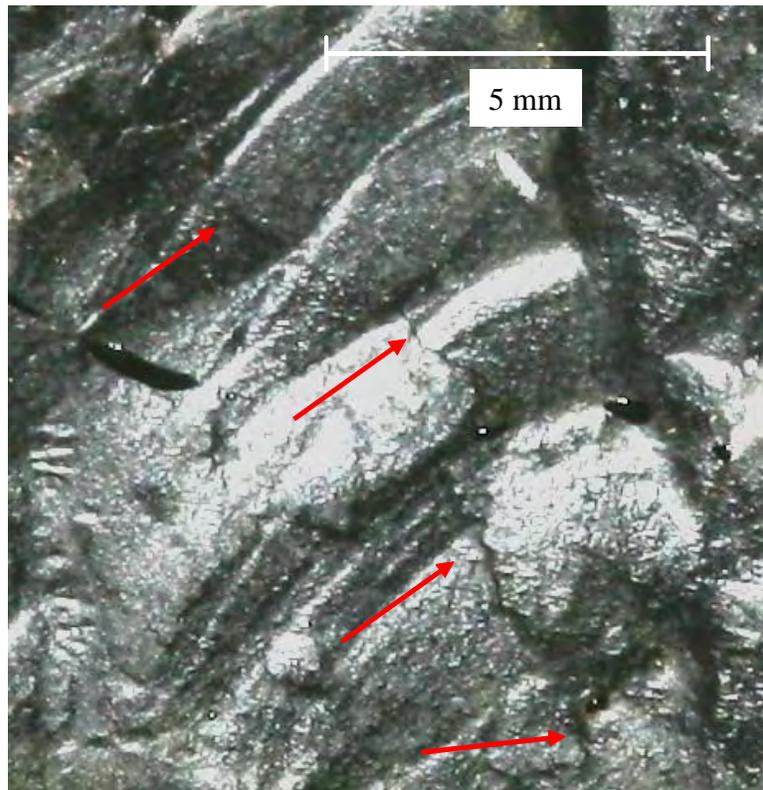
Figure 5.39. Crack-Like Indication 10 mm (0.0004 in.) Long at 145 Degrees CCW

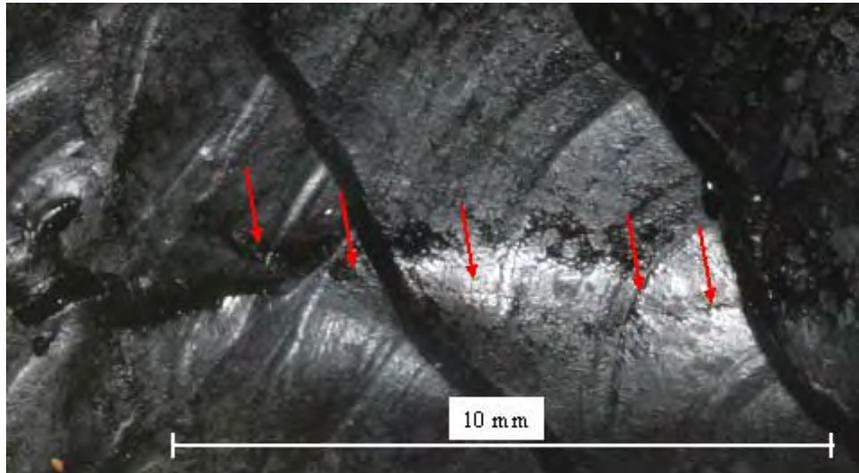
Figure 5.40. Crack-Like Indication at 135 Degrees CCW, 5 to 10 mm (0.0002 to 0.0004in.) Long

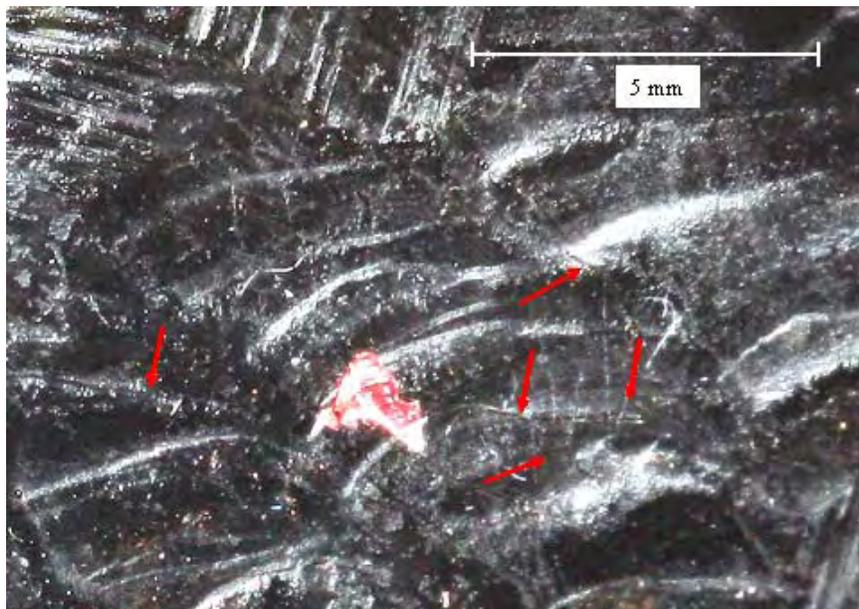
Figure 5.41. Cracked Area at 275 Degrees CCW. This branched crack-like indication traverses through the area. The cracked region is 1 cm².

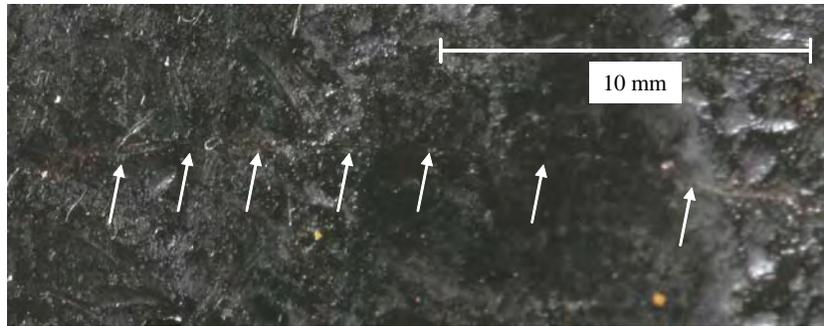
Figure 5.42. Crack-Like Indication at 315 Degrees CCW. The indication leaves the J-groove weld and propagates into the buttering. The indication is 15–20 mm (0.6–0.8 in.) long.

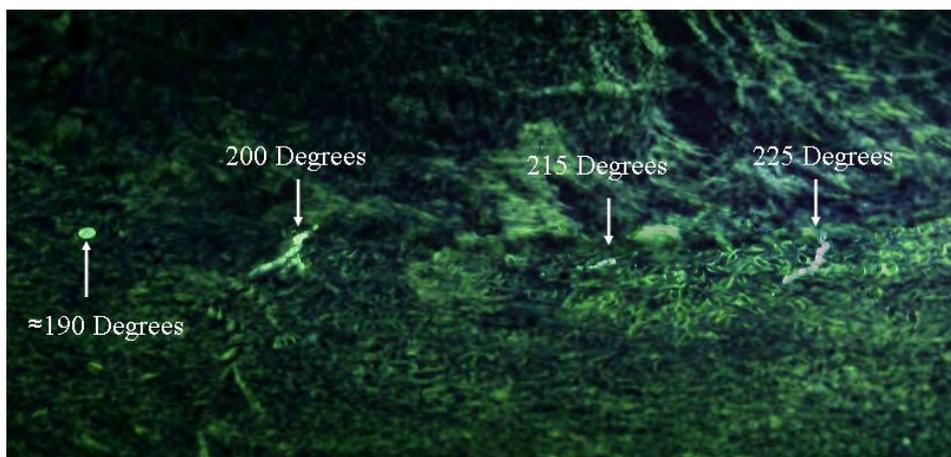
Figure 5.43. Penetrant Results at the Weld/Butter Interface Around 210 Degrees

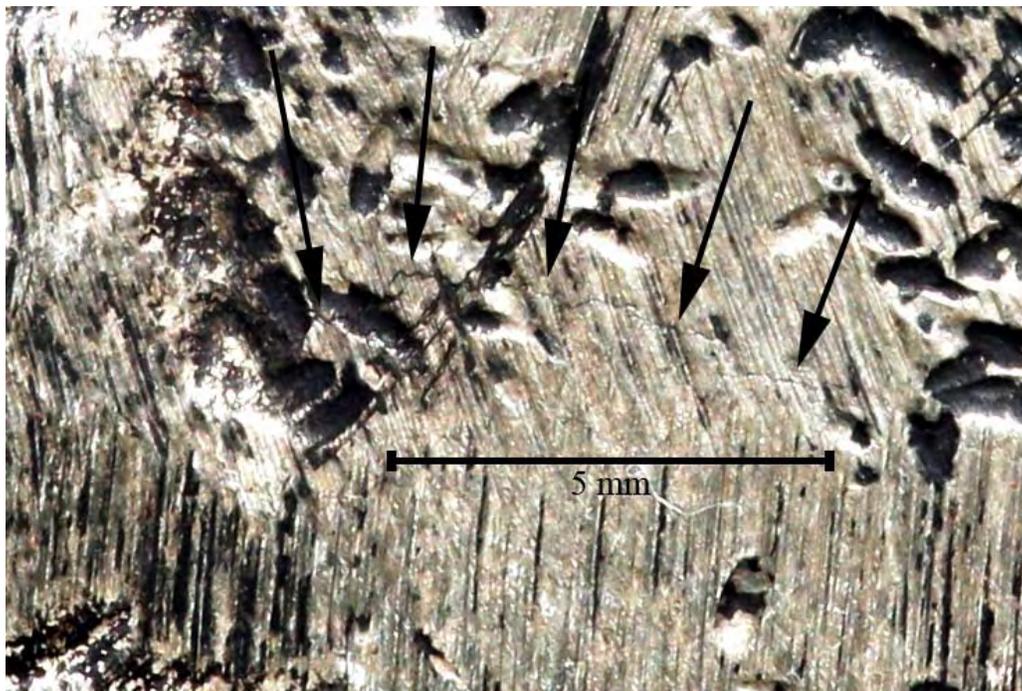
Figure 5.44. Crack-Like Indication Imaged Via Visual Testing at the Weld/Buttering Interface at 200 Degrees

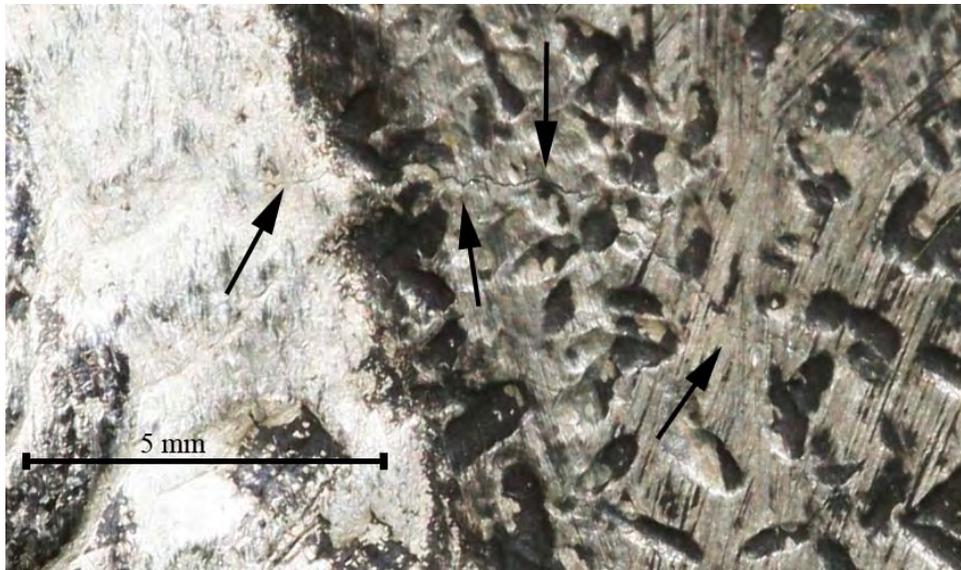
Figure 5.45. Crack-Like Indication Imaged Via Visual Testing at the Weld/Buttering Interface at 225 Degrees

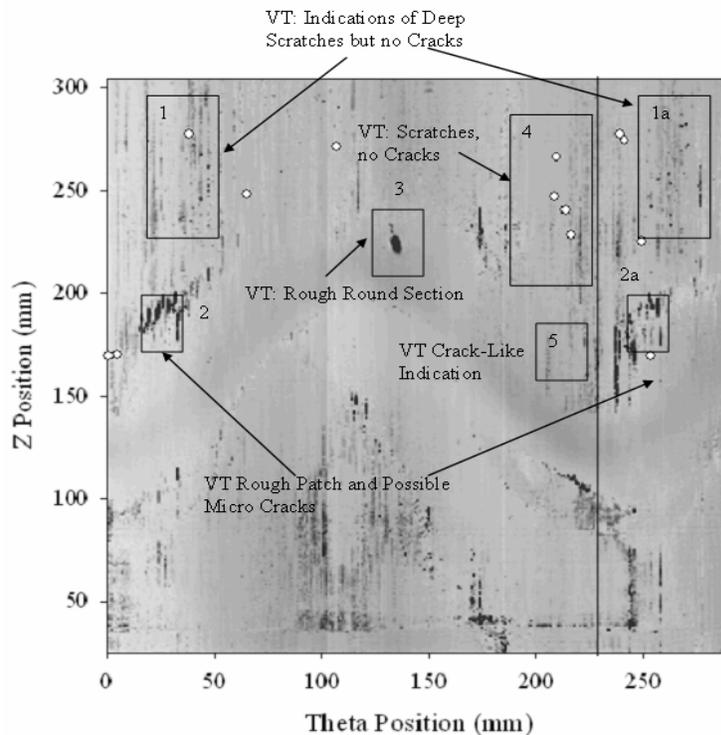
Figure 5.46. Combined Eddy Current Data with Overlaid Time-of-Flight Diffraction Indications and Visual Testing Characterization of the Results for the Penetration Tube of Nozzle 59

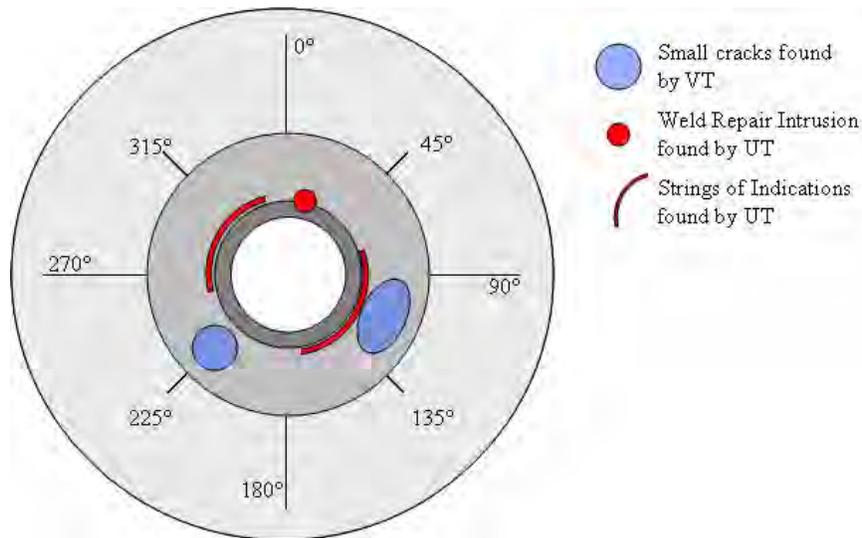
Figure 5.47. Nondestructive Examination Indications Found in Nozzle 59

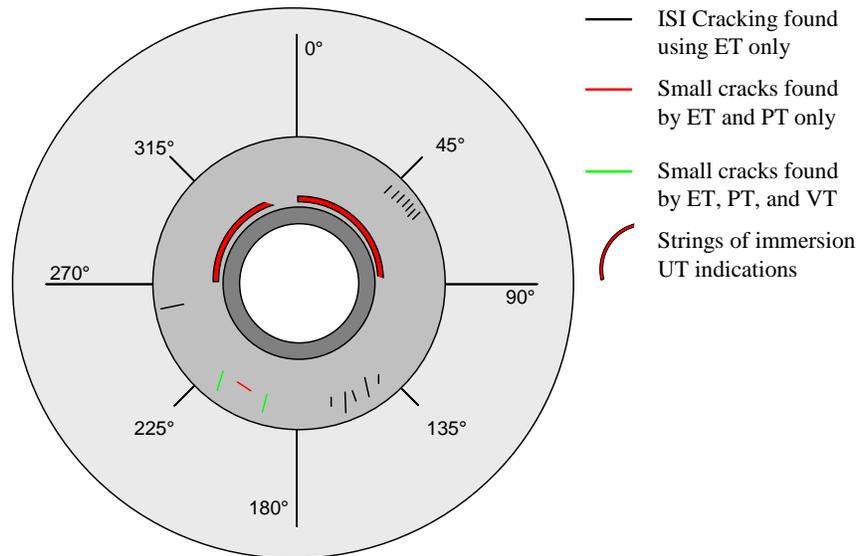
Figure 5.48. Nondestructive Examination Indications Found in Nozzle 31
