**Pacific Northwest
National Laboratory**

Operated by Battelle for the
U.S. Department of Energy

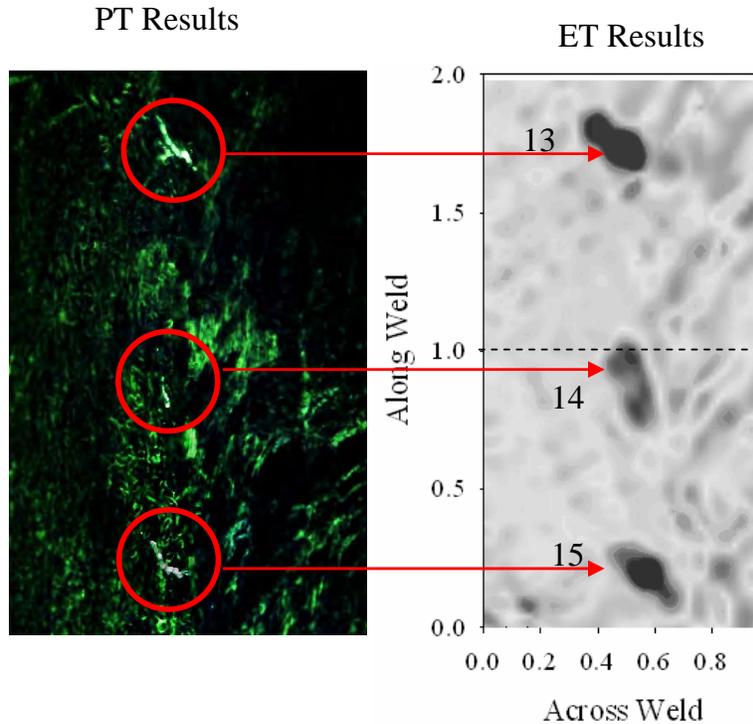
Figure 5.49. Correlated Penetrant Dye and Eddy Current Testing Results for the Weld/Butter Wetted Surface Interface in Nozzle 31 Centered at 210 Degrees

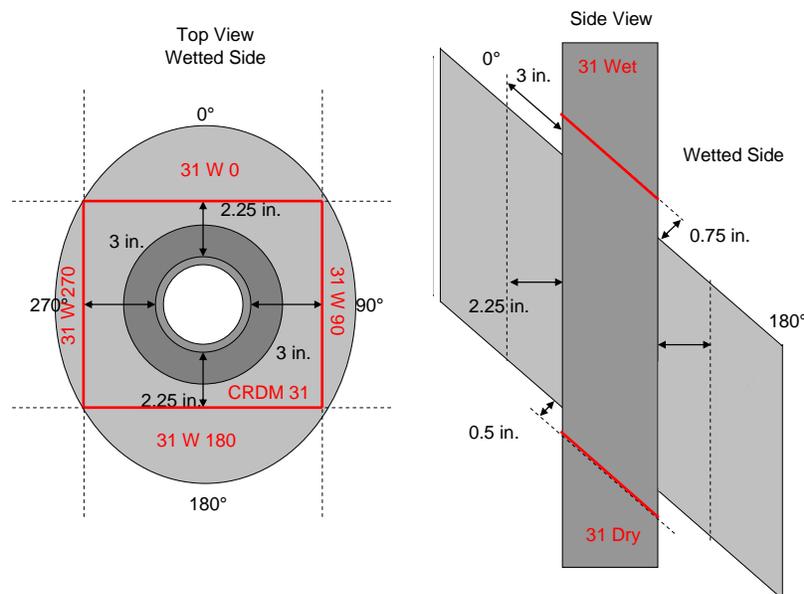
Figure 6.1. Initial Weight-Reduction Cuts Made on Nozzle 31

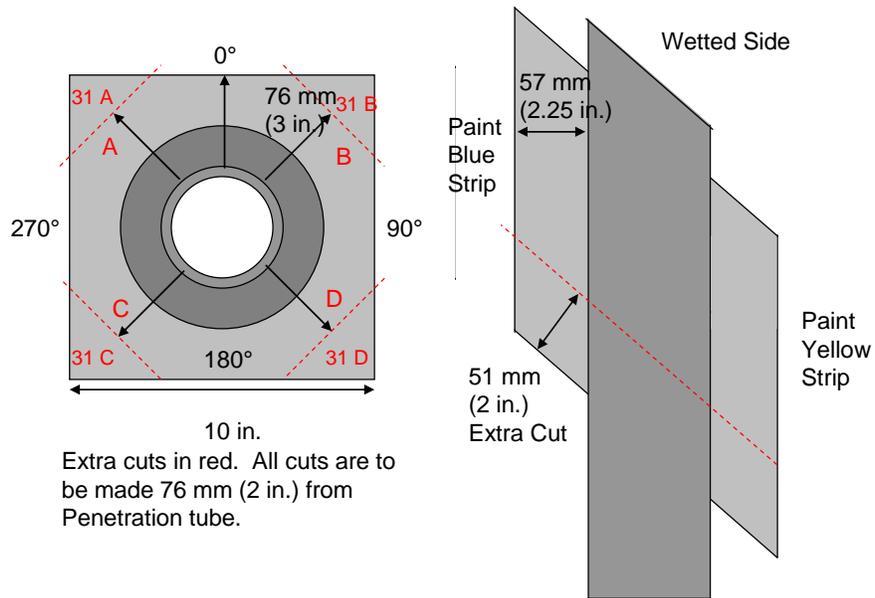
Figure 6.2. Additional Reduction Cuts Made on Nozzle 31

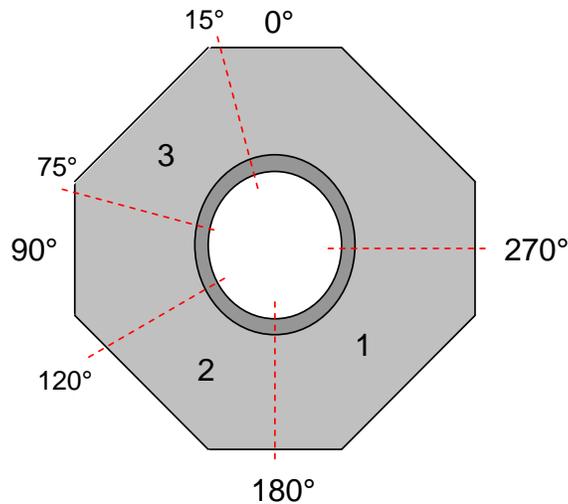
Figure 6.3. Final Cuts Made on Nozzle 31 to Remove Areas of Interest

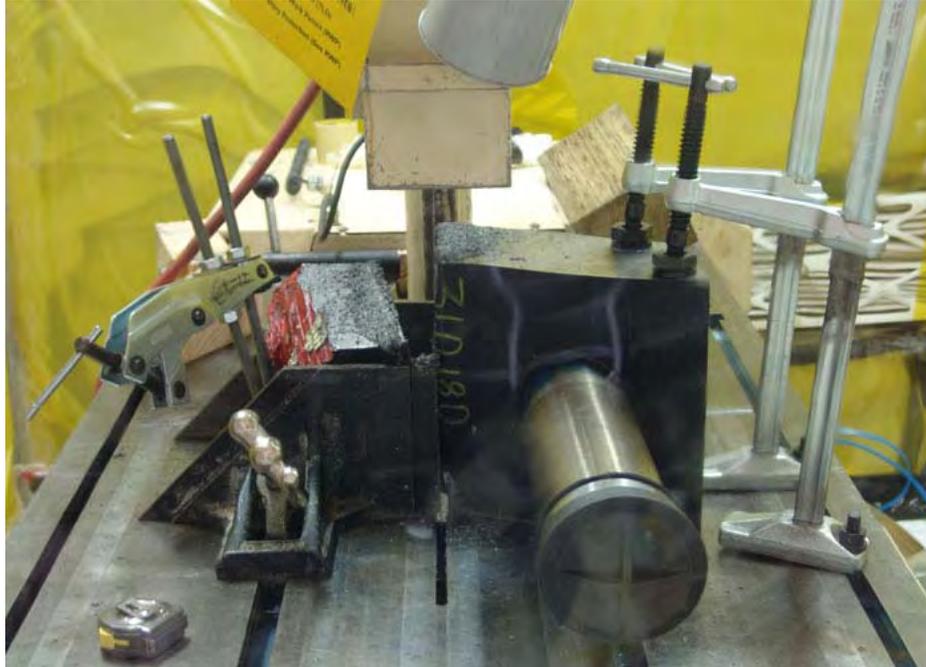
Figure 6.7. Nozzle 31 After Carbon Steel Was Cut into Square

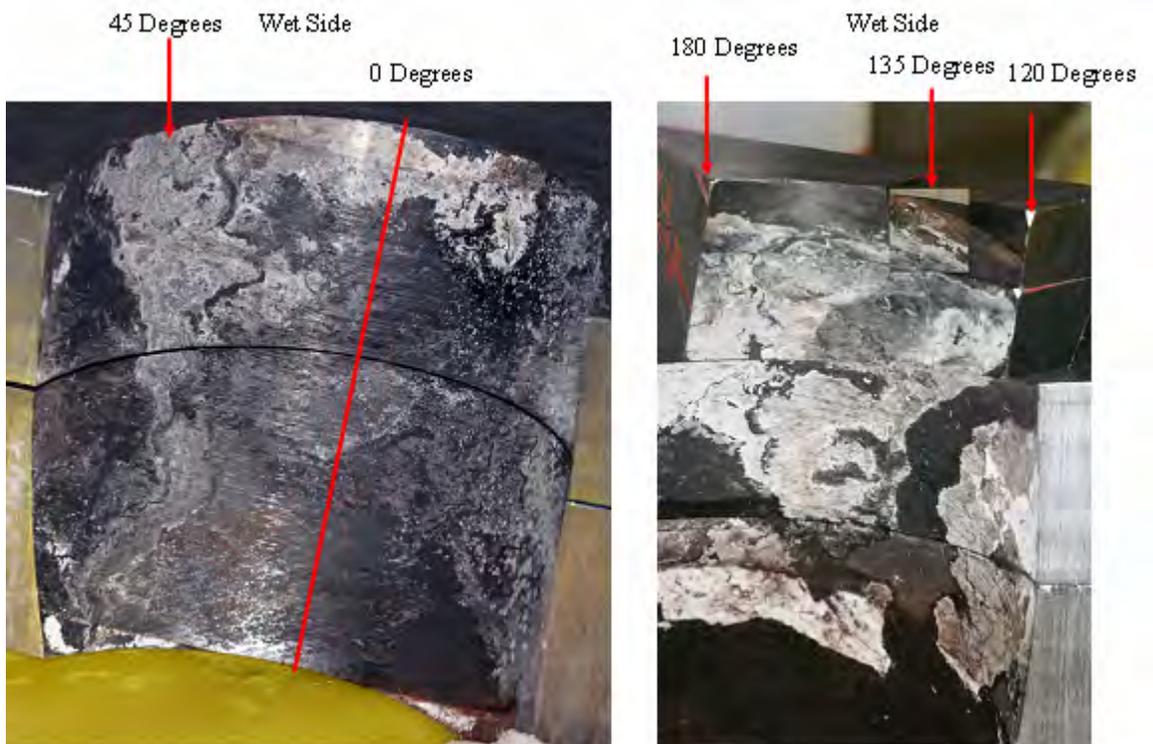
Figure 6.8. Two Main Flow Regions at 45 Degrees and 120 to 190 Degrees

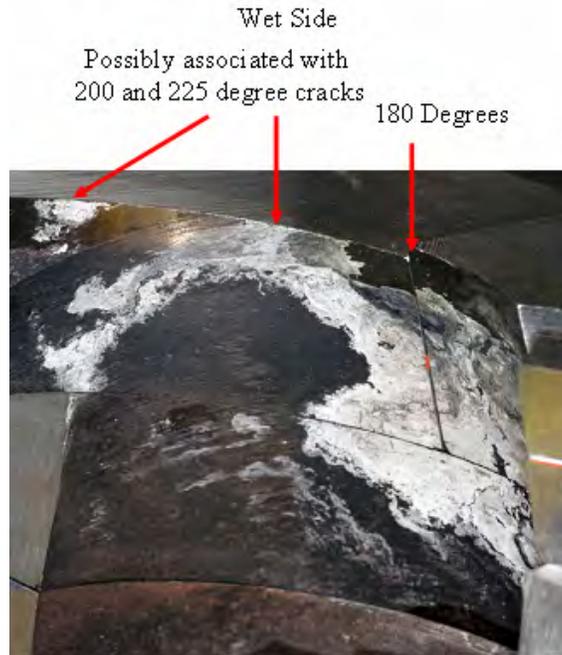
Figure 6.9. Two Smaller Flow Regions at 45 Degrees and 120 to 190 Degrees

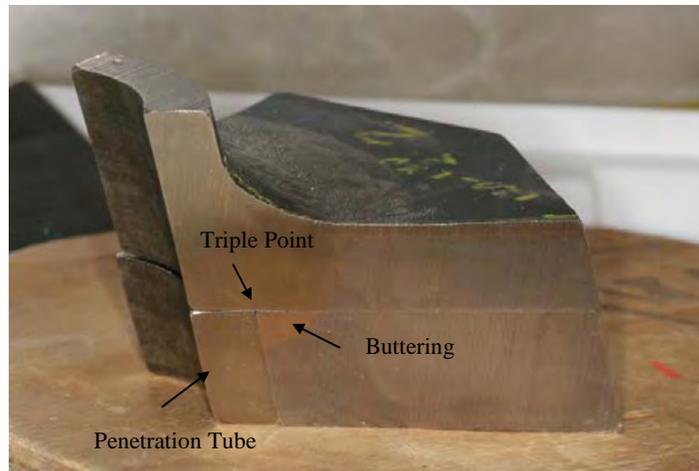
Figure 6.11. Section 2 After Cutting Above Triple Point To Remove Penetration Tube

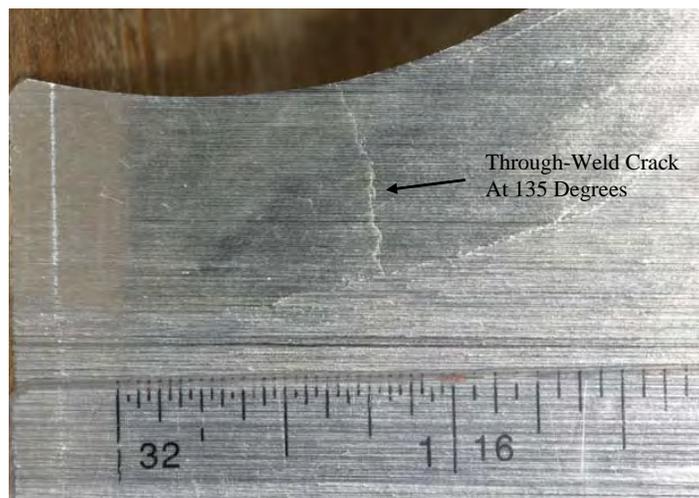
Figure 6.12. Confirmed Through-Weld Crack Found Above the Triple Point in Section 2 at 135 Degrees

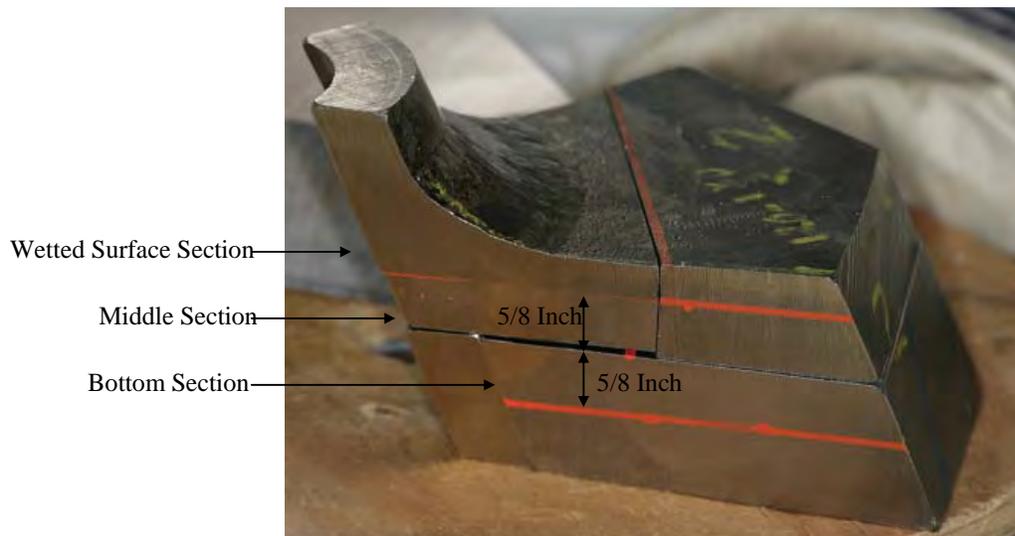
Figure 6.13. Section 2 After Cutting to Find Cracks

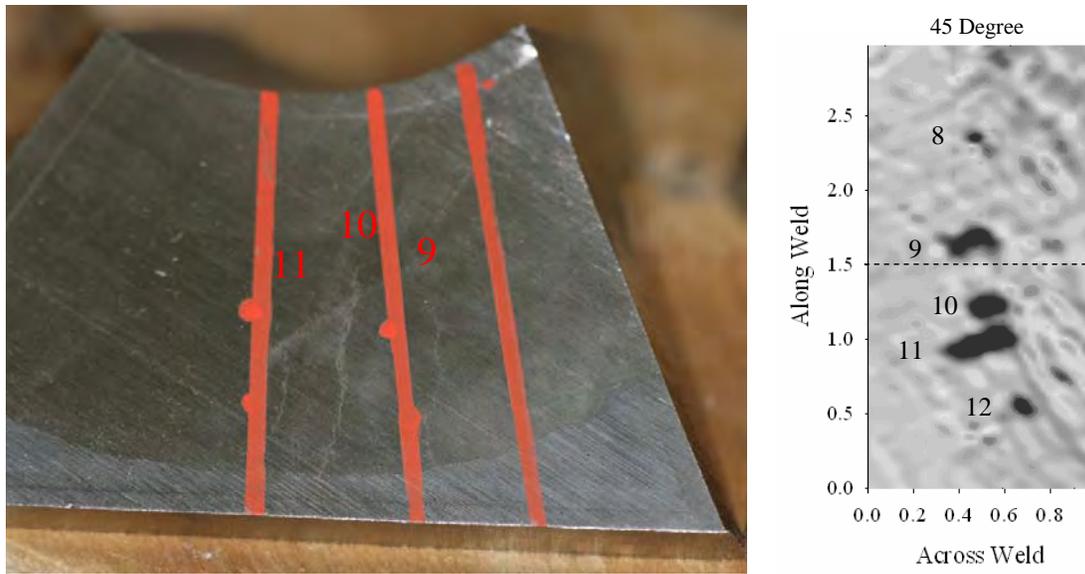
Figure 6.14. Eddy Current Testing Indications at 145, 155, and 160 Degrees Confirmed Using Destructive Examination

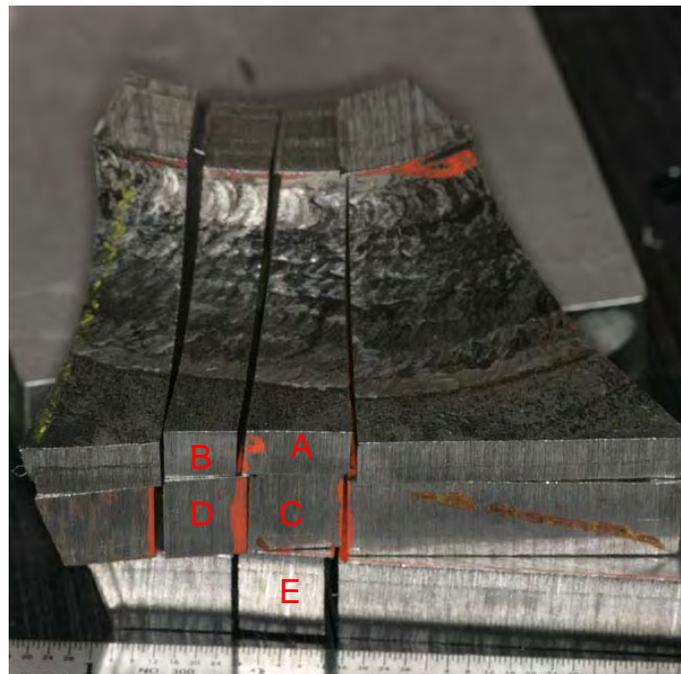
Figure 6.15. Cracked Metal Coupons Removed from Section 2

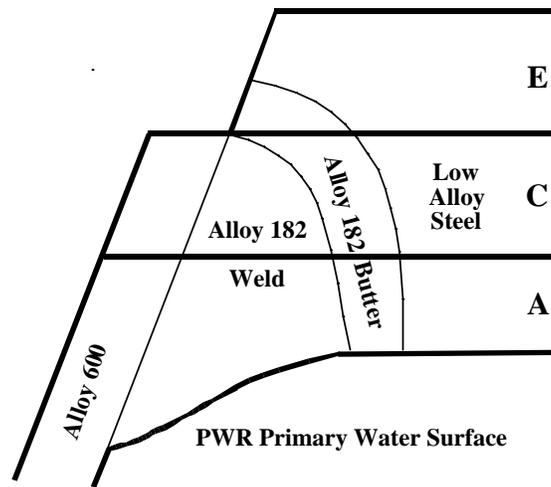
Figure 6.16. Sections A, C, and E Cut from Section 2 of Nozzle 31. Relative locations are indicated for the Alloy 600 nozzle, the Alloy 182 J-groove weld, the Alloy 182 butter passes, and the low-alloy steel.

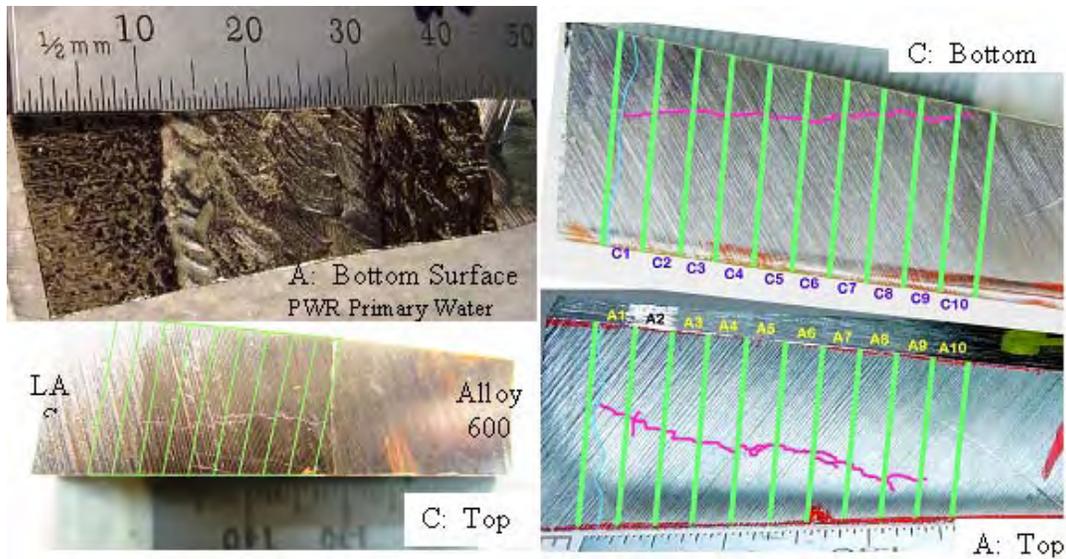
Figure 6.17. Top and Bottom Surfaces for Pieces A and C Are Shown Along with Highlighted Cracks and Proposed Serial Sectioning. The bottom surface for piece A was exposed to primary water during PWR service.

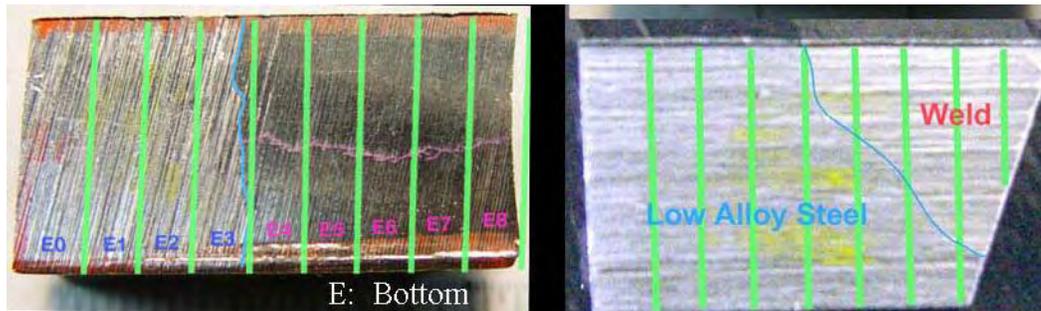
Figure 6.18. Bottom (left) and Side (right) Surfaces for E with Proposed Serial Sectioning. Note that these images are not to scale with those in Figure 6.17.

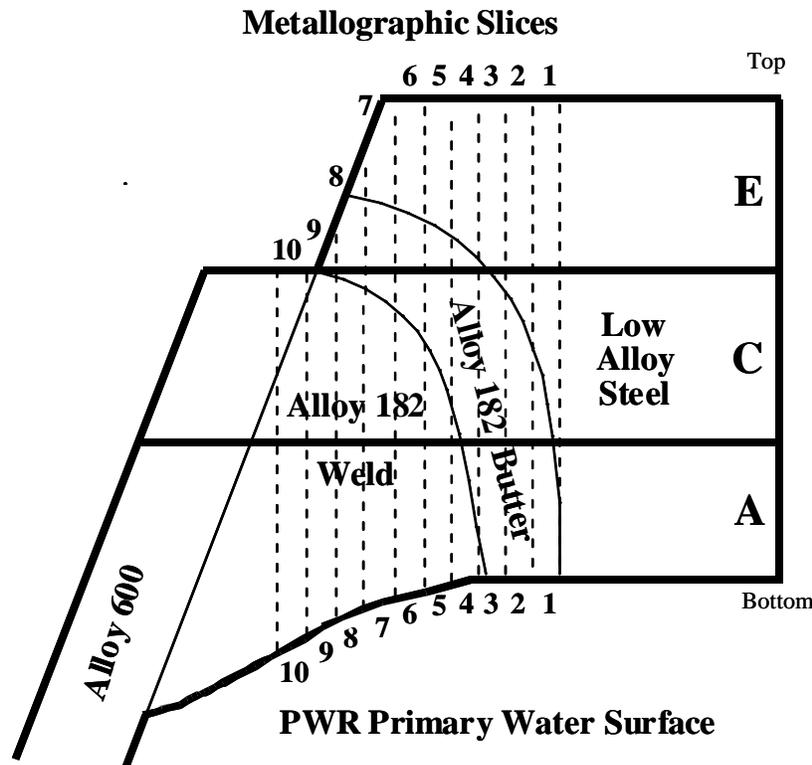
Figure 6.19. Approximate Locations (dashed lines) of Metallographic Sections Through Pieces A, C, and E

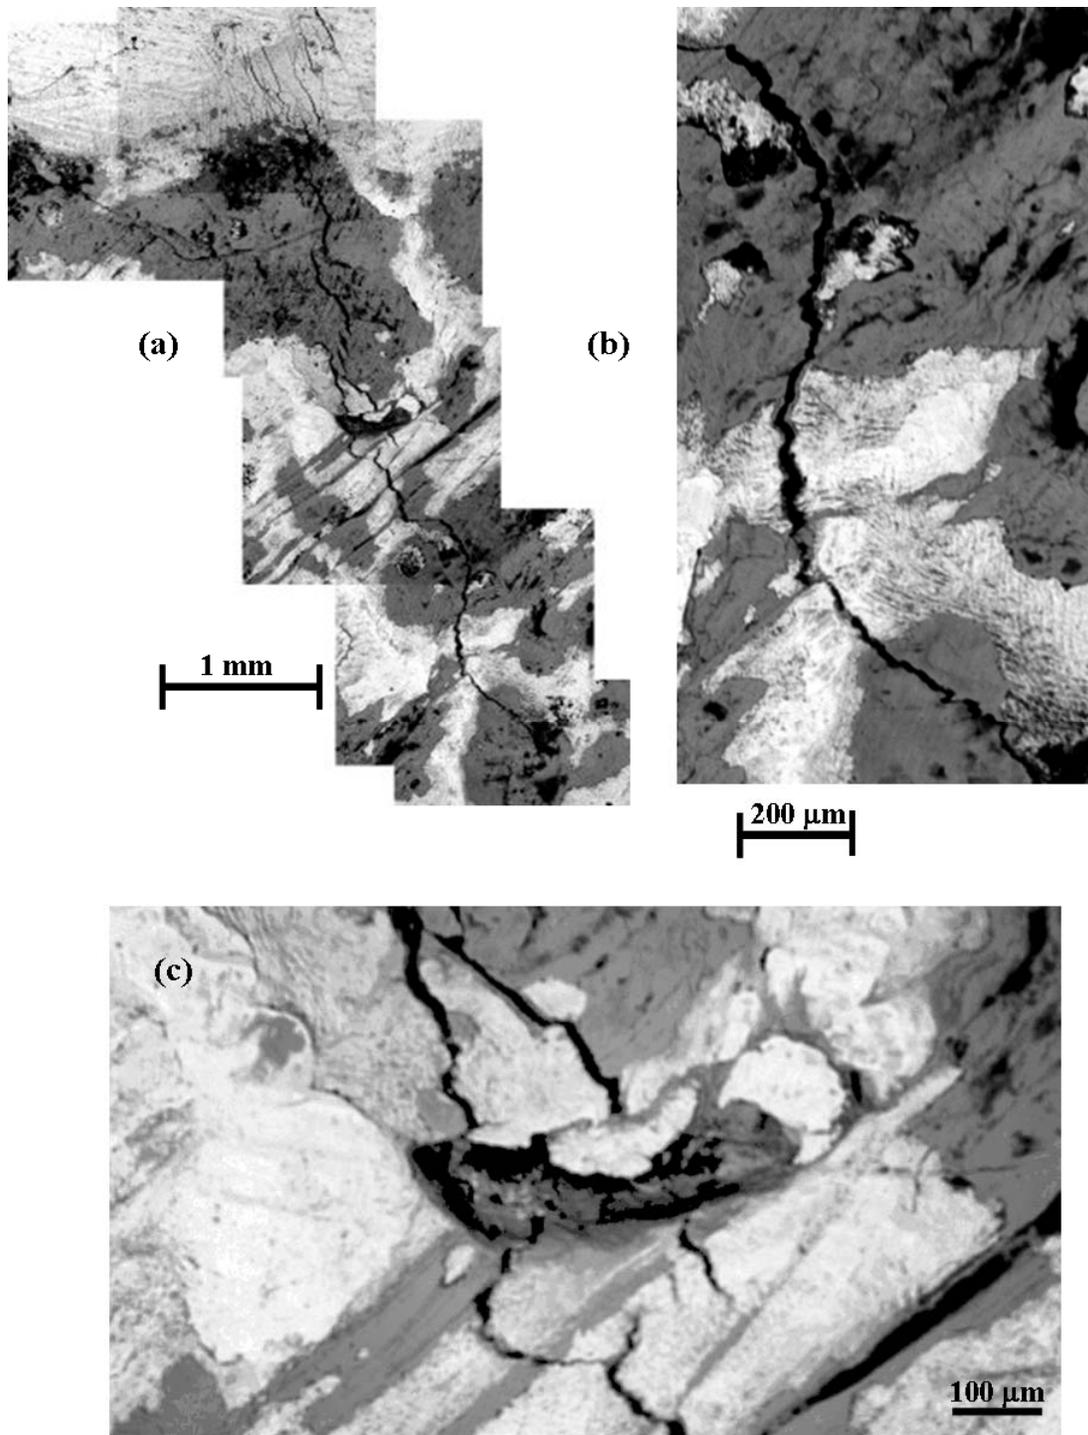
Figure 6.20. Observed Crack on the PWR Water Surface of Piece A at Two Magnifications. The rough as-welded surface and relatively thick corrosion-product oxide in places (white contrast) made SEM imaging of fine secondary cracks difficult. However, the main crack is seen to extend ~6 mm on this surface. A moderate-size defect (pit) near the center of the main crack is shown in (a) and magnified in (c).

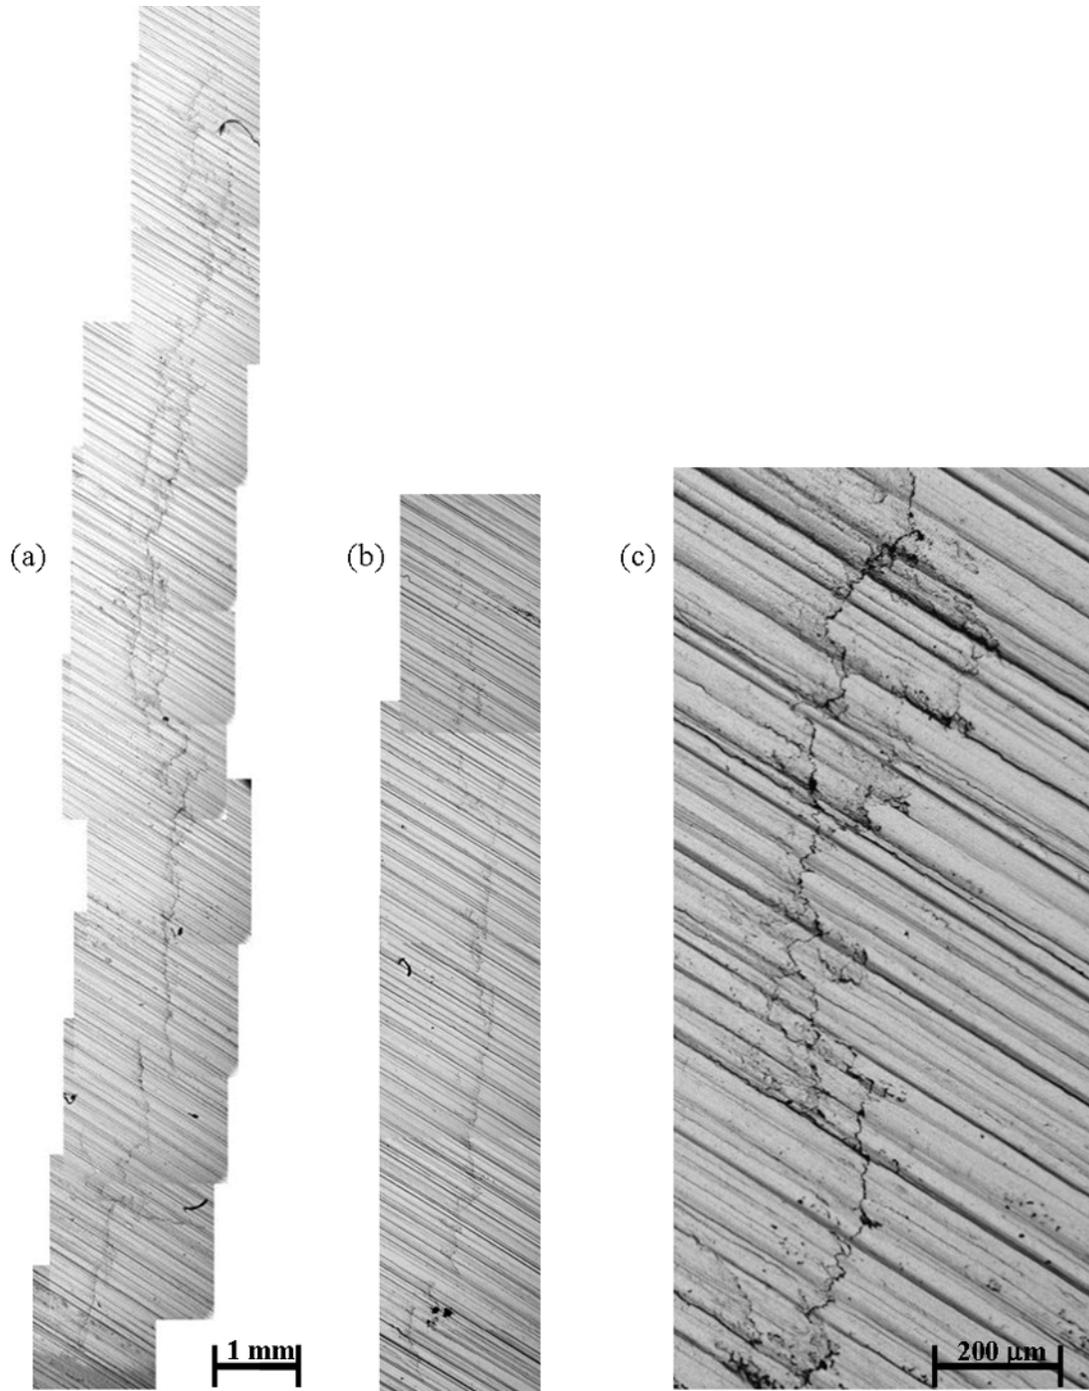
Figure 6.21. Cracks on Piece A Top (inner), Saw-Cut Surface: (a) main crack, (b) secondary crack, and (c) higher magnification of typical crack morphology from (a)

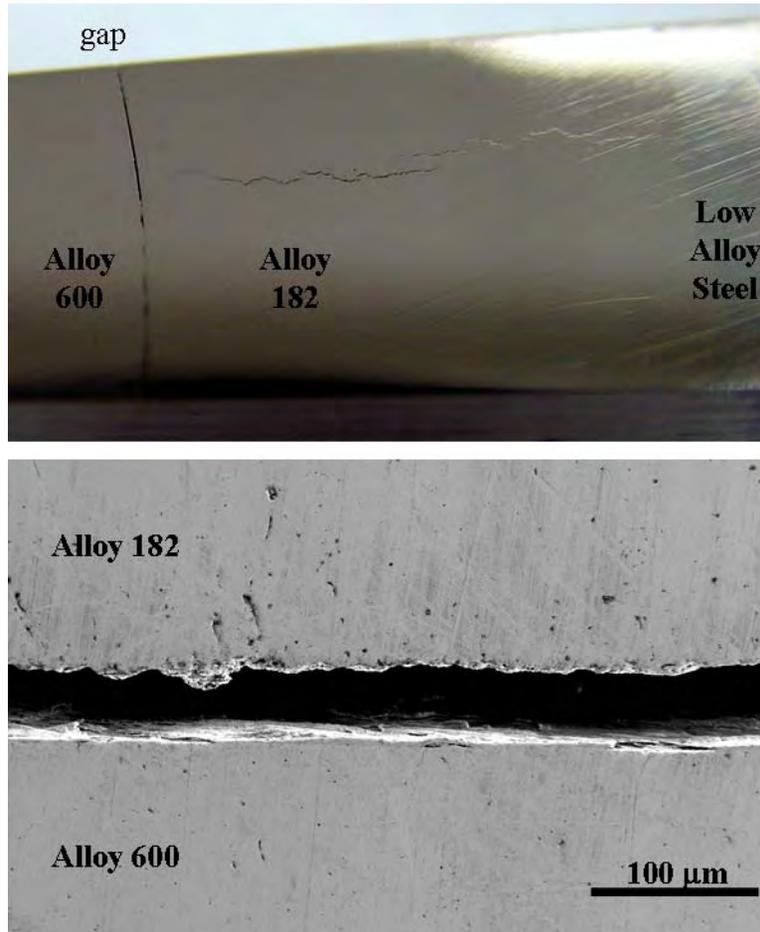
Figure 6.22. Interference-Fit Gap Between the Alloy 182 Butter Passes and the Alloy 600 Tube on Top Surface of Piece C (facing bottom surface of piece E)

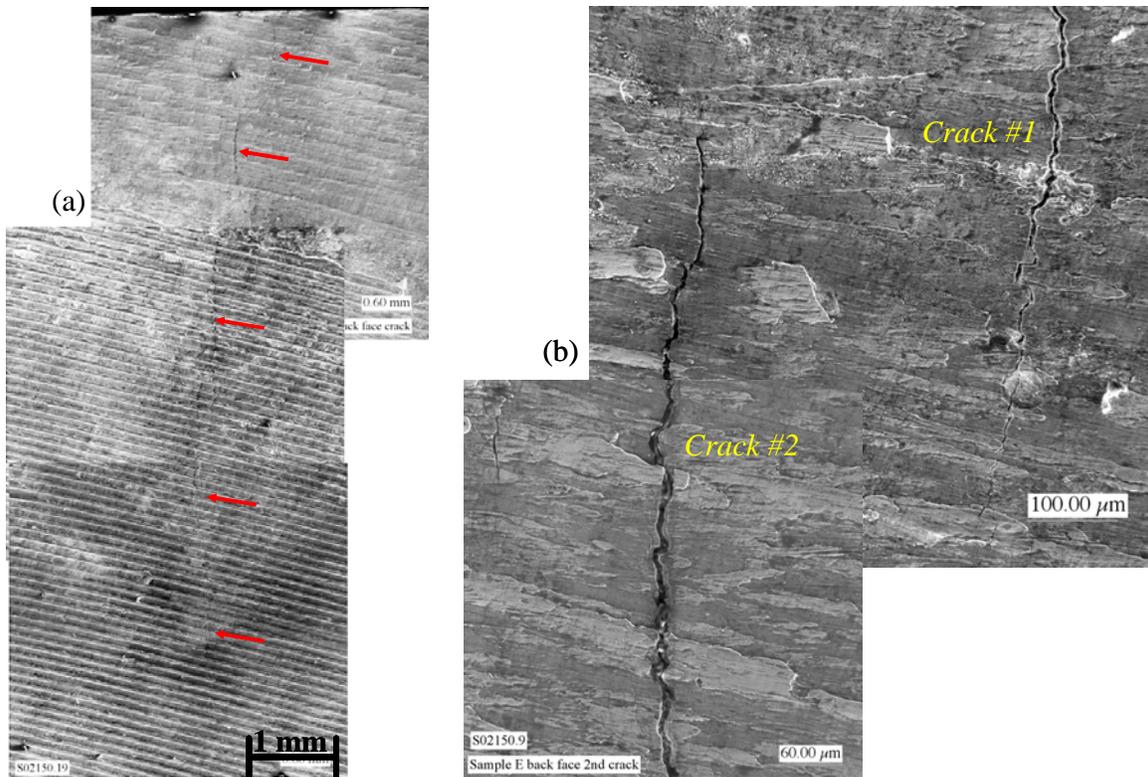
Figure 6.23. Machined Surface and Exit Location for Through-Wall Cracks from Piece E Alloy 182 Weld Metal into Interference-Fit Gap Between Alloy 182 Butter and Alloy 600 Tube. Low-magnification SEM image (a) shows full length and two major cracks, while higher magnification (b) illustrates crack morphologies.

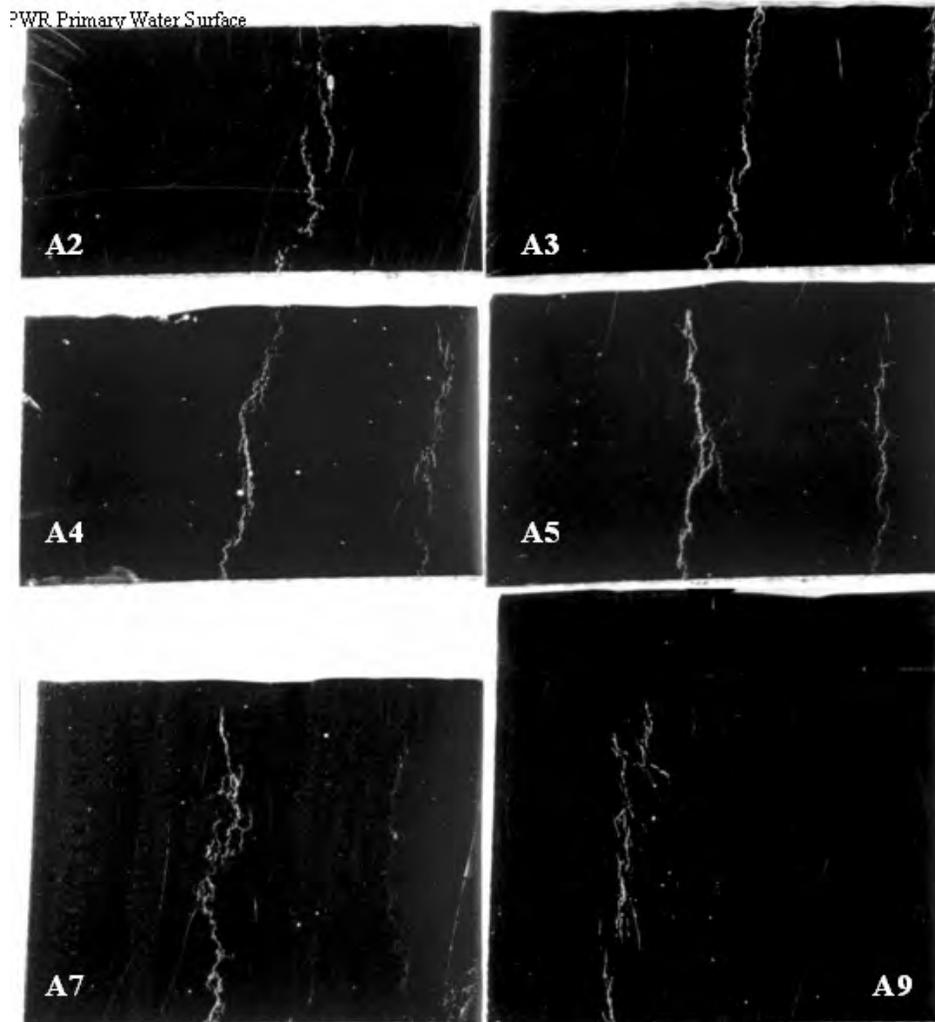
Figure 6.24. Macro Cracks in Several Cross-Section Samples from Piece A Shown Through Photography. Note that PWR primary water surface is now on the top side of these images.

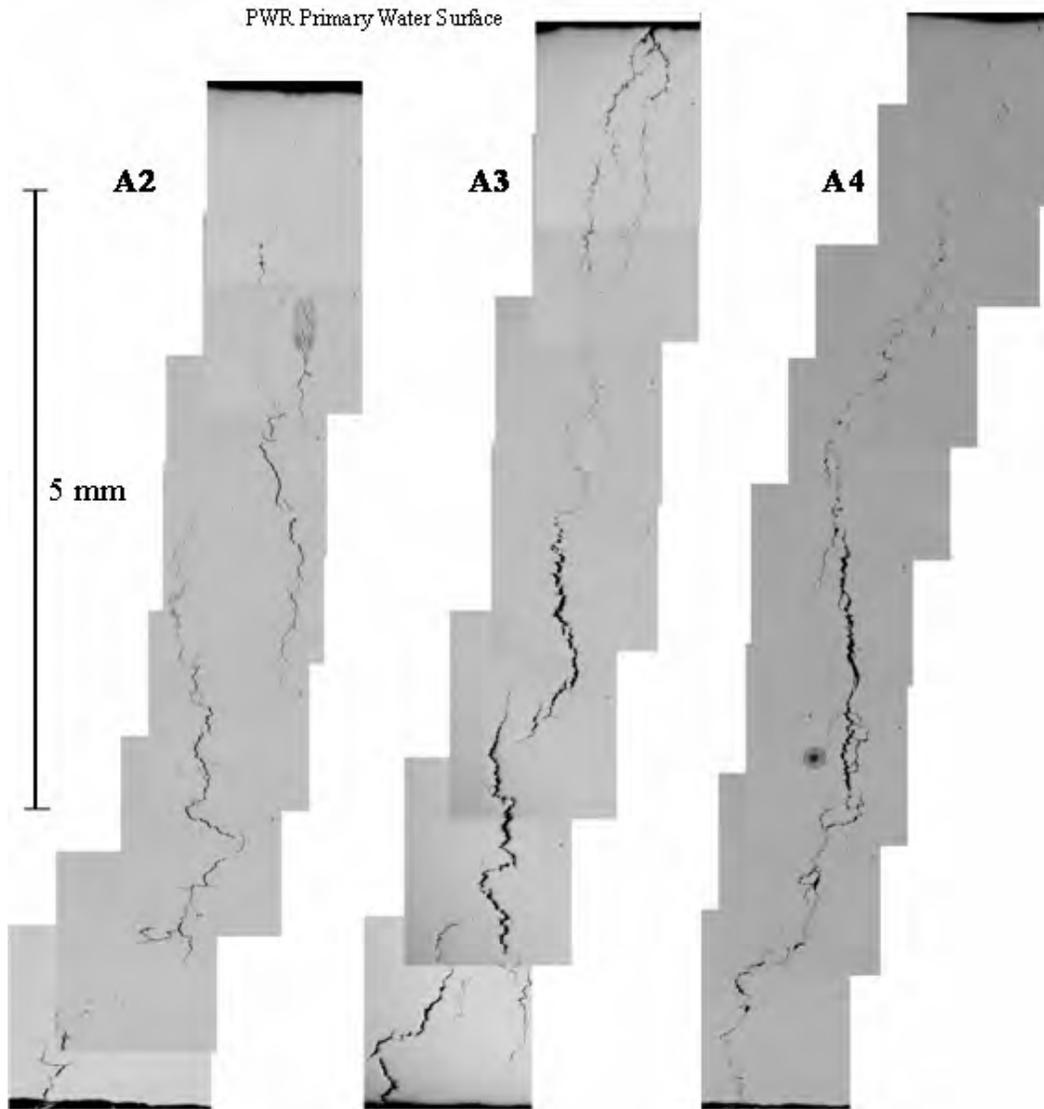
Figure 6.25. Optical Micrographs for A2, A3, and A4 Cross-Section Samples Showing the Main Crack Essentially Running Through Entire Thickness of Each Sample

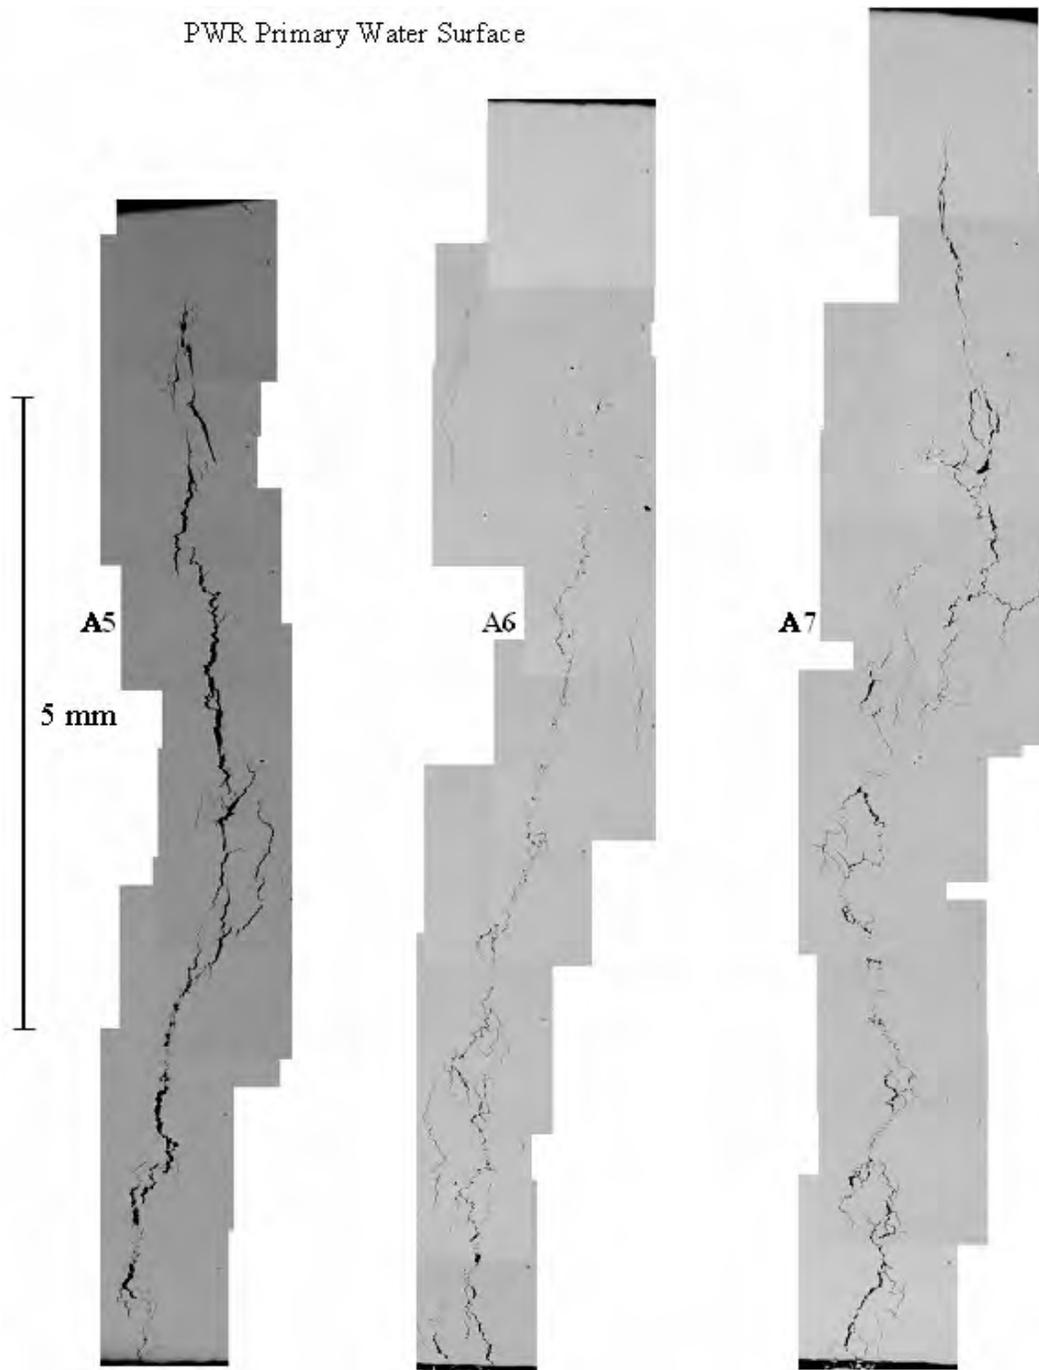
Figure 6.26. Optical Micrographs for A5, A6, and A7 Cross-Section Samples Showing the Main Crack Appearing Below the PWR Primary Water Surface and Through Remaining Thickness of Each Sample

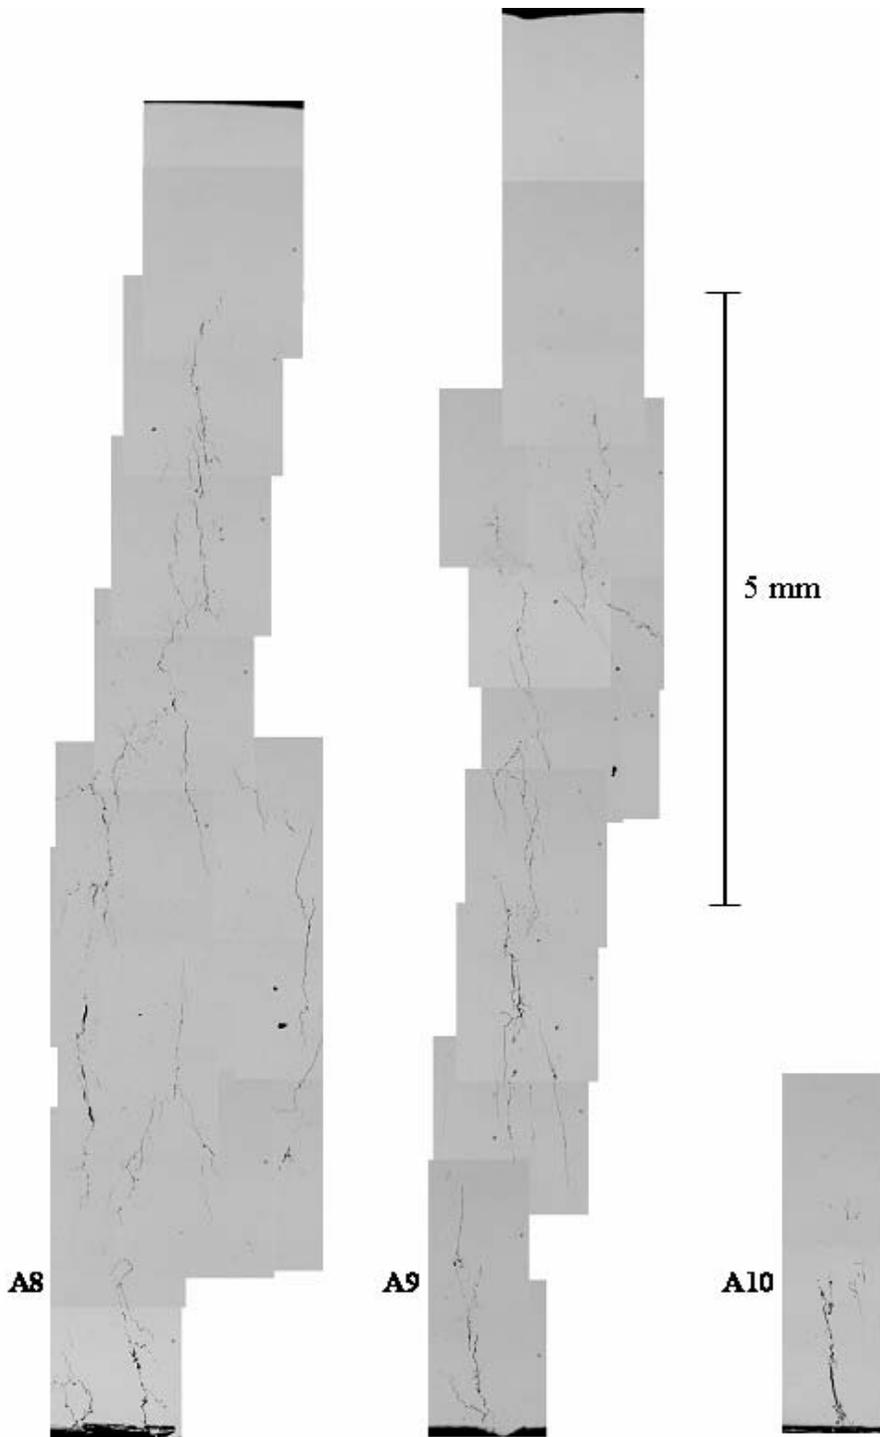
Figure 6.27. Optical Micrographs for A8, A9, and A10 Cross-Section Samples Showing the Main Crack Appearing Farther Below the PWR Primary Water Surface as a Function of Distance from the Crack Initiation Sites in A3

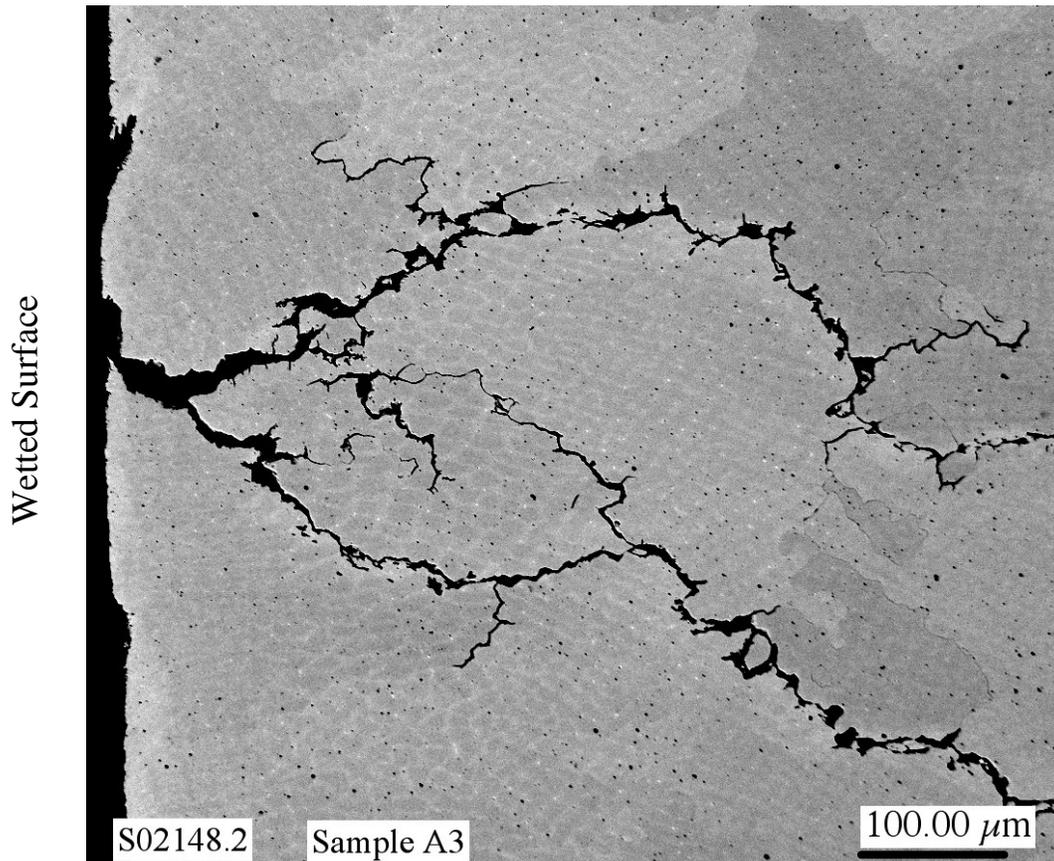
Figure 6.28. Location Where Crack Intersects the PWR Primary-Water Surface in Sample A3 and May Be Near the Initiation Site. Microstructural contrast within individual grains is due to solidification segregation in the Alloy 182 weld metal.

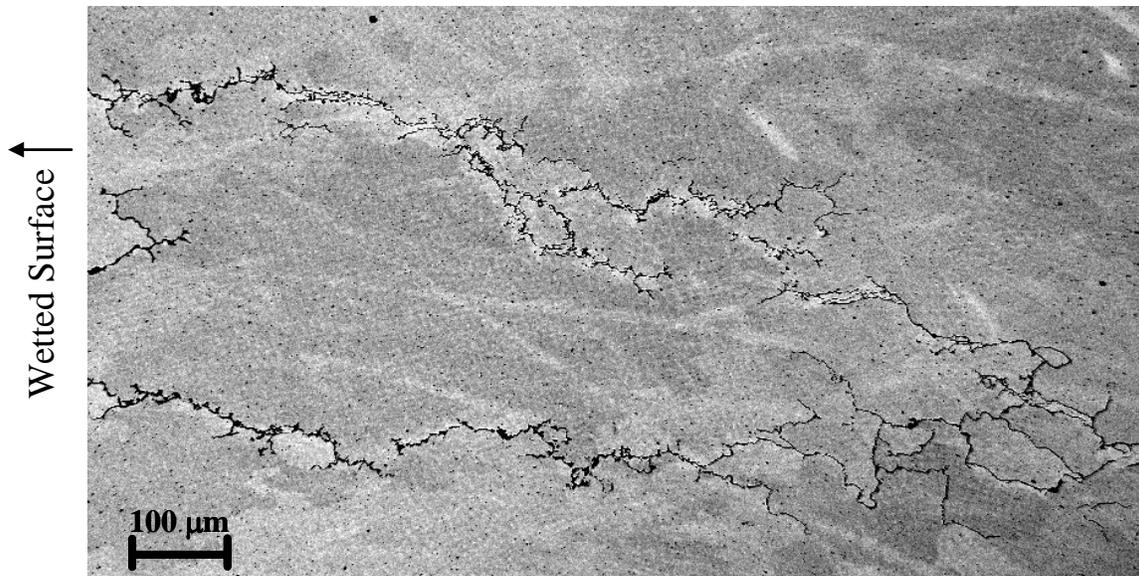
Figure 6.29. Highly Branched Cracks Near Mid-Thickness in Cross-Section Sample A3

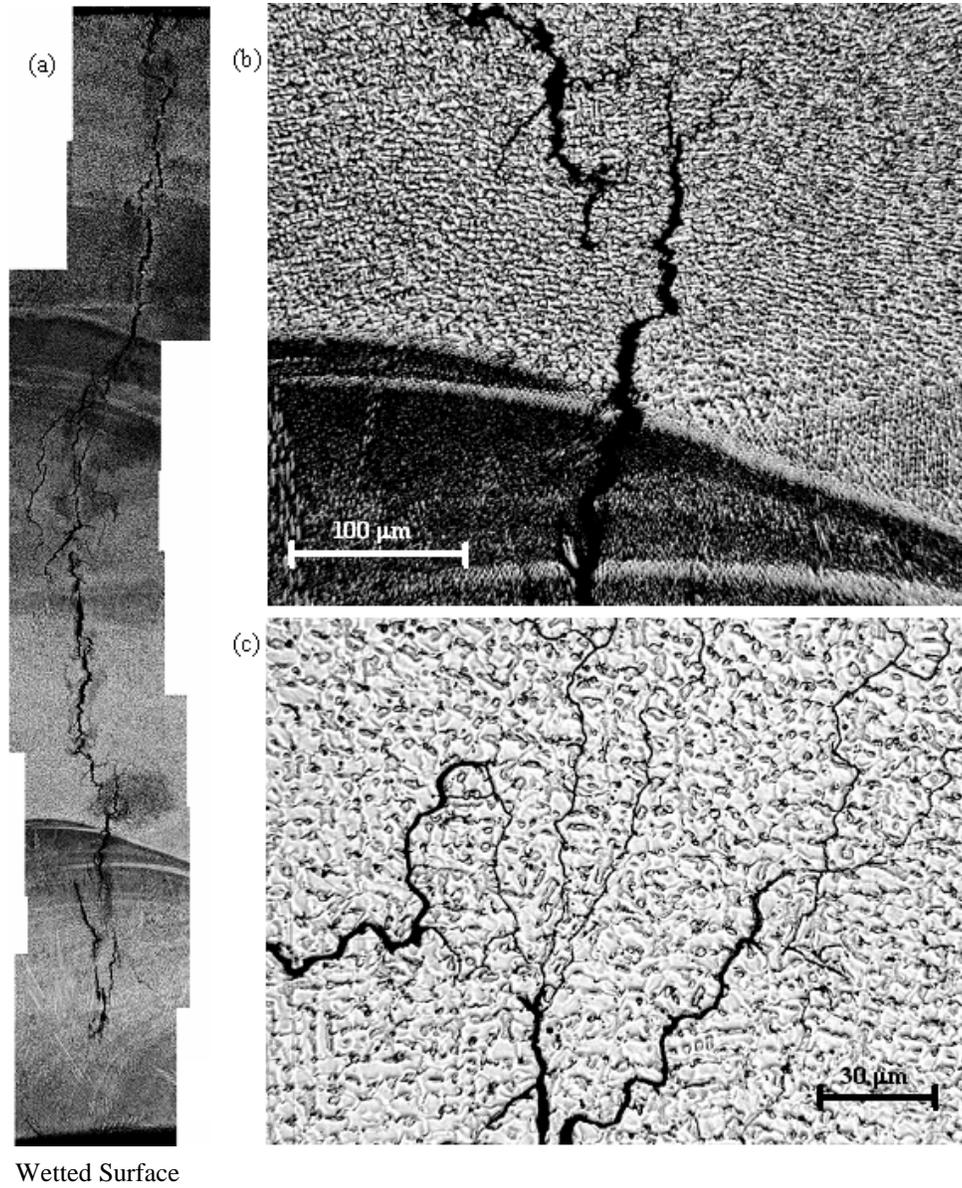
Figure 6.30. Etched Microstructures in A5 Cross-Section Sample: (a) montage showing full length of crack; (b) example of more open crack near/at weld pass interfaces; and (c) example of cracks following convoluted boundaries

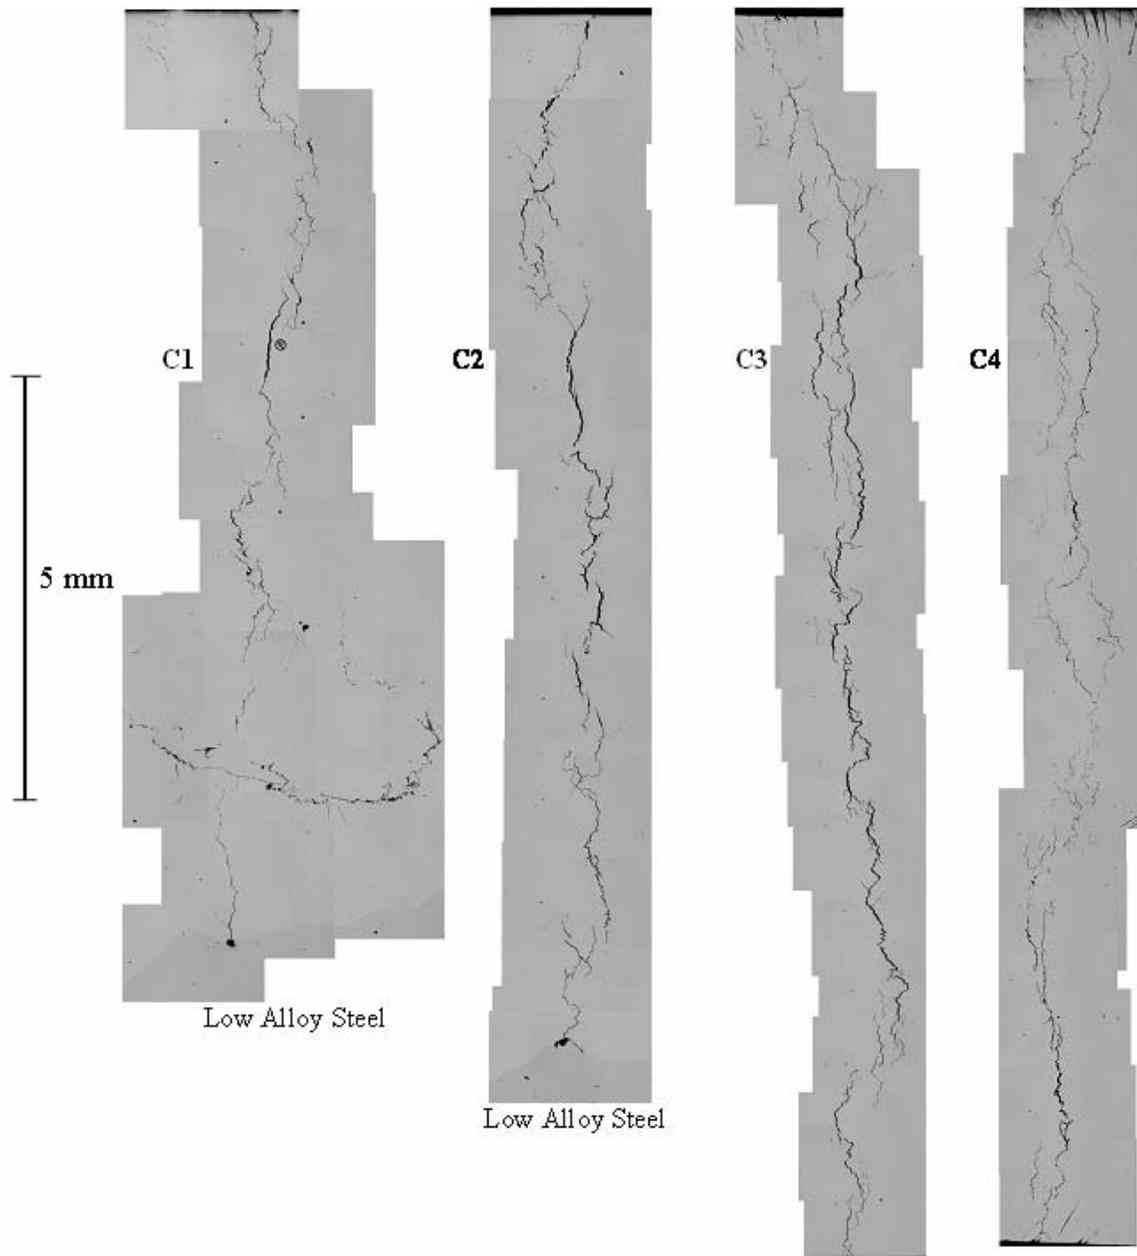
Figure 6.31. C1, C2, C3, and C4 Cross-Section Samples Showing the Main Crack Running to the Low-Alloy Steel Boundary in C1 and C2, While C3 and C4 Show Crack Propagating Through Entire Thickness in Alloy 182 Weld Metal
