**Pacific Northwest
National Laboratory**

Operated by Battelle for the
U.S. Department of Energy

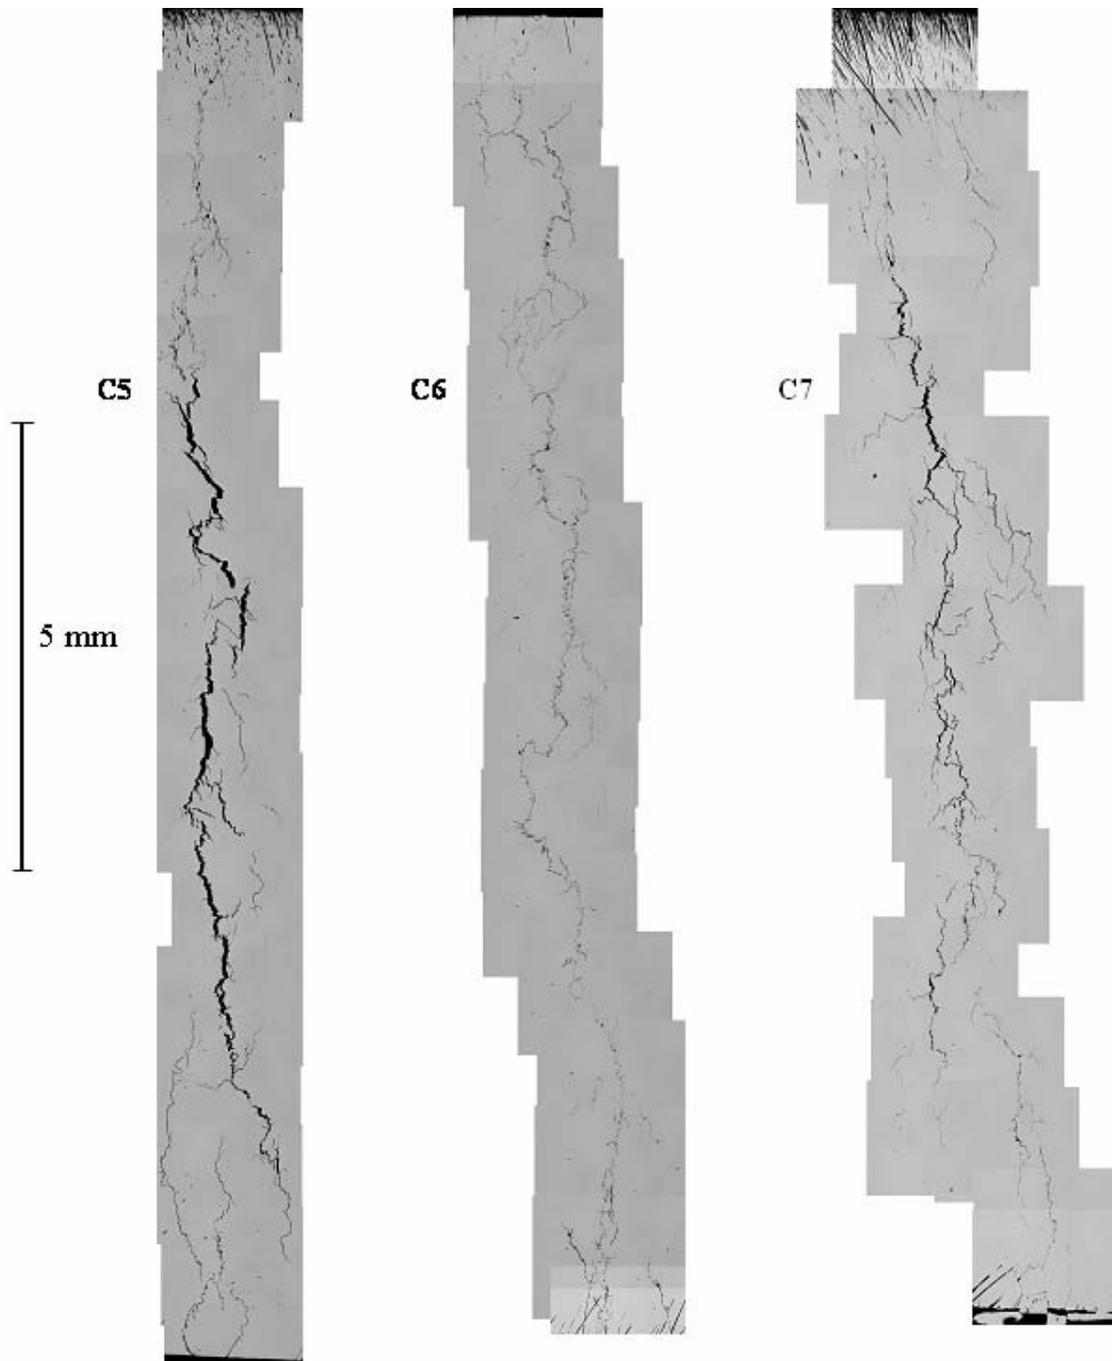
Figure 6.32. C5, C6, and C7 Cross-Section Samples Showing the Main Crack Running Through Entire Thickness for These Locations

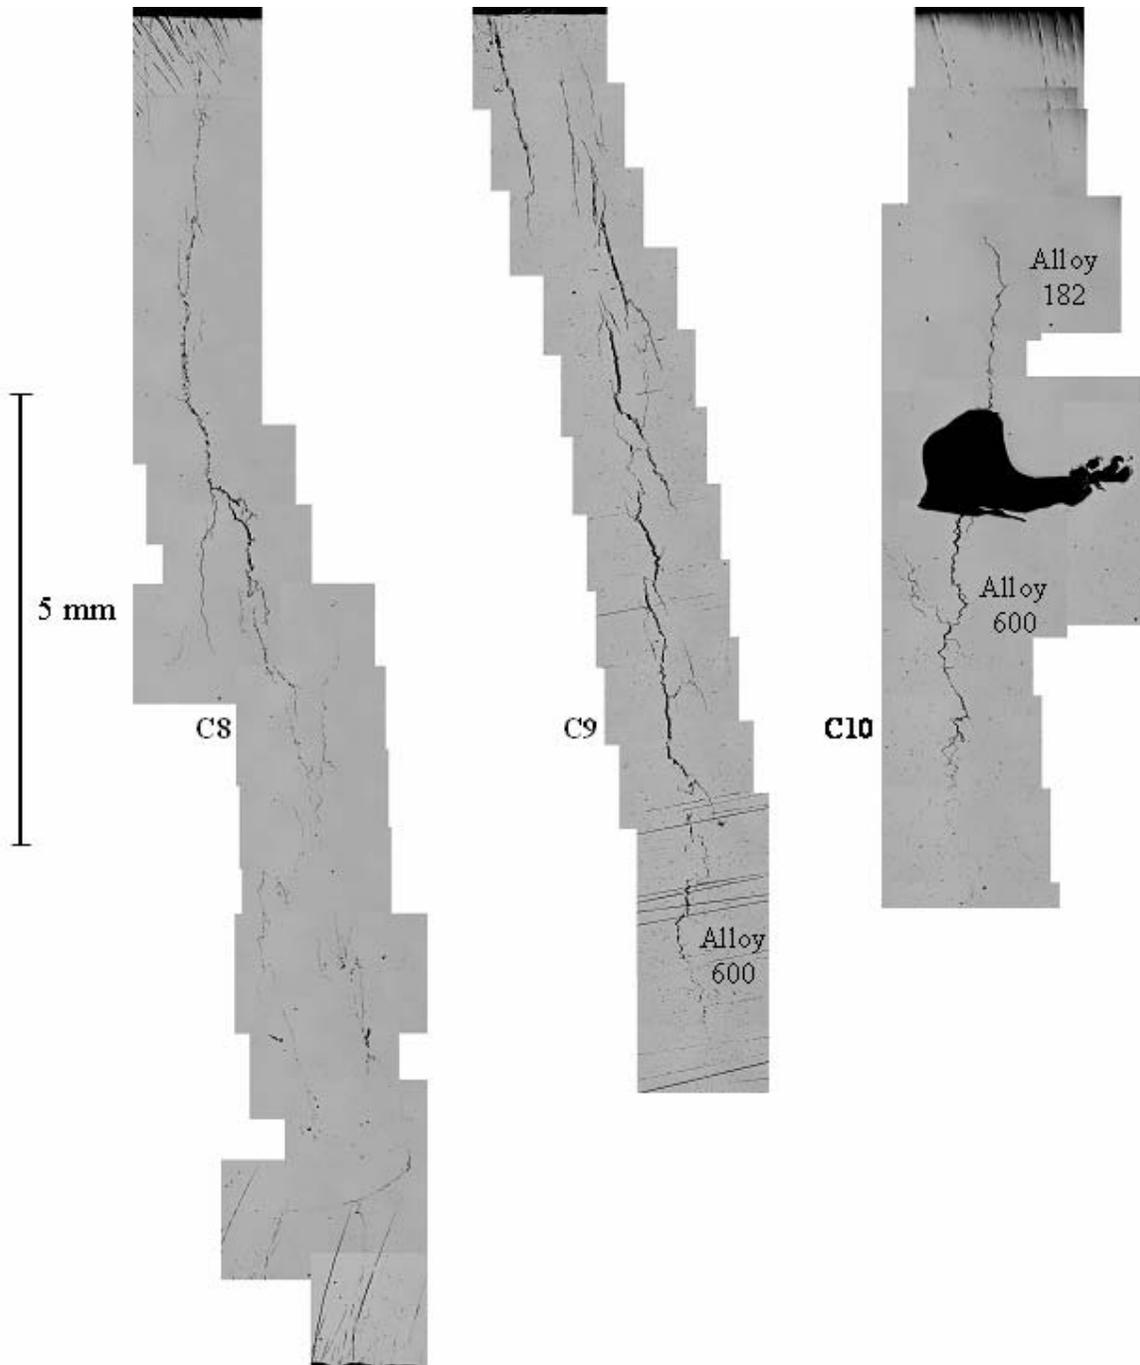
Figure 6.33. C8, C9, and C10 Cross-Section Samples Showing the Main Crack Running Through the Alloy 182 J-Groove Weld into the Alloy 600 Tube. The large hole in the C10 cross section appears to be a weld defect at the alloy fusion line between the Alloy 600 tube and the Alloy 182 weld metal.

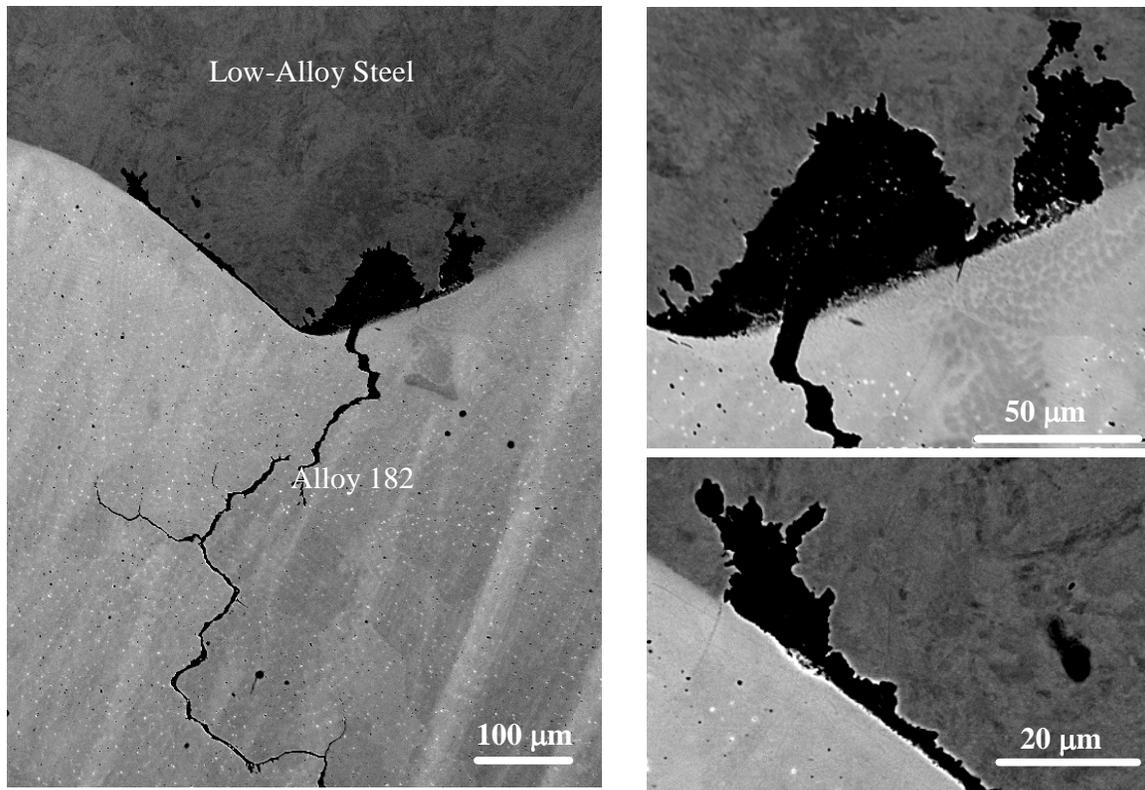
Figure 6.34. Stress Corrosion Crack in Alloy 182 Butter Pass Ending at the Low-Alloy Steel Interface and Creating Small Corrosion Pits

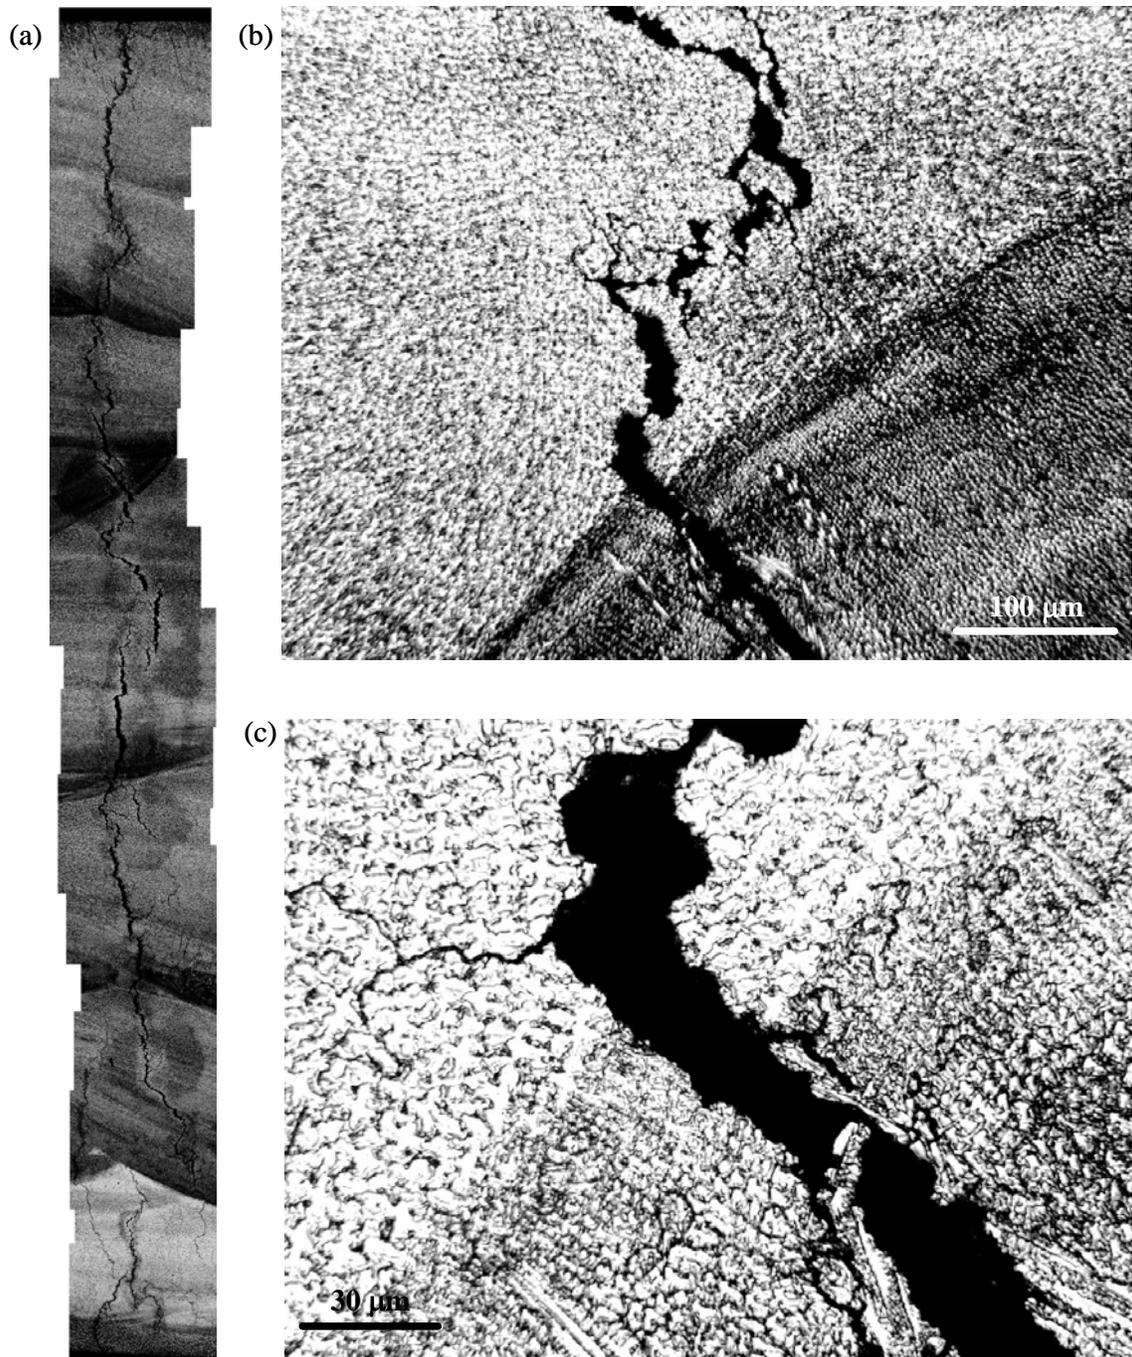
Figure 6.35. Etched C5 Cross-Section Showing Crack Propagating Through Many Alloy 182 Weld Passes

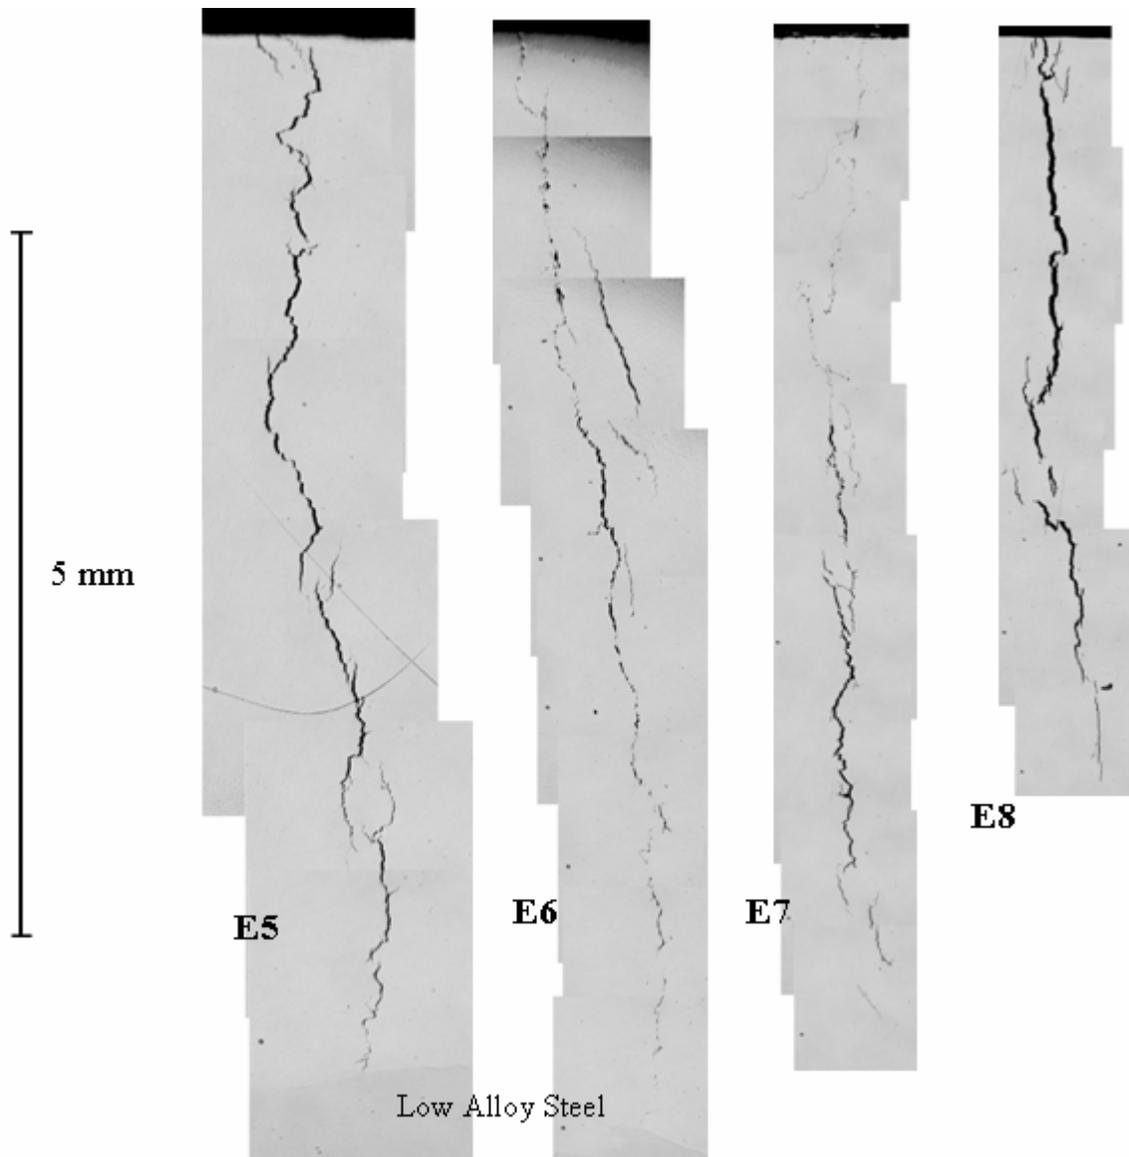
Figure 6.36. E5, E6, E7, and E8 Cross-Section Samples Showing the Main Crack Running to the Low-Alloy Steel Boundary. Only a very small crack was seen in sample E4, and E8 was the closest slice to the gap surface.

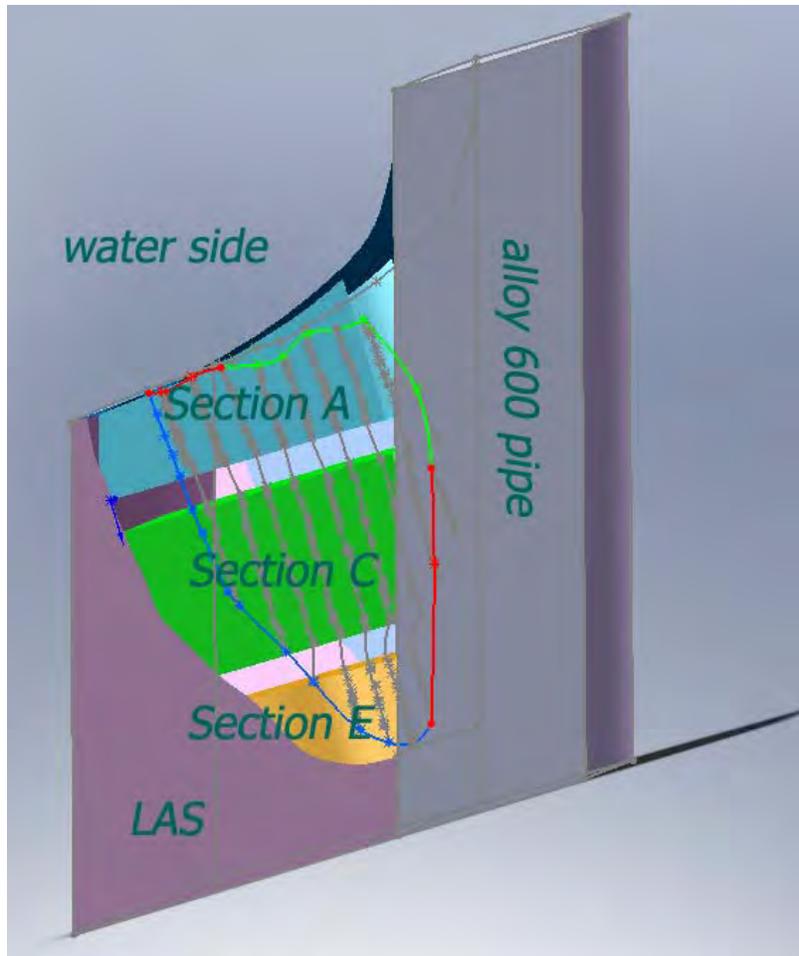
Figure 6.37. Rendering of the Crack Within a Section of the Component Showing the Locations of Sections A, C, and E

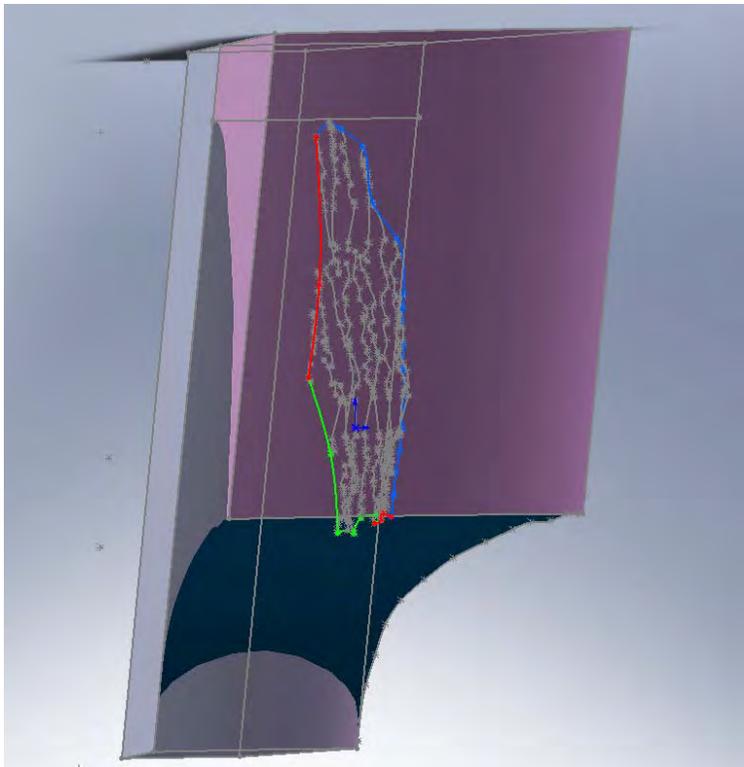
Figure 6.38. Crack Viewed from a Nearly Edge-On Orientation

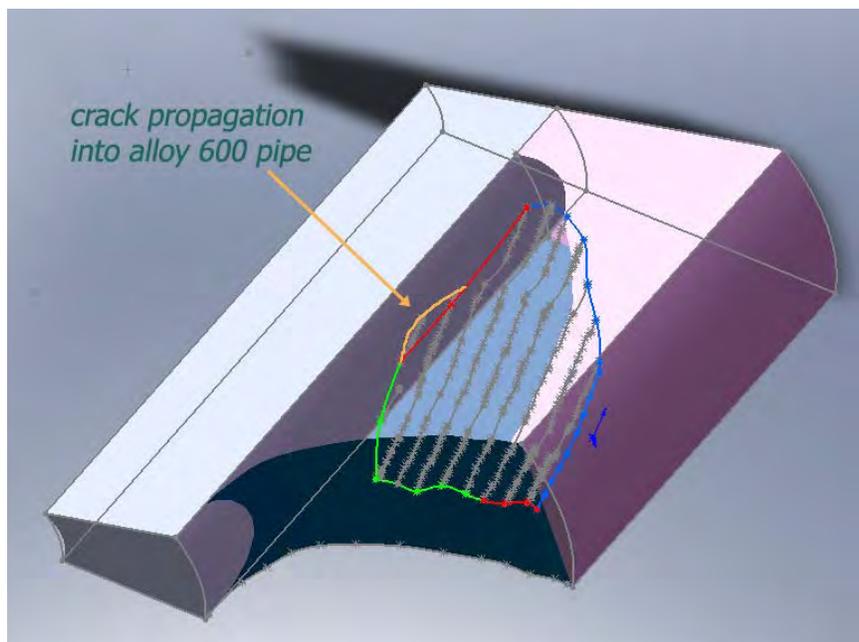
Figure 6.39. Component Section Viewed from a Tilted Orientation Where the Propagation of the Crack into the Alloy 600 Pipe Can Be Seen

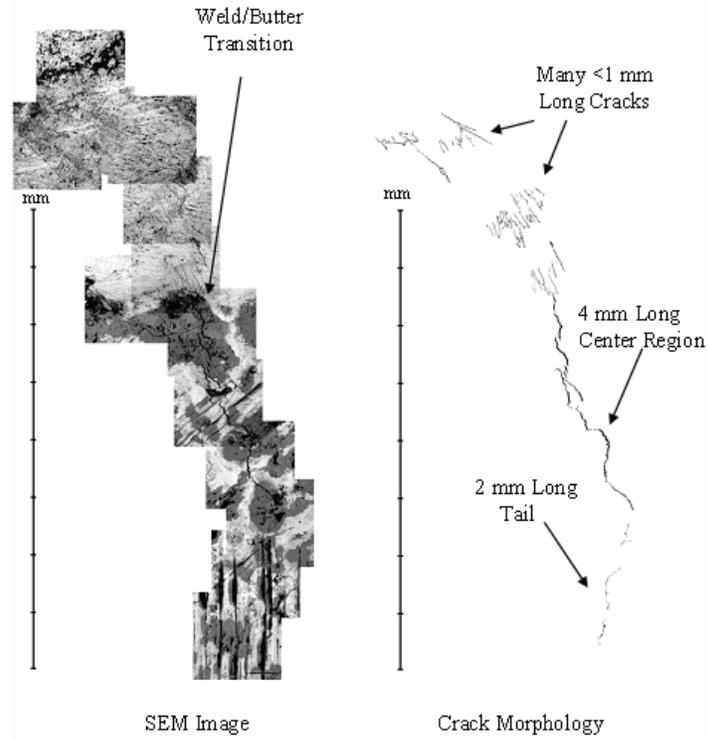
Figure 7.1. Crack Image and Crack Morphology

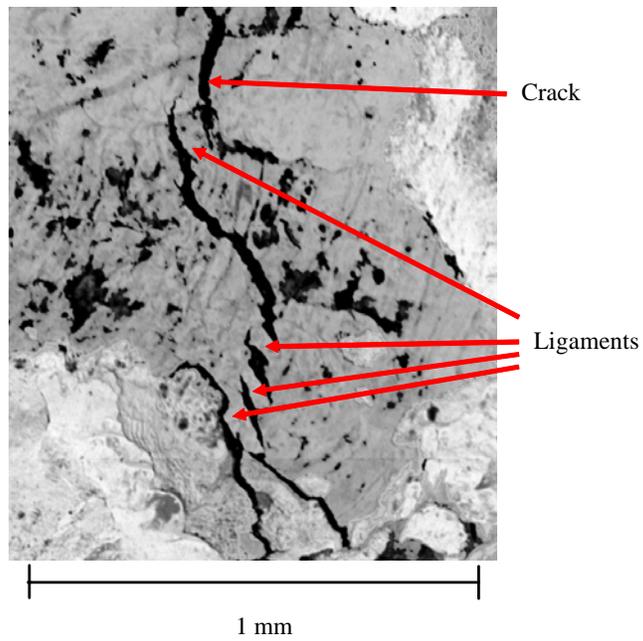
Figure 7.2. Expanded Section of the Crack Showing Ligaments Bridging the Two Sides of the Crack

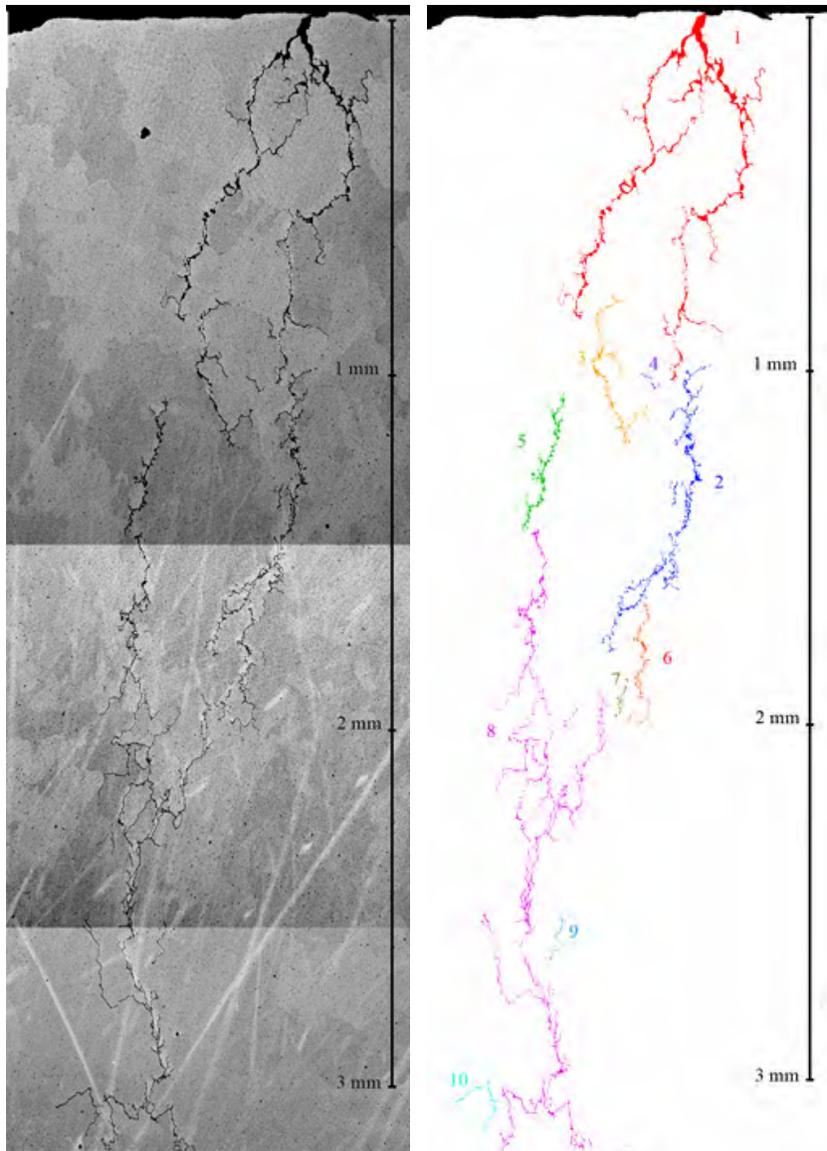
Figure 7.3. Crack Segments. SEM image (left) and color-coded image (right).

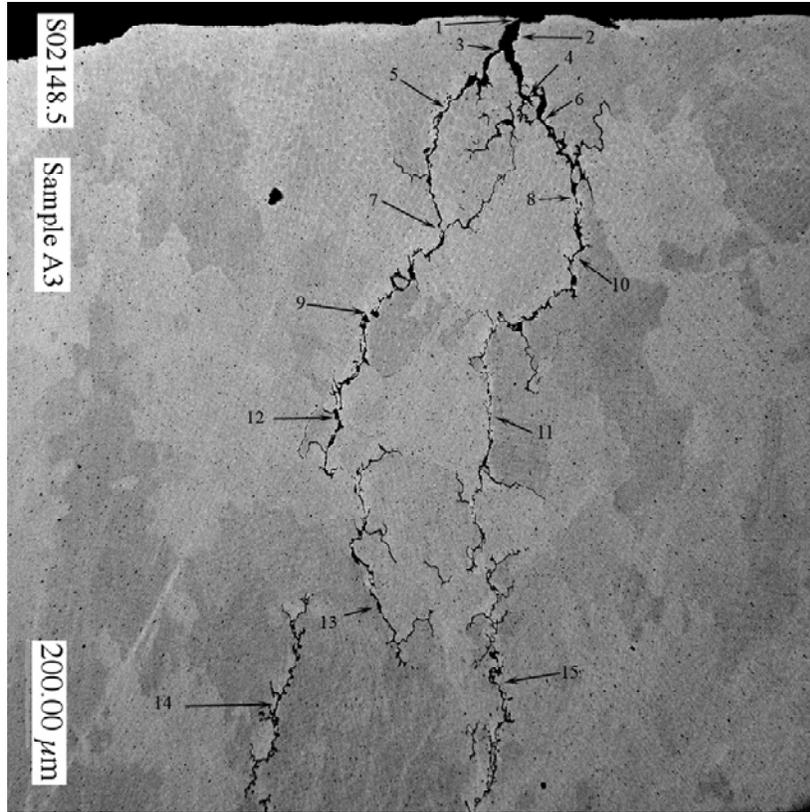
Figure 7.4. Crack CODs at Several Points Close to the Surface

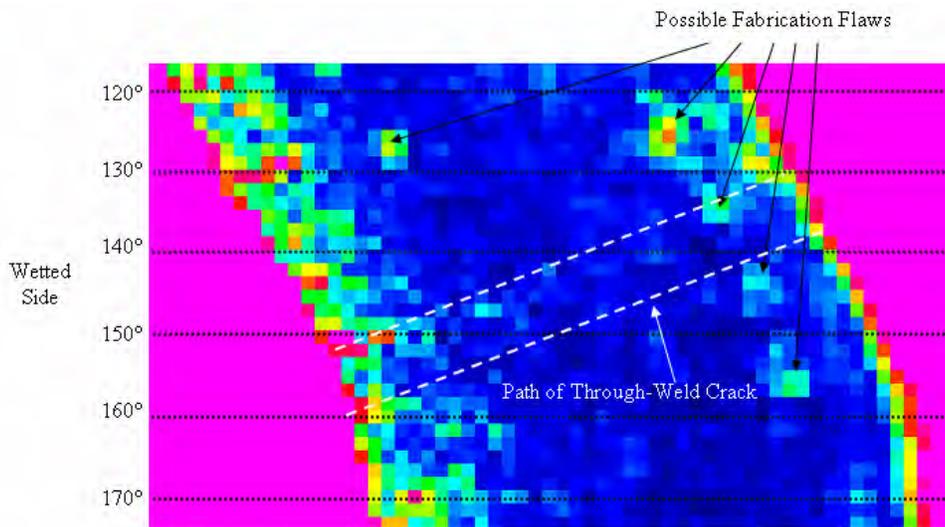
Figure 7.5. 5-MHz Ultrasonic Testing Data for the Cracked Region of the Nozzle 31 J-Groove Weld Metal

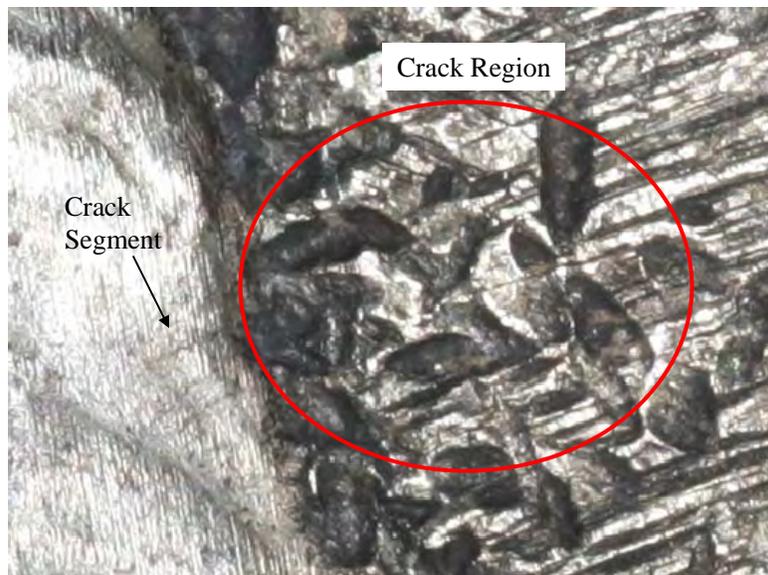
Figure 7.6. Cracked Region with Poor Crack Detection Because of Surface Features and Oxides
