PNNL-19018

# An Evaluation of Ultrasonic Phased Array Testing for Reactor Piping System Components Containing Dissimilar Metal Welds

JCN N6398, Task 2A

November 2009

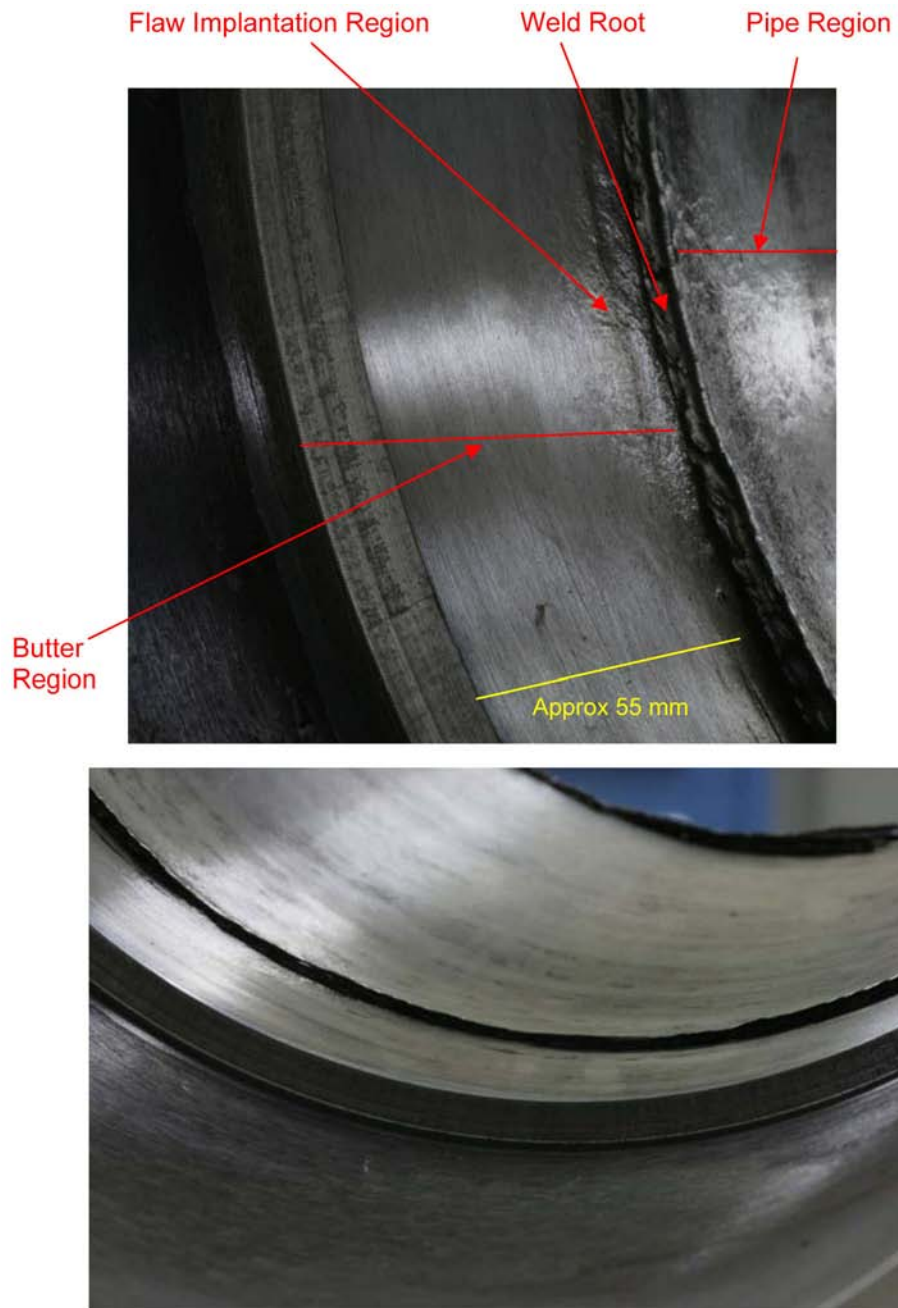
This specimen also exhibited significant ID surface conditions and geometry that, to some degree, impacted the ultrasonic responses from the PA-UT evaluations. The weld root was substantial, and can be seen in the photographs provided in Figure 7.12.

**Figure 7.12.** Photographs of the ID Surface of DMW Mock-up Specimen 9C-034 Depicting Various ID Surface and Weld Geometries

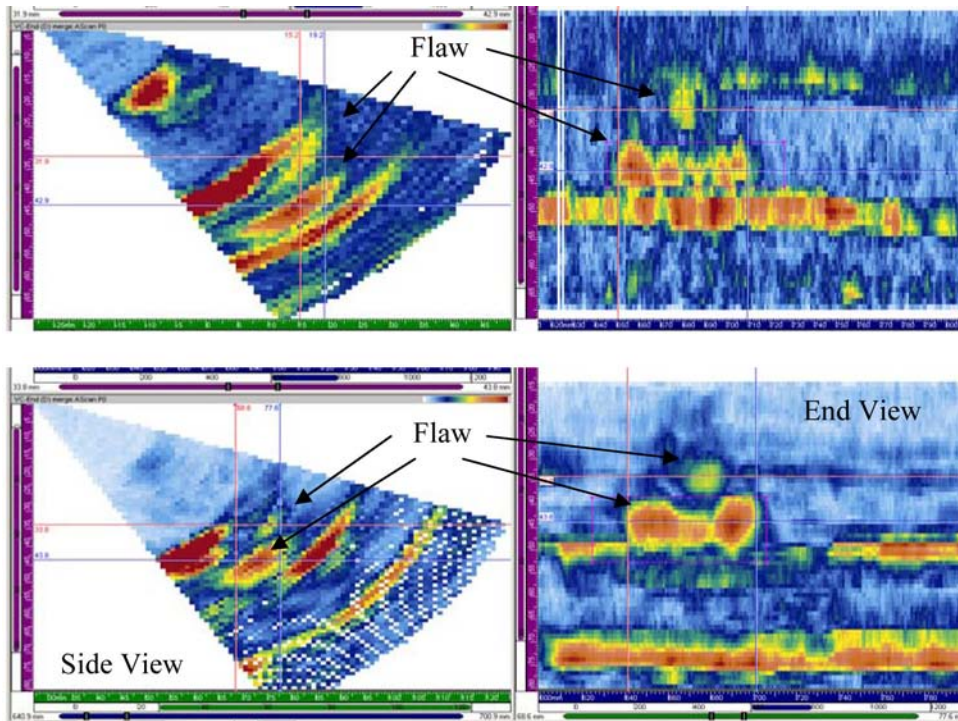
**Figure 8.2.** Flaw 3 from Specimen 8C-032 at 2 MHz on the Top and at 1.5 MHz on the Bottom. The 1.5-MHz inspection showed better separation between flaw and geometrical signals.

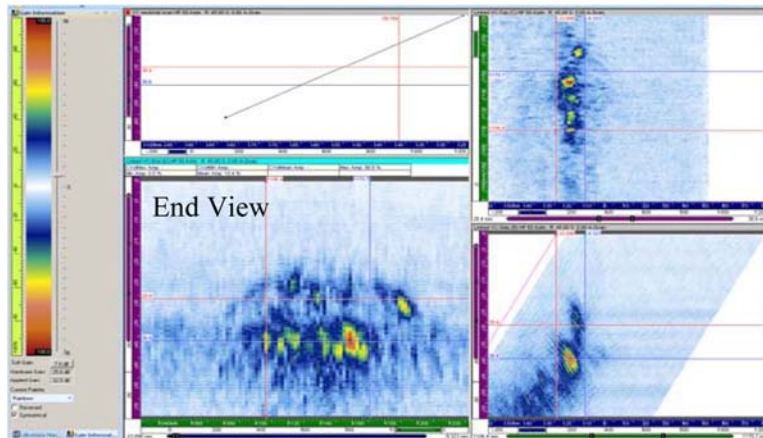
**Figure 8.5.** Flaw 1 Data on Specimen 9C-023, Obtained from the WSS Side at 1.5 MHz. Vertical markers in the end view show the flaw length as determined at the  $-6$  dB level.

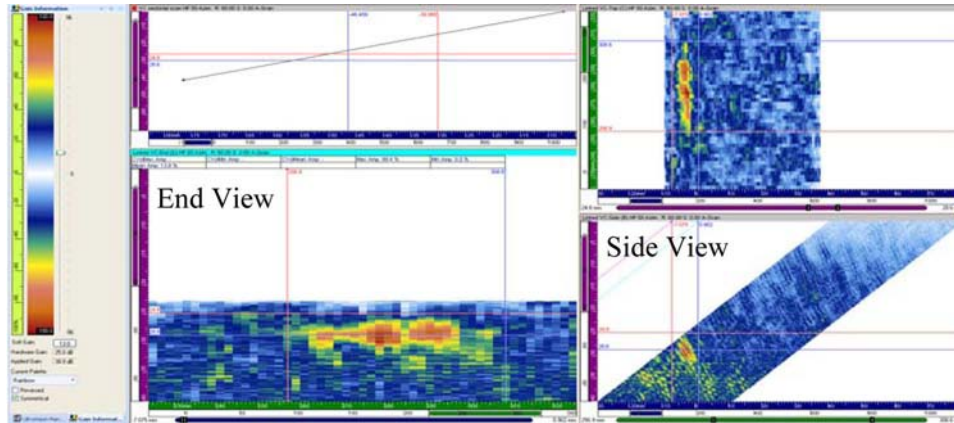
**Figure 8.15.** Specimen 9C-034 Flaw 2 at 1.5 MHz as Observed from the CASS Side of the Weld was Detected Before Weld Crown Removal at 60°

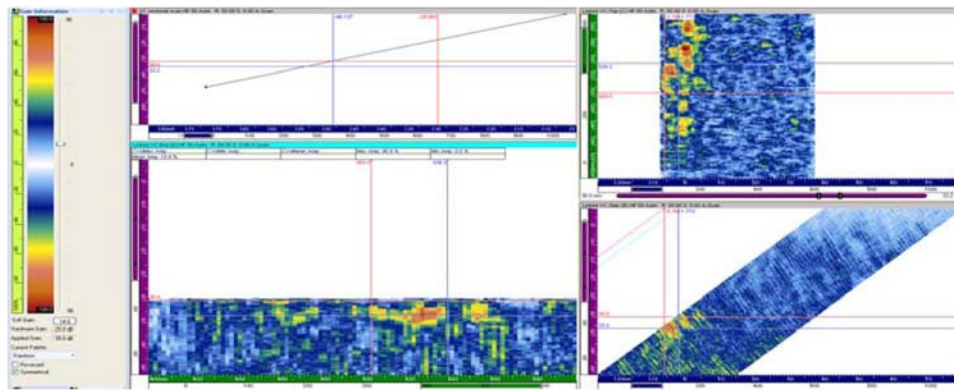
**Figure 8.16.** Specimen 9C-034 Flaw 3 at 1.5 MHz and 55° as Observed from the CASS Side of the Weld, with a Marginal Detection Before Weld Crown Removal

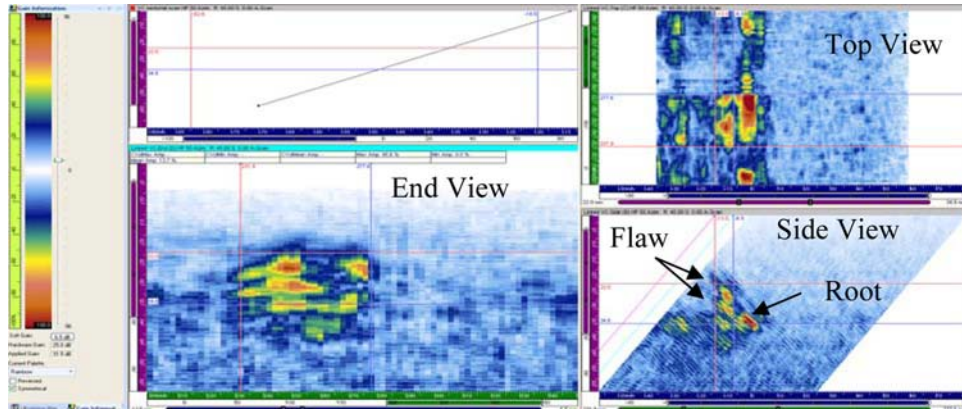
**Figure 8.17.** Specimen 9C-034 Flaw 2 at 1.5 MHz as Observed from the CASS Side of the Weld After Weld Crown Removal was Detected

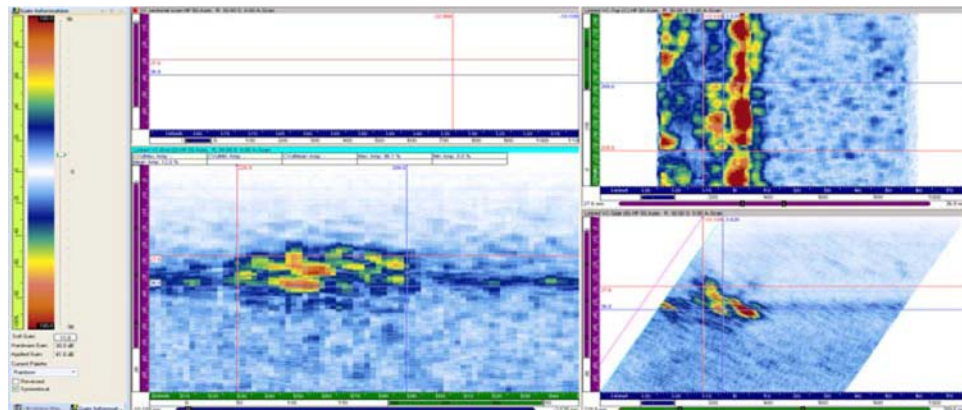
**Figure 8.18.** Specimen 9C-034 Flaw 2 at 2 MHz as Observed from the CASS Side of the Weld After Weld Crown Removal was Detected

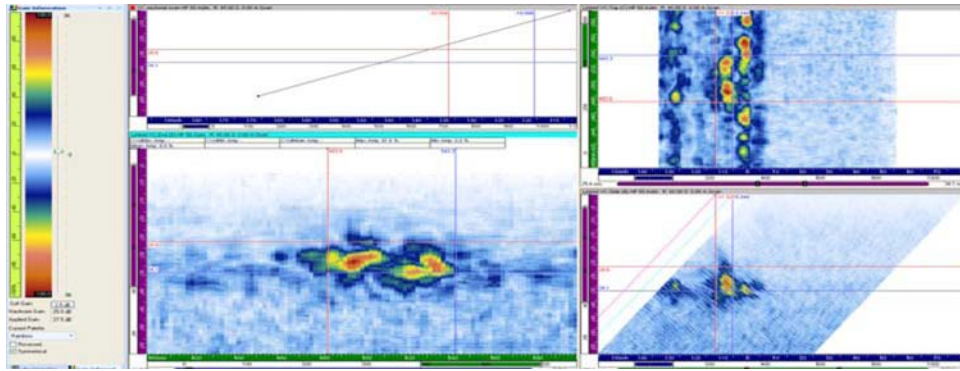
**Figure 8.19.** Specimen 9C-034 Flaw 3 at 1.5 MHz as Observed from the CASS Side of the Weld After Weld Crown Removal was Detected

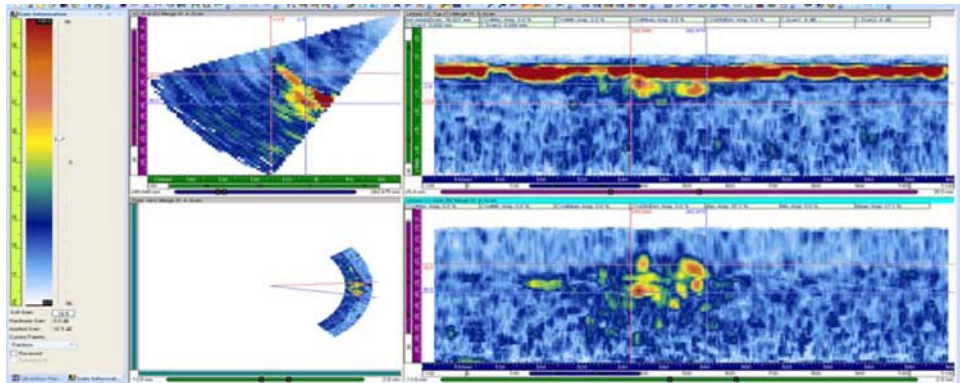
**Figure 8.20.** Specimen 9C-034 Flaw 3 at 2 MHz as Observed from the CASS Side of the Weld After Weld Crown Removal was Detected
