PNNL-11223

WASTEWATER RECYCLING AND HEAT  
RECLAMATION PROJECT  
RED LION CENTRAL LAUNDRY, PORTLAND, OREGON

*A Project of the Hospitality Industry Forum on Energy Conservation*

July 1996

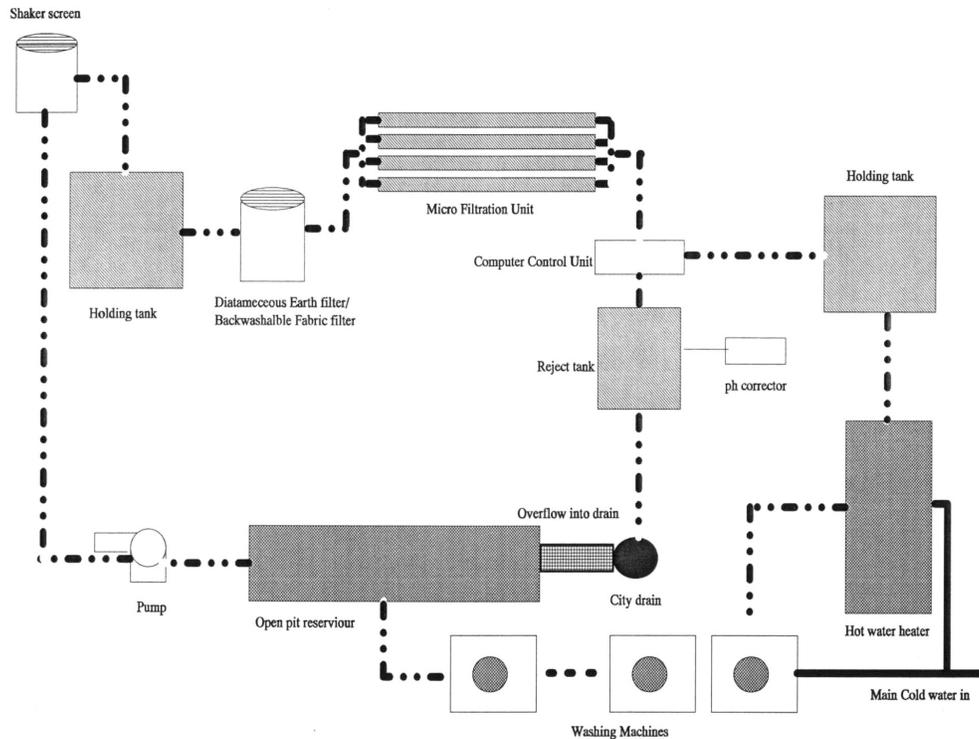
Figure 1 Water Reclamation System for Commercial Laundries

Figure 1 illustrates the system and its integration into Red Lion’s operation. Pre-installation estimates predicted that the water recovery system would supply 100 percent of the laundry’s hot water demand, which staff at the Red Lion estimated to be 60 to 65 percent of the total water consumption. Figure 2 is a photograph of the system installed in the Red Lion Central Laundry.

The MFU consists of three primary components plus auxiliary equipment. A mechanical shaker screen filters out large (>70 micron) solids. The second component is a back-washable fabric filter

used as protection to prevent solids from fouling the membrane filters. This second-stage filter is important in extending the service life of the MFU and maintaining high volume flow rates.

The third and final component is the actual MFU, where solids as small as 0.5 microns are removed. It consists of four large tubes (8 to 10 feet long, 6 to 8 inches in diameter) that are connected in parallel. (The unit has a modular design, allowing more tubes to be added if larger capacity is needed.) The membrane material is made of poly cell foam and has the appearance of white fabric. The membrane is wound around a 1-inch pipe and placed inside the larger tube. Water filters through the membrane to the 1-inch pipe, where it is sent on for reuse.

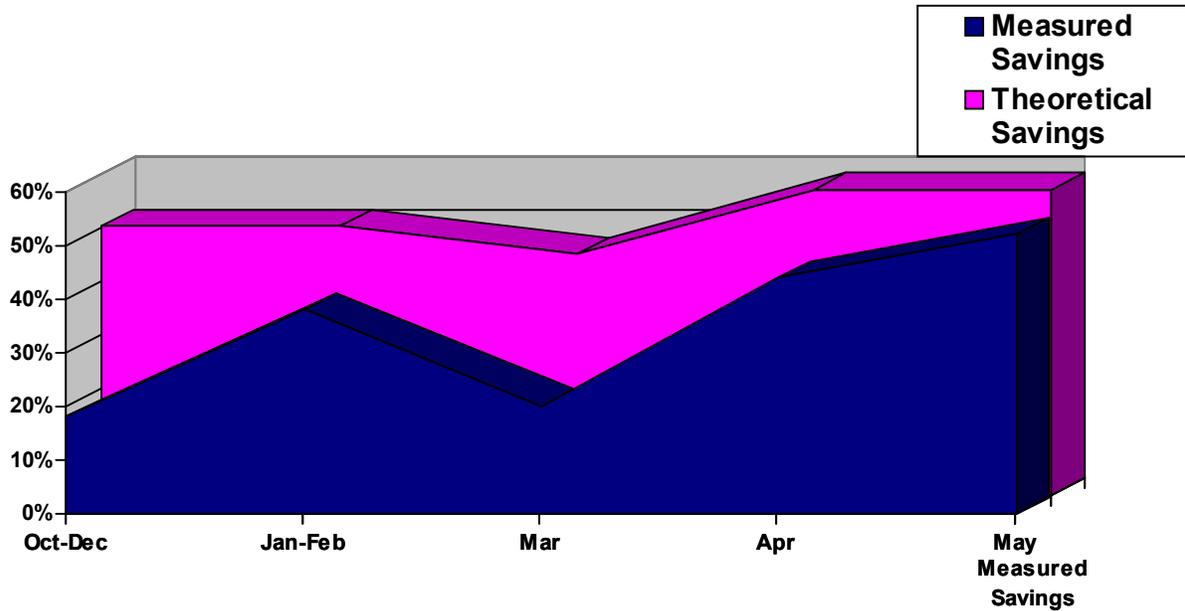
**Figure 3.** System Learning Curve

Figure 3 illustrates the concept that system performance improves with time. The lighter (larger) curve represents the theoretical percent savings based on the laundry's total hot water consumption. Notice that after the MFU came on line, the percent of hot water used dropped to below 50 percent, thus the theoretical savings dropped (see the dip in the curve in March). Because the MFU does not completely filter out soaps and other chemicals, the pH level of the water became too high (pH 11). This forced the laundry to increase the amount of cold city water to act as a diluting agent and lower the pH. By the end of March, a pH controller was added and hot water consumption increased to 57 percent of the total water consumption. Changes in the

measured savings (lighter curve) were not only due to changes in hot water savings, but also to a number of other factors as previously discussed in Section IV.C and highlighted in Appendix E.

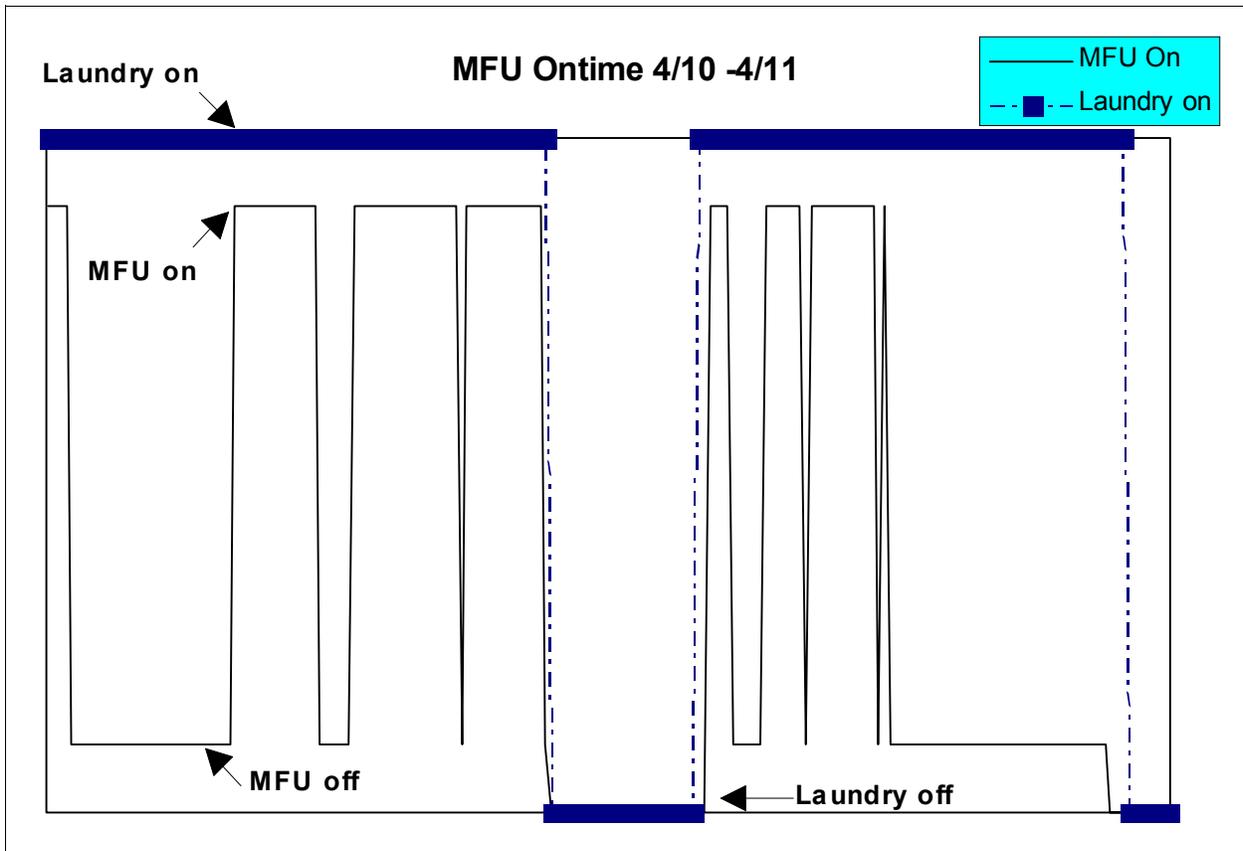
Figure 4. MFU Ontime 4/10-4/11

Note: The few spikes when the MFU momentarily turns off are considered normal functioning.
