Water Velocities: Congdon

General Observations: Congdon

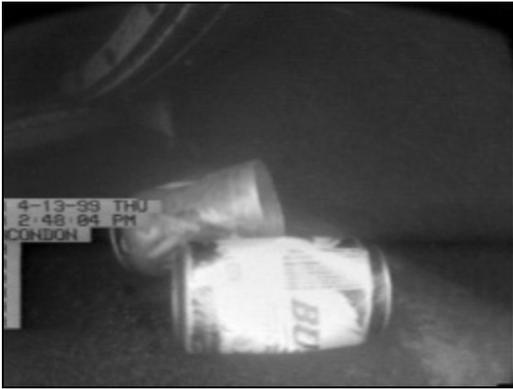
Screen Site	Date (Tape #)	Location (screen # & VCR counter)	VCR Counter	Notes	Photos	Descriptor
Congdon	5/13/99 (1)	1	0:48:30	pop & beer can, stick stick & unknown object	0:49:08	T1
		2	0:51:44			
		3	0:54:15	stick & some sand throughout bottom	0:55:27	AVG
		Bypass	0:56:27			
Congdon	7/14/99 (2)	1	1:02:02	pop cans and sticks at bottom		
		2	1:03:54	trash on the bottom		
		3	1:05:22			
		Bypass	1:07:52	1:07:53
