Water Velocities: Naches Cowiche

General Observations: Naches Cowiche

1997 Photos: Naches Cowiche

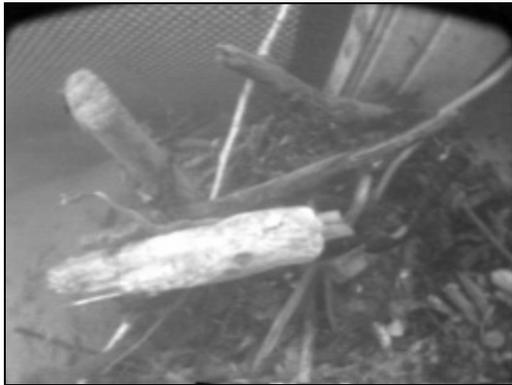
Screen Site	Date (Tape #)	Location (screen # & VCR counter)	VCR Counter	Notes	Photos	Descriptor	
Naches Cowiche	5/13/99 (1)	1	0:41:39	0:42:07	sand and stick pile in corner fish, 5-6" sticks, sand pile covering seal sediment along bottom opening at bottom of ramp-door open?	0:42:24	D1
				0:42:49		0:43:03	F1
				0:43:42		0:43:51	S1
		2	0:44:37	0:45:22		0:45:46	S2
		Bypass	0:46:17	0:47:28			
Naches Cowiche	7/14/99 (2)	1	0:51:29	0:52:34	sediment and debris in corner can't see bottom seal, sediment/dark debris pile, large sticks, sediment brush pile in corner		
				0:54:11			
				0:54:31			
				0:54:48			
		2	0:55:31	0:56:02		brush pile in corner brush and sediment up over seal and on screen all the way across	
Bypass	0:58:08	0:58:29	sediment on bottom
