**Evaluation of PFP Furnace Systems
for Thermal Stabilization of Washed
High Chloride Plutonium Oxide Items**

December 17, 2002

Prepared for Fluor Hanford by
Pacific Northwest National Laboratory
Richland, Washington 99352

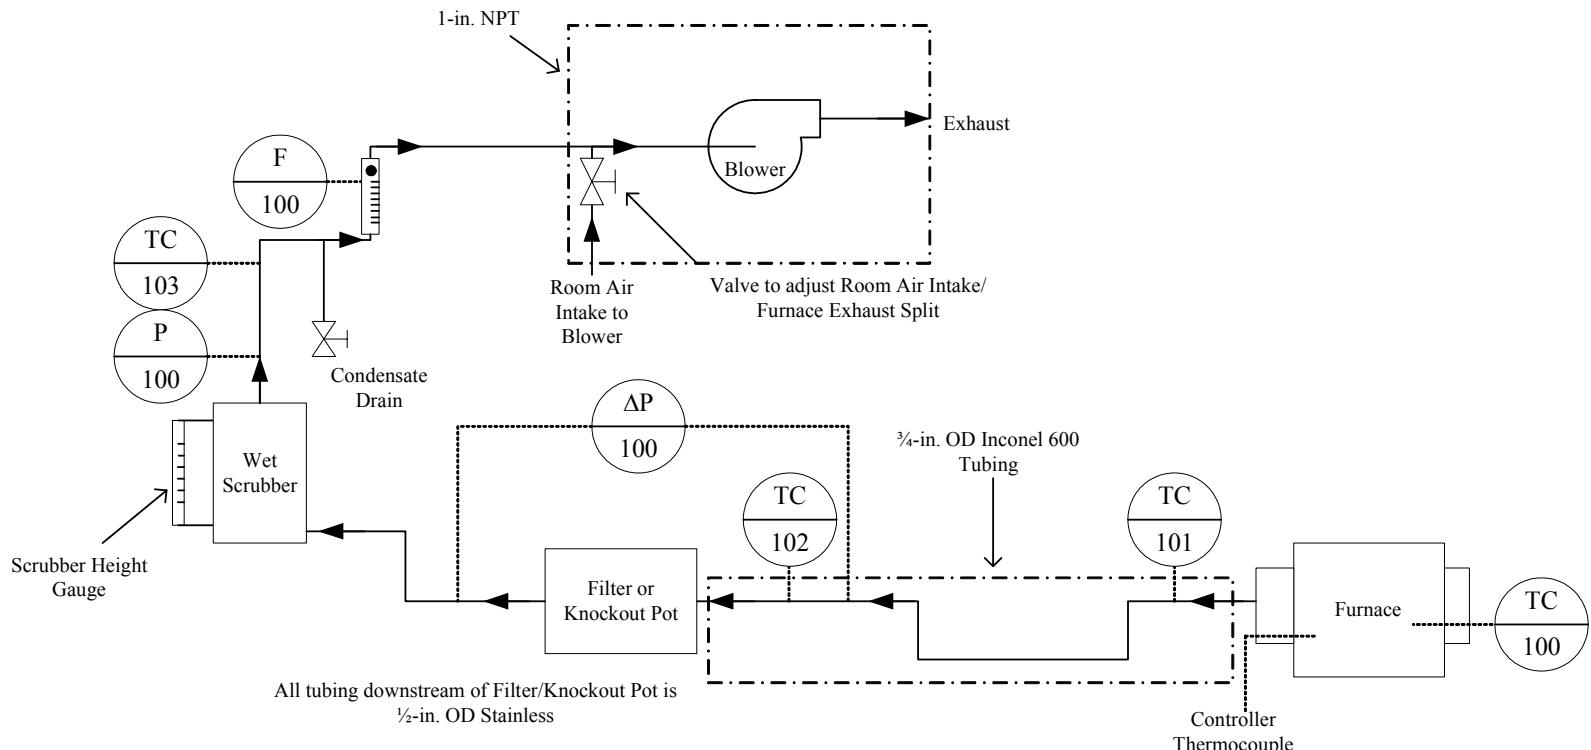
Figure 2.1. Test Stand for PFP Furnace and Offgas System Evaluation

The layout of the complete scrubbing system is shown in Figure 2.1. All tubing was 1/2-in.-OD 304 stainless steel. The offgas exiting the filter or knockout pot was directed through a sparge tube located inside a 12 5/8-in. OD x 24 5/8-in.-high 304 stainless steel tank. The sparge tube was ~10 in. long with 10 1/8-in. holes and is submerged in 8 to 11 in. of water. A sight glass was installed onto the side of the tank to monitor water height. There was also a plug on top of the tank to allow additions of sodium bicarbonate for acid neutralization.

The offgas exited the top of the scrubber tank and entered a 1-L condenser pot (304L stainless steel) to remove water from the saturated offgas stream. The offgas was heated to ~30°C with a heat tape, and then flowed through a Dwyer Model RMA 0-100 or 0-200 SCFH flowmeter (Models RMA-8-TMV or RMA-10-TMV, respectively). An Omega 1/8-in.-OD, 12-in.-long type K thermocouple (I-600 sheathed, P/N KQIN-18U-12) and a Dwyer 0-30 in.-H₂O 2000 Series Magnehelic ΔP gauge (Model 2030) were located on the 1/2-in. stainless steel line between the heat tape and the flowmeter. Directly below the flowmeter was a section of 1/2-in.-OD tubing that served as a drop leg to catch any condensation that may have passed through the condenser.

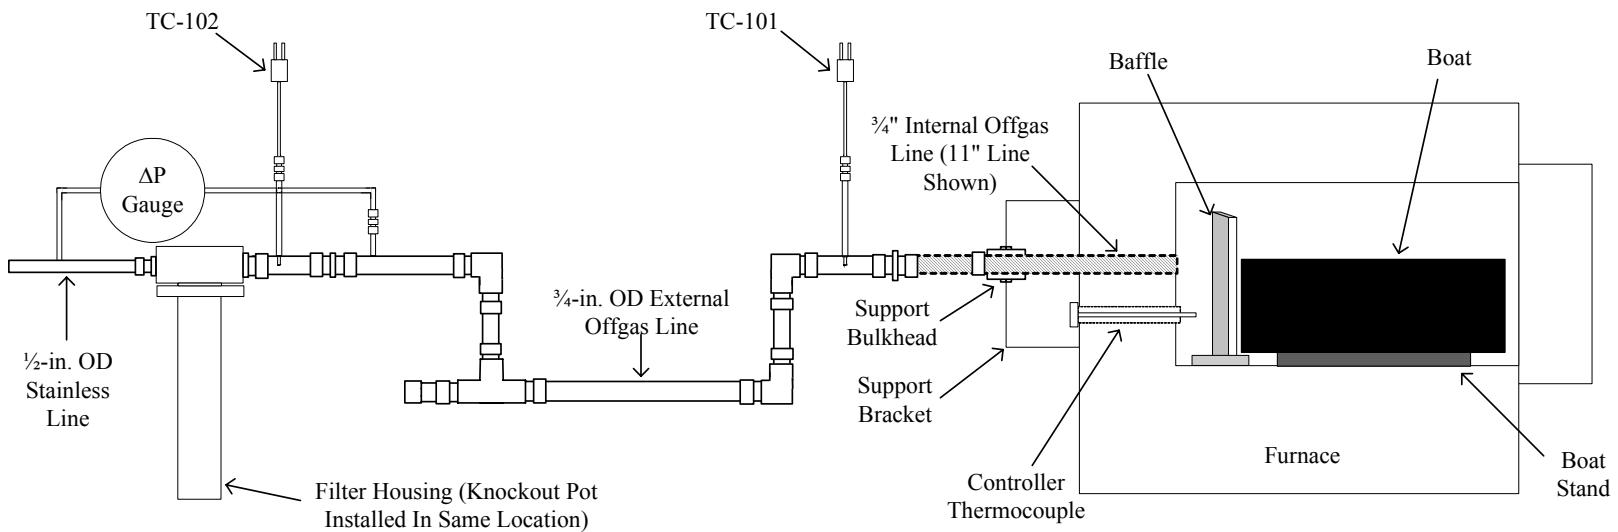
Figure 2.2. Furnace, 3/4-in. Offgas Lines, and Filter/Knockout Pot Configuration

The external offgas line was connected to the other end of the bulkhead (6-in. lines) or directly to the internal offgas line with a union (11-in. lines). The external line was 3/4-in.-OD Inconel 600 tubing, 0.028-in. wall thickness. There were four 90-degree bends to better represent the current system used by PFP. Three of the bends were 90-degree elbows and the fourth was a tee (one end of the branch was plugged; Figure 2.2). The tee and elbows were 316L stainless steel. Two Omega 1/8-in.-OD, 12-in.-long type K thermocouples (I-600 sheathed, P/N KQIN-18U-12) were inserted into the offgas line (see Figure 2.2 for locations).

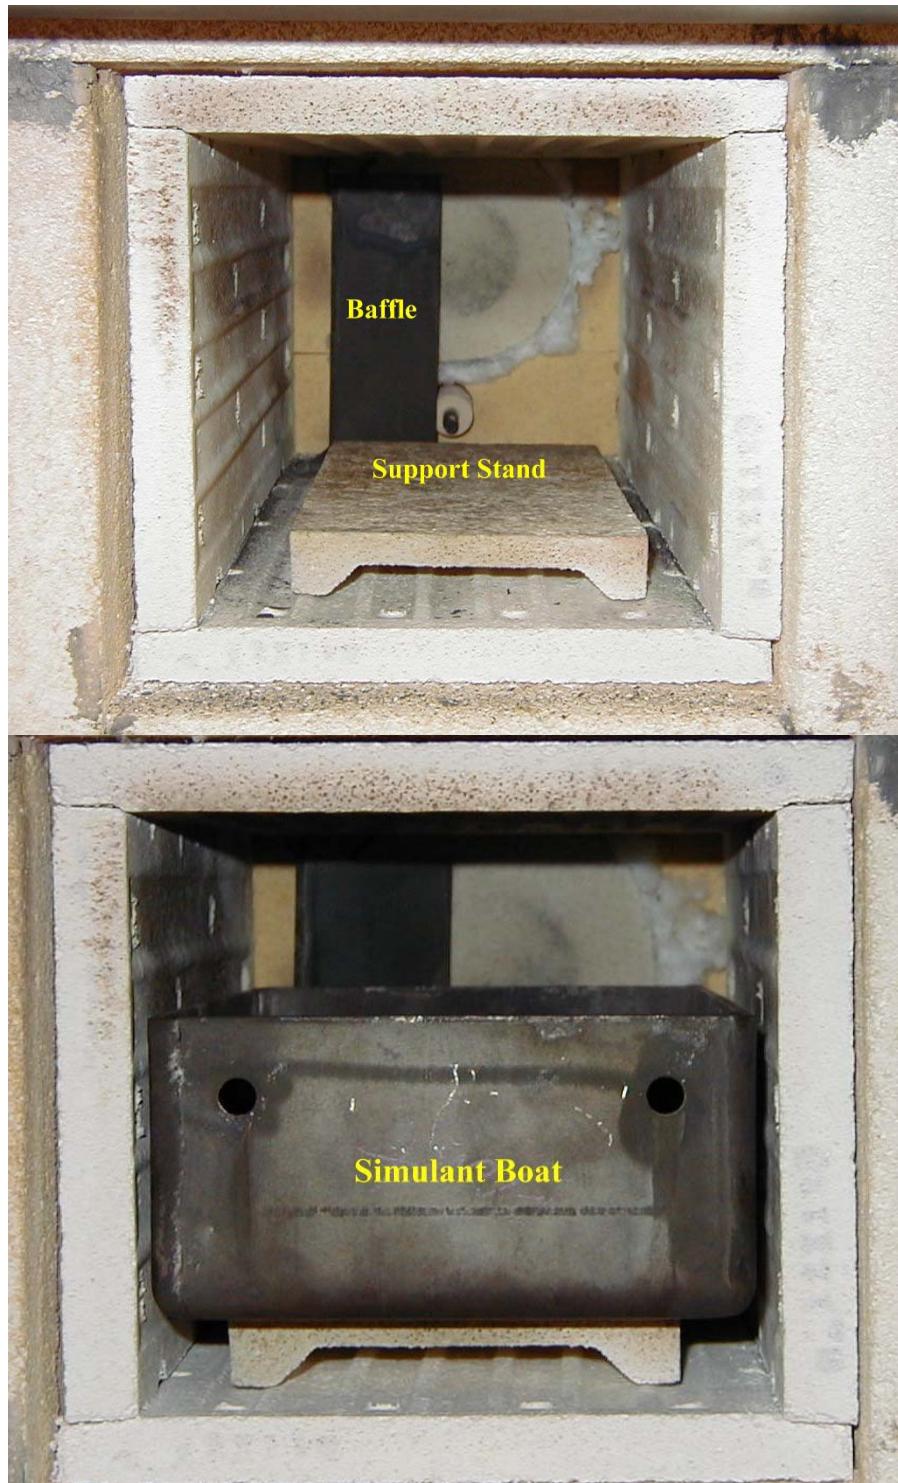
Figure 2.3. Front View of the Furnace Chamber to Show the Arrangement of the Baffle and Support Stand (above) and the Simulant Boat (below). Note that the furnace chamber was just wide enough for the simulant boat to fit.

The furnace used for this testing was a Thermolyne Model FA-1630-1 muffle furnace, identical to that used by PFP for materials stabilization. Four 240 VAC, 17.0 A heating elements, wired in series, lined the top, bottom, and side walls of the furnace. Actual dimensions of the furnace cavity with heating elements installed were 5.5 in. wide x 5 in. high x 13 in. deep (total chamber volume: 357.5 in.³). Maximum short-term and continuous operating temperatures recommended by the manufacturer were 1177°C and 1066°C, respectively. A ceramic stand was placed inside the furnace directly on the bottom heating element to support a Hastelloy X sample boat, which was 11 in. long x 5.0 in. wide x 2.5 in. high. The boat was used to hold simulant and any corrosion coupons to be tested. A baffle constructed of Haynes HR-160 alloy was located at the back wall of the furnace chamber behind the boat, directly in front of where the gases exited the furnace. The arrangement of the baffle, support stand, and sample boat in the furnace is shown in Figure 2.3.

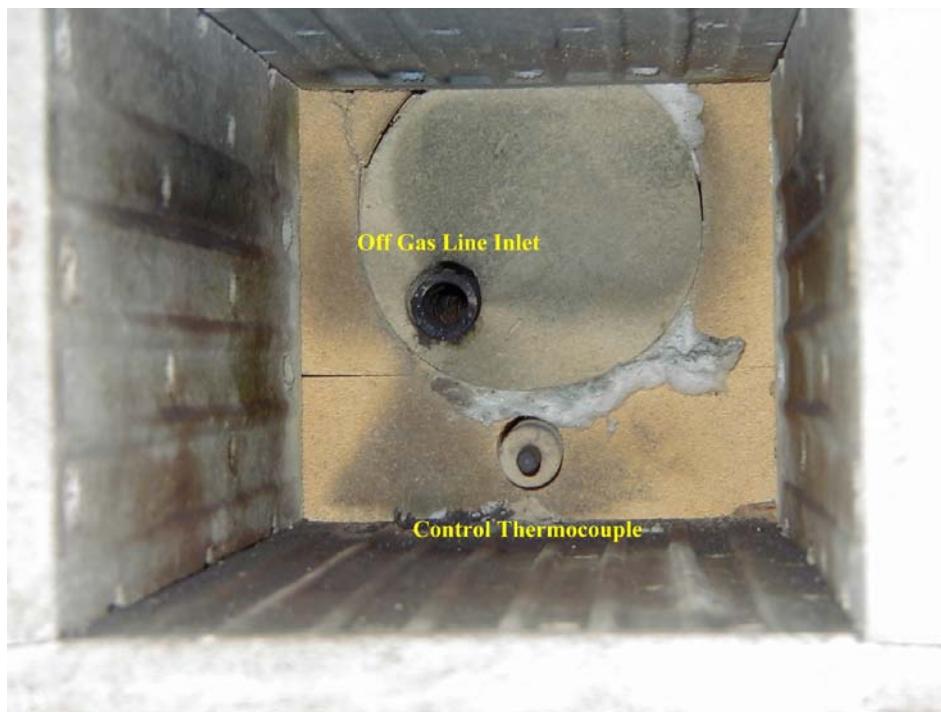
Figure 2.4. Internal Offgas Line Inlet and Controller Thermocouple as Installed in the Furnace

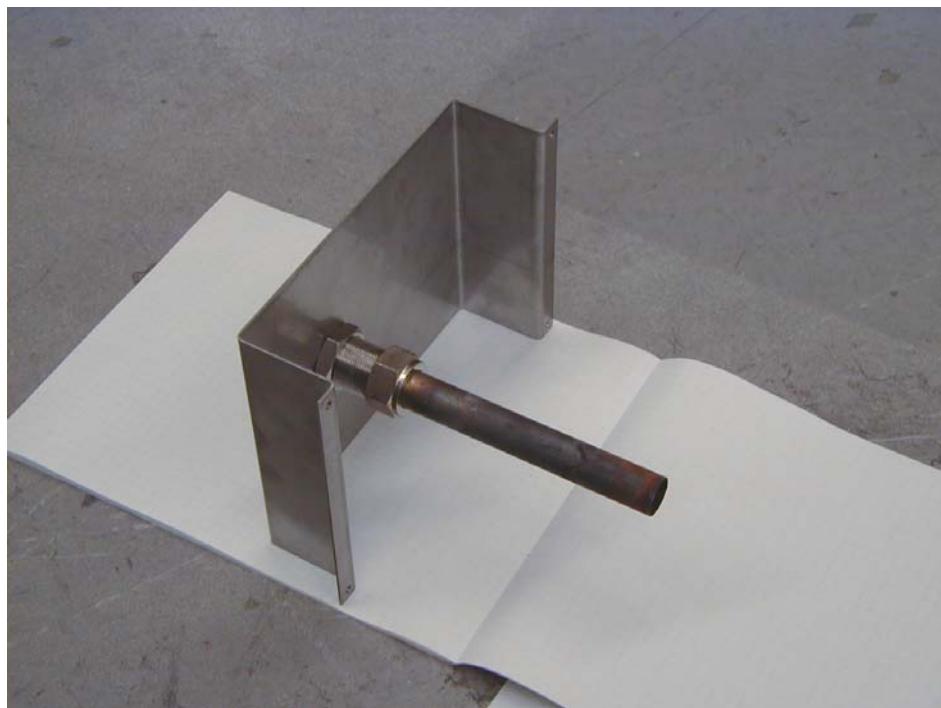
Figure 2.5. Bulkhead Used to Connect the External Offgas Line to a 6-in.-long Internal Offgas Line

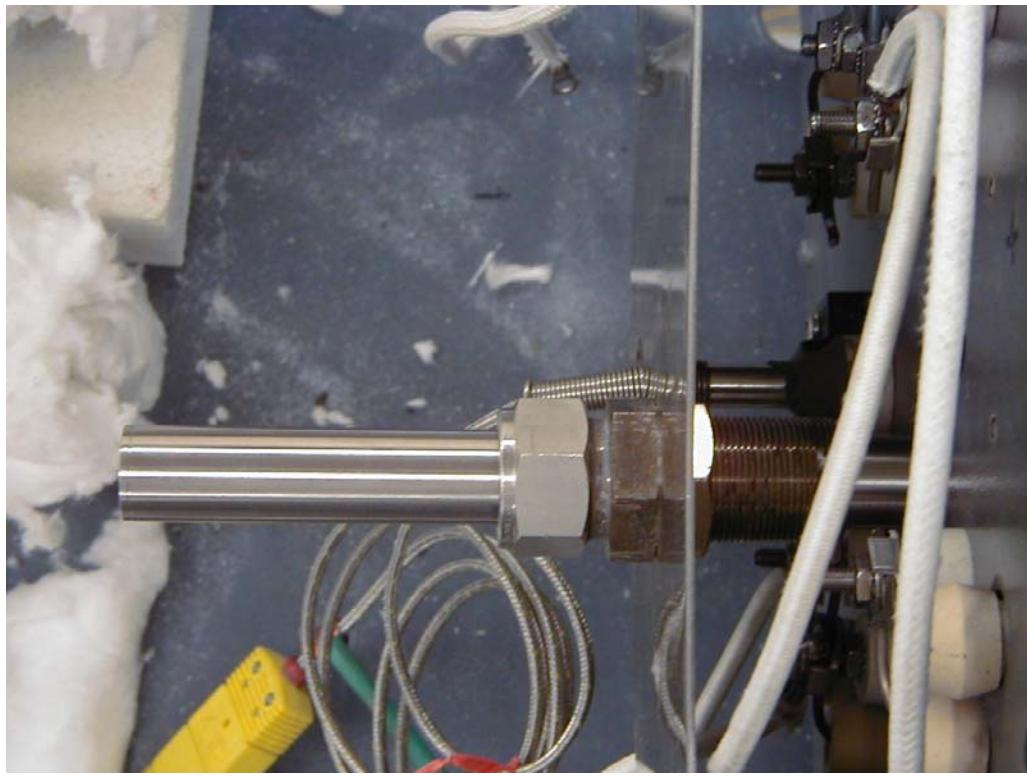
Figure 2.6. Bored-Out Bulkhead for Supporting 11-in.-long Internal Offgas Lines

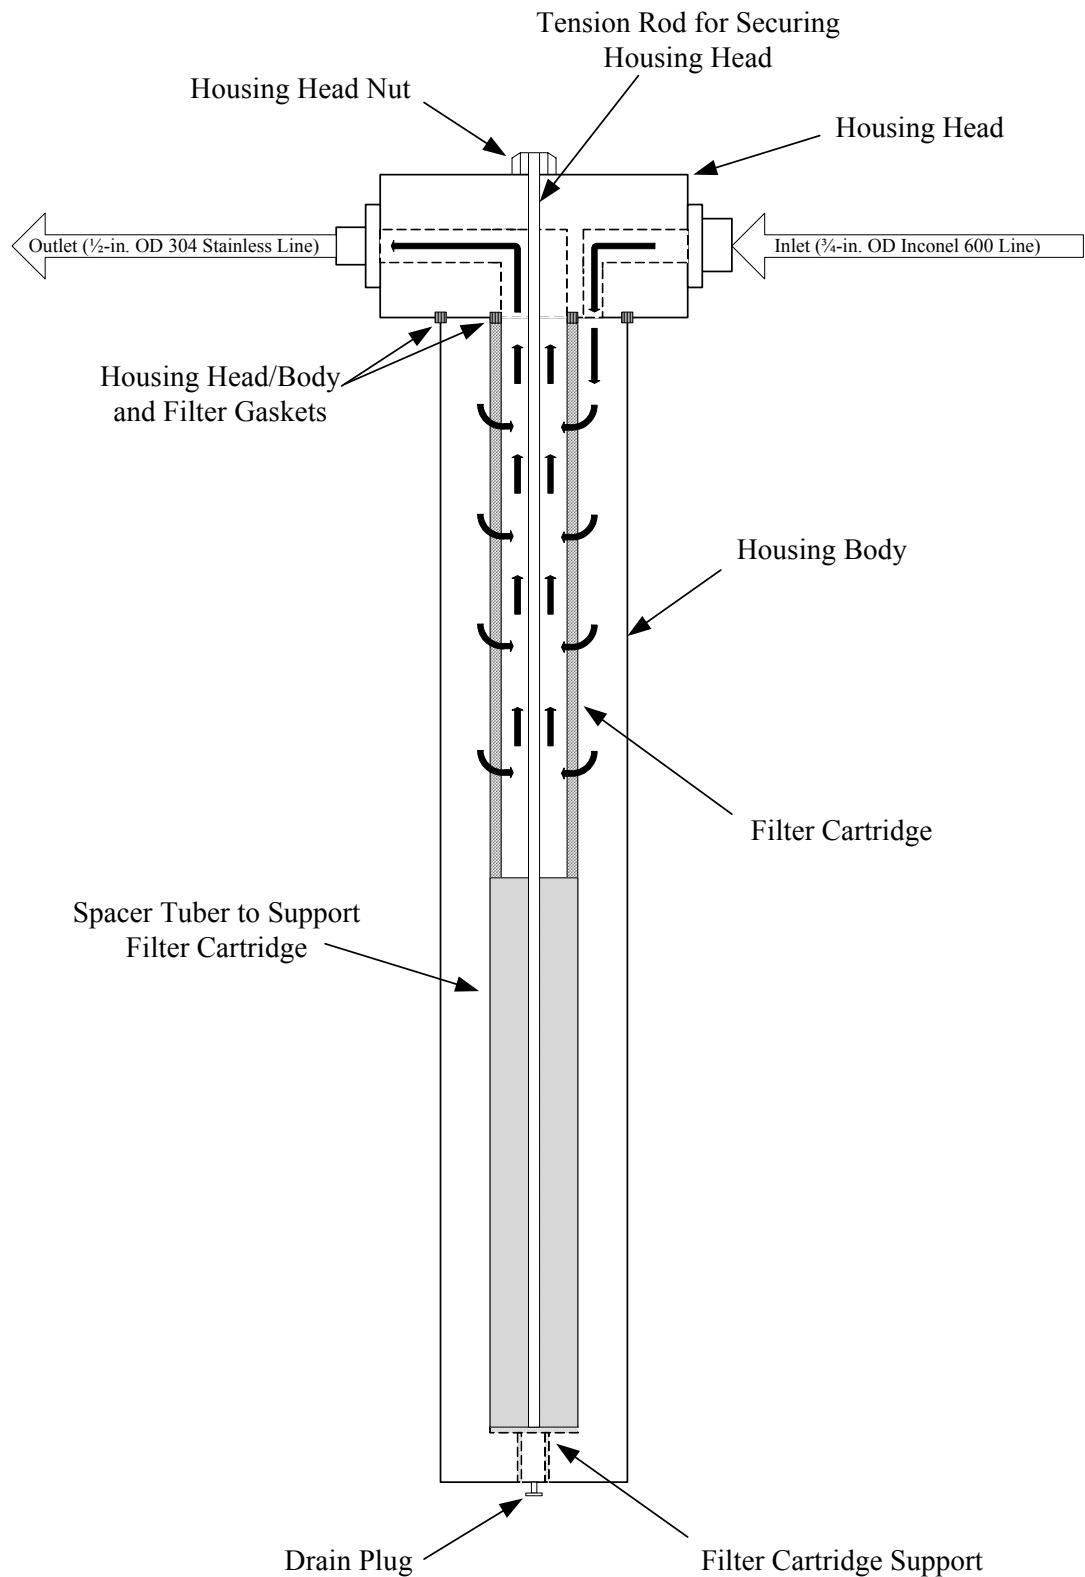
Figure 2.7. Schematic of a Purlator Cartridge Filter Installed in a Shelco Housing

- ♦ 212°C maximum temperature (at 250 psi max)
 - Purlator Filter:
 - ♦ Poroplate 10-µm 316L stainless steel sintered metal cartridge filter, Model PP10DOE10

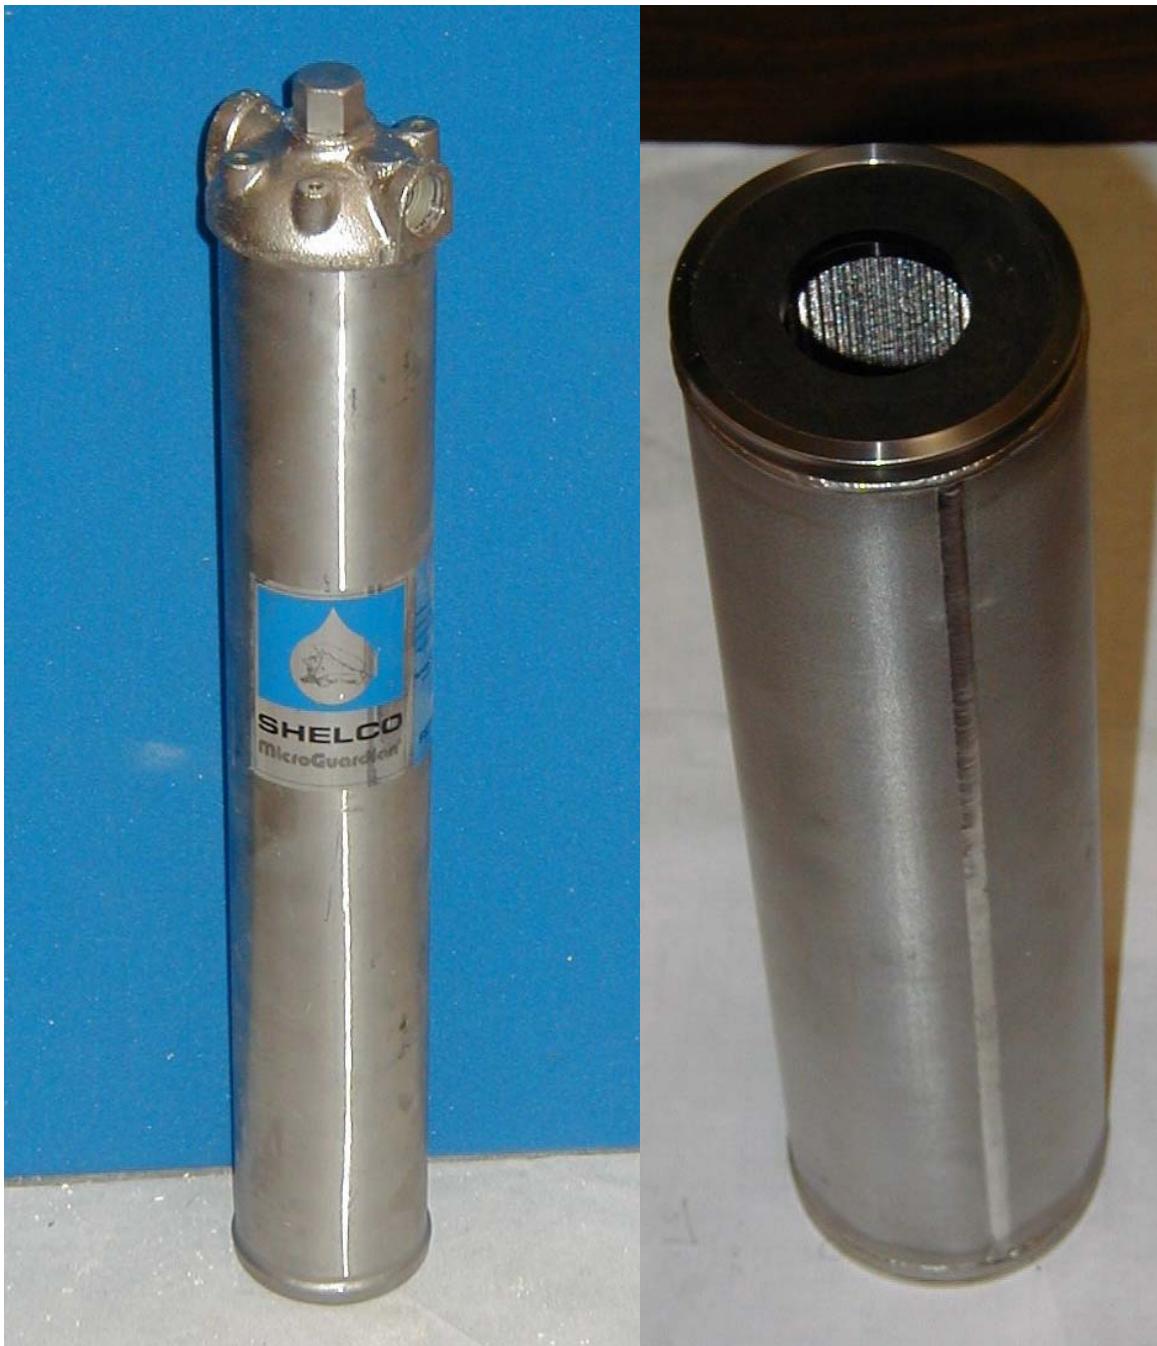
Figure 2.8. Shelco Housing and Purlator Cartridge Before a Test Cycle

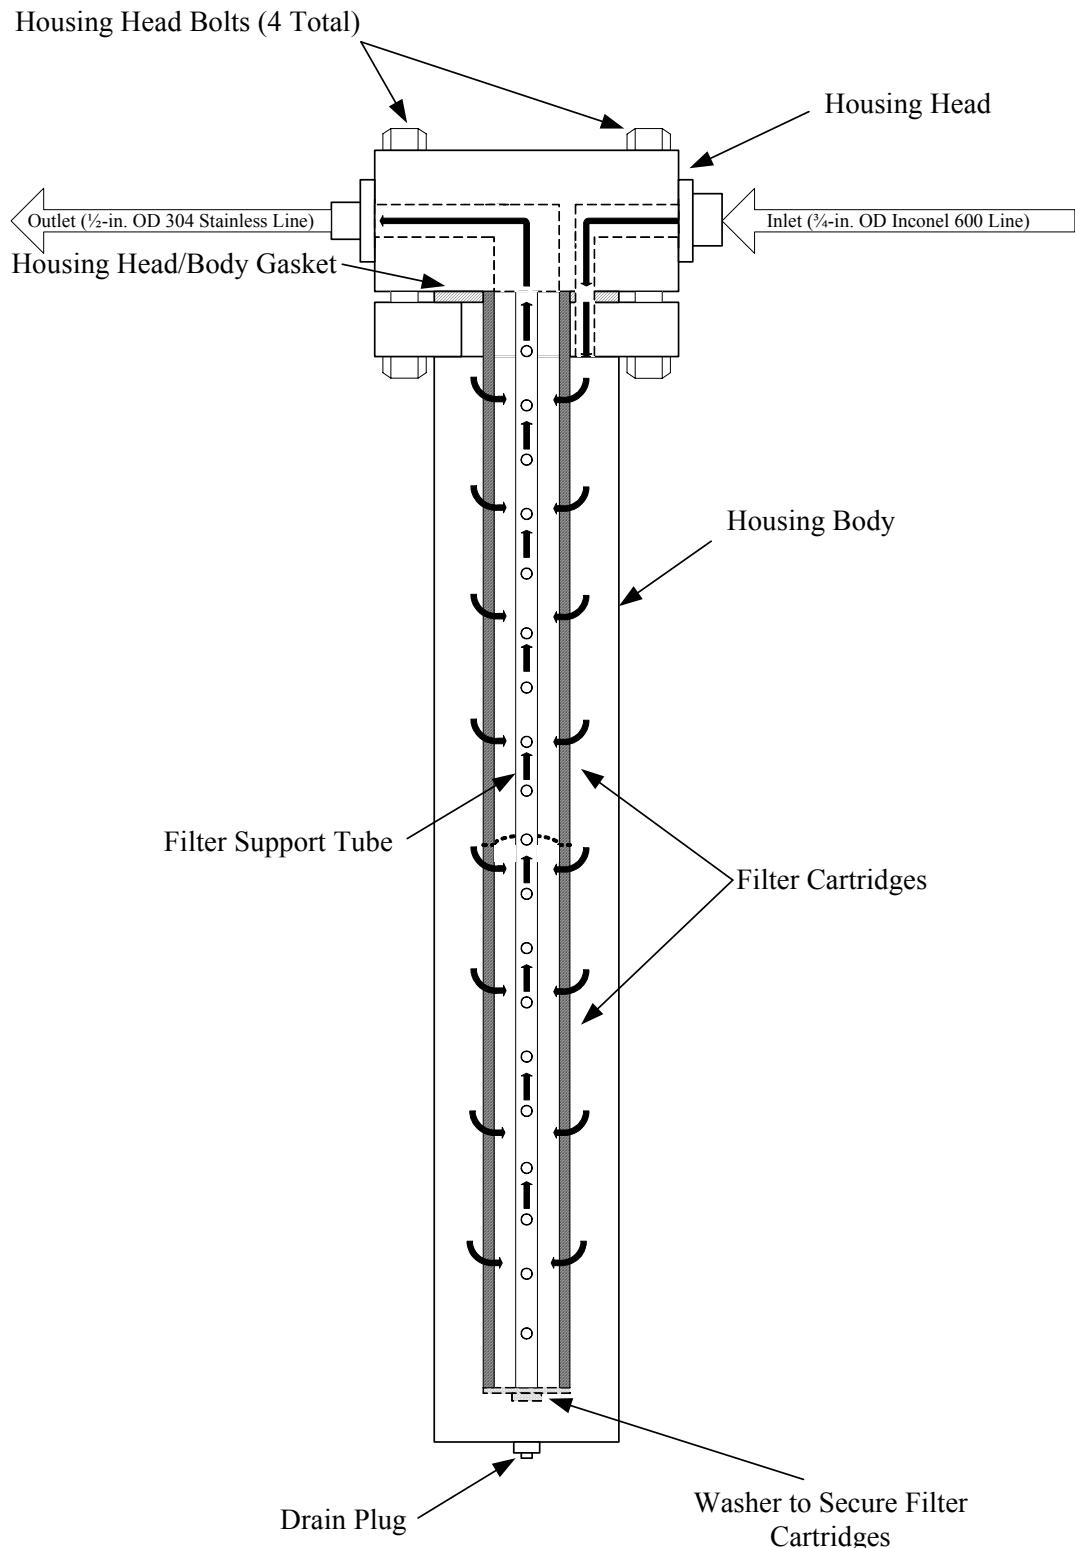
Figure 2.9. Schematic of the Nowata Filtration System Implementing Woven Glass Filter Cartridges

- Housing:
 - ♦ 1UY Series 316 stainless steel, 3.5-in. OD (body), 4.6-in. OD (head), 24.5-in. overall length, 36 lb shipping weight
 - ♦ P/N 1UY2N15N15KT

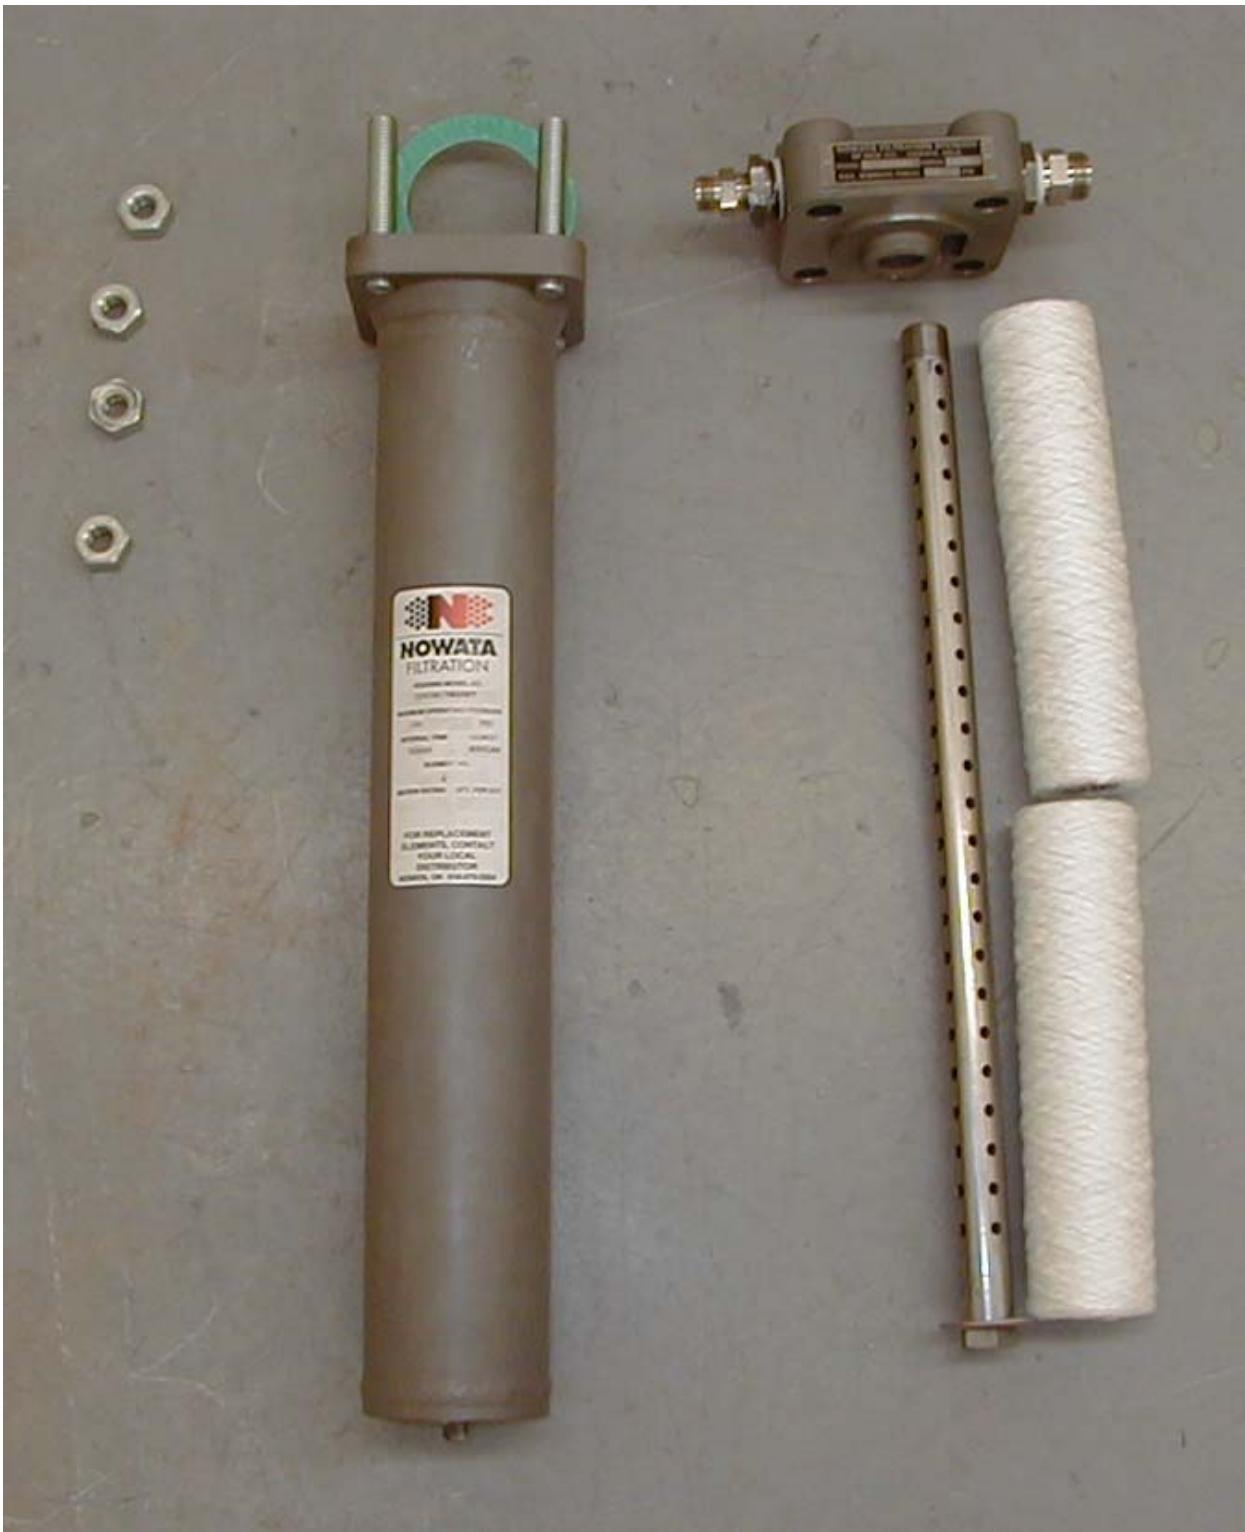
Figure 2.10. Nowata Filter Housing and Cartridges Before Installation. Housing outer diameter was 3.5 in. and shipped at 36 lb. Each filter cartridge was 2.5-in. OD and 9.75-in. long.

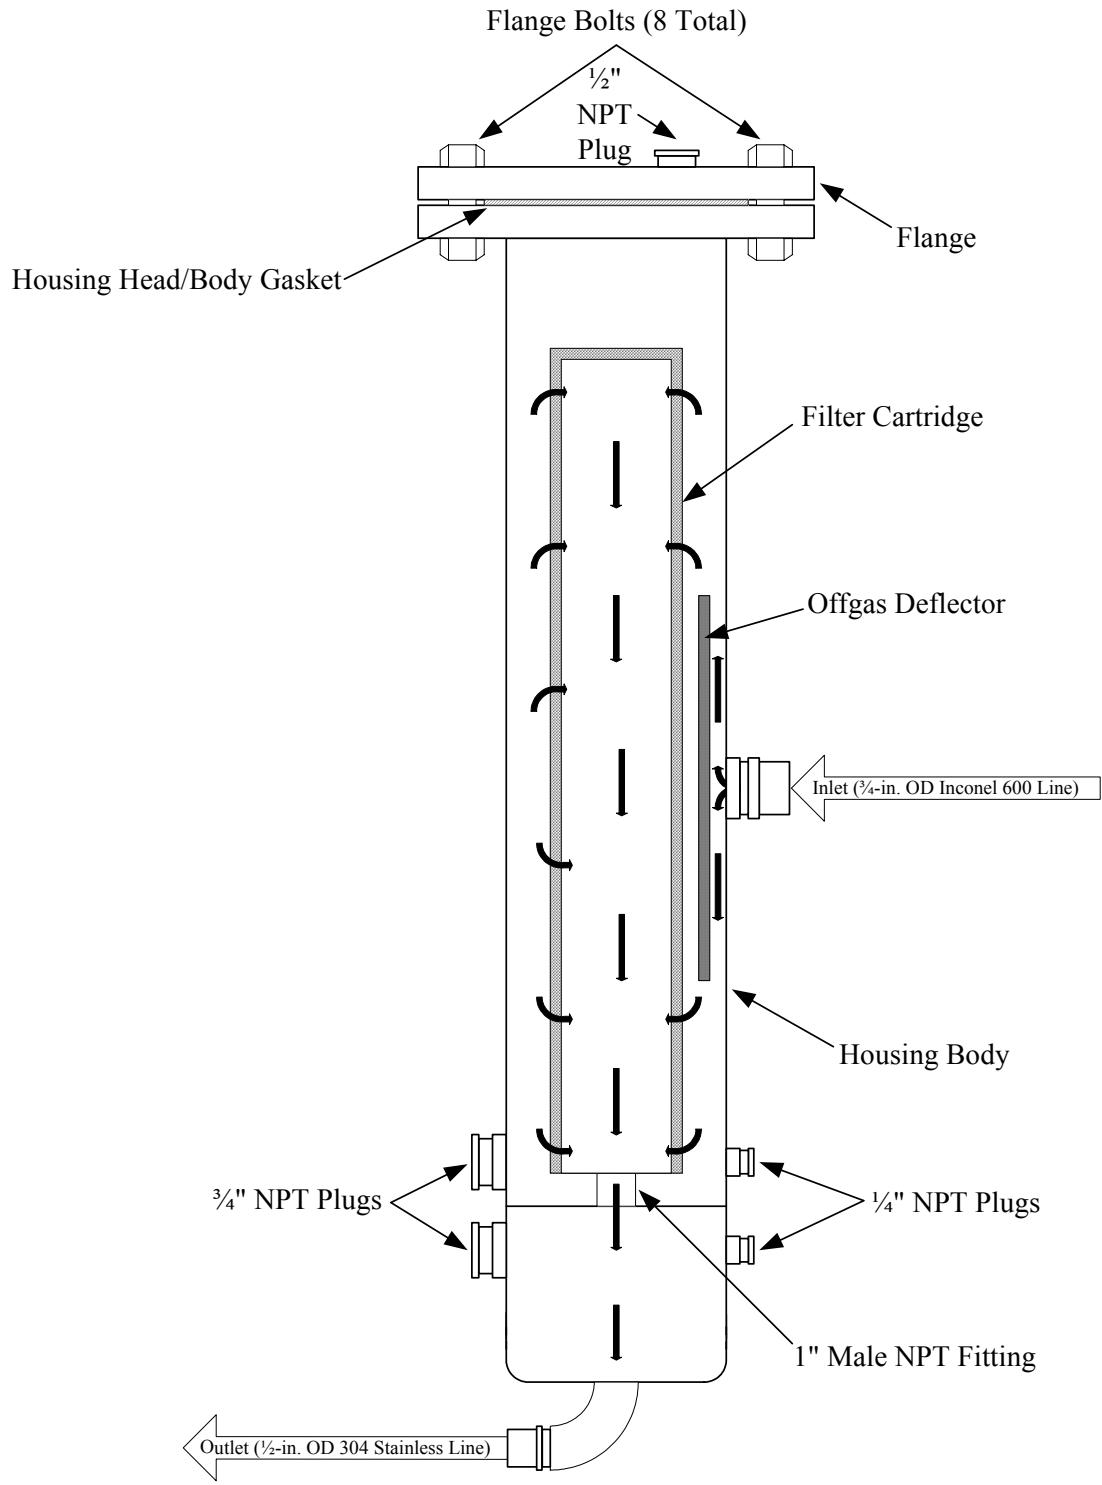
Figure 2.11. Schematic of the Rosedale Filtration System Implementing Pleated Metal Filter Cartridges

- Rosedale Products of California, Inc. (Coarsegold, California)
 - Housing:
 - ♦ Model 4, 304 stainless steel, 4.5-in. OD (body), 10-in. OD (flange), 30-in. overall length (including flange thickness and outlet port), 91 lb shipping weight

- Filters:
 - ♦ 5-µm (P/N 20-5-P-S-1NPTF-SP), 10-µm (P/N 20-10-P-S-1NPTF-SP), and 20-µm (P/N 20-20-P-S-1NPTF-SP) nominal opening rating
 - ♦ 304 stainless steel pleated cartridges

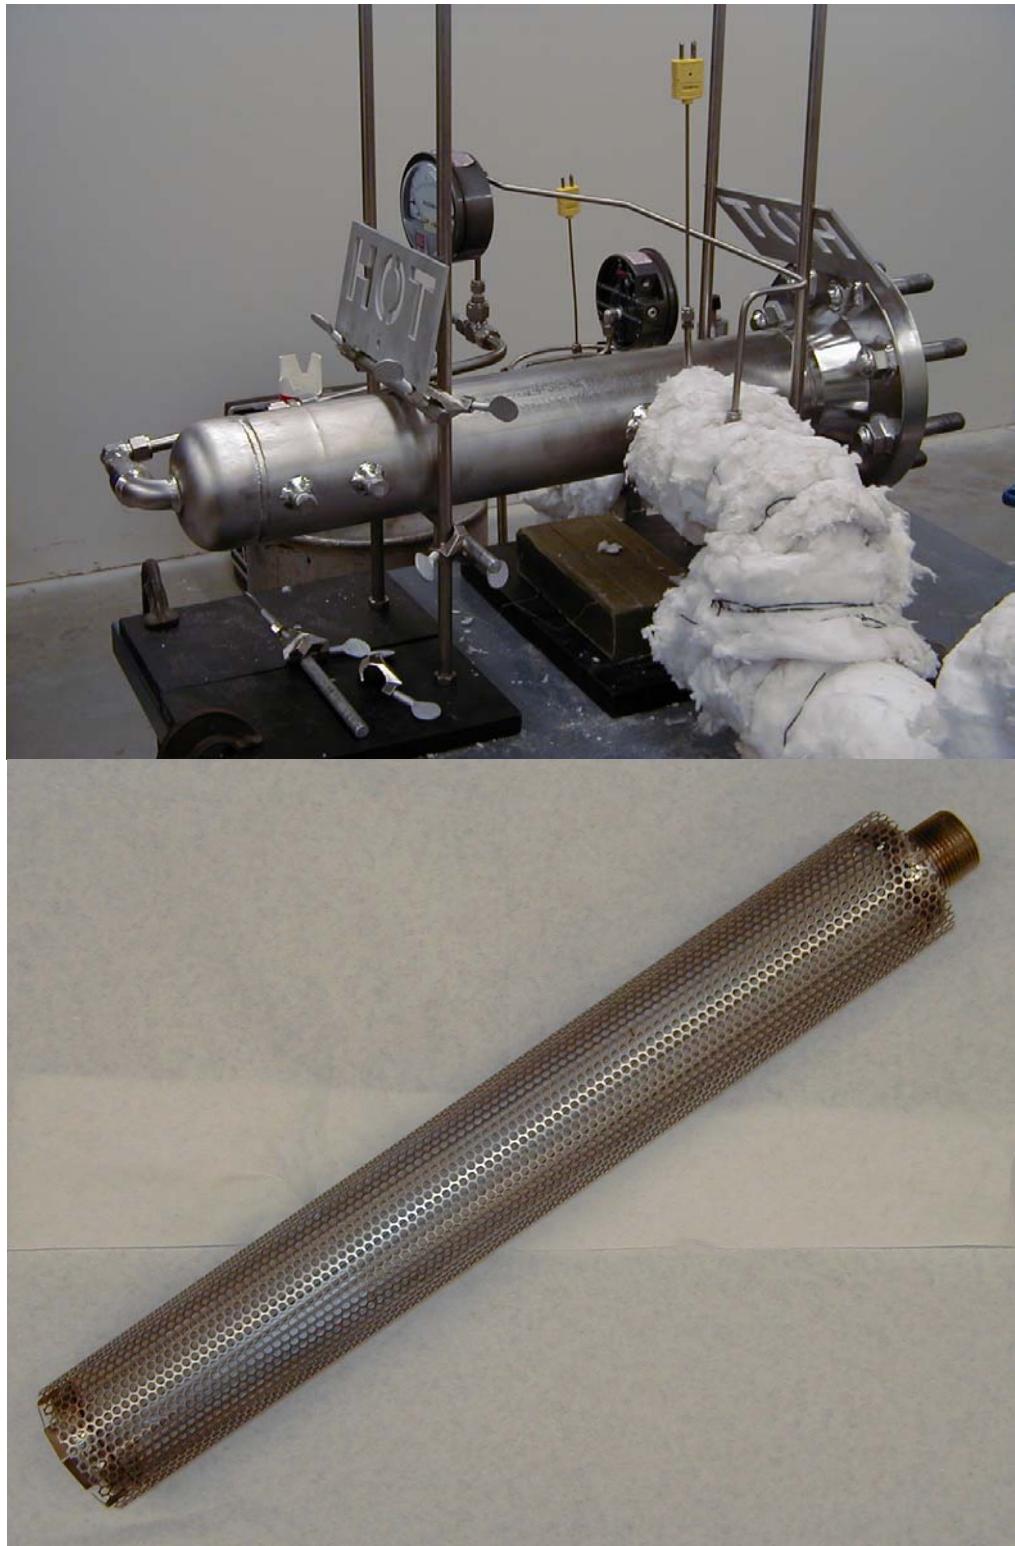
Figure 2.12. Rosedale Filter Housing and Cartridge Before Installation. Housing outer diameter was 4.5 in. and shipped at 91 lb. Each filter cartridge was 2.6-in. OD and 20-in. long.

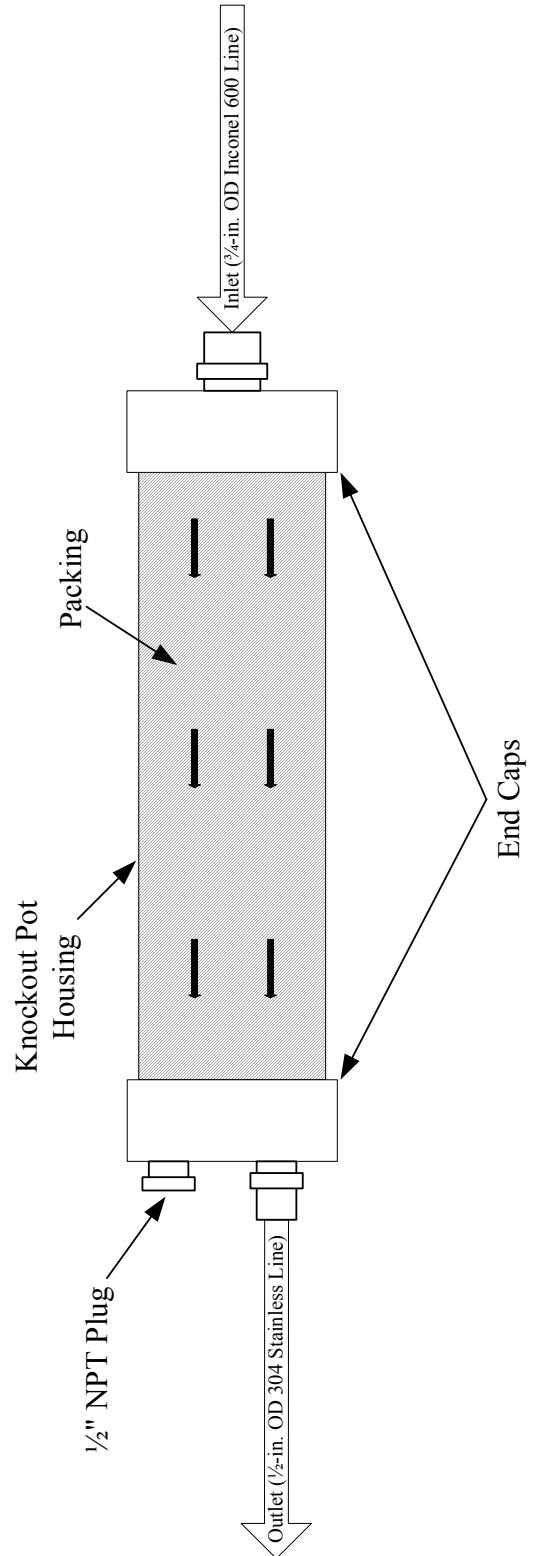
Figure 2.13. Schematic of the 2-in. Schedule 40 Stainless Steel Knockout Pot

- 2-in. Schedule 40 Stainless Steel Pipe
 - Housing:
 - ♦ 2-in. Schedule 40 stainless steel pipe, 10 in. long
 - ♦ Threaded piece of pipe with machined end caps

- ♦ Wire screens inserted into both end caps to hold packing in place
 - Packing:
 - ♦ 1/2-in. nominal ceramic Intalox saddle rings
 - ♦ Stainless steel wire mesh with 1/8-in. x 3/16-in. and 1/8-in. x 5/16-in. openings

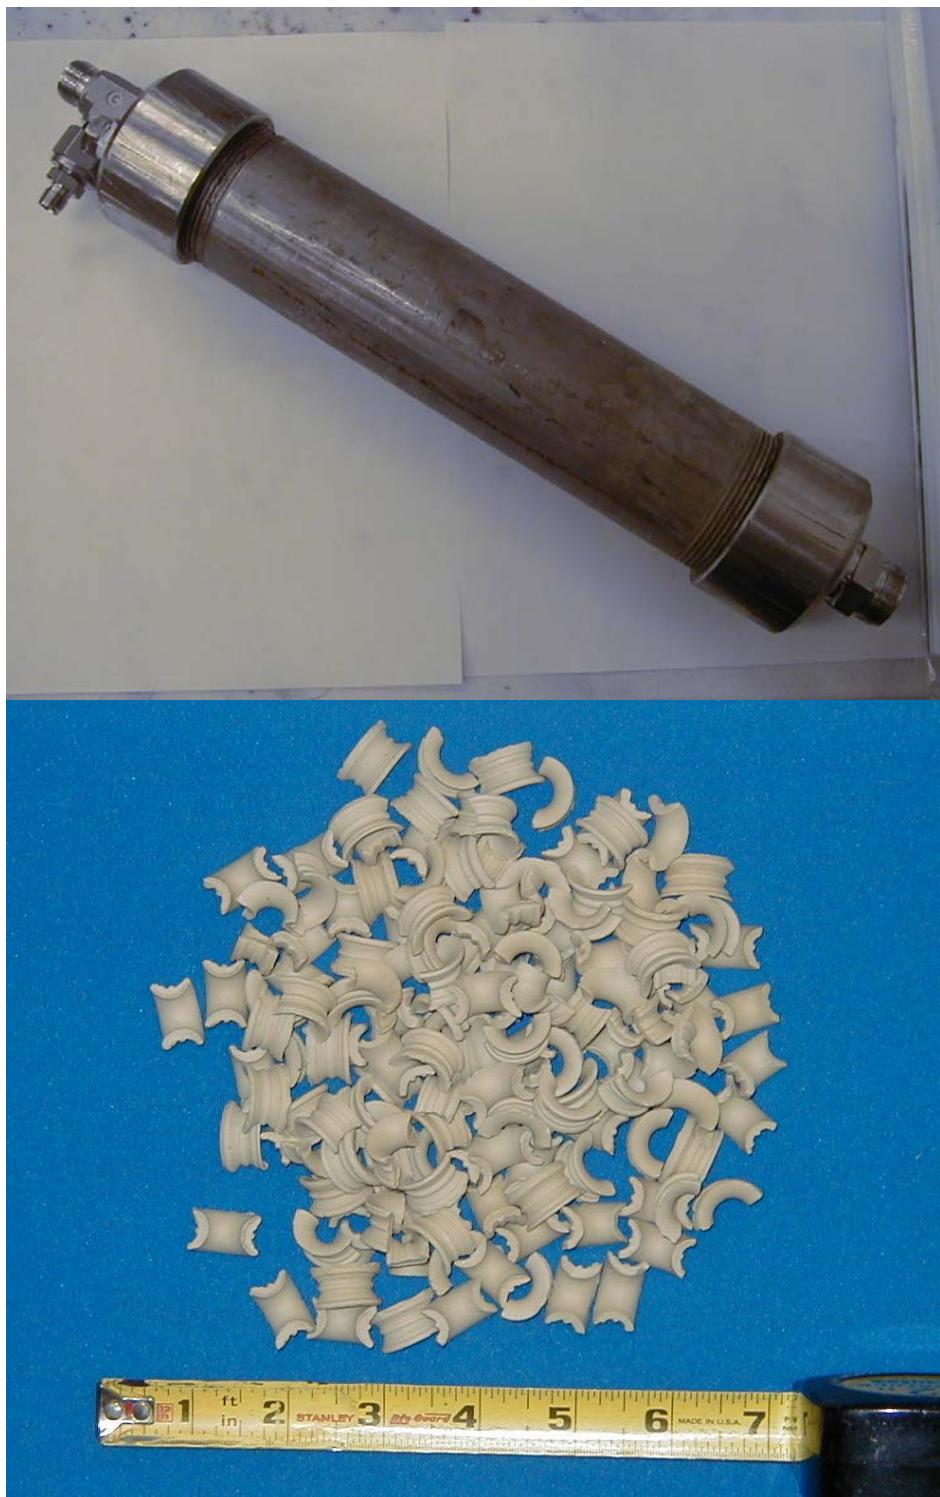
Figure 2.14. 2-in. Schedule 40 Stainless Steel Knockout Pot Housing and Intalox Ceramic Packing Before Installation

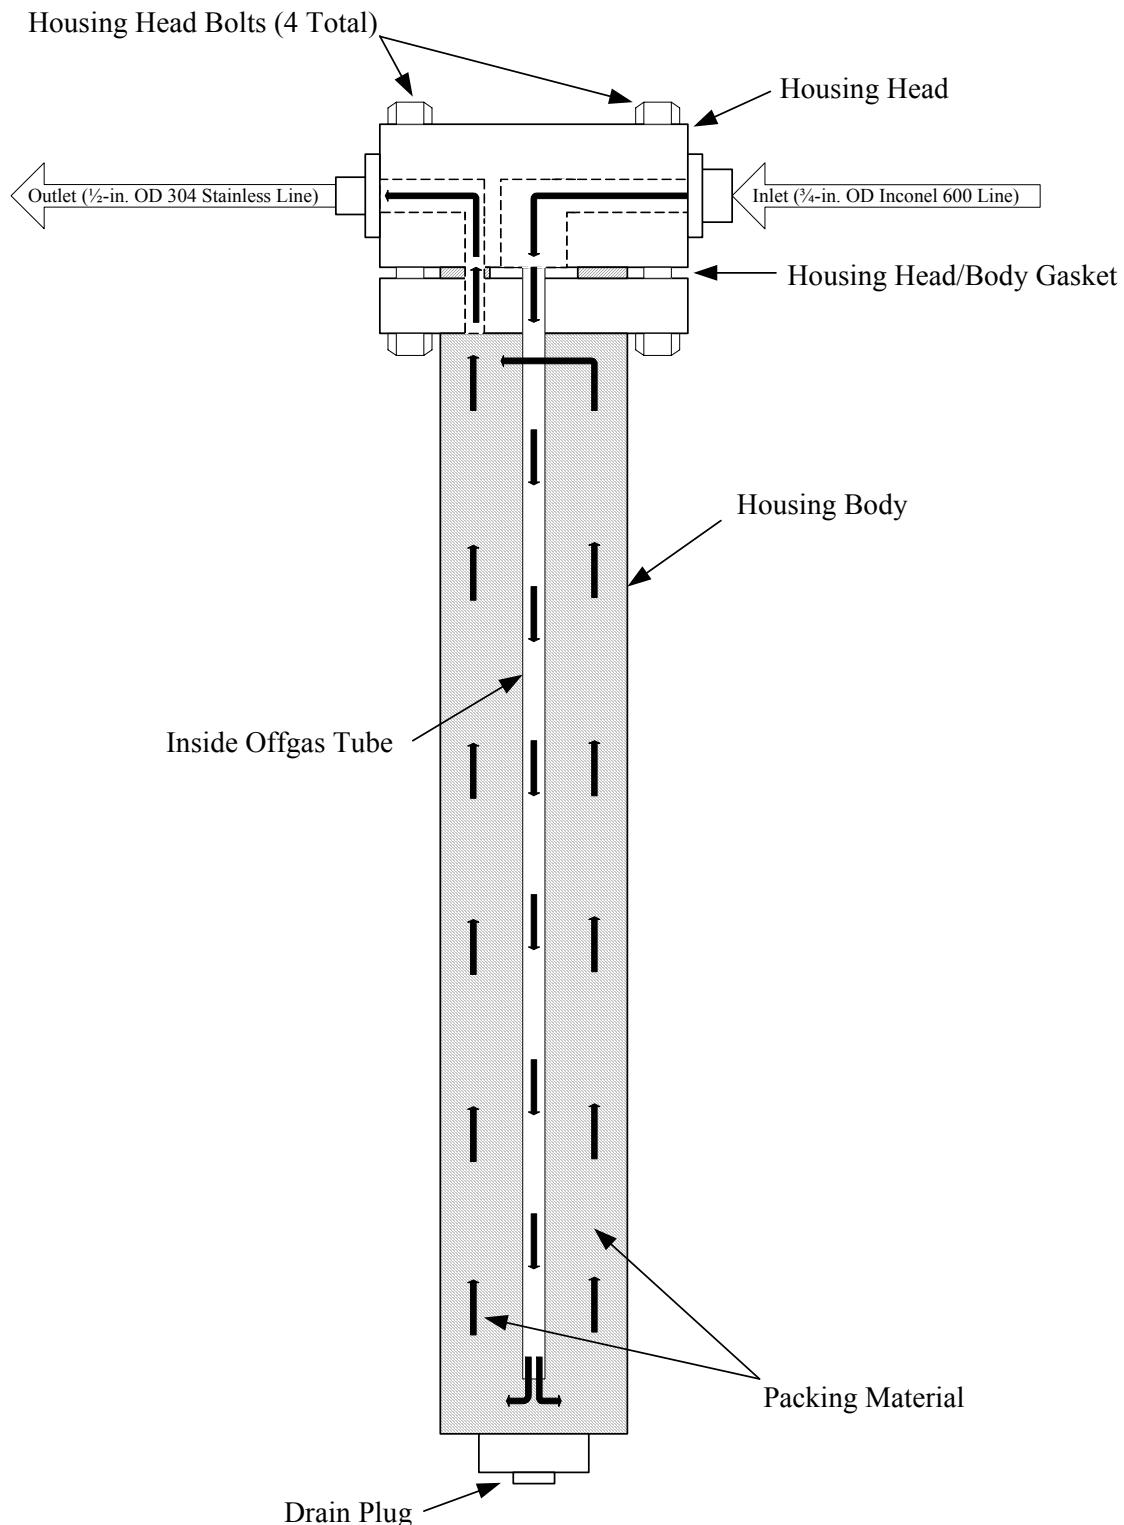
Figure 2.15. Schematic of the Nowata Filter Housing Converted to a Knockout Pot

- Housing:
 - ♦ 1UY Series 316 stainless steel, 3.5-in. OD (body), 4.6-in. OD (head), 24.5-in. overall length, 36 lb shipping weight
 - ♦ P/N 1UY2N15N15KT

- ♦ End of housing tapped and plugged with a 1.5-in. NPT plug
 - ♦ 316°C maximum temperature (at 150 psi max pressure)
 - Packing:
 - ♦ Interpack 10-mm nominal 316 stainless metal random packing

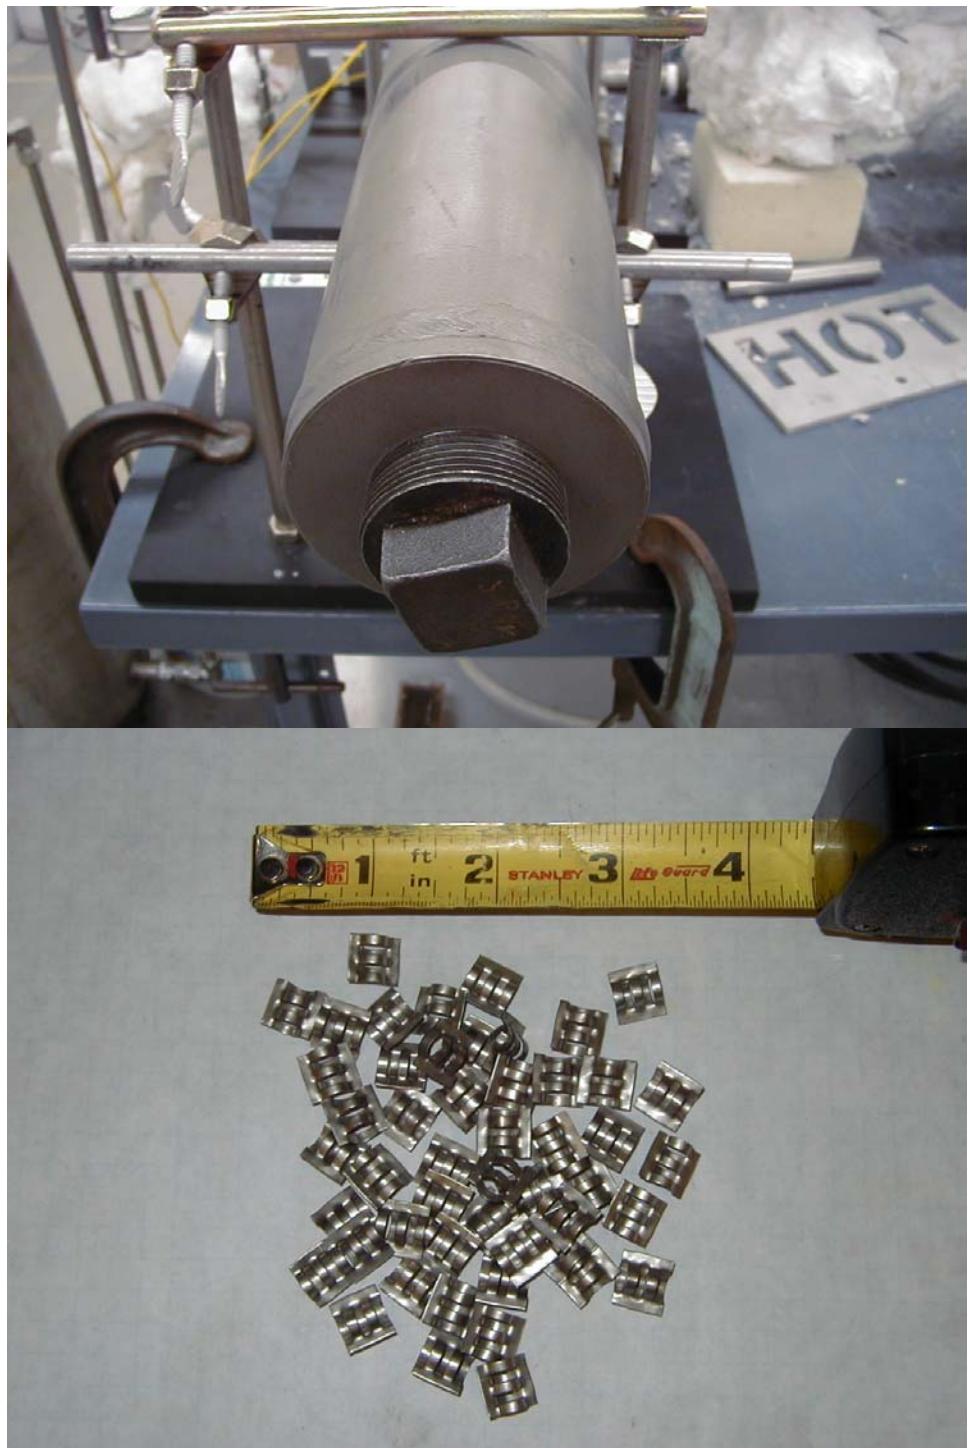
Figure 2.16. Nowata Knockout Pot Conversion and 10-mm Nominal Interpack Stainless Steel Packing Before Installation
