**Evaluation of PFP Furnace Systems
for Thermal Stabilization of Washed
High Chloride Plutonium Oxide Items**

December 17, 2002

Prepared for Fluor Hanford by
Pacific Northwest National Laboratory
Richland, Washington 99352

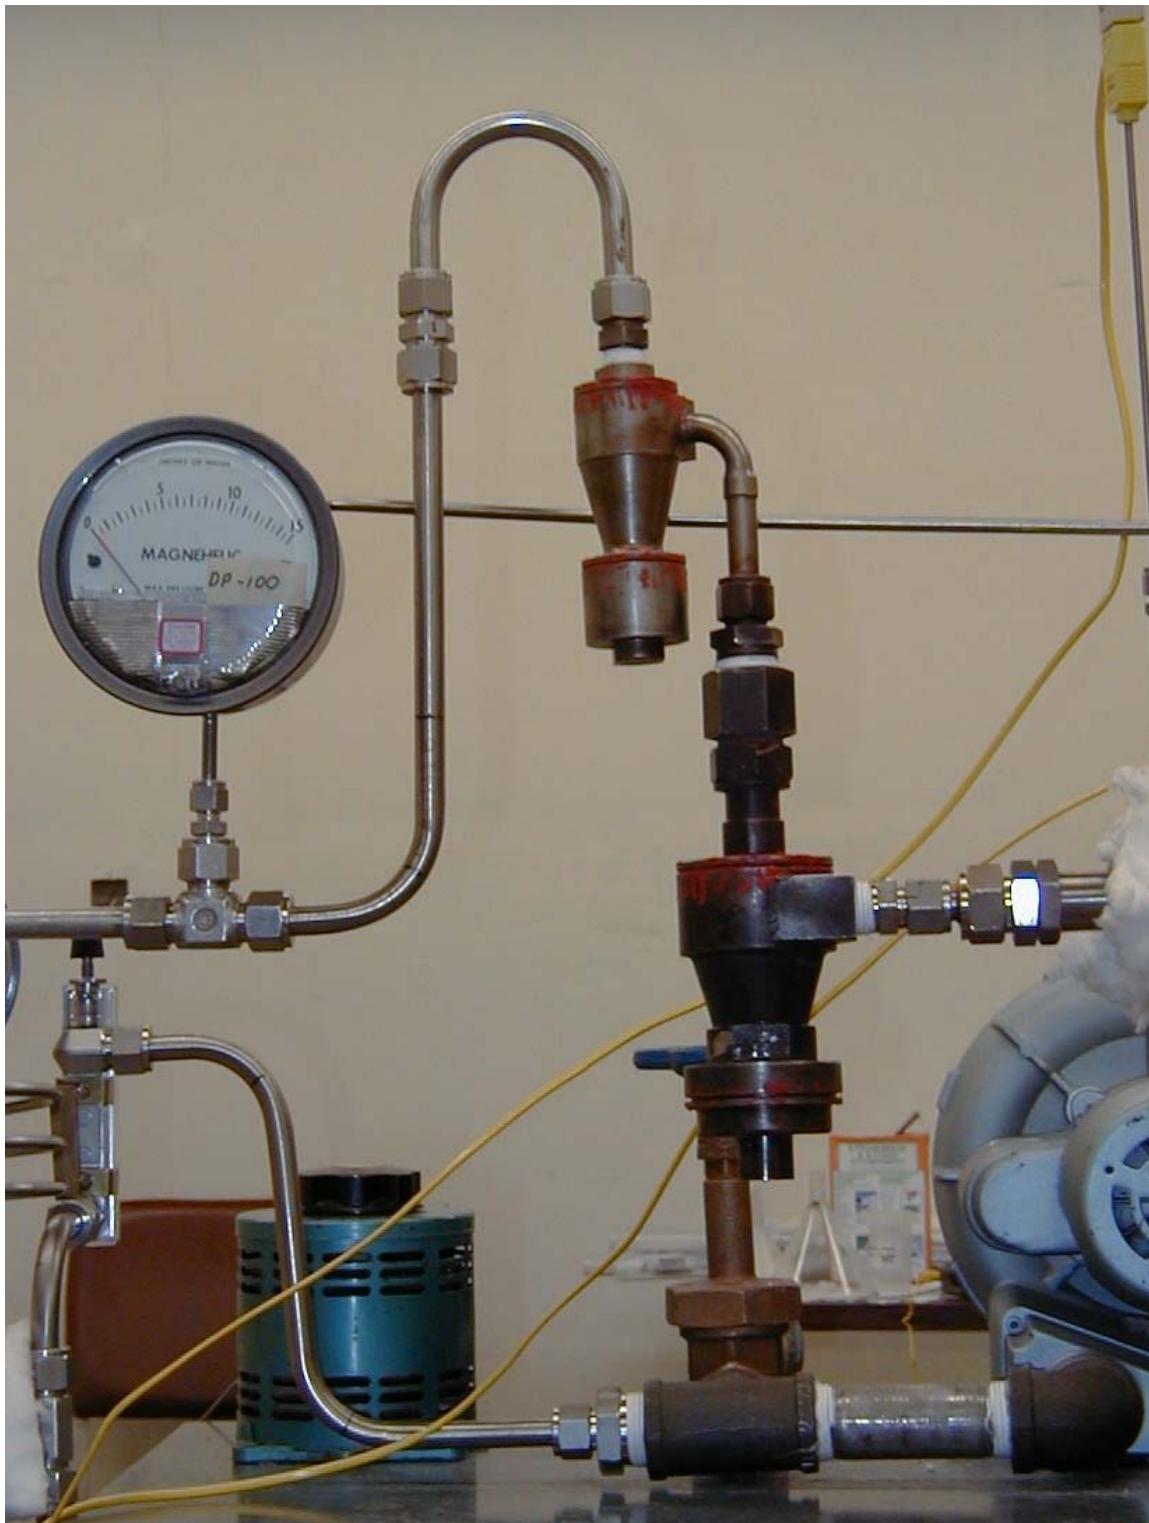
Figure 2.17. Series 280 In-Stack Cascade Cyclone Samplers

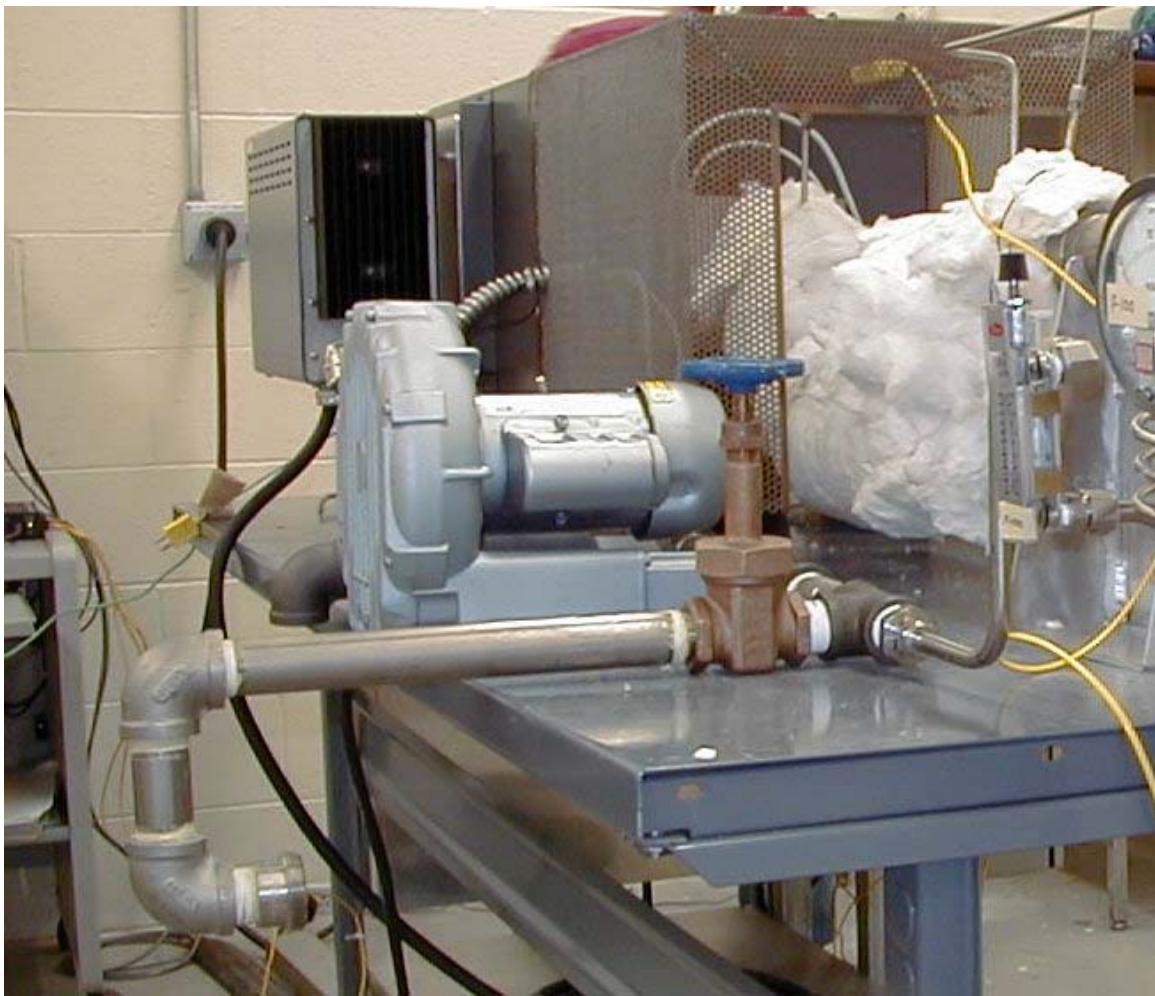
Figure 2.18. Blower and Control Valve Used to Draw Offgas from Furnace

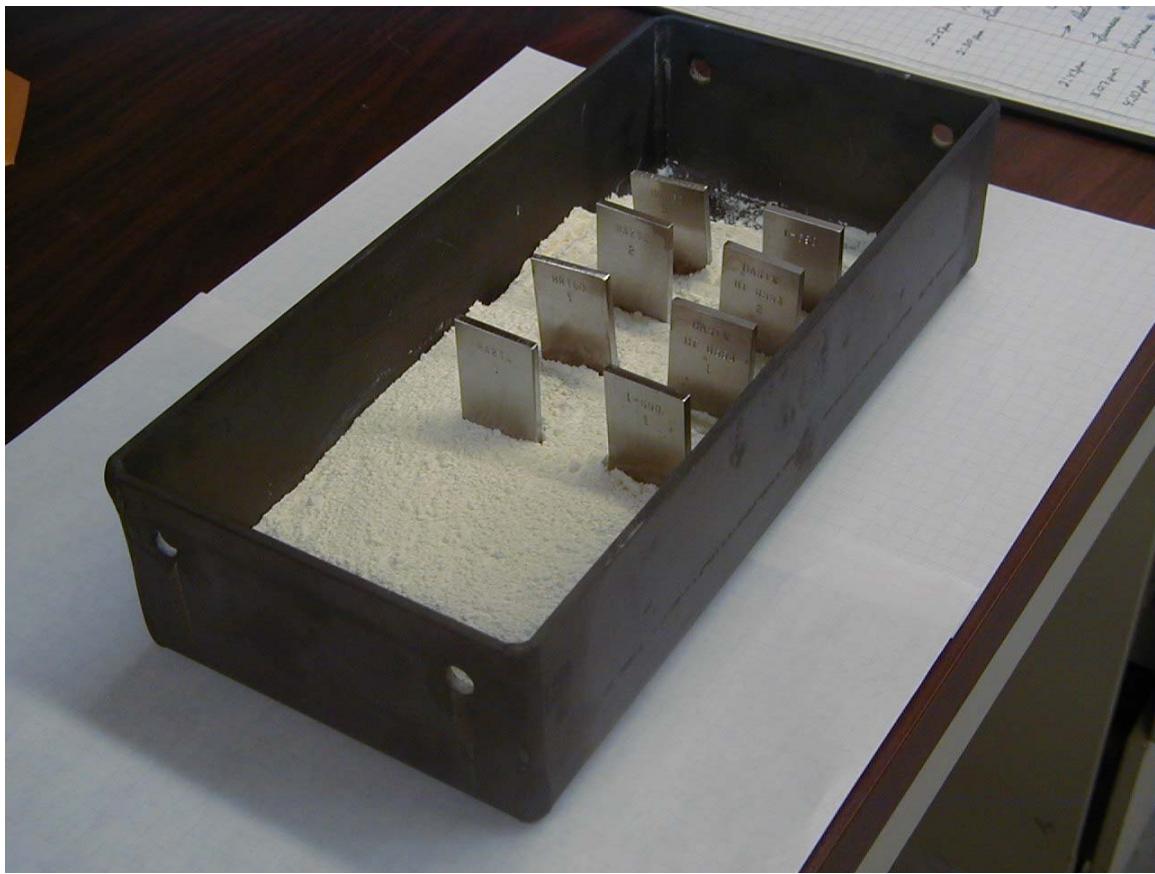
Figure 3.1. New Coupon Specimens Loaded in the Simulant Boat

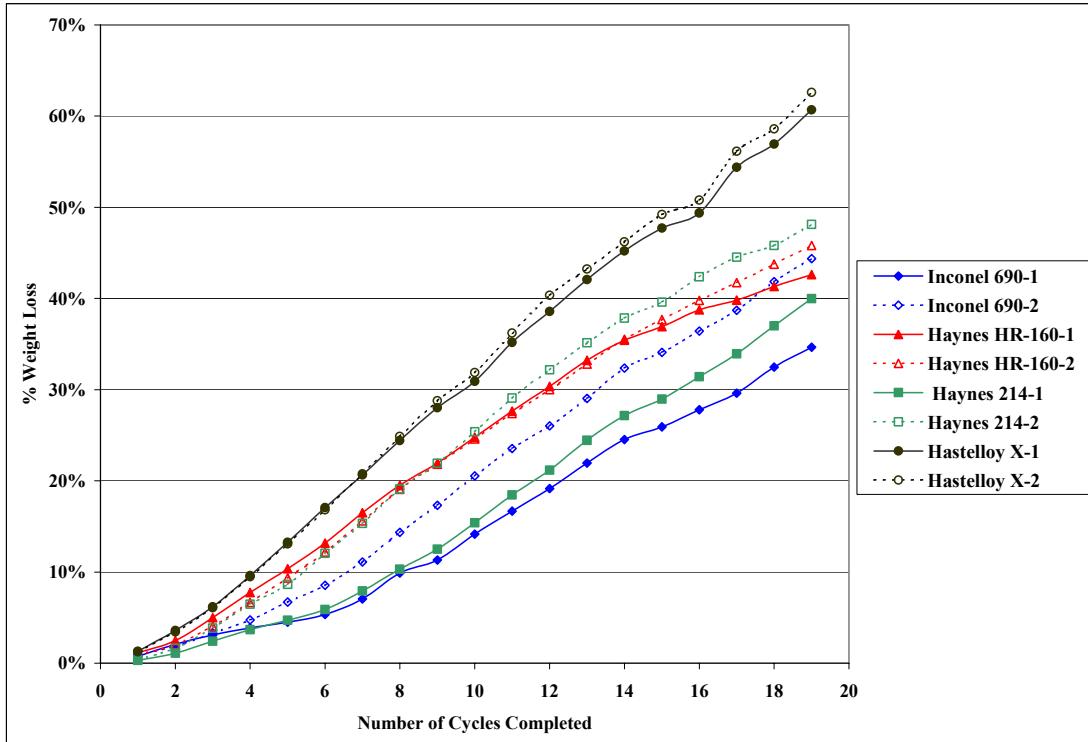
Figure 3.2. Percent Weight Loss Versus Number of Cycles Completed for Coupon Set #1

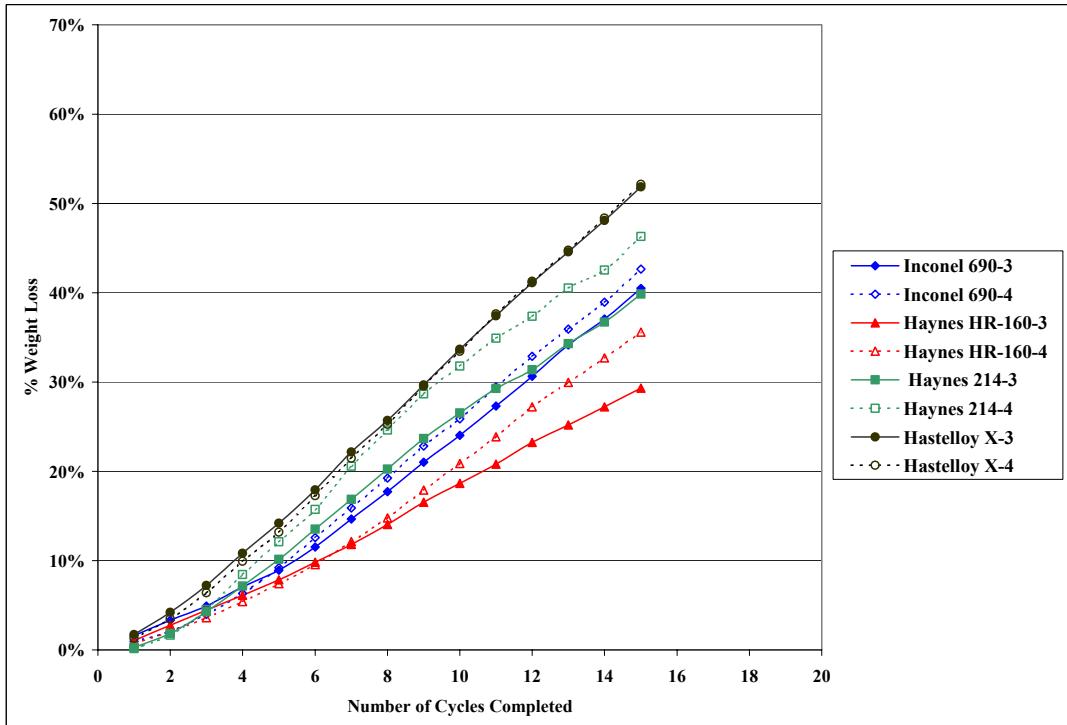
Figure 3.3. Percent Weight Loss Versus Number of Cycles Completed for Coupon Set #2

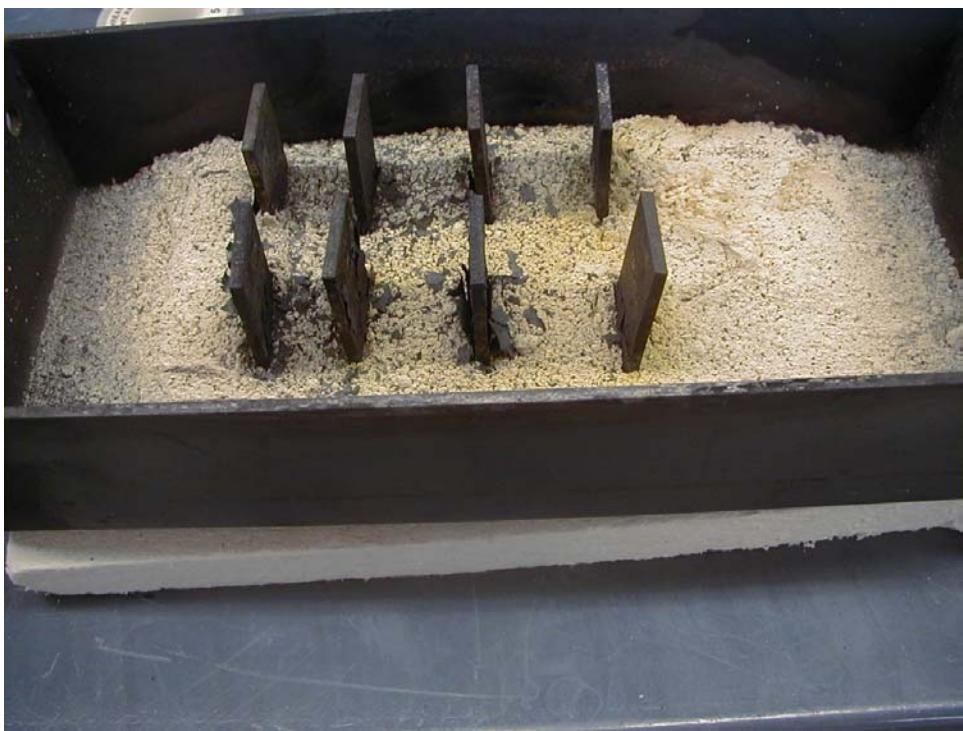
Figure 3.4. Coupon Specimens After a Test Cycle. Note the thin pieces of oxidized metal peeling off the coupons.

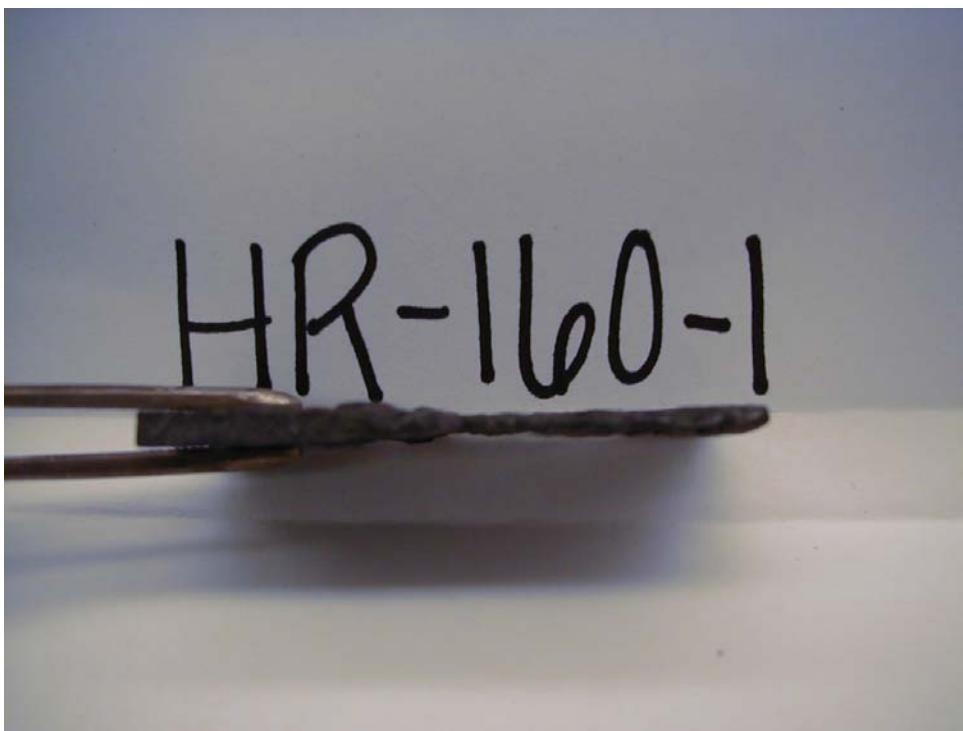
Figure 3.5. Haynes HR-160 Coupon with Scale Buildup

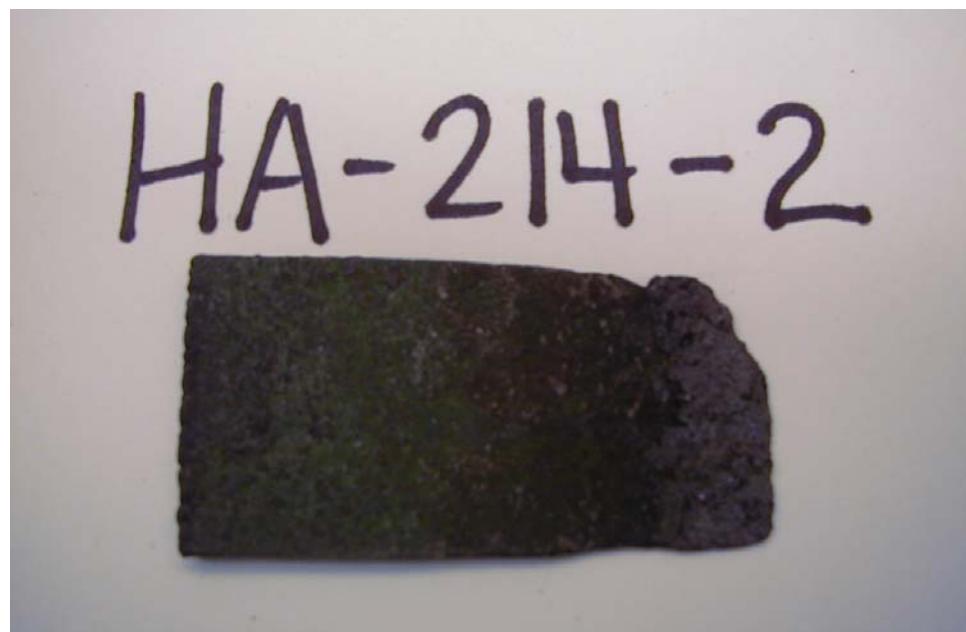
Figure 3.6. Haynes 214 Coupon with a Broken Corner

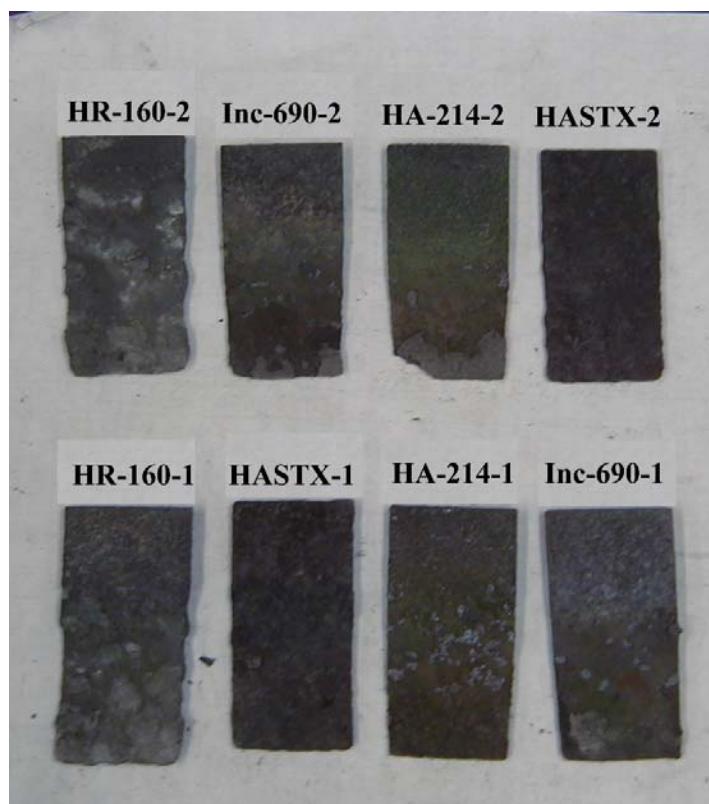
Figure 3.7. Wedge-Shaped Coupons from Set #1 After 19 Consecutive Test Cycles.
HR-160=Haynes HR-160, Inc-690=Inconel 690, HR-214=Haynes 214,
HASTX= Hastelloy X.

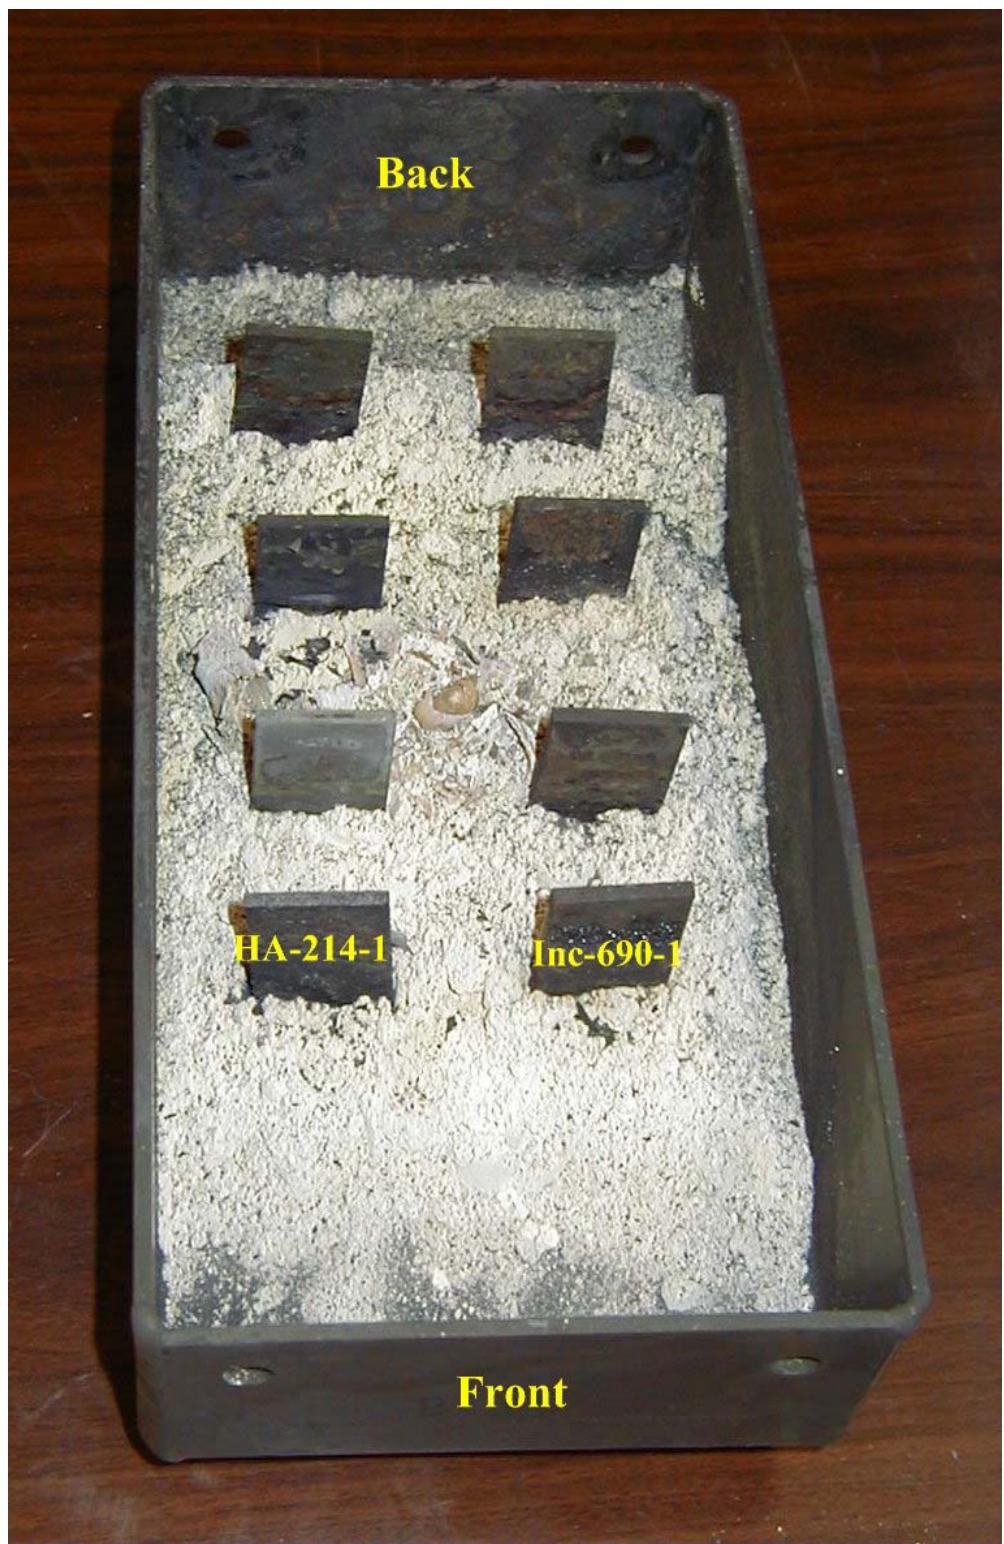
Figure 3.8. Inconel 690-1 (Inc-690-1) and Haynes 214-1(HA-214-1) Coupons at the Front of the Simulant Boat

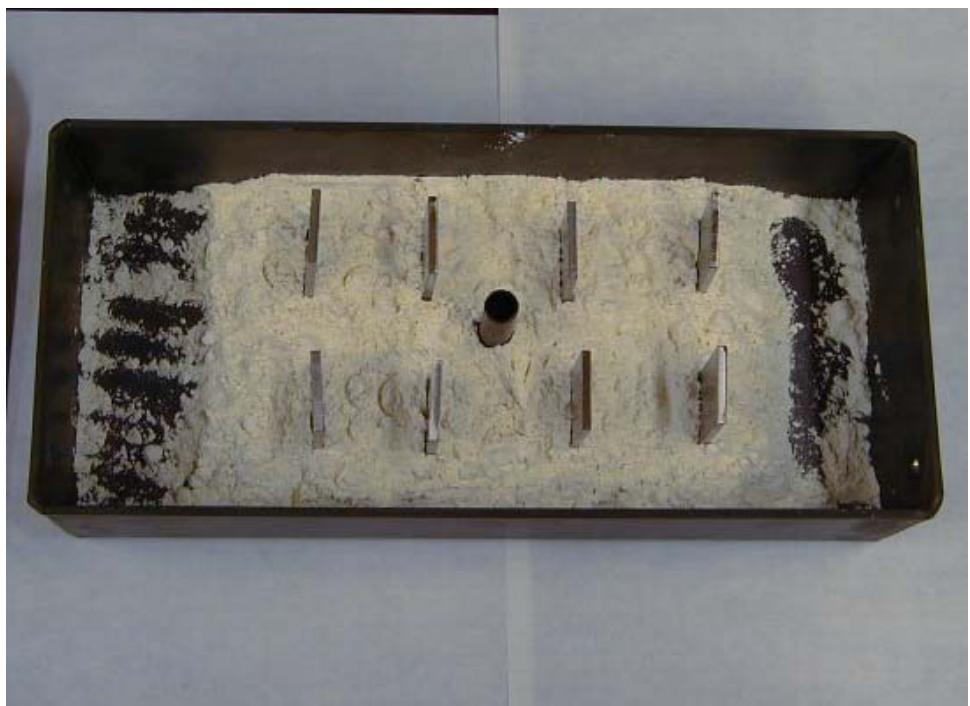
Figure 3.9. Zircaloy Tubing (center) Used as a Corrosion Coupon

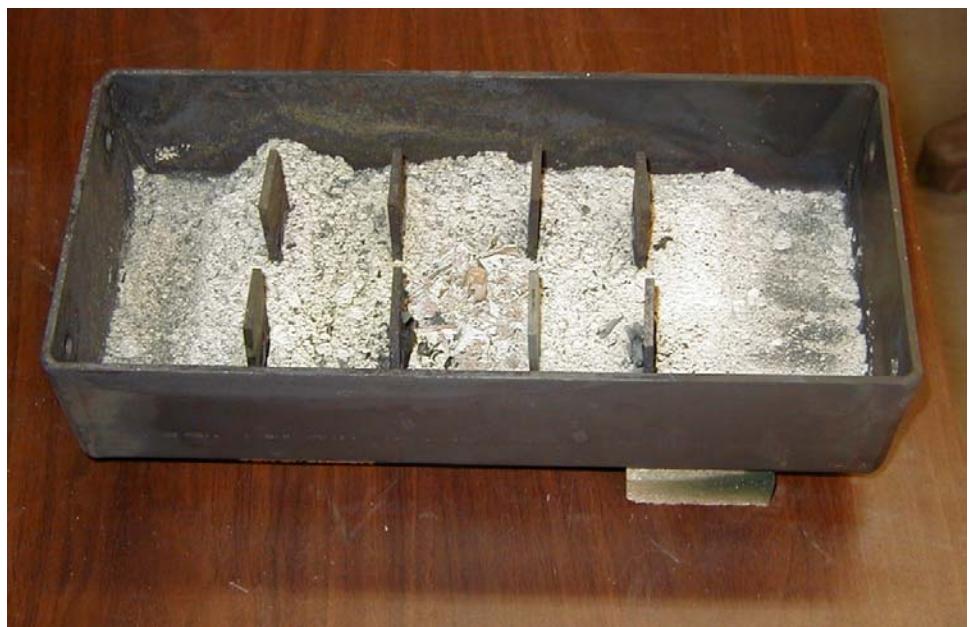
Figure 3.10. Zircaloy Tubing Residue (center) After One Test Cycle

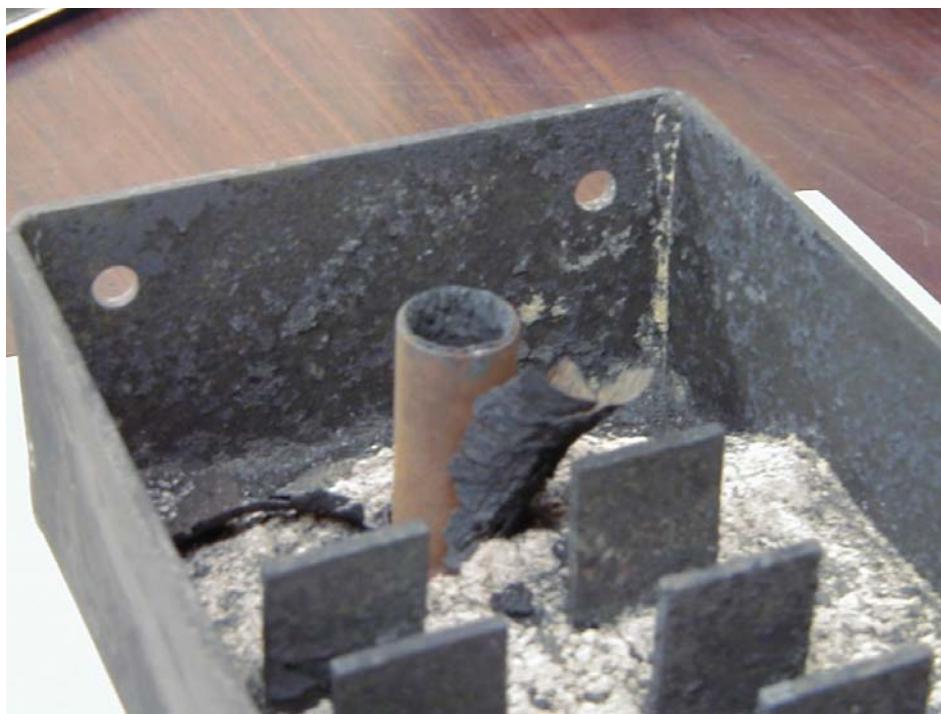
Figure 3.11. Inconel 600 Tubing (left center) Used as a Corrosion Coupon.
Condition after one test cycle.

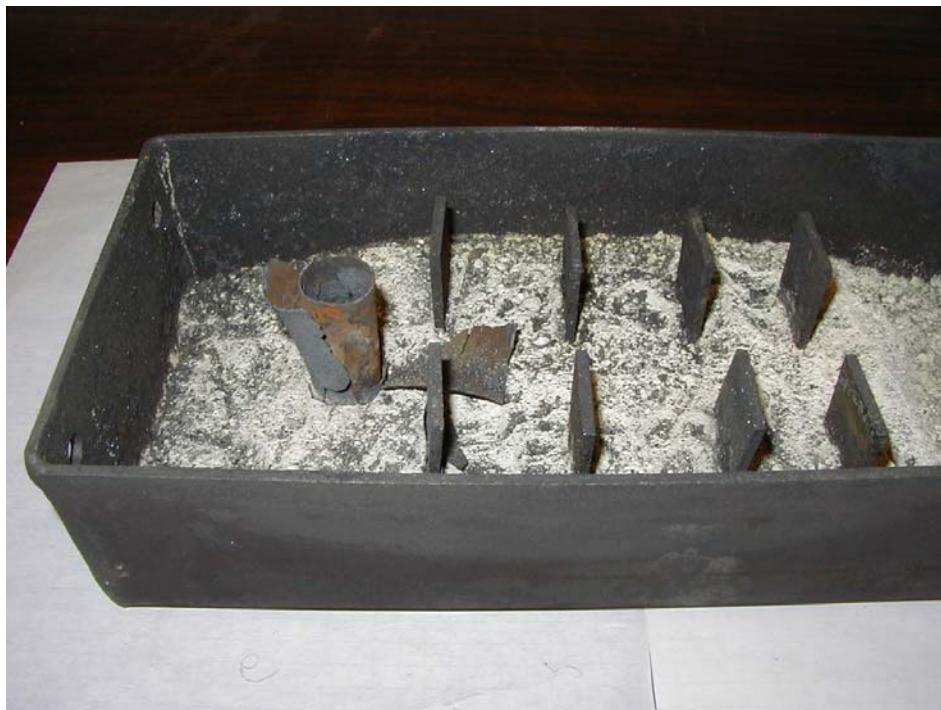
Figure 3.12. Inconel 600 Tubing Used as a Corrosion Coupon.
Condition after three test cycles.

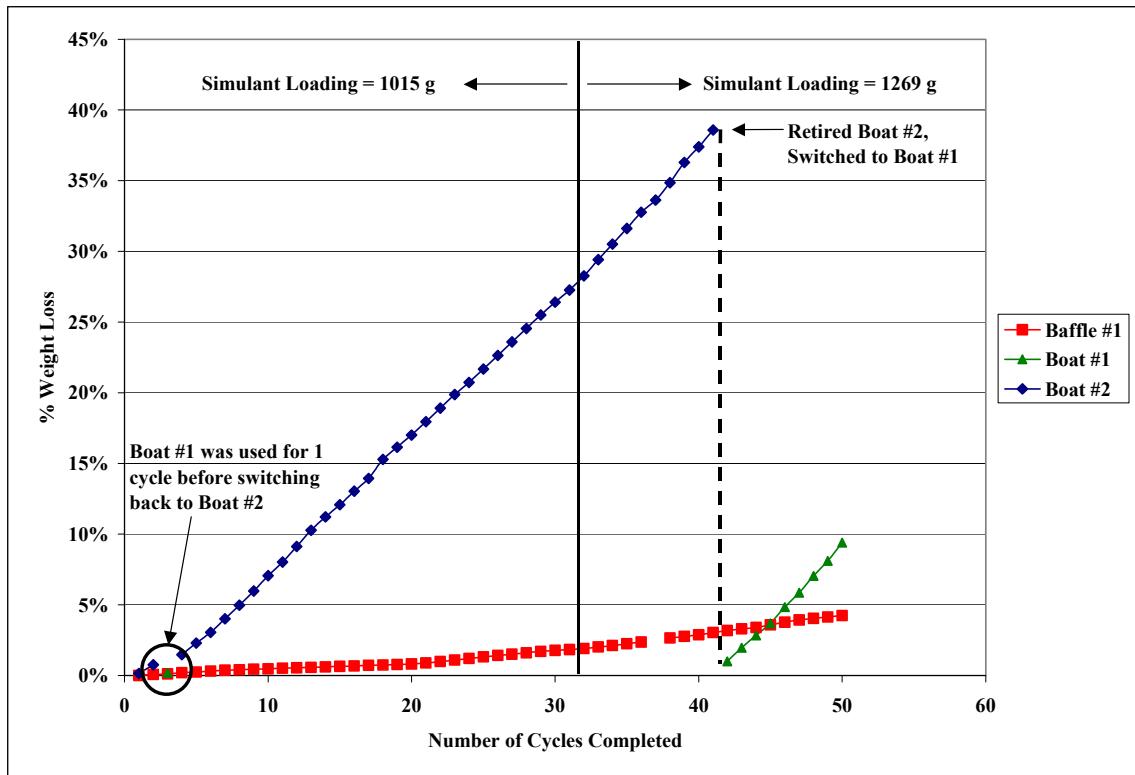
Figure 3.13. Percent Weight Loss Versus Number of Cycles Completed for Simulant Boats #1 and #2, and Baffle #1

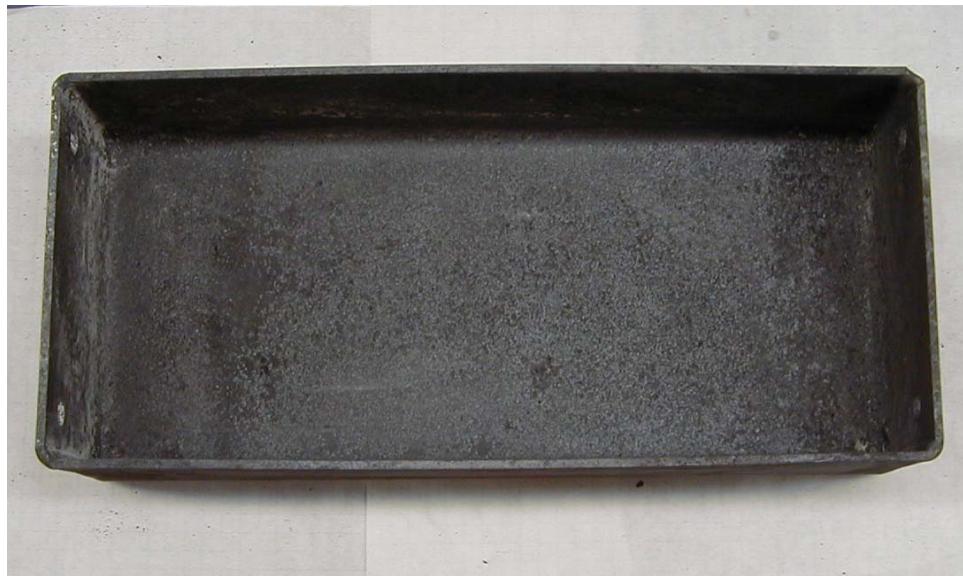
Figure 3.14. Corrosion at the Bottom of Simulant Boat #2 After Five Test Cycles

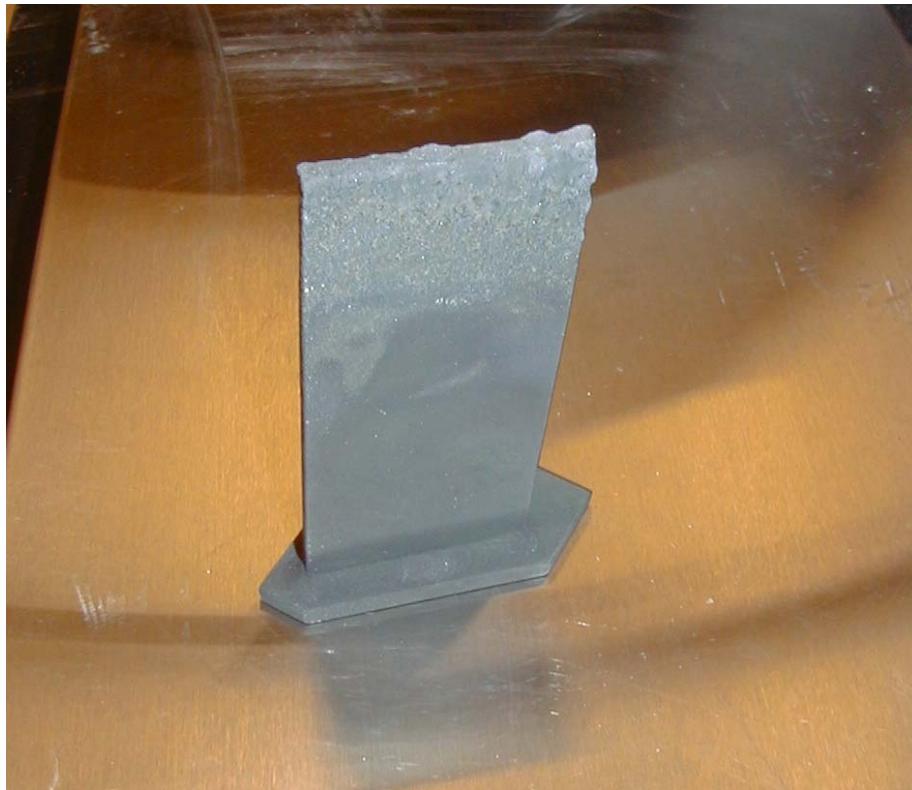
Figure 3.15. Scale Buildup on Baffle After 50 Test Cycles

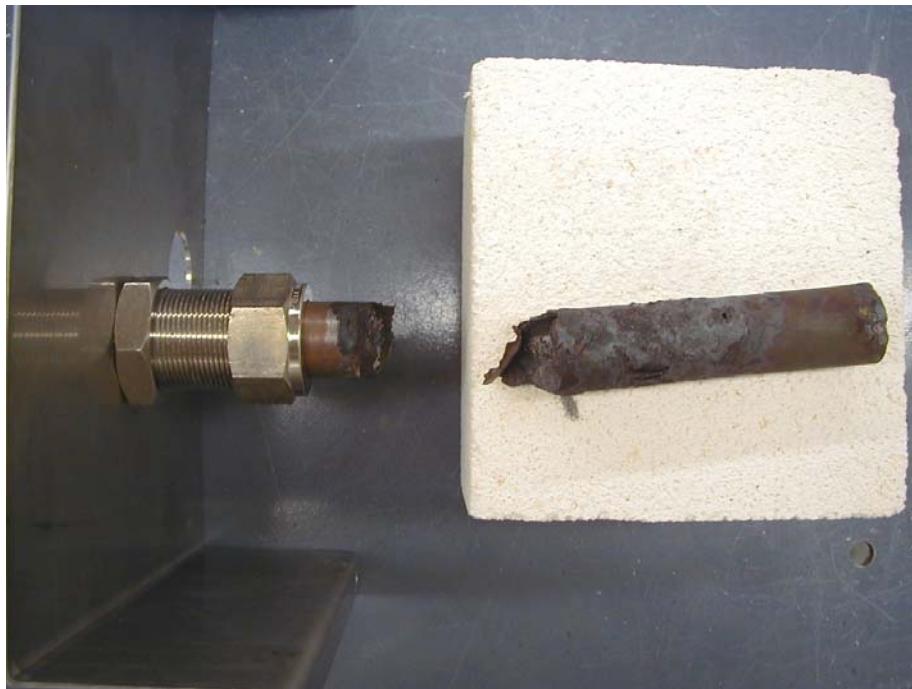
Figure 3.16. Inconel 600 Internal Offgas Line After Five Test Cycles

After the 5th furnace cycle, the internal Inconel 600 tube failed as a result of severe corrosion, which was apparently caused by a zone of condensed molten chloride salts. The susceptibility of the Inconel 600 tube to chloride salts at high temperature was confirmed by a subsequent near failure of a second internal tube after three cycles and by coupon testing in the sample boat. Coupon testing also identified Inconel 690 as exhibiting a lower corrosion rate than other materials tested. Therefore, the internal offgas line was replaced with a heavy-walled Inconel 690 line, and an acceptable service life was obtained (i.e., greater than 12 cycles). While the internal offgas line underwent significant corrosive attack (with both

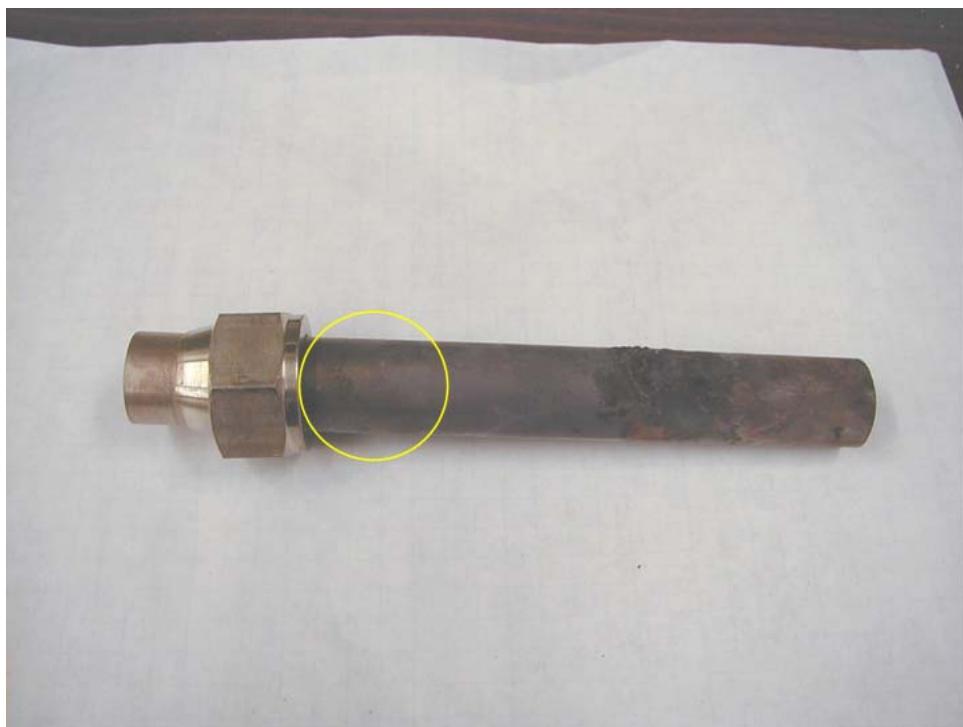
Figure 3.17. Approximate Location of Hard Deposits that Formed in the Inconel 600 Internal Offgas Line

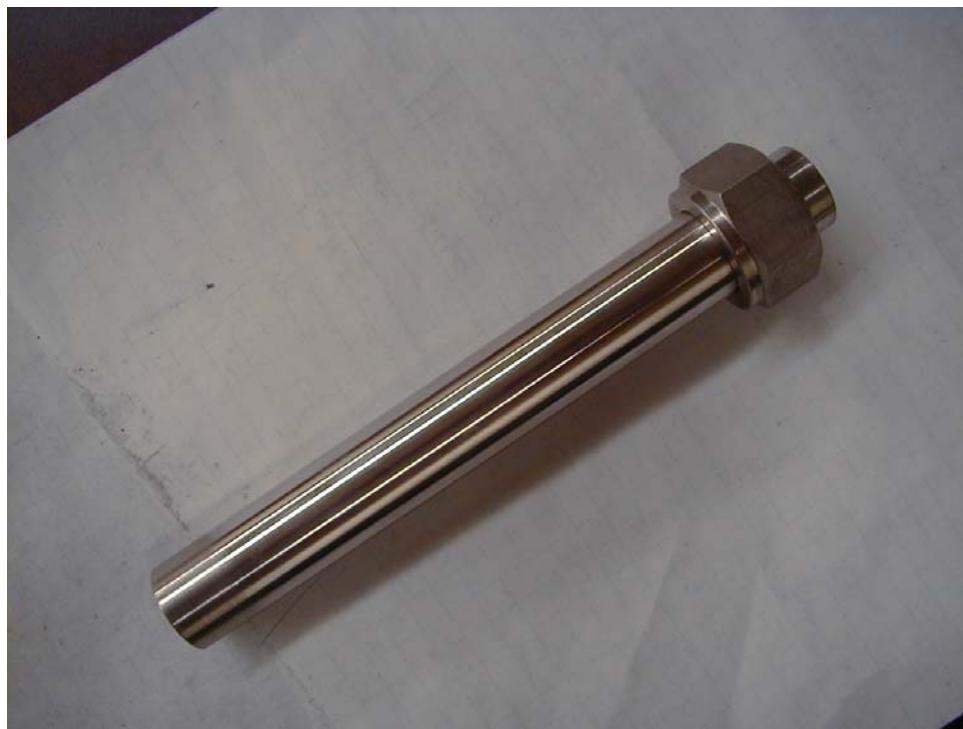
Figure 3.18. Inconel 690 Internal Offgas Line Ready for Installation

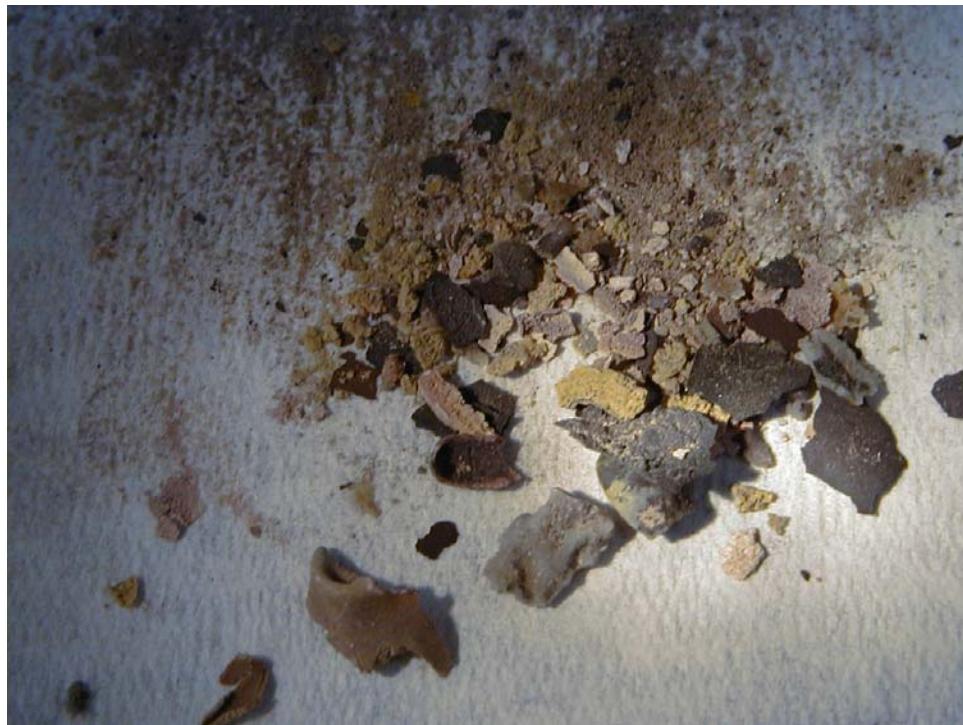
Figure 3.19. Salt Deposits and Corrosion Products Removed from Inconel 690 Internal Offgas Line

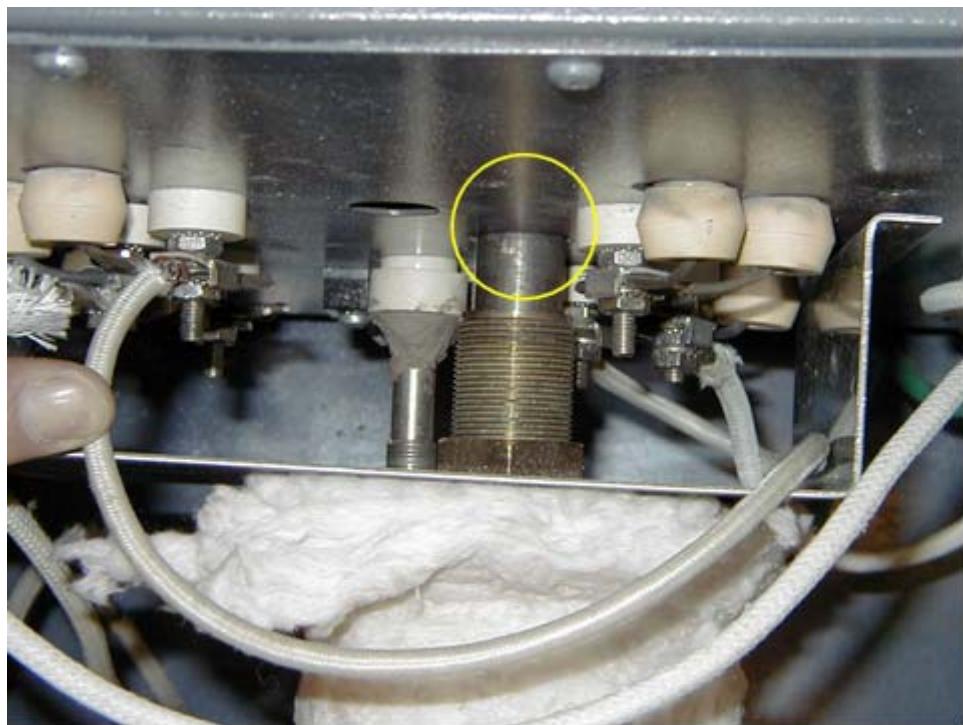
Figure 3.20. Approximate Location of Hard Deposits Removed from Inconel 690 Internal Offgas Line

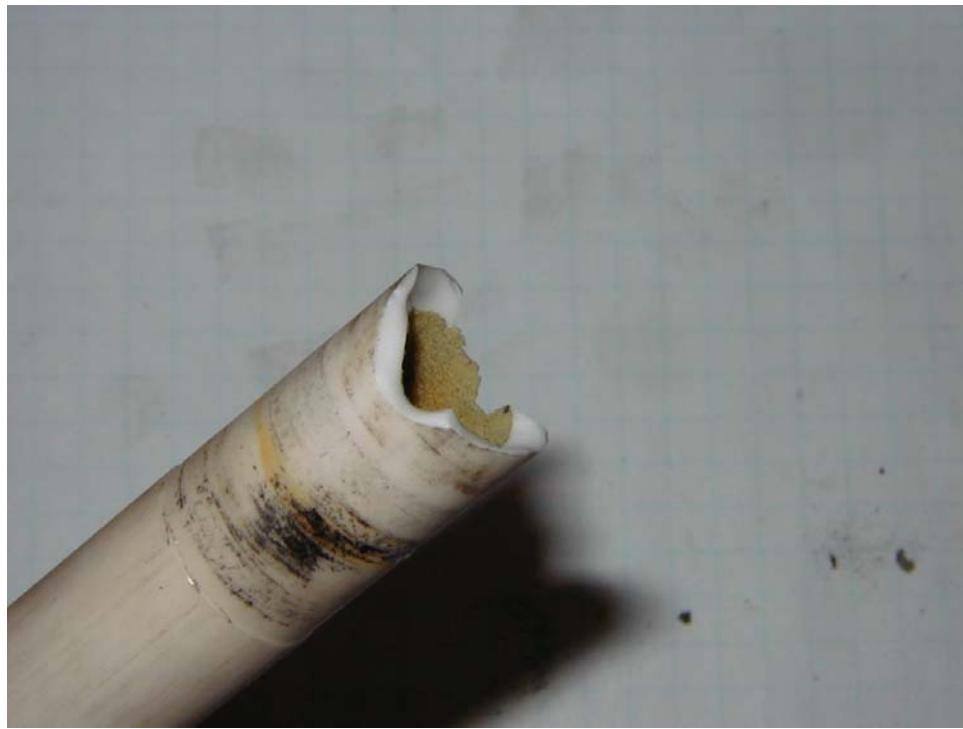
Figure 3.21. Chipped End of Ceramic Internal Offgas Line

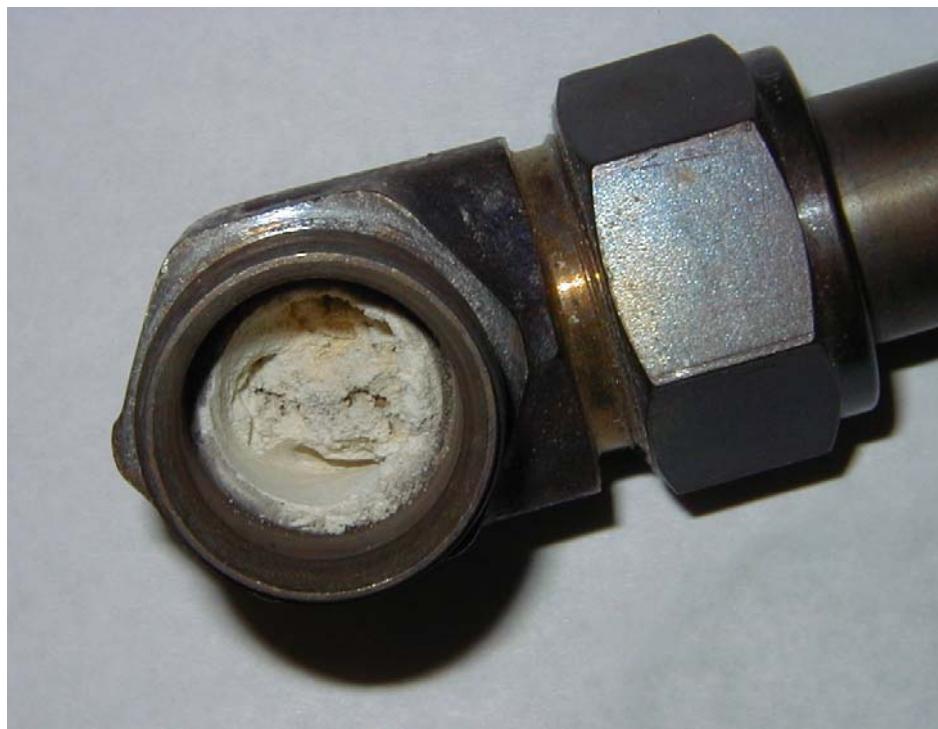
Figure 3.22. Final Bend on Inconel 600 External Offgas Line Plugged with Salt Deposits

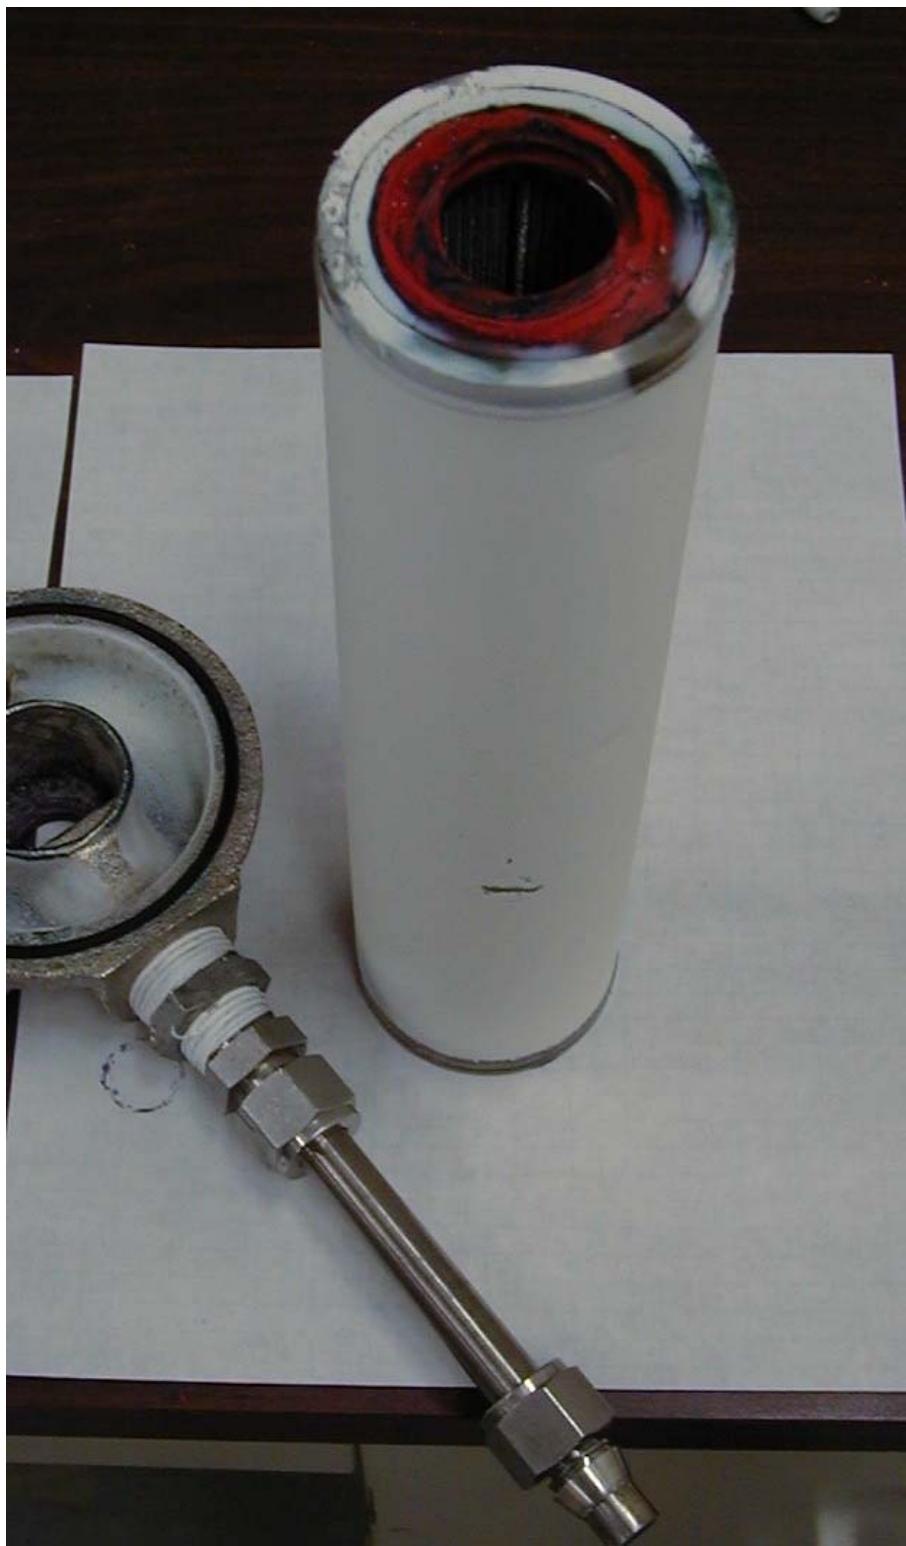
Figure 3.23. Purlator Sintered Metal Cartridge Blinded by Salt Deposits

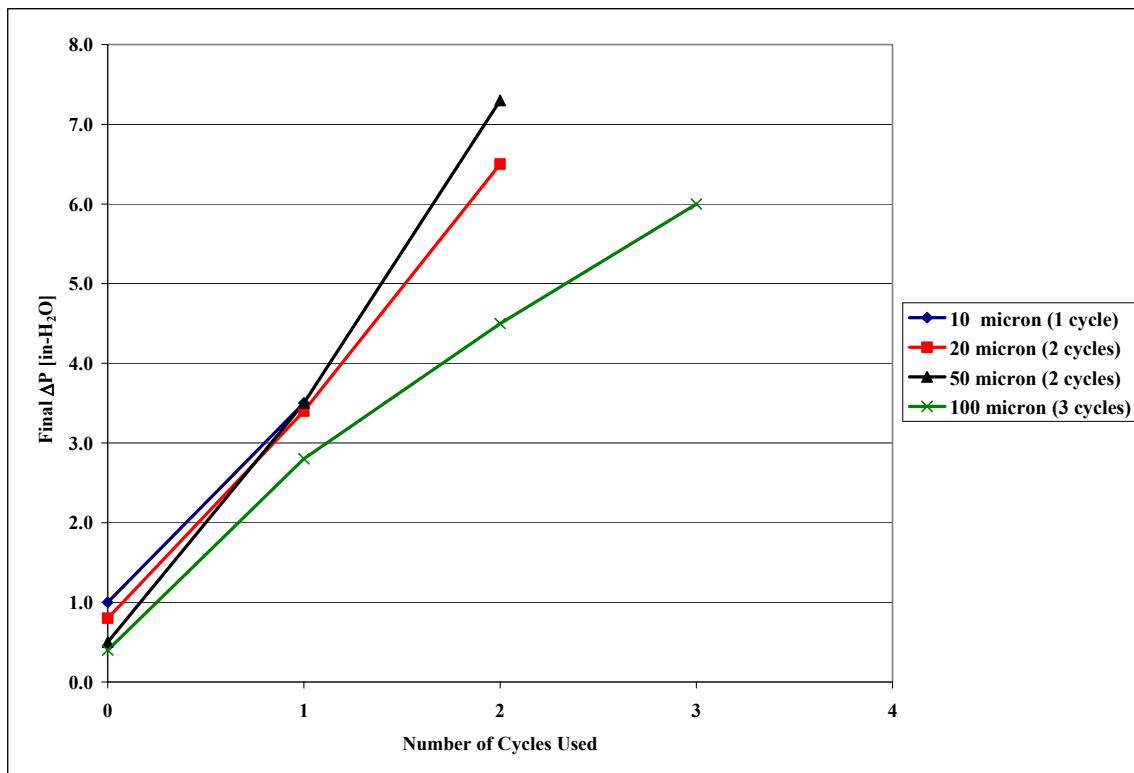
Figure 3.24. New Cartridge Initial Pressure Drop and Final Pressure Drop at the End of Each Completed Cycle for Nowata Woven Glass Filter Cartridges. Legend indicates total number of cycles completed with each filter cartridge.
