**Evaluation of PFP Furnace Systems
for Thermal Stabilization of Washed
High Chloride Plutonium Oxide Items**

December 17, 2002

Prepared for Fluor Hanford by
Pacific Northwest National Laboratory
Richland, Washington 99352

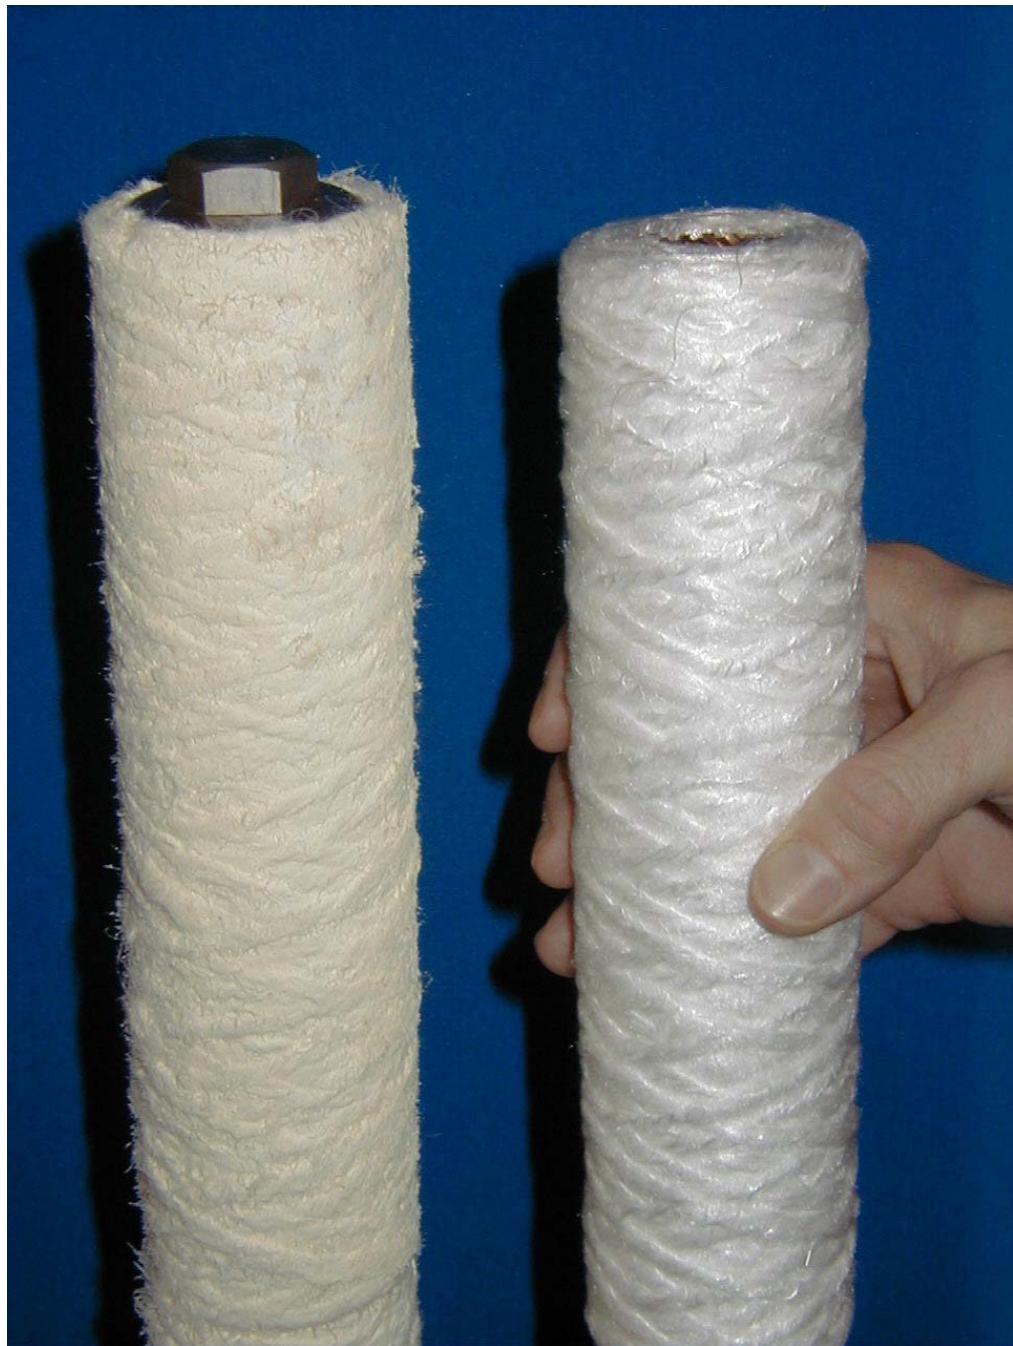
Figure 3.25. Woven Glass Fiber Cartridge (left) Blinded by Salts Compared to New Cartridge (right)

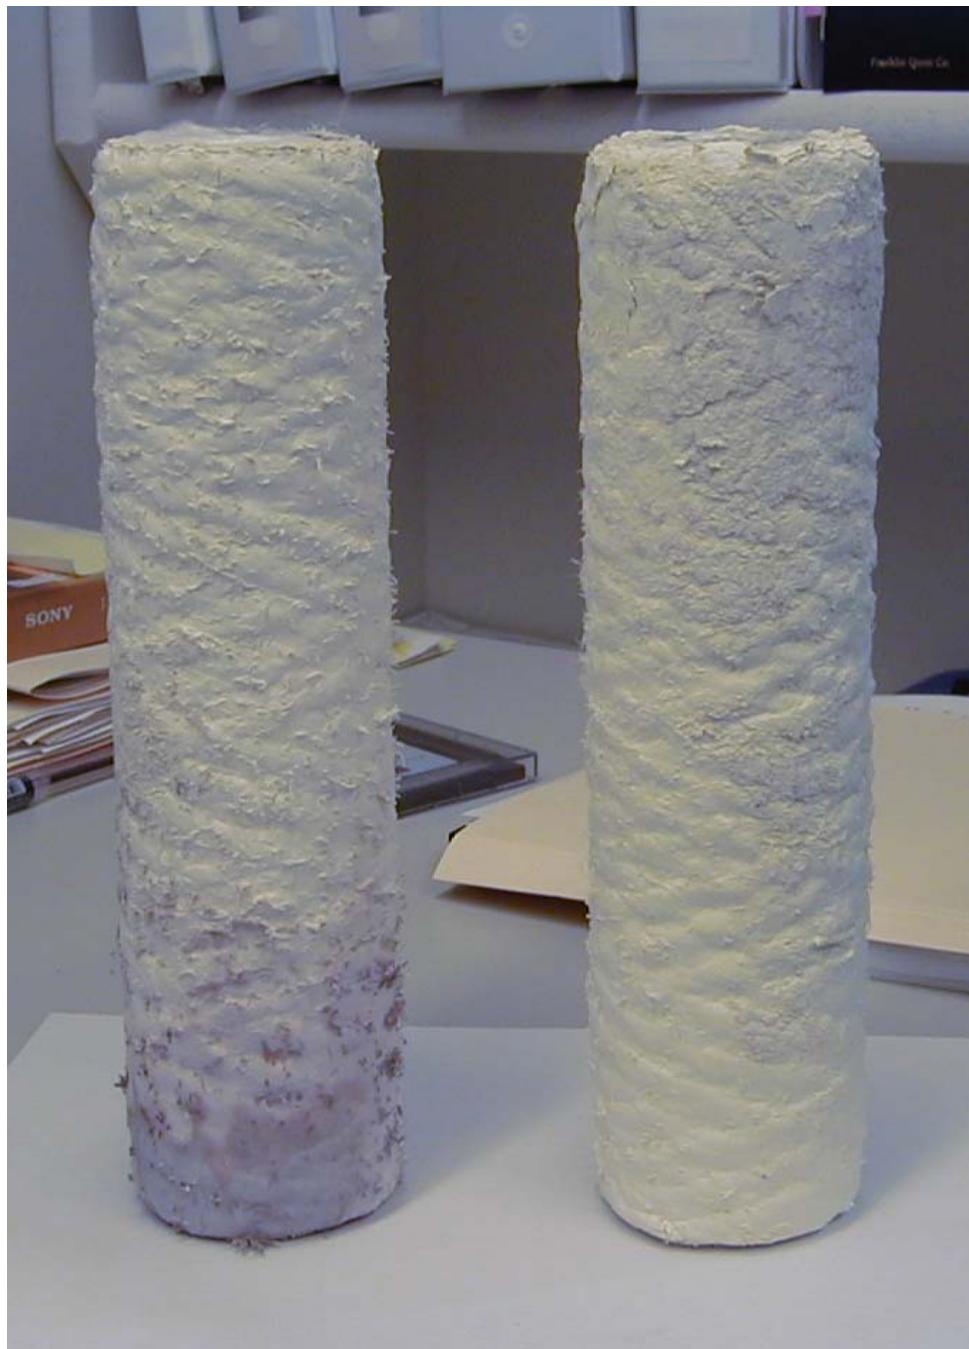
Figure 3.26. Darkened Area (lower left) of 100- μm Woven Glass Filter Cartridge After Three Test Cycles

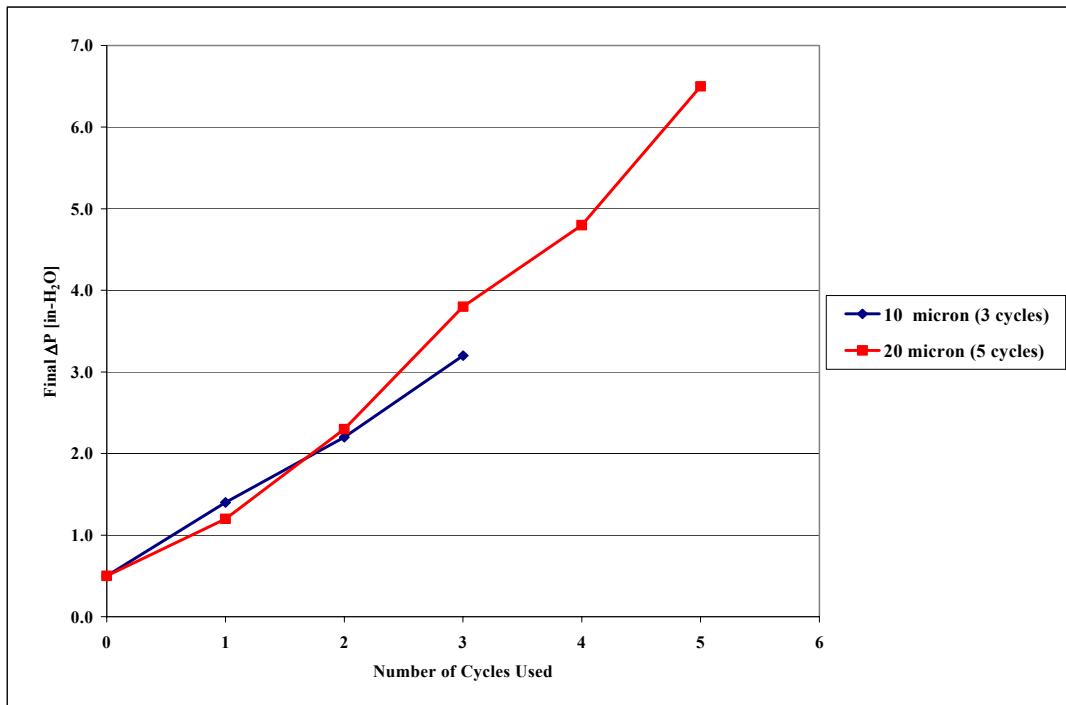
Figure 3.27. New Cartridge Pressure Drop and Final Pressure Drop at the End of Each Completed Cycle for Rosedale Pleated Metal Filters. Legend indicates total number of cycles completed with each filter cartridge.

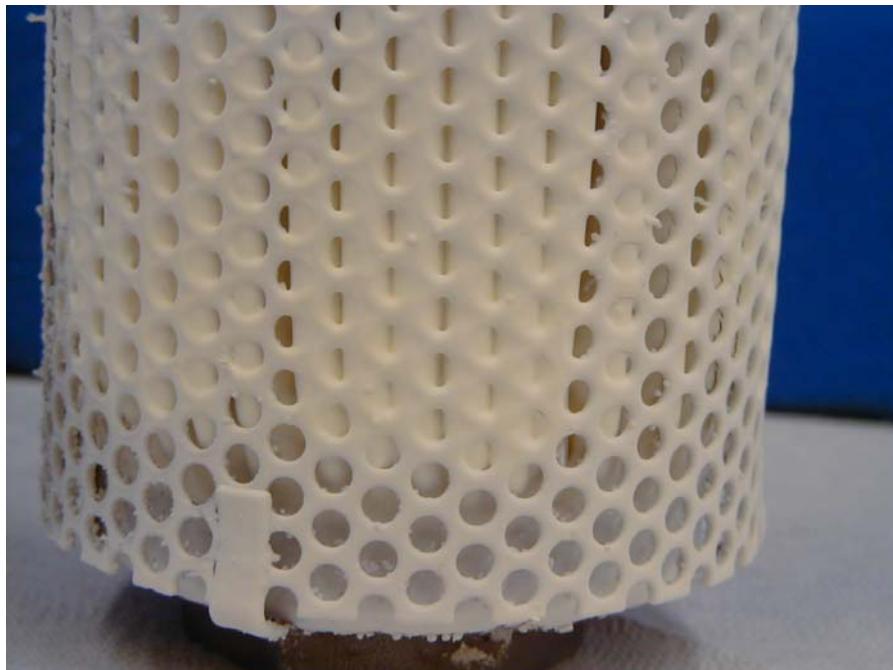
Figure 3.28. Salt Deposits on Outer Shell (pleated protector) of 20-micron Rosedale Pleated Metal Filter Cartridge After Five Test Cycles

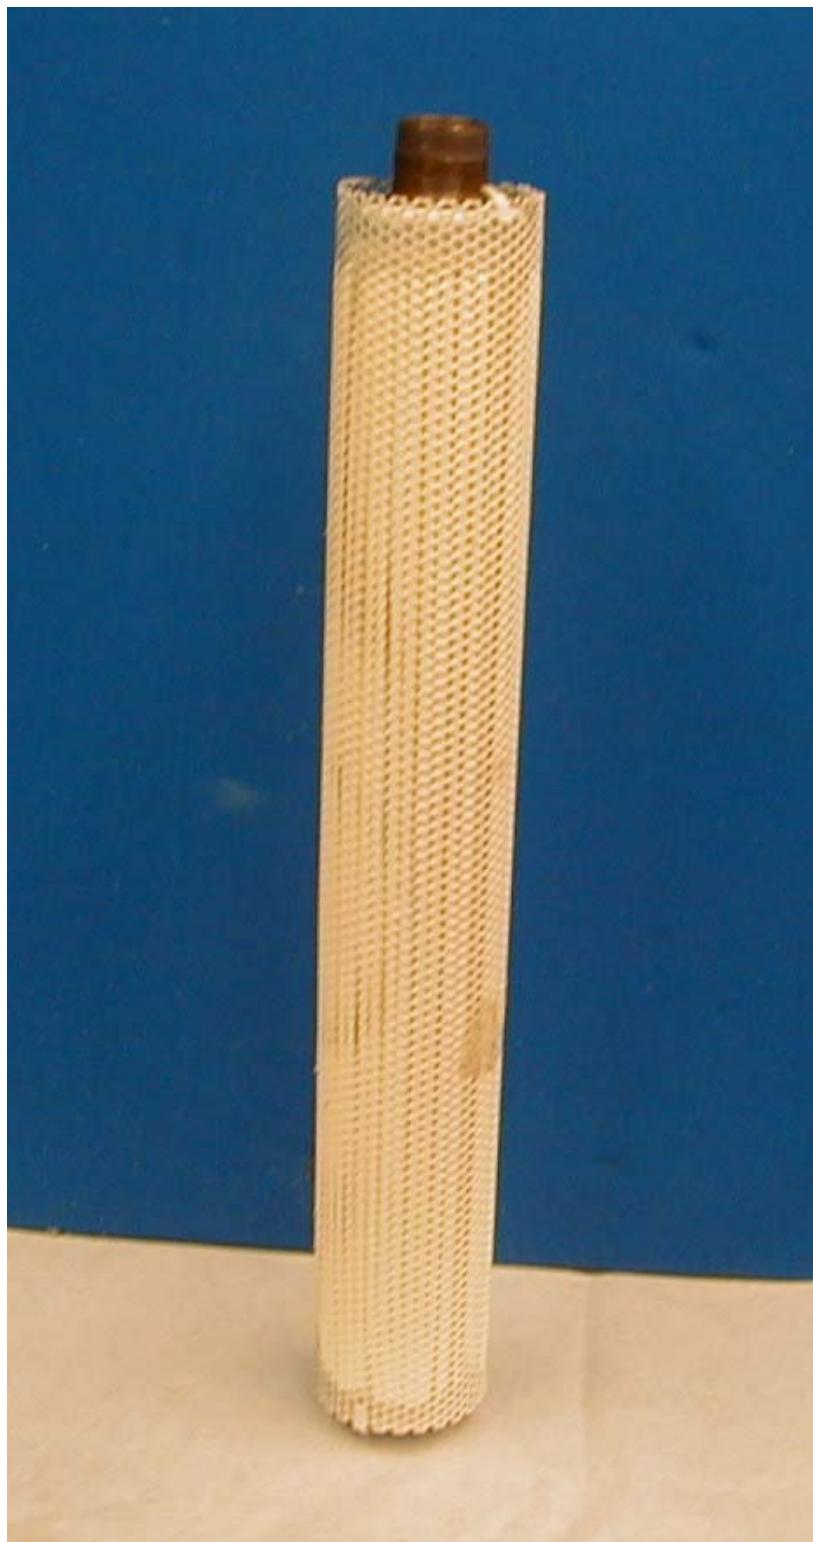
Figure 3.29. 20-micron Rosedale Pleated Metal Filter Cartridge
Blinded by Salt Deposits After Five Test Cycles

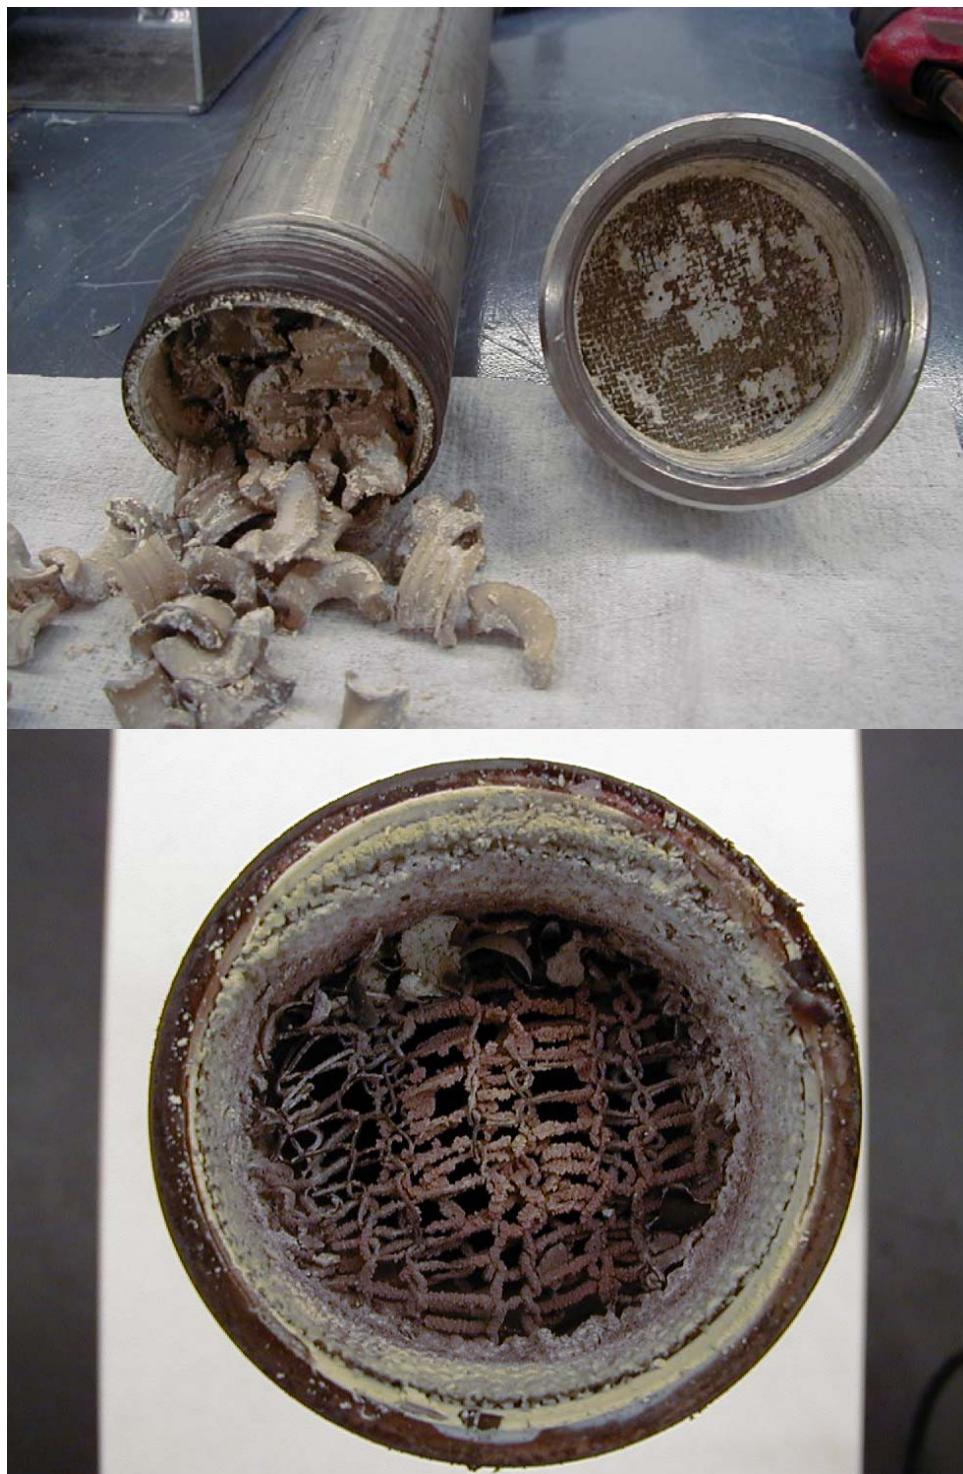
Figure 3.30. Intalox Ceramic Packing (top) and Wire Mesh (bottom) in 2 in. Schedule 40 Stainless Steel Knockout Pot. Condition after three test cycles.

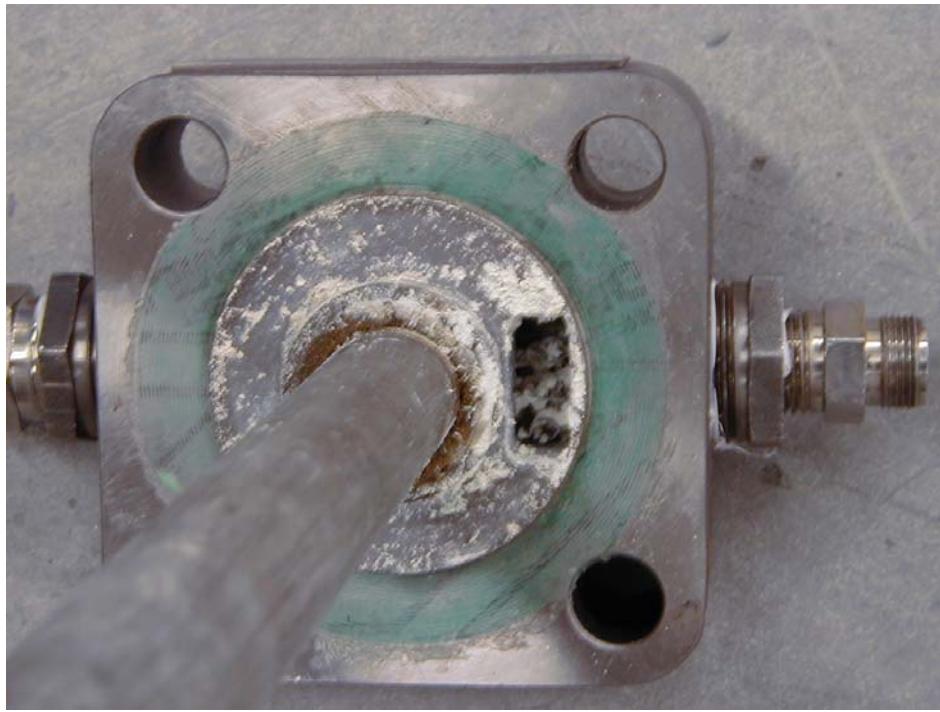
Figure 3.31. Inlet Port of the Nowata Housing that Filled with Packing and Plugged During the First Cycle

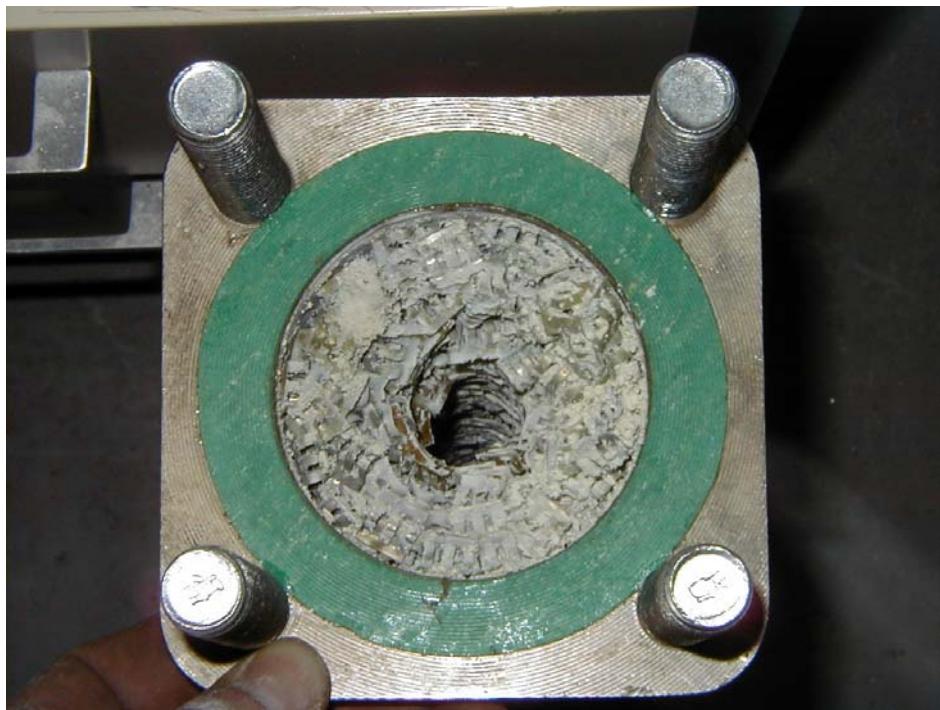
Figure 3.32. Interpack 10-mm Nominal Packing After Two Test Cycles

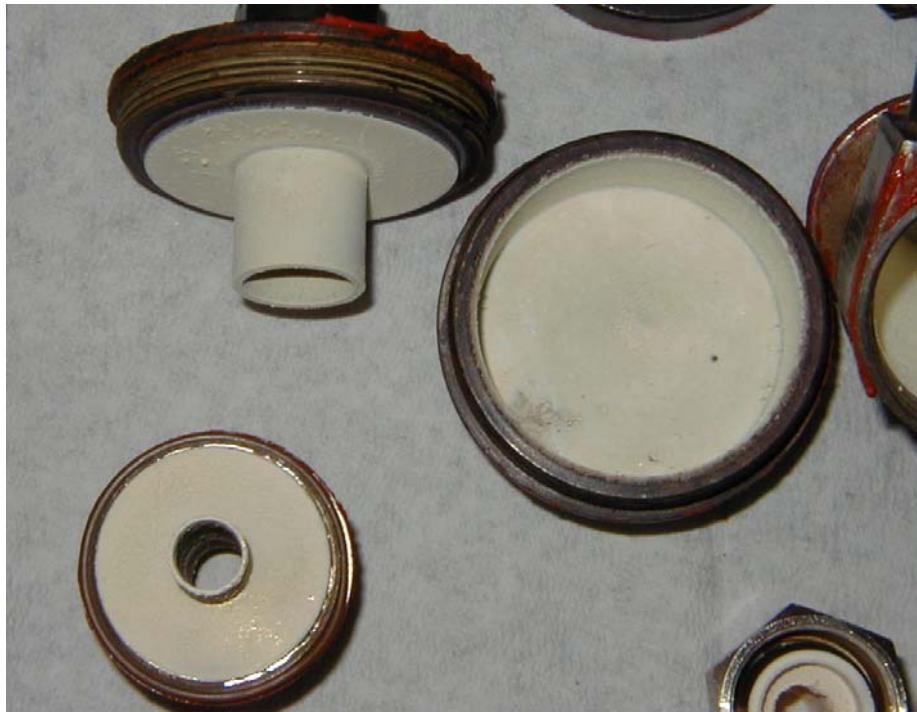
Figure 3.33. Salt Deposits on Internal Walls of In-Stack Cascade Cyclone Samplers

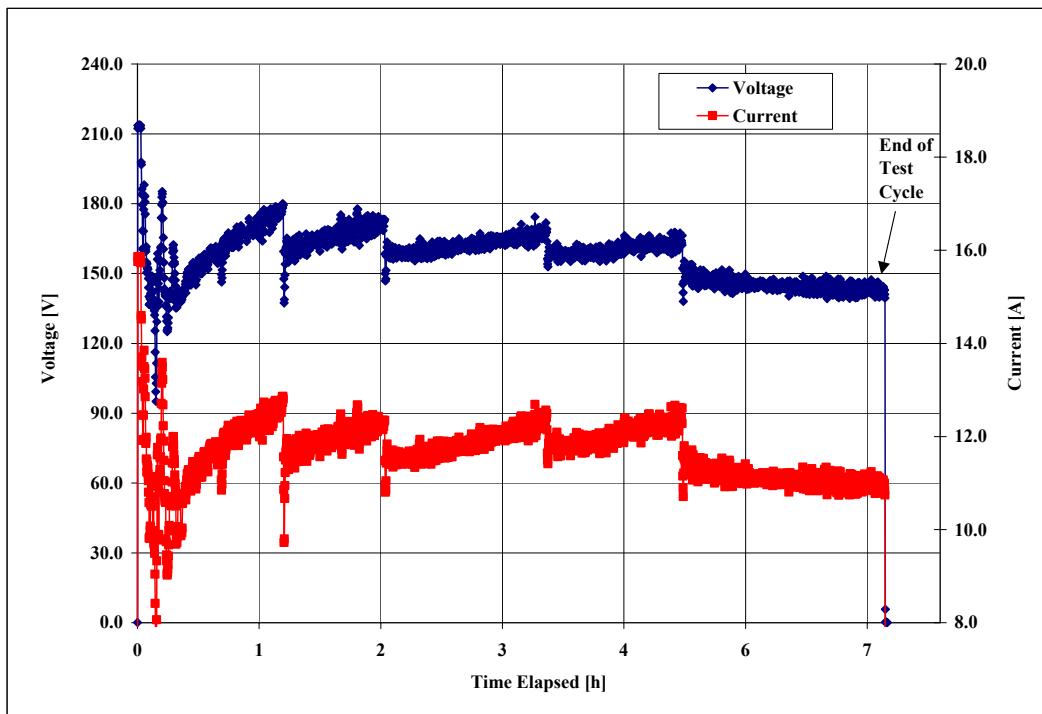
Figure 3.34. Typical Furnace Voltage/Current Profile During a Test Cycle

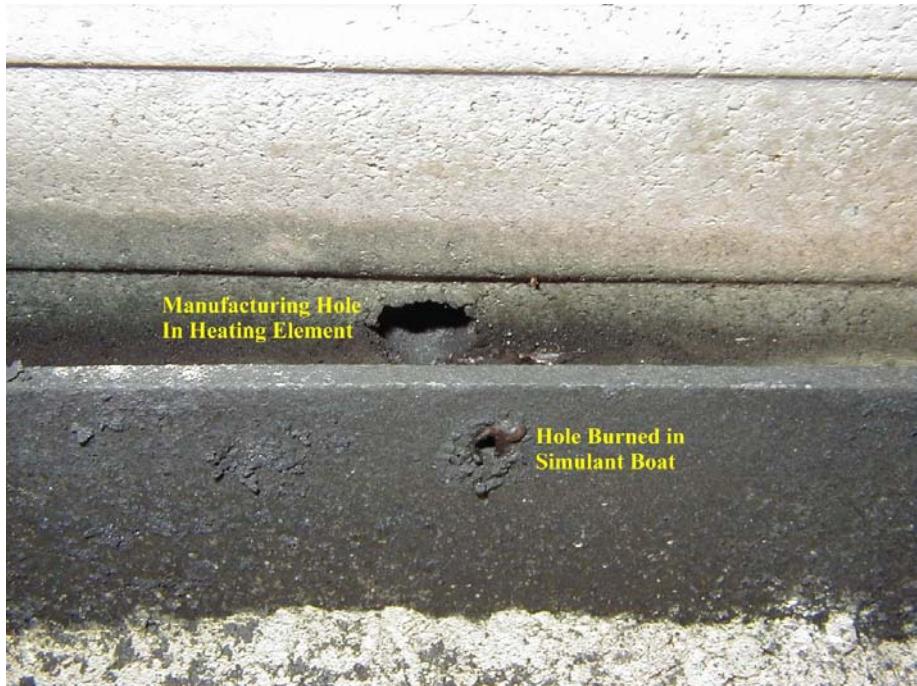
Figure 3.35. Hole Caused by the Side-Heating Element Arcing to the Boat

During the 50 furnace test cycles, only one furnace element failed (during the 16th cycle). This failure is believed to be the result of arcing caused by contact between a side furnace element and the Hastelloy X sample boat. As a result of the thermal cycling, the width of the sample boat had increased to about 5.25 in. (from 5.0 in.). Further furnace element failures were avoided by monitoring the boat width and adjusting it back to 5.0 in. between cycles. Consequently, during actual operations, sample boats should be examined for evidence of bowing after every cycle and the boats should be accurately centered between the side heating elements when being loaded into the furnace.

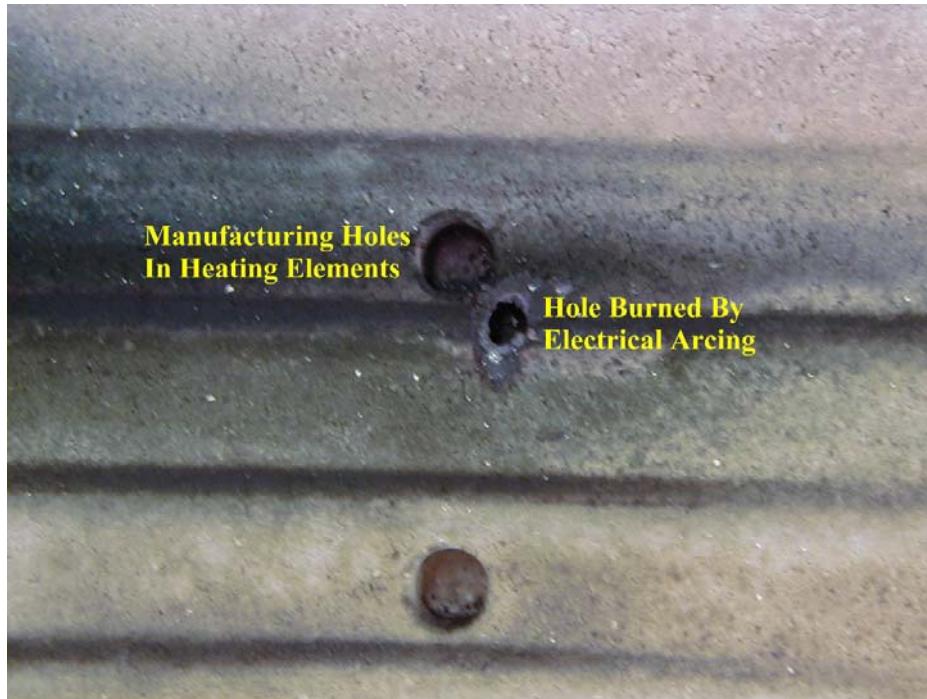
Figure 3.36. Area Where Side-Heating Element Failed and Arced Across to the Simulant Boat

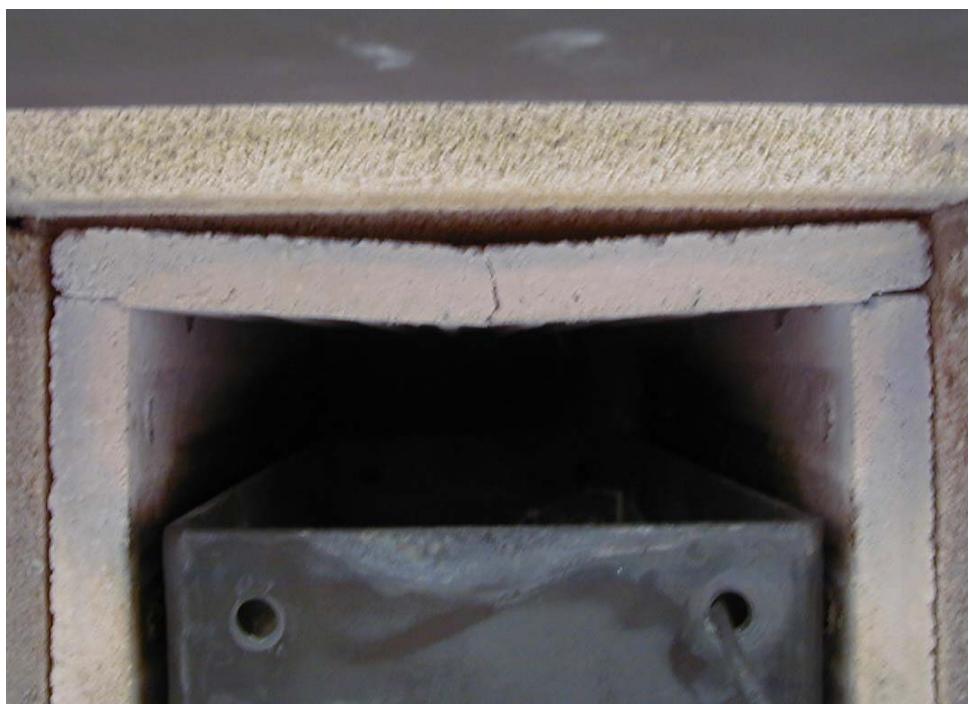
Figure 3.37. Top Heating Element After 31 Test Cycles (Set #2).
Element has cracked and bowed downward.

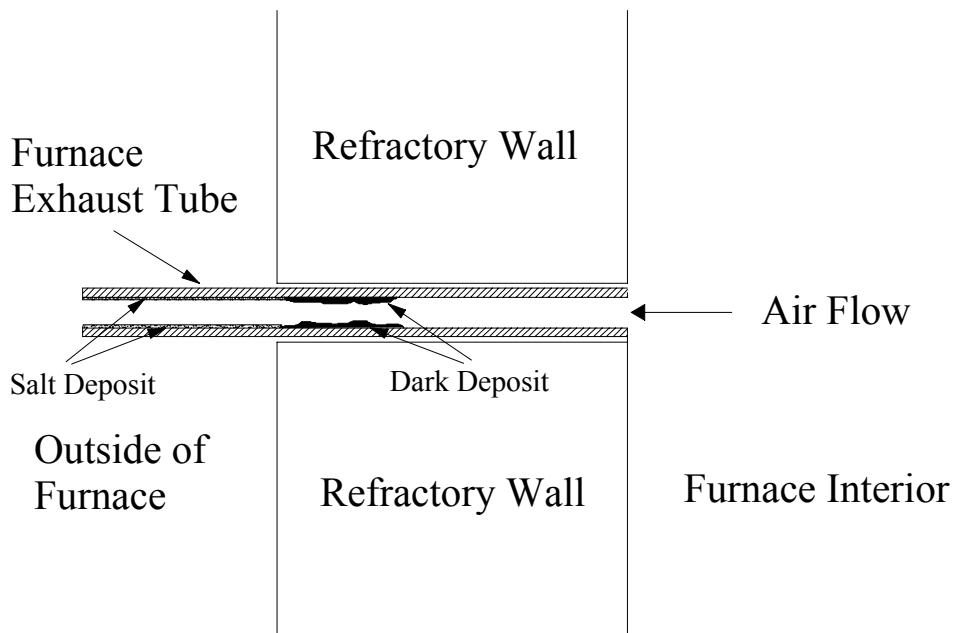
Figure D.1. Schematic of Furnace Wall and Exhaust Tube Showing Approximate Location of the Deposits

Two samples were retrieved for analysis when the furnace exhaust tube was removed and scraped to remove deposits following the second cycle. One sample was a hard dark material either deposited or formed in the region where corrosion was the greatest. This material separated from the wall in large flakes with aggressive scraping. It came from a region of the tube inside the furnace wall but near the outside wall surface as shown in Figure D.1. The second sample was a brittle dirty yellow deposit collected downstream from the first deposit. This material, which was chipped off with less aggressive scraping was dark on the side nearest the tube wall. The exact location of both samples was not measured. There was evidence of corrosion of the tube upstream from the dark deposits and nearer to the furnace interior but there was no removable deposit in this region.

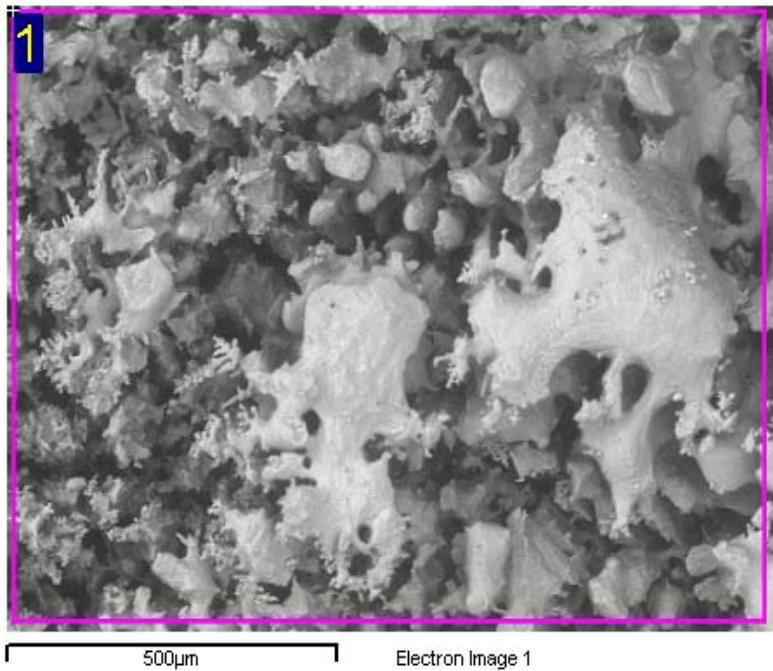
Figure D.2. Electron Image of Yellow Deposit

The appearance of molten material interspersed within a delicate solids deposit as shown in Figure D.2 suggests that the deposit was below the melting point of the salt mixture, but it was trapping molten droplets of salt entrained in the gas. The alkali salt mixture composition would have a melting point of about 720°C assuming that the presence of chromium (or possible alkali oxides based on the deficiency of chloride and the presence of oxygen) did not depress the melting point of the alkali salt mixture. The dark deposit sample appearance was more like that of corrosion products, consistent with the relatively high concentration of oxygen in the deposit (37 mole %). Figure D.3 suggests that the dark deposit did not have a delicate open structure as did the yellow deposit. However, the presence of a significant concentration of alkali salt suggests that the salts were depositing but probably as molten material that interacted with the metal tube. The fact that the deposit was from a higher temperature region of the tube would be consistent with this hypothesis.
