New Technology Demonstration of Microturbine with Heat Recovery at Fort Drum, New York

April 2004

Pacific Northwest National Laboratory
Richland, Washington

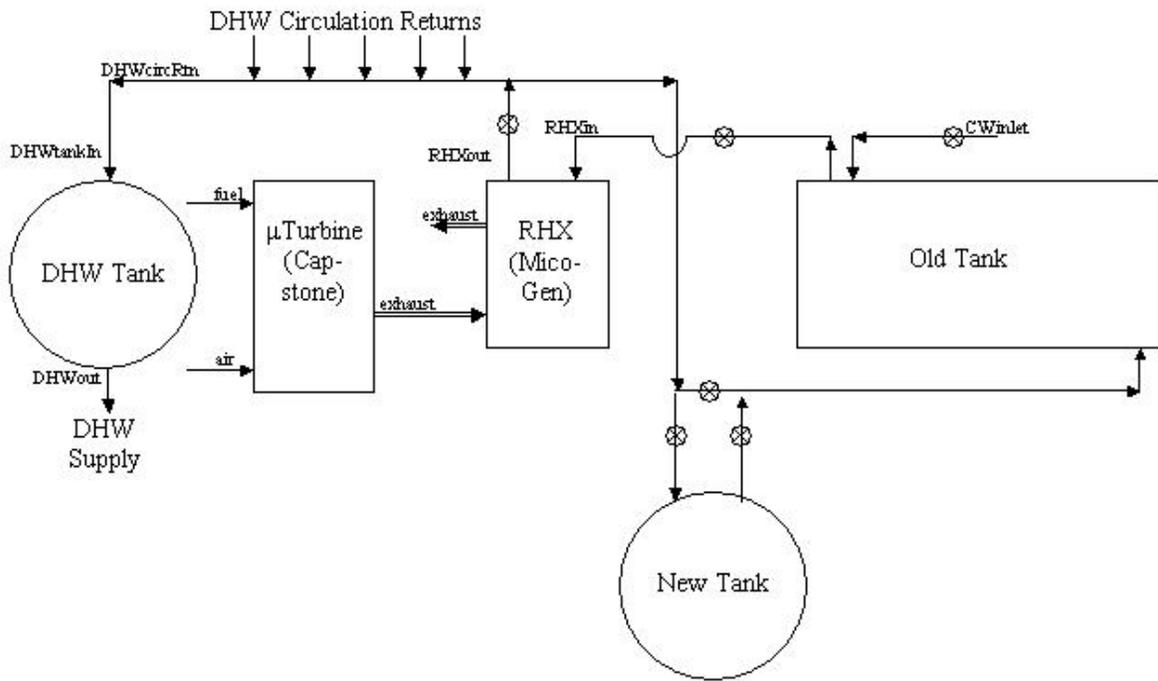
Figure 2.1. Layout of Microturbine, Heat Exchanger, Tanks, and Circulation Loop

The equipment was placed inside the existing boiler room, which had ample space for installation. Room revisions included pouring an elevated concrete pad for the microturbine, removing an old insulated water storage tank, purchasing and installing a new 1000-gallon insulated water storage tank, plumbing an existing 1200-gallon storage tank, rewiring the emergency electrical panel, and purchasing and installing a step-down transformer to reduce the microturbine generator's 480-volt, three-phase output to 208-volt, three-phase to match the barracks' electrical distribution system. The system layout is shown schematically in Figure 2.1 and pictured in Figure 2.2.

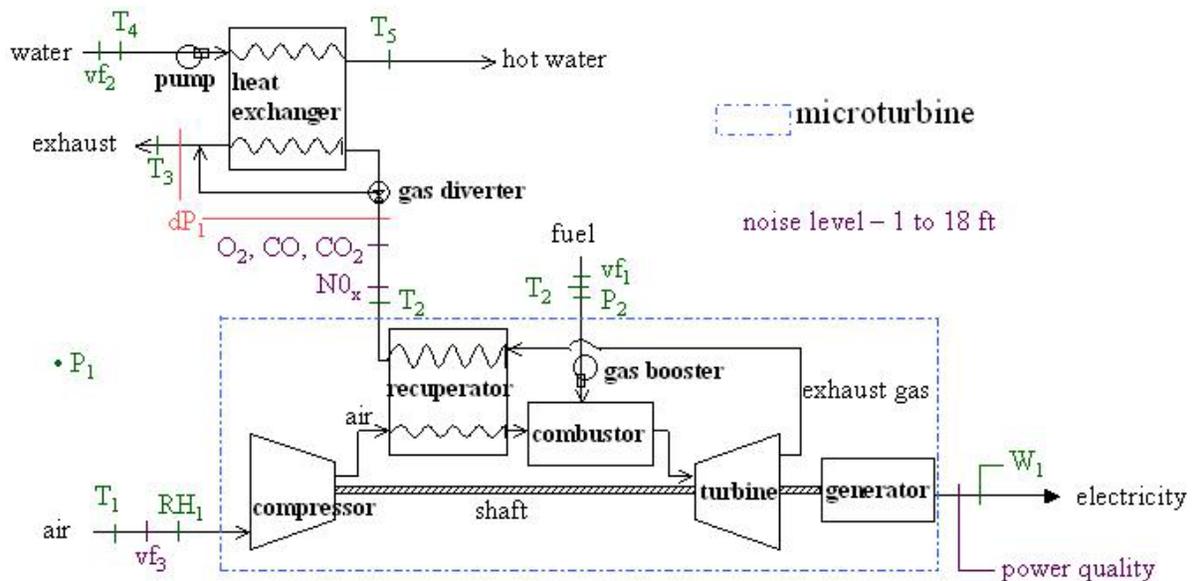
Figure 3.1. Data Collection for Performance Verification

Instrumentation was installed and data collected to assess the efficiency of the microturbine (fuel energy in/electric + heat energy out) and to measure gas emissions (CO, NO_x), noise level, power quality, microturbine electric power output, and heat exchanger thermal power output over varying operating conditions. Figure 3.1 shows all the measuring points used in the performance verification.

To calculate the efficiency of the microturbine, the fuel energy in and the electric energy and water heating energy out needed to be measured. The volumetric flow rate, pressure, and temperature of the fuel were measured to calculate the mass flow of fuel. The higher heating value (HHV) of the fuel was obtained from the natural gas utility. We were not able to obtain information regarding the composition of the fuel, so the lower heating value (LHV) was estimated to be the higher heating value (HHV) divided by 1.1. (This is the assumption made by Capstone in their specifications.) A watt transducer was used to measure power out of the microturbine. The volumetric flow rate and temperature differential of the water in the recuperative heat exchanger were measured to calculate the heat recovered by the heat exchanger. The specific heat of the water was assumed to be constant in the heat exchanger.

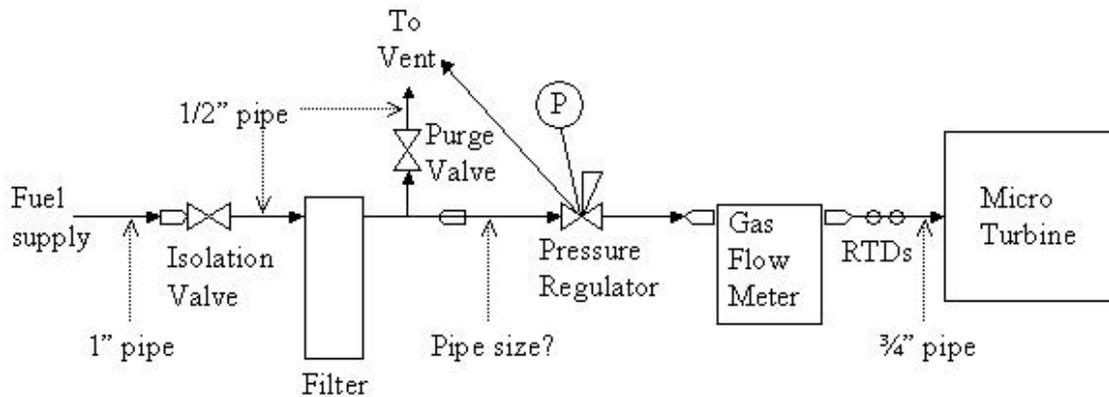
Figure 3.2. Gas Piping Schematic

The pressure and temperature of the fuel as well as the temperature, humidity, and pressure of the air were measured to assess their effect on the performance of the microturbine. Figure 3.2 shows the gas piping and measurement layout and Figure 3.3 shows the final gas metering installation.

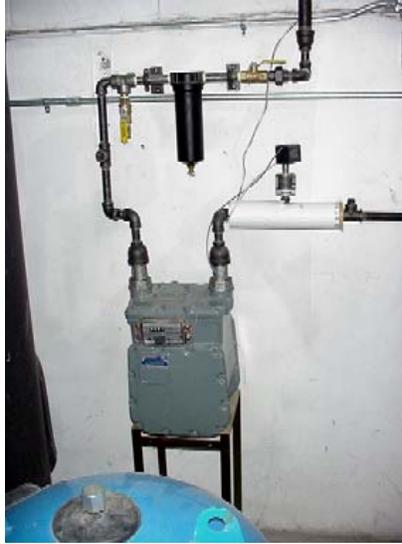
Figure 3.3. Volumetric Flow Meter with Gas Temperature and Pressure Sensors at the Outlet (Right-Hand Riser) and Filter Situated on the Inlet Line (Left-Hand Riser)

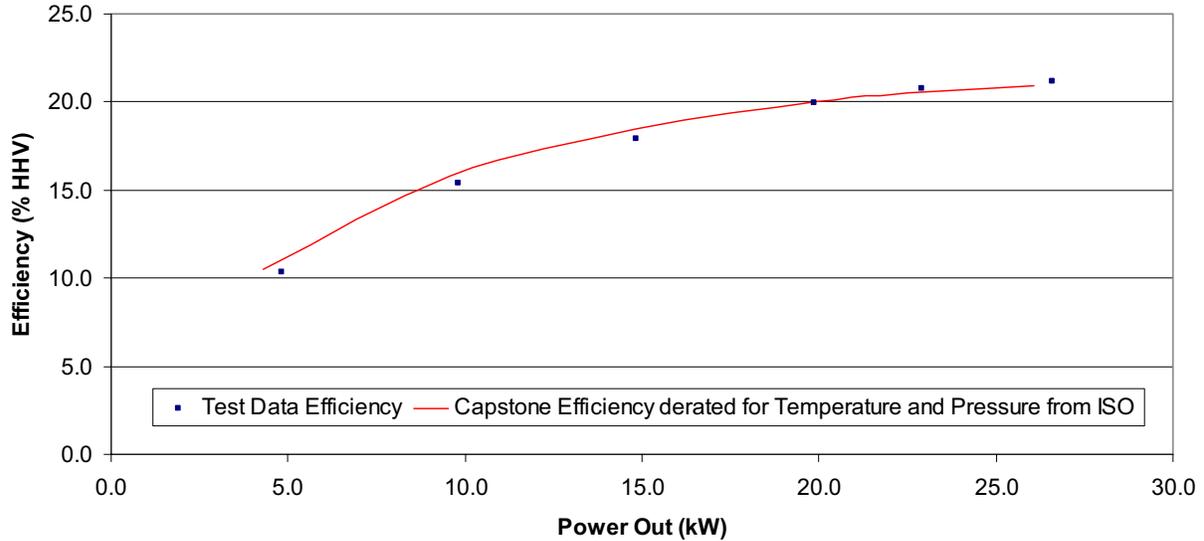
Figure 4.1. Comparison of Capstone Specifications of Partial Load Efficiency (% of HHV) with Measured Data

A comparison between the Capstone specifications and the test data for partial load efficiency is shown in Figure 4.1. The Capstone data was modified to account for air pressure and temperature derating at the test conditions. As you can see, the microturbine efficiency decreases only 17% with a 50% reduction in electrical power generation.

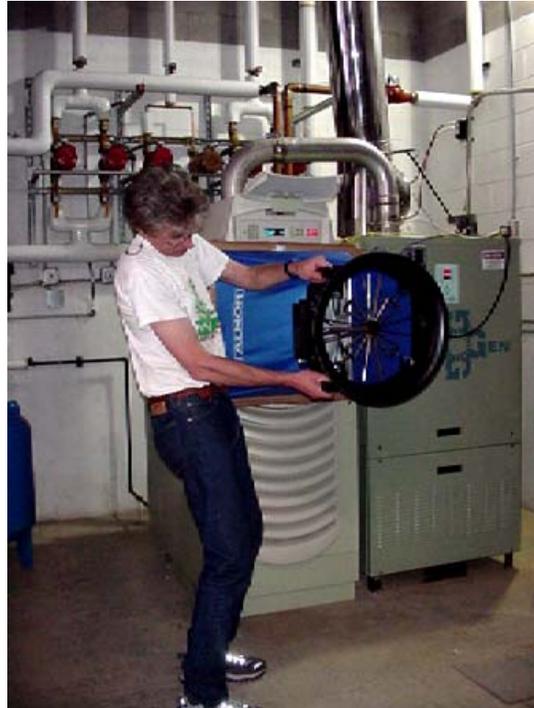
Figure 4.2. Air Intake Measured by a Flow Hood During the One-Time Test

Inlet air flow rate cannot be measured directly without interfering with turbine operation (e.g., increased pressure drop). However, the existing inlet channel can serve as a flow element if properly calibrated. A one-time calibration has been performed using a standard flow hood. Figure 4.2 shows the flow hood installed on the microturbine. Additional pressure drop from the flow hood means that performance is a little off during the process, but the temporary loss of turbine efficiency affects neither the resulting calibration curve nor its subsequent application.

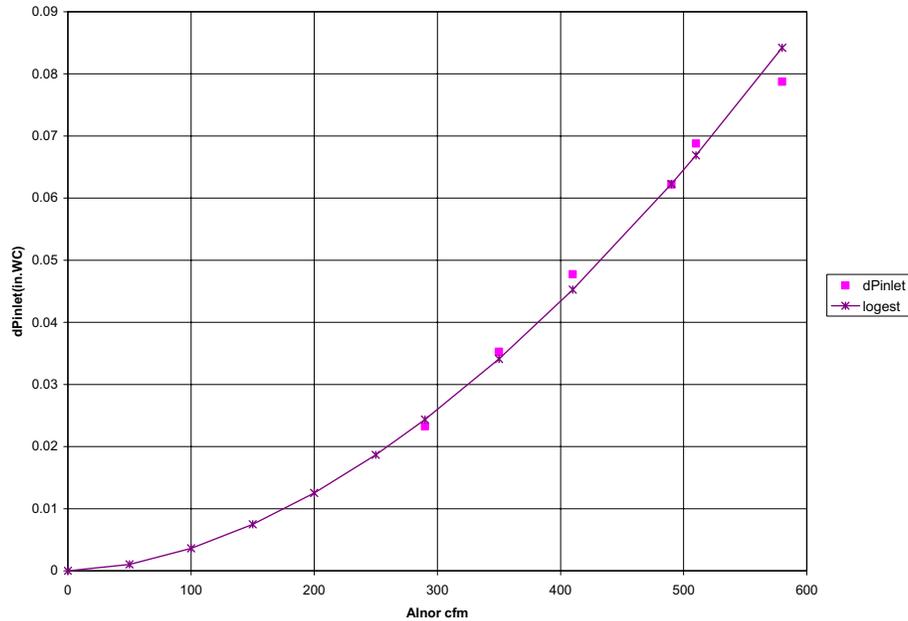
Figure 4.3. Air Flow-Pressure Relation: Data Points and Curve Fit Based on $dP^{0.5}$ Log-Log Regression

The data are plotted with regression curves in Figure 4.3. Air conditions at the time were 22 to 28°C, 988 mB, and 33 to 45% relative humidity, implying an air density of 1.3 kg/m³. A log-log regression results in

$$vf = 2035 \text{ dP}^{0.5}$$

with standard error = 4.7%, vf is CFM and dP is inWC.

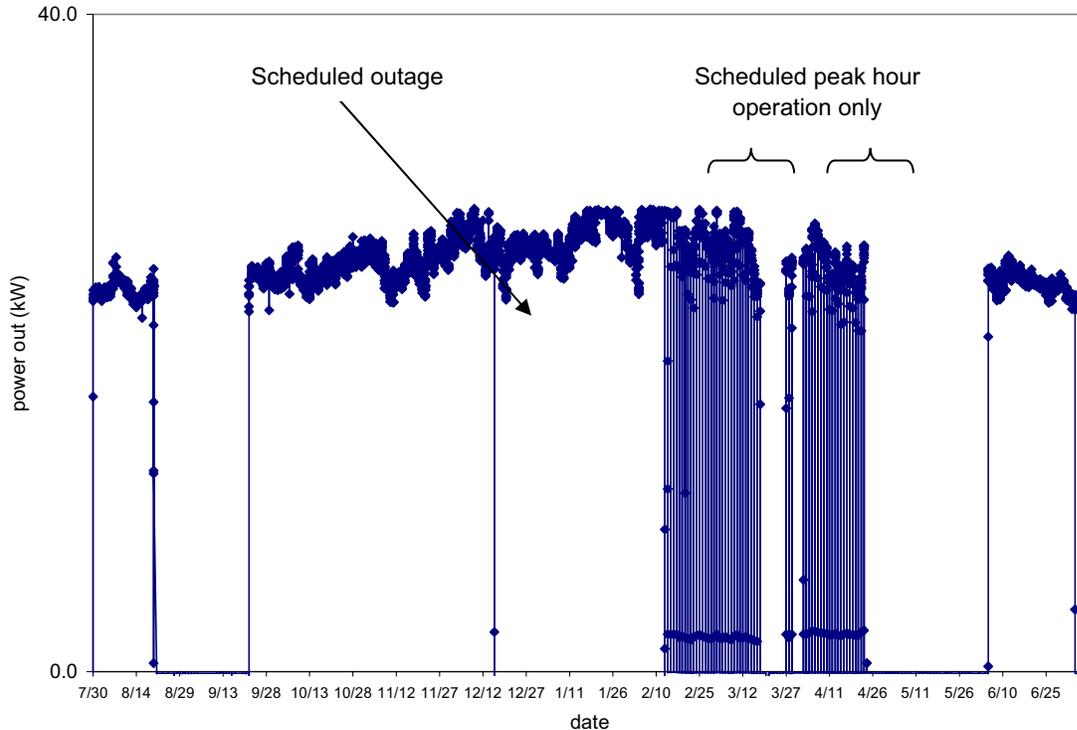
Figure 5.3. Fort Drum Microturbine Electric Availability from July 2002 to July 2003

The electrical output of the microturbine from July 31, 2002 to July 6, 2003 is shown in Figure 5.3. Between February 14 and April 23, 2003, the microturbine was scheduled to be operational during peak electric hours only (8 am to 10 pm). The graph shows output going to zero every night during that period, but the availability is considered 100% during that time.

For the first year of operation (July 31, 2002 to July 6, 2003) the availability was 74%. Availability is defined here as the actual operating hours divided by scheduled run hours multiplied by 100%. The reasons for the microturbine being unavailable can be found in Appendix B, Operational Log.

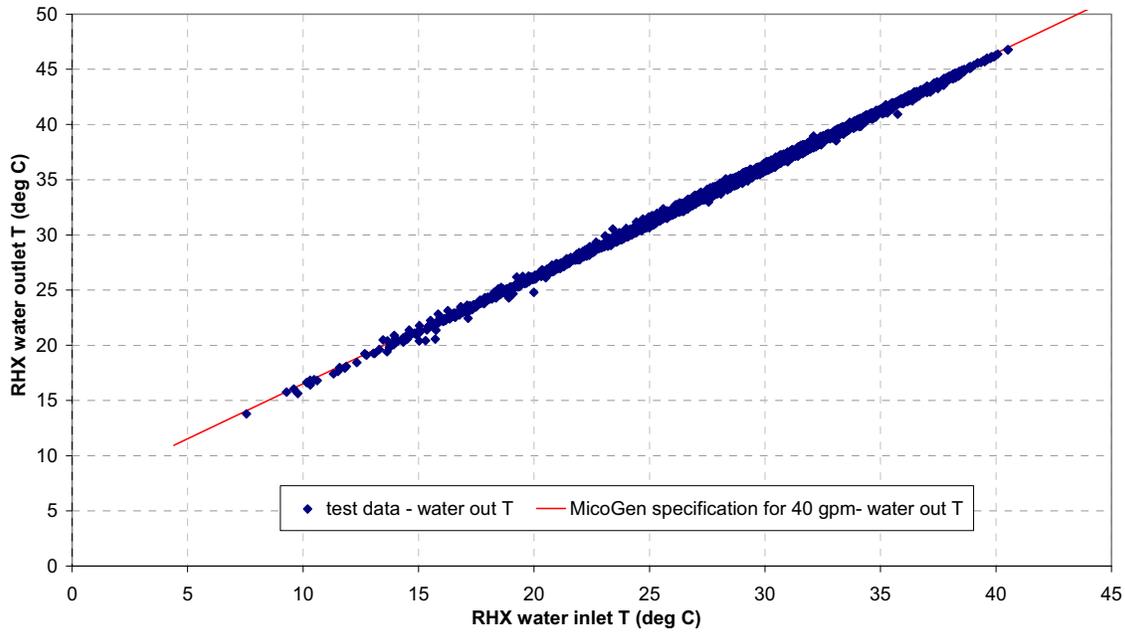
Figure 5.4. Heat Exchanger Water Outlet Temperature Versus Inlet Temperature from September 2002 to January 2003

The RHX performance was compared with manufacturer's data. Because Unifin has stopped manufacturing the micoGen heat exchangers, the comparisons on the heat exchanger performance are not rigorous. Manufacturer's specifications provide graphs of outlet water temperature and heat recovered versus inlet water temperature. Figures 5.4 and 5.5 compare these parameters with manufacturer's specifications. As can be seen from the graphs, the heat exchanger performed very close to specifications for the water exit temperature, but the heat recovery data seem to indicate that the inlet water temperature had no effect on performance. The data points graphed were taken between September 22, 2002 and January 11, 2003.

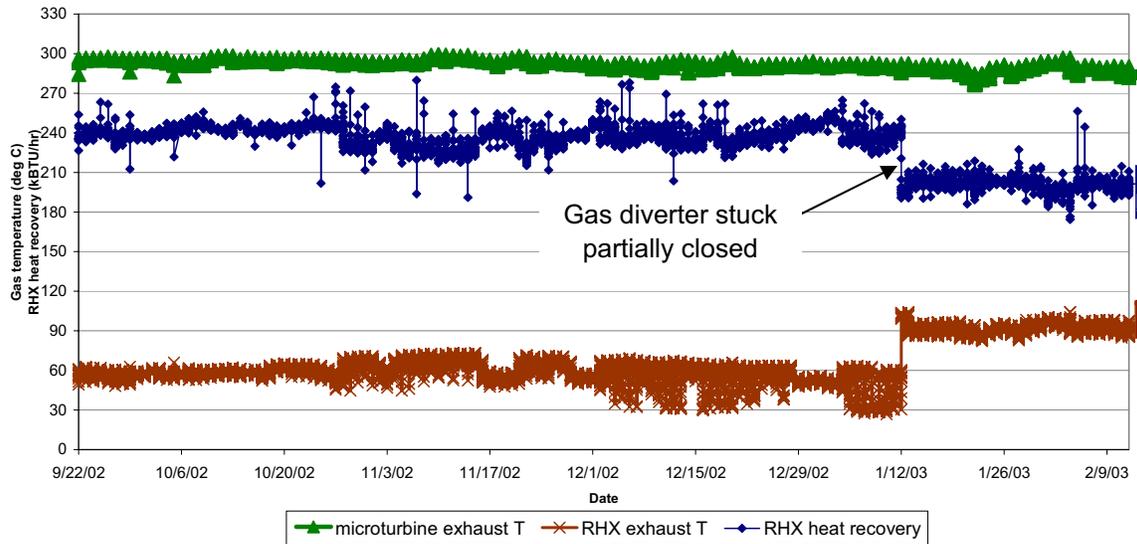
Figure 5.6. Heat Exchanger Gas Temperatures and Heat Recovered from September 2002 to February 2003

As can be seen from Figure 5.6, the heat exchanger had an increase in gas outlet temperature and a drop in heat recovered on January 12, 2003. The gas diverter had stuck partially closed and a fault-detection light did not illuminate on the panel. This reduced the effectiveness of the heat exchanger from 0.89 to 0.70. The UA of the heat exchanger was 0.66 to 0.69 kW/°C when the diverter was operating correctly and dropped to 0.39 to 0.32 kW/°C when it was not. The NTU dropped from 2.3 in early operation to 1.2 with the stuck diverter.

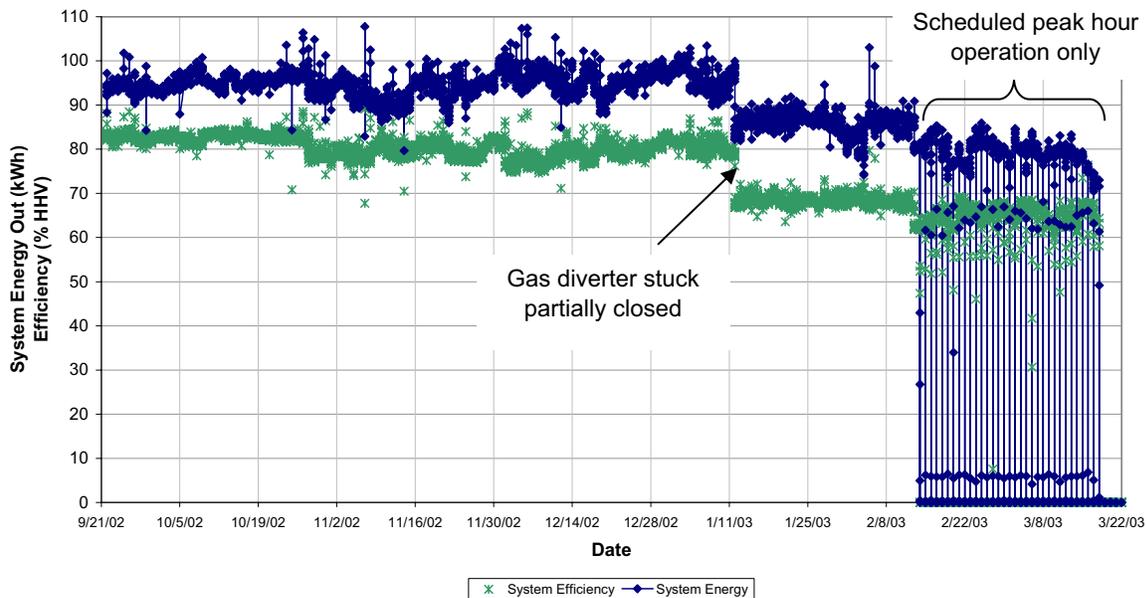
Figure 5.7. System Energy Output and Efficiency from September 2002 to March 2003

Figure 5.7 shows the system performance for the first six months of operation. The system efficiency is approximately 80% until January 12, 2003, when the gas diverter in the heat exchanger stuck partially closed and system efficiency dropped to approximately 67%.

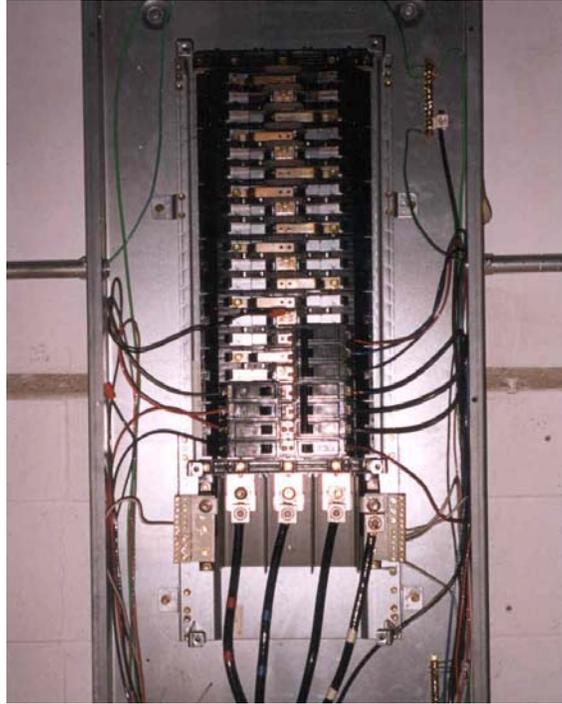
Figure D.1. Panel that serves the mechanical room pumps, fans, and power burners

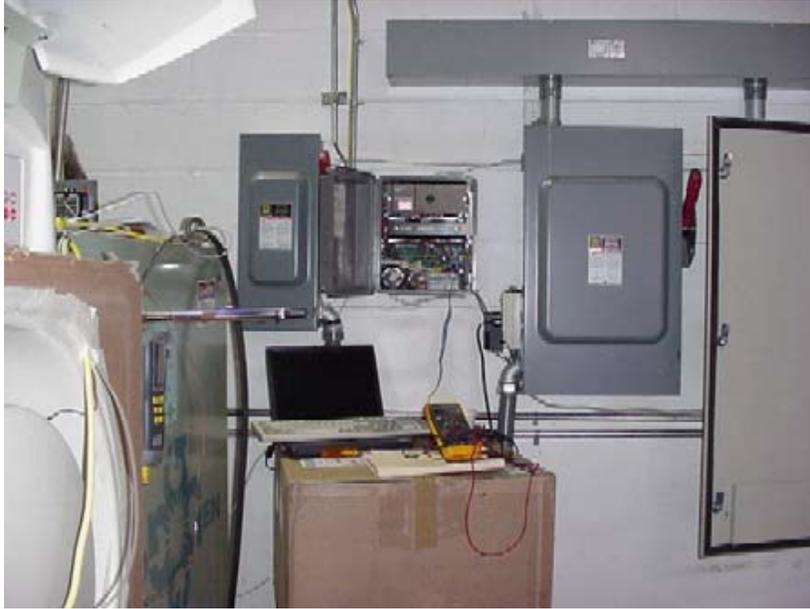
Figure D.2. Step-down transformer (bottom) with disconnects on 480V (left) side and 208V (right) side. MT and RHX are at far left. Data acquisition system is mounted on the wall between disconnects.

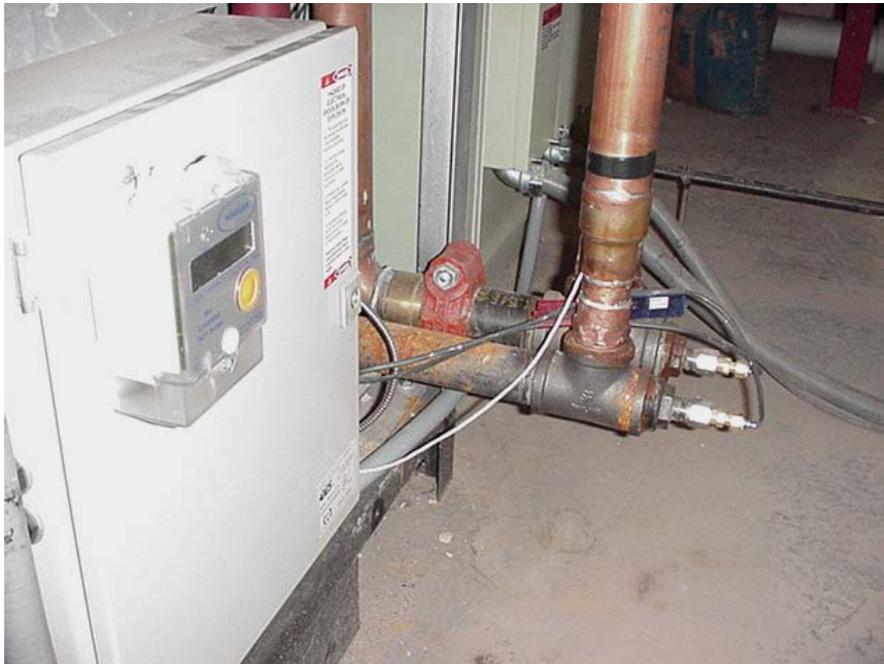
Figure D.3. Btu meter mounted on back access door of RHX (left) and RHX water-side thermowells mounted in the inlet and outlet T fittings (center).

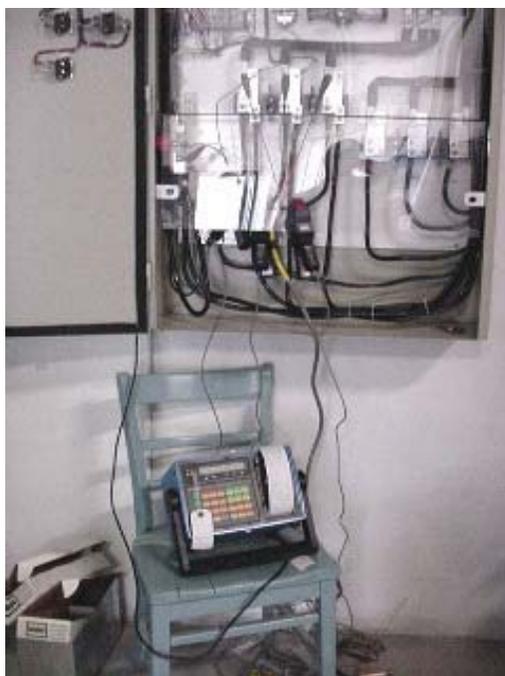
Figure D.4. Control panel (top) with Dranetz power analyzer hooked up

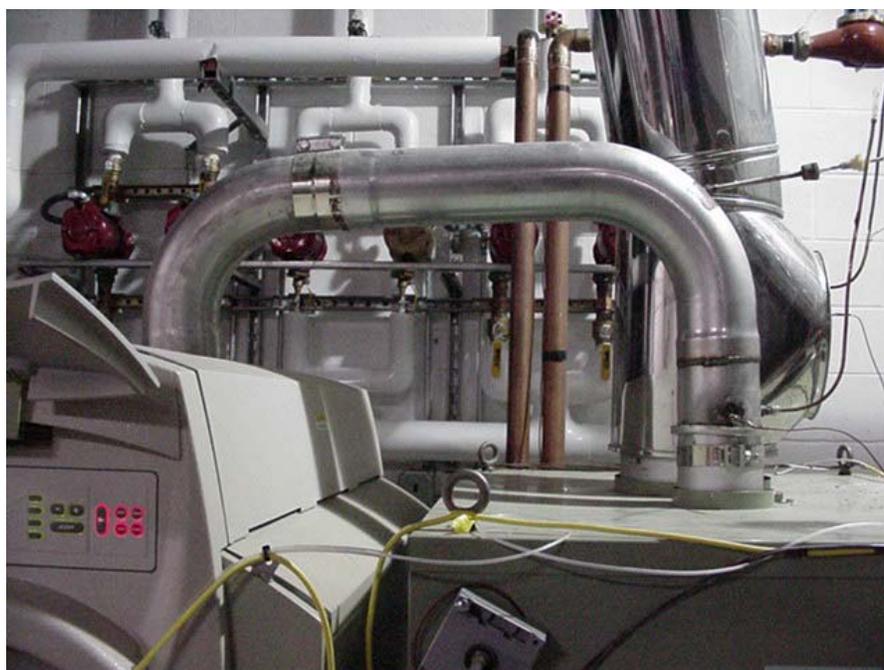
Figure D.5. Exhaust duct from MT to RHX. Larger RHX exhaust stack to roof is partially hidden. Water meter that measures RHX flow rate is just visible in upper right.

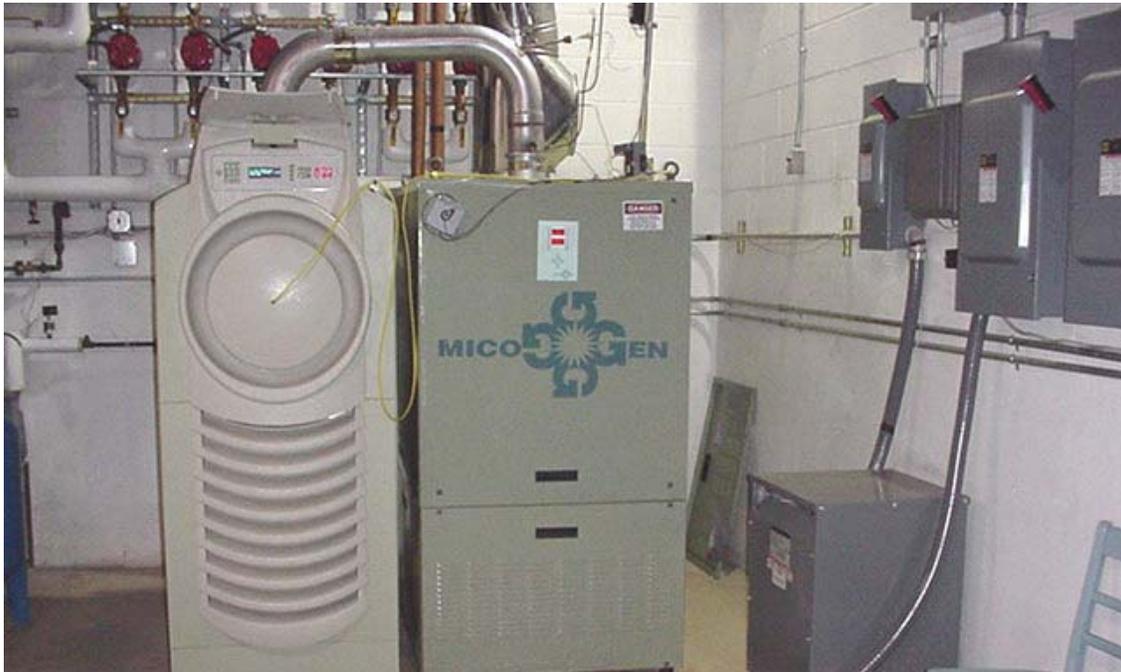
Figure D.6. Overview (L to R) of MT, RHX, transformer, and switchgear. Note DHW recirculation pumps on wall above and behind the microturbine.

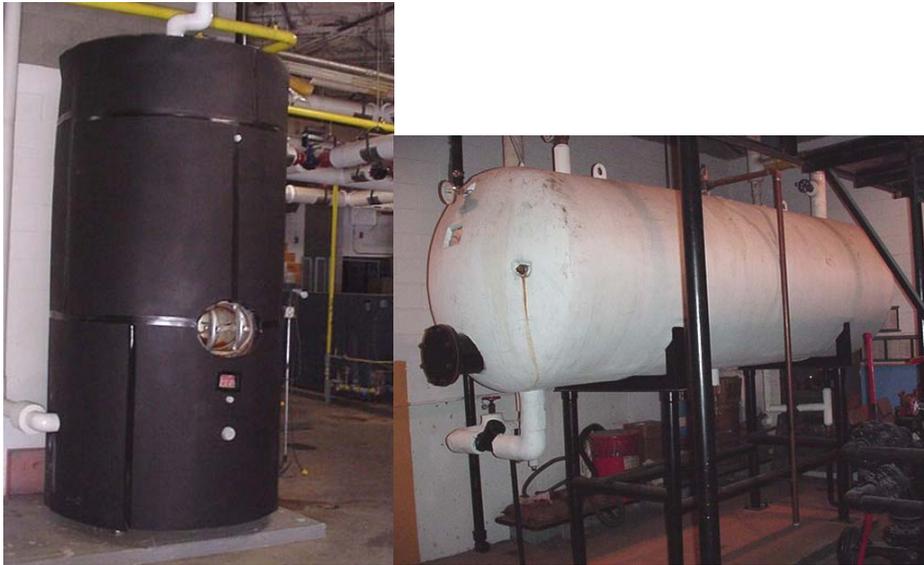
Figure D.8. New (left) and Existing (right) hot water storage tanks
