Demonstration Assessment of Light Emitting Diode (LED) Walkway Lighting

***Host Site: Federal Aviation Administration
William J. Hughes Technical Center,
Atlantic City, New Jersey***

**Final Report prepared in support of the
U.S. DOE Solid State Lighting
Technology Demonstration Gateway Program**

**Demonstration Assessment of
Light Emitting Diode (LED)
Walkway Lighting at the
Federal Aviation Administration
William J. Hughes Technical Center,
in Atlantic City, New Jersey**

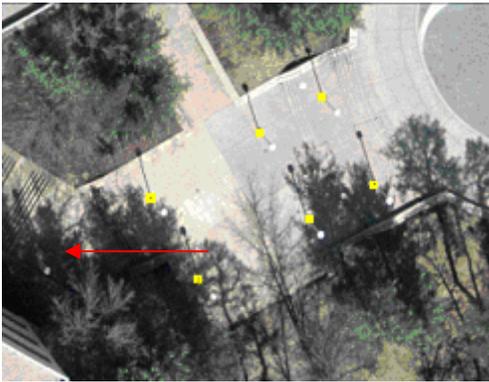
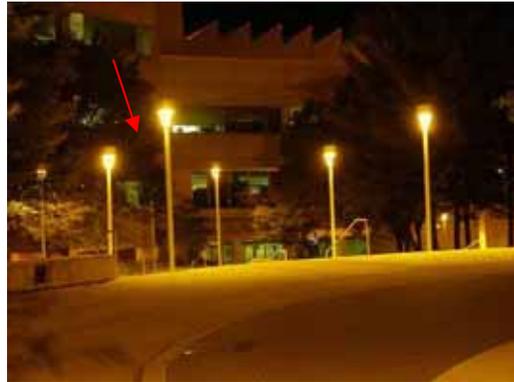
Figure 2.1. Aerial and Color Views of Original HPS Luminaires

The chosen area is a high-volume walkway running from Parking Lot B to Building 300; it includes three short sets of stairs with a number of other staircases in the general area. The walkway is also adjacent to another building, Building 316, which serves to further increase the volume of foot traffic past the demonstration luminaires. A total of six luminaires illuminate the walkway. Four of the luminaires (L3, L4, L5, and L6) are located on a flat section of walkway and two luminaires (L1 and L2) are located on a higher section of walkway leading to a round plaza. This section is adjacent to the first section via a staircase of five stairs. All of the luminaires are mounted on 14-foot poles. A seventh fixture is located nearby but was not included in the demonstration. This seventh luminaire is obscured by foliage from an adjacent tree much of the year (see arrows in Figure 1.1). Image 1 was taken from a GIS satellite; yellow dots in the photo indicate the location of the six luminaires in the demonstration. Image 2 was taken at night during the initial site visit.

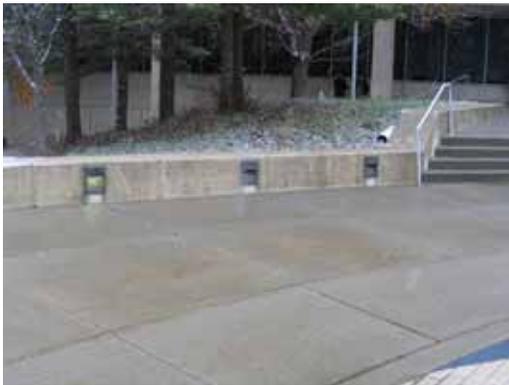
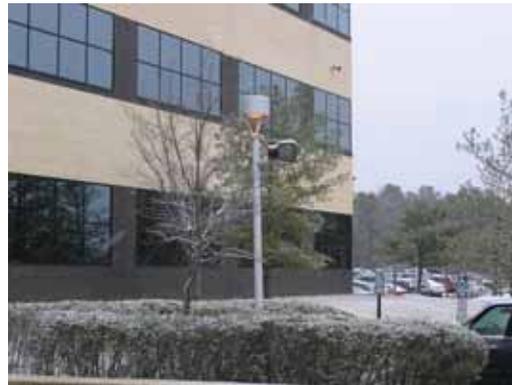
Recessed step lights are also installed within the plaza (see Image 3 in Figure 2.2), which appear to use metal halide (MH) lamps, though they were not working properly at the time of demonstration. The round plaza adjacent to the demo walkway contains similar step lights, and only a few of those were working properly. Floodlights are also mounted to some of the walkway poles just outside of the round plaza (see Image 4 in Figure 2.2). The floodlights use HPS lamps and provide illumination where the step lights do not. Due to the grade changes between the plaza and the demonstration walkway (about

4 feet) the light from the HPS floodlights spills over onto the walkway. Supply voltage to all luminaire types is 277 volts.

Figure 2.2. Nearby Walkway Area Lights that Were not Replaced. Image 3 shows Recessed Step Lights, most of which were not working. Image 4 shows flood lights that were mounted to nearby poles to provide stair lighting in place of the non-functioning recessed step lights; these flood lights provided some light to the test area which was included in the ambient light measurements.

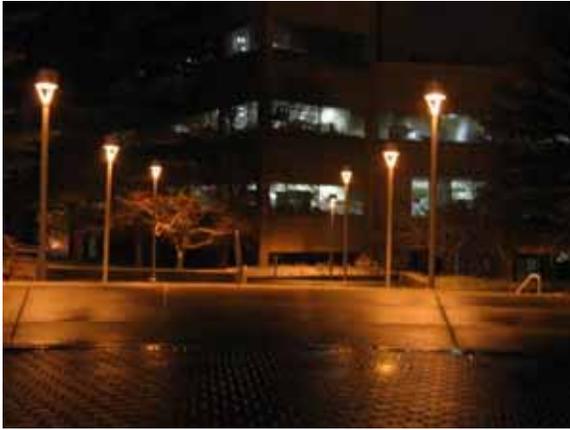
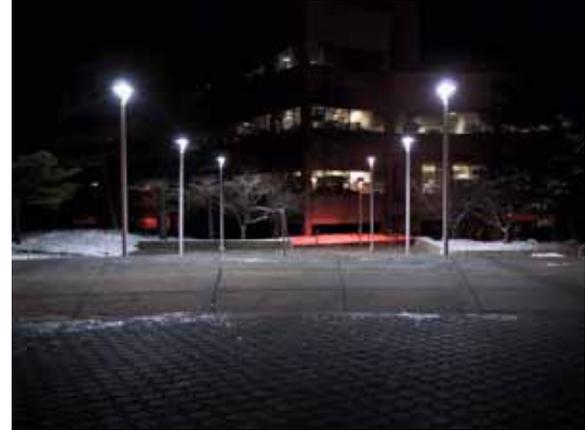
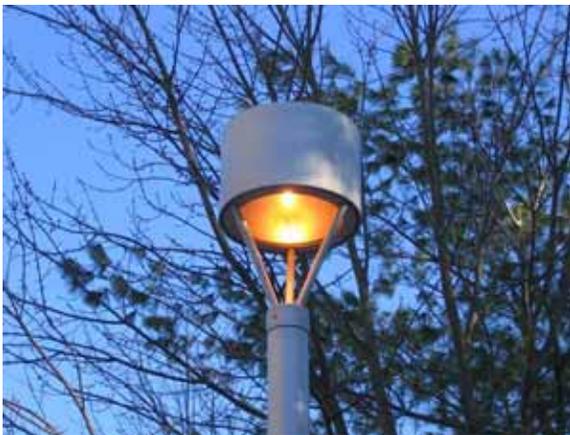
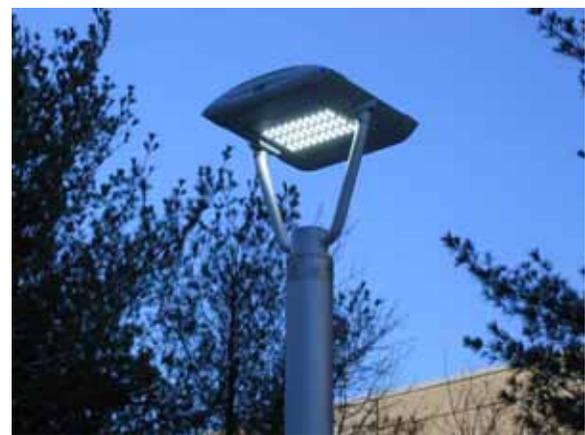
Figure 2.3 provides comparative side-by-side images of the two luminaire types. Image 5 and Image 7 in Figure 2.3 are of the original HPS luminaires and Image 6 and Image 8 are the replacement LED luminaires. One of the original HPS fixtures is also visible in the background of Image 6.

Figure 2.3. Images 5 and 6 show the Six Study Luminaires with the original HPS Lighting and After Replacement with the LED Luminaires. Images 7 and 8 show details of the HPS and LED Luminaires.
