PNNL-18596

## Technical Letter Report

# Assessment of Ultrasonic Phased Array Inspection Method for Welds in Cast Austenitic Stainless Steel Pressurizer Surge Line Piping

JCN N6398, Task 1B

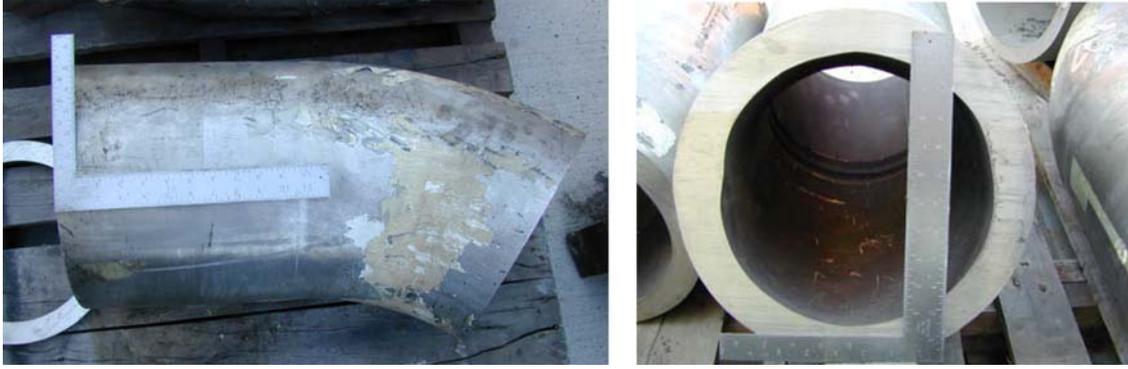
**Figure 3.1.** Photographs of the Side-View (left) and End-View (right) of the CASS PZR Ring Segment (specimen 7C-059)

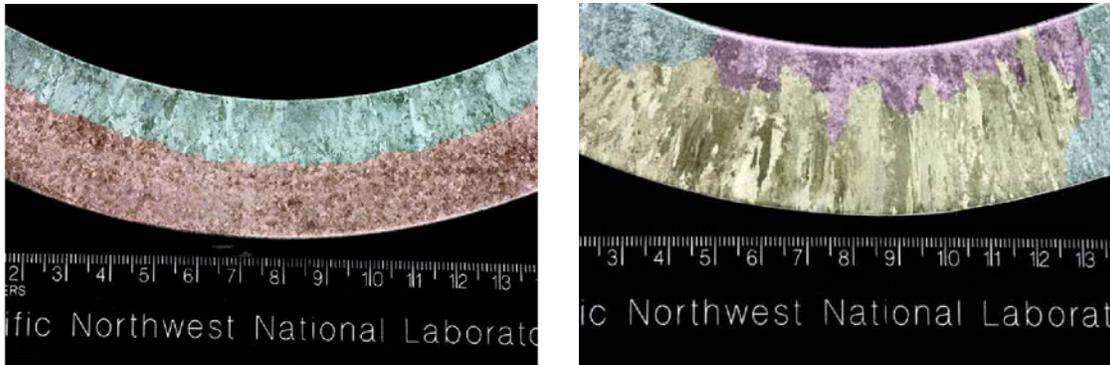
**Figure 3.2.** Photographs of Polished and Chemically Etched CASS PZR Ring Segment (specimen 7C-059) Showing the Pipe-Side (CCSS) Grain Microstructure (left) and the Elbow-Side (SCSS) Grain Microstructure (right)

Nominal wall thickness on the pipe side of specimen 7C-059 was 30 mm (1.2 in.) and on the elbow side, 39 mm (1.5 in.). Four circumferentially oriented TFCs were implanted in the weld region of this specimen. An additional long segment of a surge line from Washington Nuclear Power Unit 3 (WNP-3) was obtained (see Figure 3.3). The foreground elbow was removed and cut in half to make two pipe-to-elbow specimens, 9C-001 and 9C-002. Again, rings from the two pipe sides and common elbow side were cut and the surfaces polished and chemically etched to display the microstructures. Figure 3.3 shows the microstructure from the two pipe rings, center and outside legs, and Figure 3.4 shows the elbow microstructure. Nominal wall thickness on the pipe side was 33 mm (1.3 in.) and 34–44 mm (1.3–1.7 in.) on the elbow side. Three circumferentially oriented TFCs were implanted in each of these two specimens.

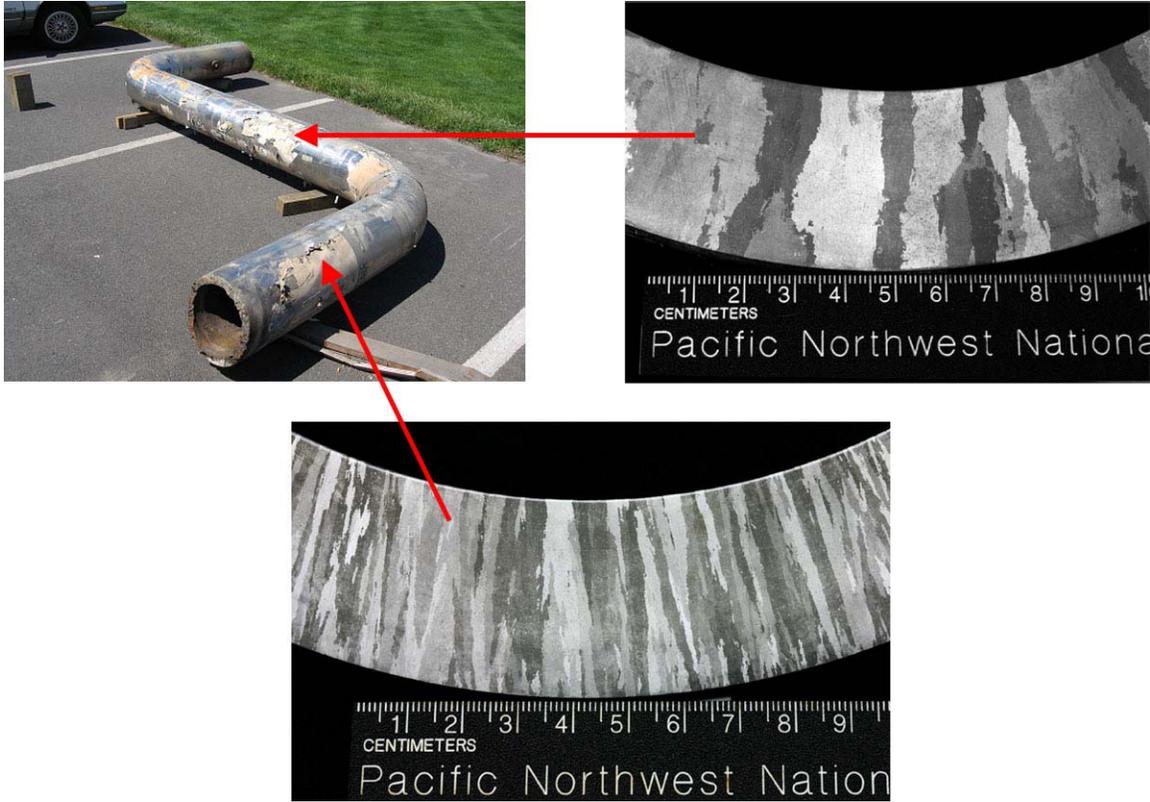
**Figure 3.3.** WNP-3 Surge Line Section Showing the Locations of the Pipe and Elbow Cuts to Produce Two Pipe-to-Elbow Specimens, 9C-001 and 9C-002. The centrifugally cast pipe microstructures are displayed for both specimens.

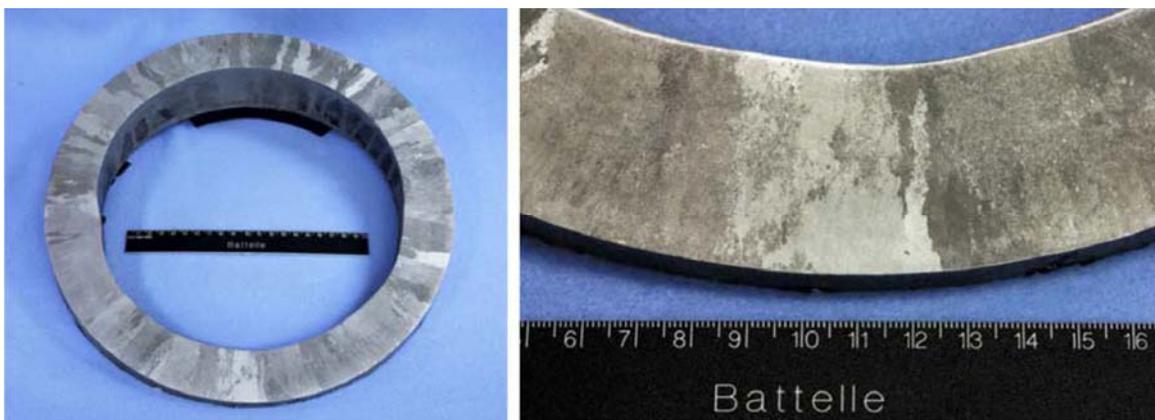
**Figure 3.4.** WNP-3 Surge Line Elbow Microstructure

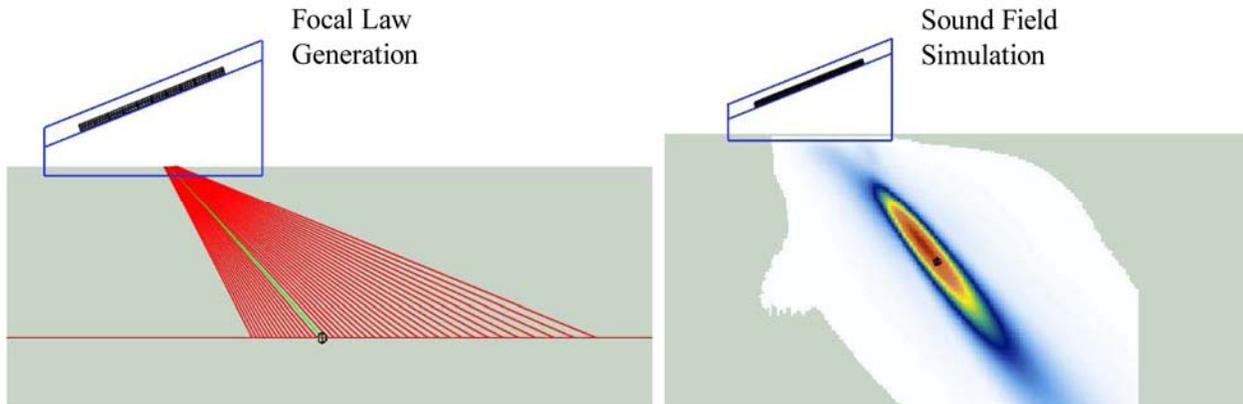
**Figure 4.1.** The ZETEC<sup>®</sup> Advanced Phased Array Calculator is Useful for Generating Focal Laws (left) and Simulating the Sound Field for the Focal Law (right) to Determine Beam Characteristics

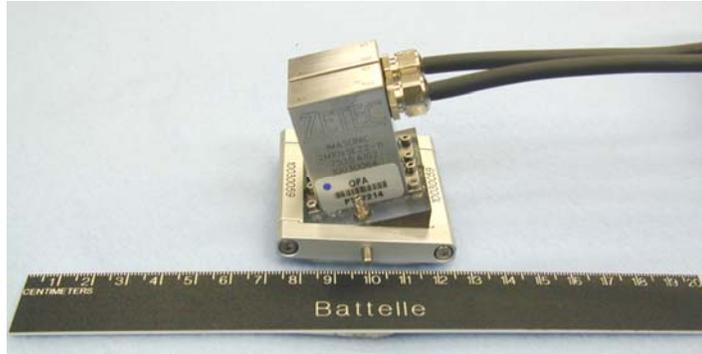
**Figure 4.2.** 2.0 MHz, Phased-Array Probe, Originally Developed for Inlays, Onlays, and Overlays

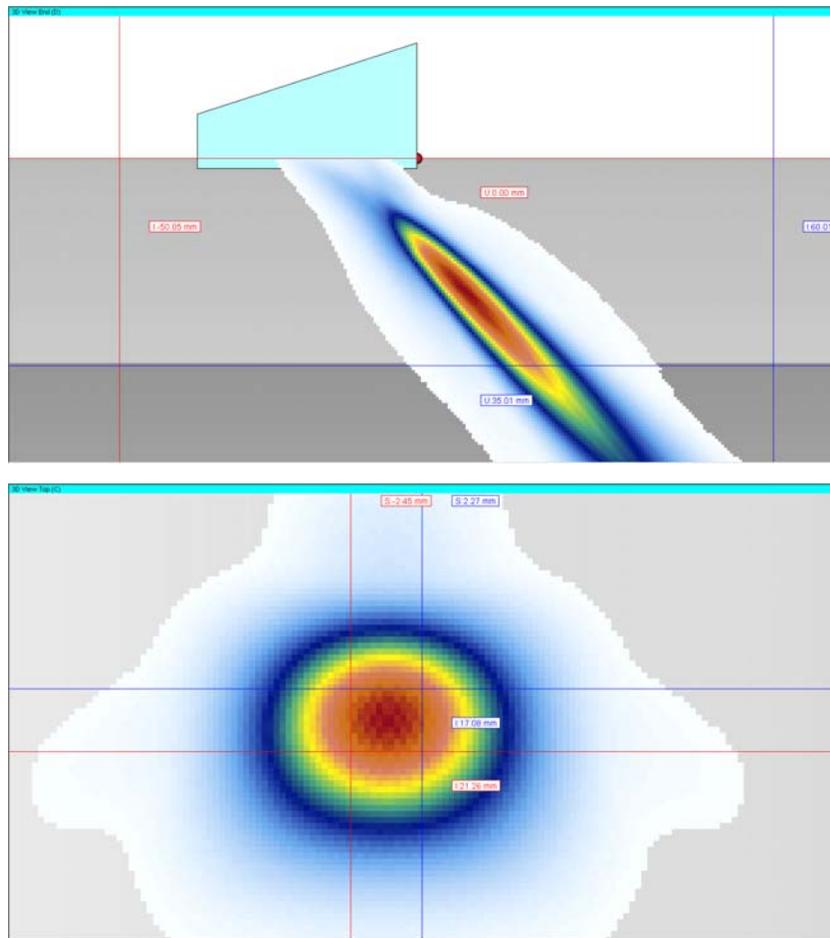
**Figure 4.3.** Un-normalized Beam Simulations for the 2.0-MHz PA Probe at 45° Incidence in the Cast PZR Surge-Line Specimen, Using a Half-Path Focus at 50 mm (1.97 in.). Top: side-view of focused sound field at 45° incident angle in the part. Bottom: cross-sectional view of sound field at the focal spot, where cursors mark the -3dB points.

Specific focal laws were generated for the PZR surge-line specimens based on the thickness of each specimen and the width of the welds in each specimen. While a frequency of  $2.0\text{ MHz}$  would normally be considered too high for use on CASS specimens, inspection work at  $1.5\text{ MHz}$  indicated that even at higher frequencies, detection and sizing of flaws in smaller bore piping (e.g., CASS PZR surge-line piping) could be achieved. To push the detection limits and determine whether microstructurally induced attenuation would dominate, a higher "conventional" inspection frequency of  $2.0\text{ MHz}$  was employed. Based on the focal laws and the results of the simulation, it was determined that the  $2.0\text{-MHz}$  probe was capable of effectively insonifying the region surrounding the weld in the PZR surge-line samples. The  $2.0\text{-MHz}$  probe produces a wavelength that is generally smaller than the majority of average grain diameters in all three of the PZR surge-line specimens evaluated in this study. Example simulations of the  $2.0\text{-MHz}$  beam using one set of focal laws are shown in Figure 4.3.

The 2.0-MHz probe was found to produce a beam with a horizontal width of 4.72 mm (0.19 in.) by vertical width of 4.18 mm (0.16 in.) at 45° at the -3 dB points. The 2.0-MHz probe is able to provide an effective sound field at distances from almost directly under the probe to a distance approximately 45 mm (1.8 in.) in front of the wedge. As with the 1.5-MHz probe, the ability of the probe to accurately measure crack width and depth improves with proximity between the probe focal spot and the flaw, as this is the location of tightest focusing and highest sensitivity.

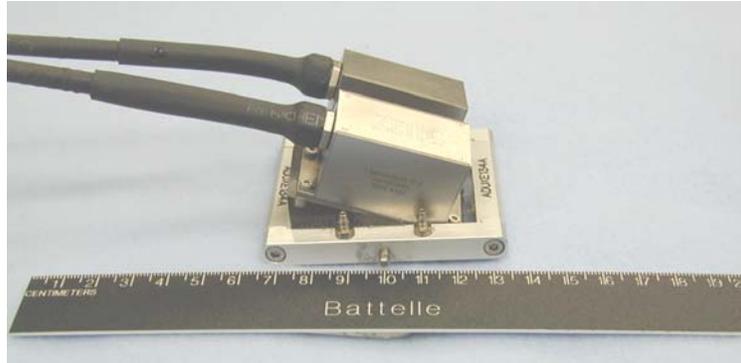
**Figure 4.4.** 1.5-MHz TRL Probe Originally Designed for Wrought Stainless Steel Welds

This 1.5-MHz TRL probe was originally designed by PNNL for examinations of wrought stainless steels (WSS), and consists of two 1.5-MHz PA transducers mounted side-by-side on a Rexolite® wedge. The 1.5-MHz probes operated in the pitch-catch mode with wedges held together by an aluminum frame. The wedge dimensions were 49 × 50 mm (1.93 × 1.97 in.). Both transmit and receive probes were identical in design with a 3×10 element array, an active area of 35 × 17.5 mm (1.38 × 0.69 in.) and a greater than 60% bandwidth at -6 dB. The 1.5-MHz probe has been used in previous examinations of flaws on the near and far sides of austenitic welds in WSS. 1.5 MHz is, however, generally considered to be too high in frequency for examining CASS components which have larger and more complex grain structures than WSS. The 1.5-MHz TRL probe was included in this study because the probe has proven effective in examining materials of similar thickness to the surge line and provides a point of comparison for the other techniques. Skew angles of ±10 degrees were possible with this array. The probe is shown in Figure 4.4.

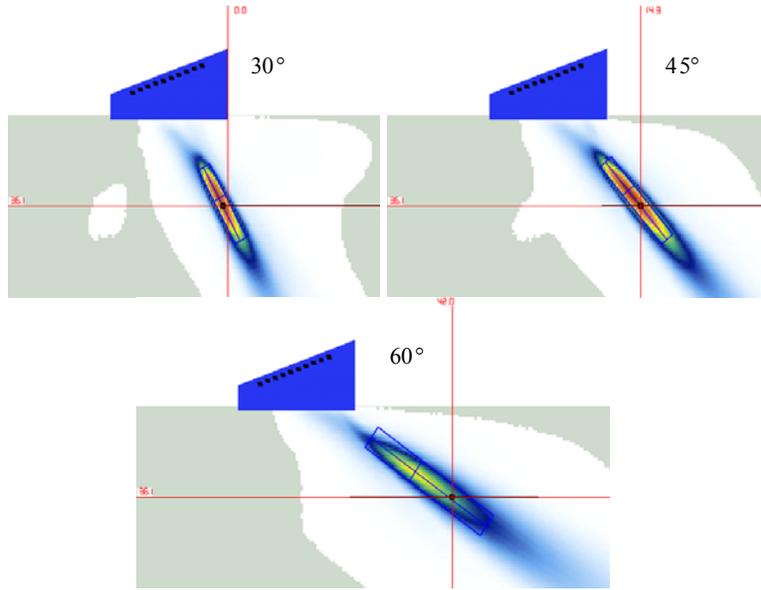
**Figure 4.5.** Simulations of the Beams Created by the 1.5-MHz TRL Arrangement for 30°, 45°, and 60°

Example simulations of the 1.5-MHz probe steered to 30°, 45°, and 60°, focused at a depth of 36 mm (1.4 in.), is shown in Figure 4.5. The wavelength for a 1.5-MHz probe is 3.8 mm (0.15 in.). From Figure 4.6, the 1.5-MHz probe was found to produce a beam with a horizontal width of 5.01 mm (0.20 in.) by vertical width of 3.81 mm (0.15 in.) at 45° at the -3dB points.

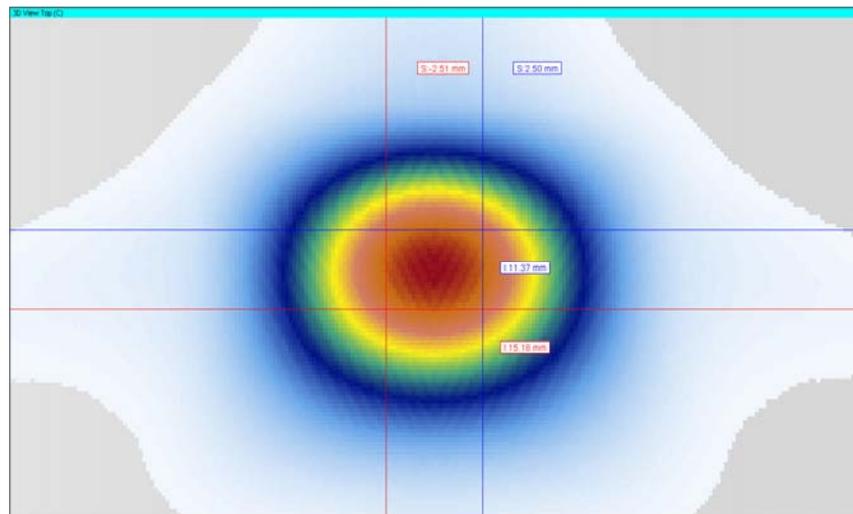
**Figure 4.6.** Beam Simulations for the 1.5 MHz PA Probe at 45° Incidence in the Cast PZR Surge-Line Specimen, Using a Half-Path Focus at 50 mm (1.97 in.). This is a cross-sectional view of sound field at the focal spot, where cursors mark the -3 dB points.

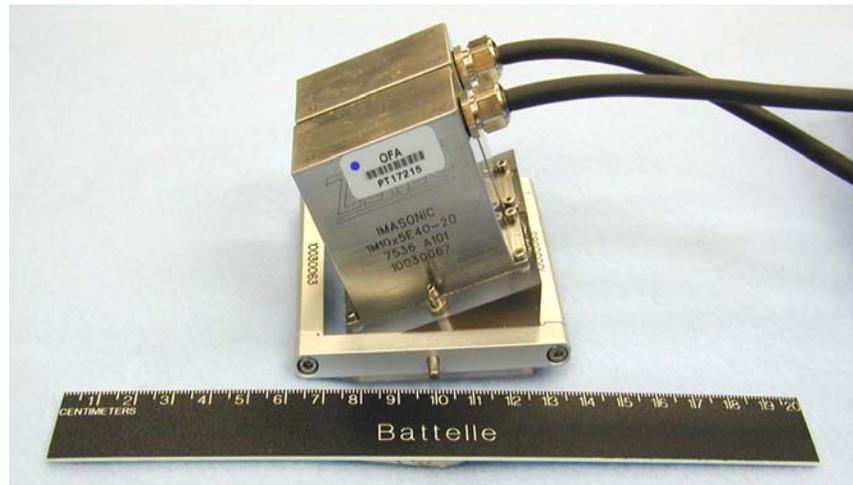
**Figure 4.7.** 1.0 MHz, Phased-Array Probe, Originally Developed for Inlays, Onlays, and Overlays

The 1-MHz TRL array (Figure 4.7) was originally designed for evaluating inspection effectiveness of PA methods on components with inlays, onlays, and overlays. It consists of two 5-element by 10-element matrix arrays. One array is used for transmitting, the other for receiving ultrasonic signals. This probe has a 58% BW at  $-6$  dB and an approximately  $50\text{-mm}^2$  ( $1.97\text{-in.}^2$ ) footprint with a customized wedge for data collection in tight geometrical configurations. This probe size generally allows insonification of the far side of a specimen even with a weld crown present, but can be prohibitive if the weld crown is too large. The probe's nominal wavelength in stainless steel is  $5.31$  mm ( $0.21$  in.) at its average center frequency of  $1.1$  MHz. Skew angles of  $\pm 20$  degrees were possible with this array.

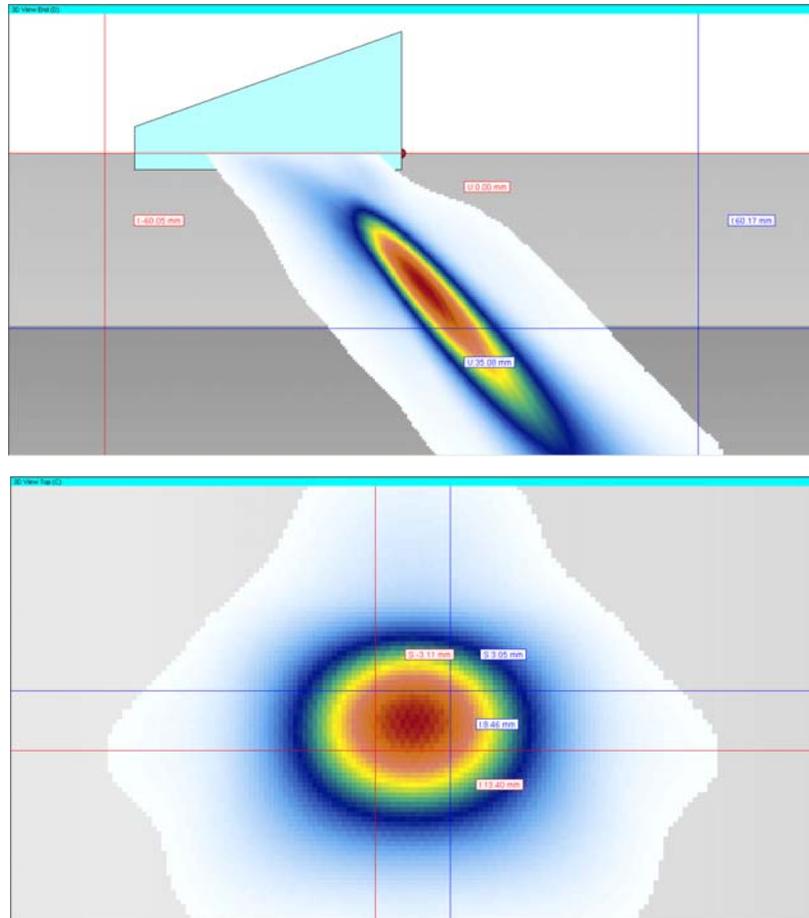
**Figure 4.8.** Un-normalized Beam Simulations for the 1.0-MHz PA Probe at 45° Incidence in the Cast PZR Surge-Line Specimen, Using a Half-Path Focus at 50 mm (1.97 in.). Top: side-view of focused sound field at 45° incident angle in the part. Bottom: cross-sectional view of sound field at the focal spot, where cursors mark the –3 dB points.

Specific focal laws were generated for the PZR surge-line specimens based on the thickness of each specimen and the width of the welds in each specimen. A frequency of  $1.0$  MHz was chosen to more effectively complete the evaluation of the PA inspection over the entire frequency range between  $800$  kHz and  $2.0$  MHz. Thus, it was determined that  $1.0$ -MHz data would provide valuable information to supplement data acquired between  $800$  kHz and  $1.5$  MHz. Based on the focal laws and the results of the simulation, it was determined that the  $1.0$ -MHz probe was capable of effectively insonifying the region surrounding the weld in the PZR surge-line samples. The  $1.0$ -MHz probe produces a wavelength that is generally the same size as the majority of average grain diameters in all three of the PZR surge-line specimens evaluated in this study. Example simulations of the  $1.0$ -MHz beam using one set of focal laws are shown in Figure 4.8.

The 1.0-MHz probe was found to produce a beam with a horizontal width of 6.16 mm (0.24 in.) by vertical width of 4.94 mm (0.19 in.) at 45° at the –3dB points. The 1.0-MHz probe is able to provide an effective sound field at distances from almost directly under the probe to a distance approximately 45 mm (1.8 in.) in front of the wedge. The probes were designed at PNNL and built by Imasonic®. As with the 1.5-MHz probe, the ability of the probe to accurately measure crack width and depth improves with proximity between the probe focal spot and the flaw, as this is the location of tightest focusing and highest sensitivity.

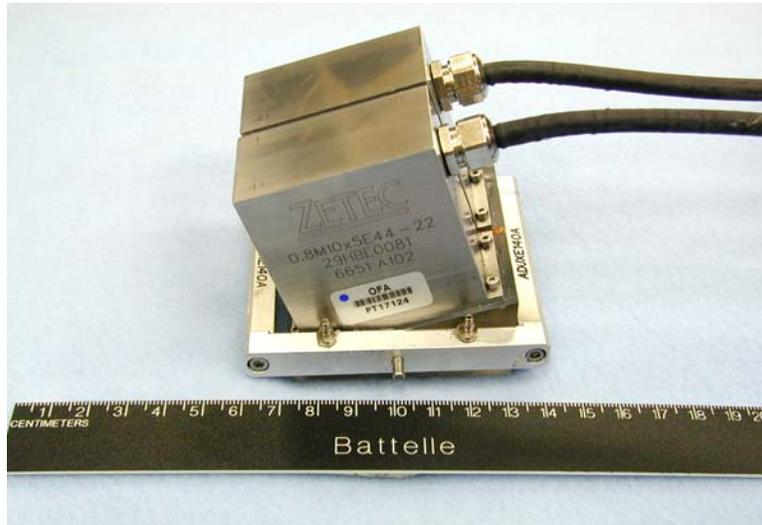
**Figure 4.9.** 800-kHz TRL Probe

probes were identical in design and consisted of a  $10 \times 5$  element array with an active area of  $43.2 \times 21.2$  mm ( $1.70 \times 0.84$  in.) and a greater than or equal to 50% bandwidth at  $-6$  dB. The probes were designed at PNNL for this inspection and built by Imasonic<sup>®</sup>. The wedges were curved to match the approximate 318-mm (12.5-in.) diameter of the surge line piece.

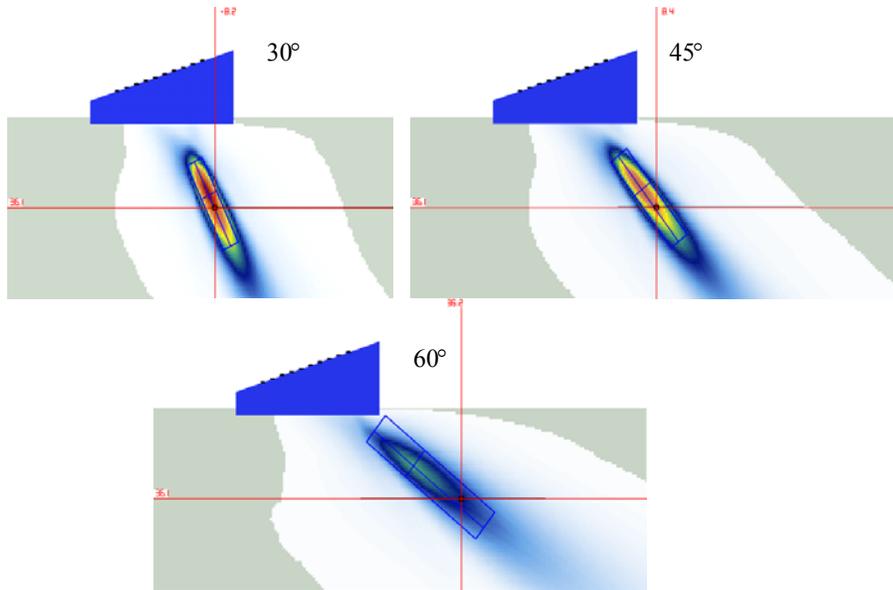
**Figure 4.10.** Simulations of the Beams Created by the 800-kHz TRL Arrangement for 30°, 45°, and 60°

Specific focal laws were generated for the PZR surge-line specimens based on the thickness of each specimen and the width of the welds in each specimen. Based on the focal laws and the results of the simulation, it was determined that the 800-kHz probe was capable of effectively insonifying the region surrounding the weld in all three PZR surge-line samples. The 800-kHz probe produces a 7-mm (0.28-in.) wavelength in stainless steels, almost twice the wavelength of the 1.5-MHz probe. Example simulations of the 800-kHz beam using one set of focal laws are shown in Figure 4.10.

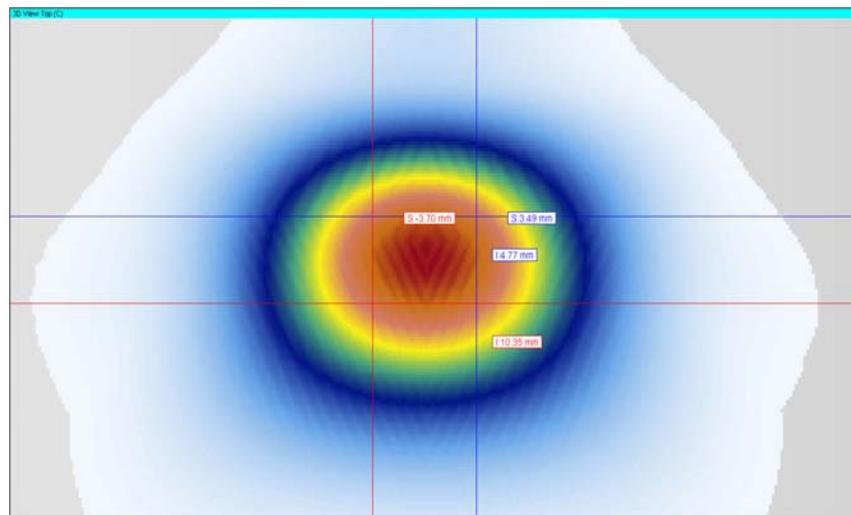
**Figure 4.11.** Beam Simulations for the 800 kHz PA Probe at 45° incidence in the Cast PZR Surge-Line Specimen, Using a Half-Path Focus at 50 mm (1.97 in.). This is a cross-sectional view of sound field at the focal spot, where cursors mark the -3dB points.

From Figure 4.11, the 800-kHz probe was found to produce a beam with a horizontal width of 7.19 mm (0.28 in.) by vertical width of 5.58 mm (0.22 in.) at 45° at the -3 dB points. Using the modeling and simulation capabilities of the Ultravision® software, the focal dimensions of the sound field as a function of frequency (probe) and incident angle were computed for the dimensions corresponding to both 9C-001 and 9C-002 CASS PZR specimens. The focal spot size was computed at both the -3 dB and -6 dB points in both horizontal and vertical planes. Table 4.2 summarizes the focal spot size data.

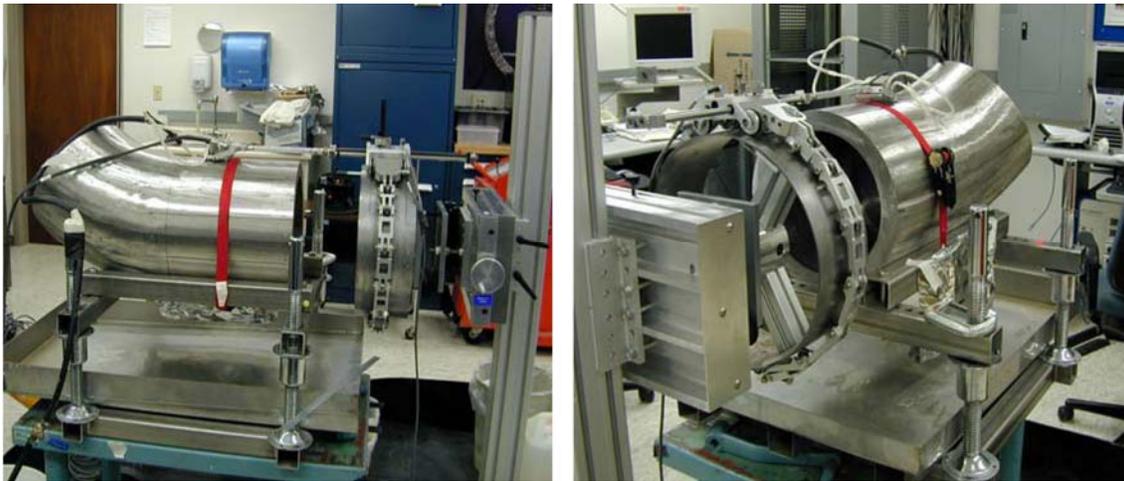
**Figure 5.1.** Photographs of the PZR Surge-Line Specimen 7C-059. Left: Configured for standard PA-UT with the pipe-end on the right and the elbow-end on the left side of the photograph. Right: The guide ring, translation slide and floor-to-ceiling brace are shown to the left.

Setup and laboratory configuration for PA-UT data acquisition on the PZR surge lines required the use of the manual-encoded scanner mounted on an adjustable guide track or ring supported by a custom-designed floor-to-ceiling brace. The floor-to-ceiling brace was equipped with a translation slide providing additional control and degrees of freedom for movement both horizontally and vertically. This translation slide provided easy manipulation for fine-tuning of the guide-ring position, relative to the pipe specimen. The setup is shown in Figure 5.1 with the manual scanner on the guide ring section. The probe is mounted on an extension arm that is adjustable along the pipe axis. Two encoders on the manual track scanner provide positional information in either or both the axial and circumferential directions for line and raster scanning.

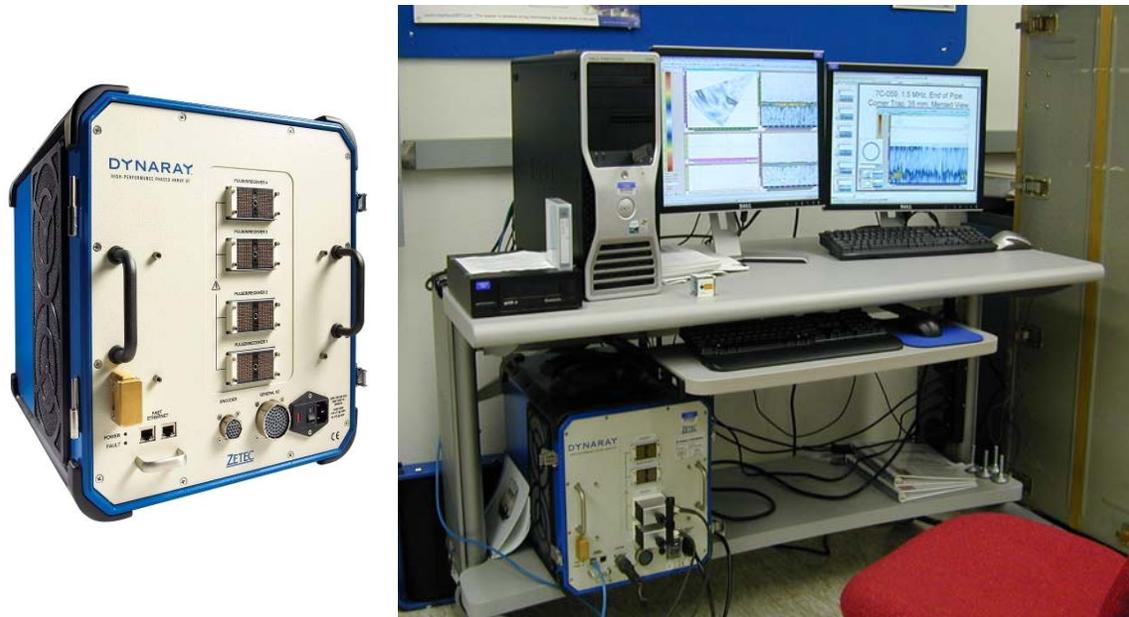
**Figure 5.2.** Data Acquisition System and Laboratory Workstation. Left: DYNARAY® phased array data acquisition system (courtesy of ZETEC®). Right: Laboratory workstation for both data acquisition and data analysis, with the DYNARAY® system on the lower shelf.

electronics will drive probes in the 0.2–20 MHz range. Phased-array data were acquired over a range of inspection angles from 30° to 70°, in 1° increments. The laboratory workstation and DYNARAY® data acquisition system are shown in Figure 5.2.

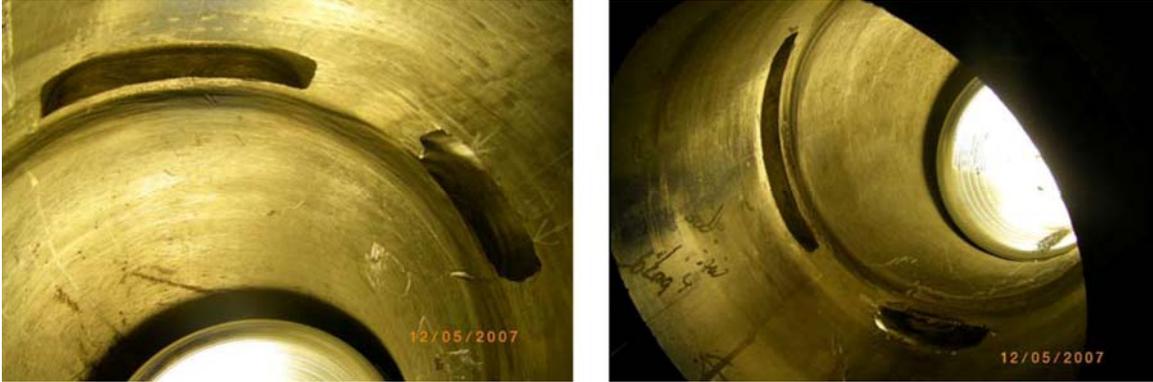
**Figure 6.1.** Photographs of the Inside Surface of the CASS PZR Surge-Line after Excavation and Preparation of the Areas Targeted for Flaw Implantation (courtesy of FlawTech<sup>®</sup>, Inc.)

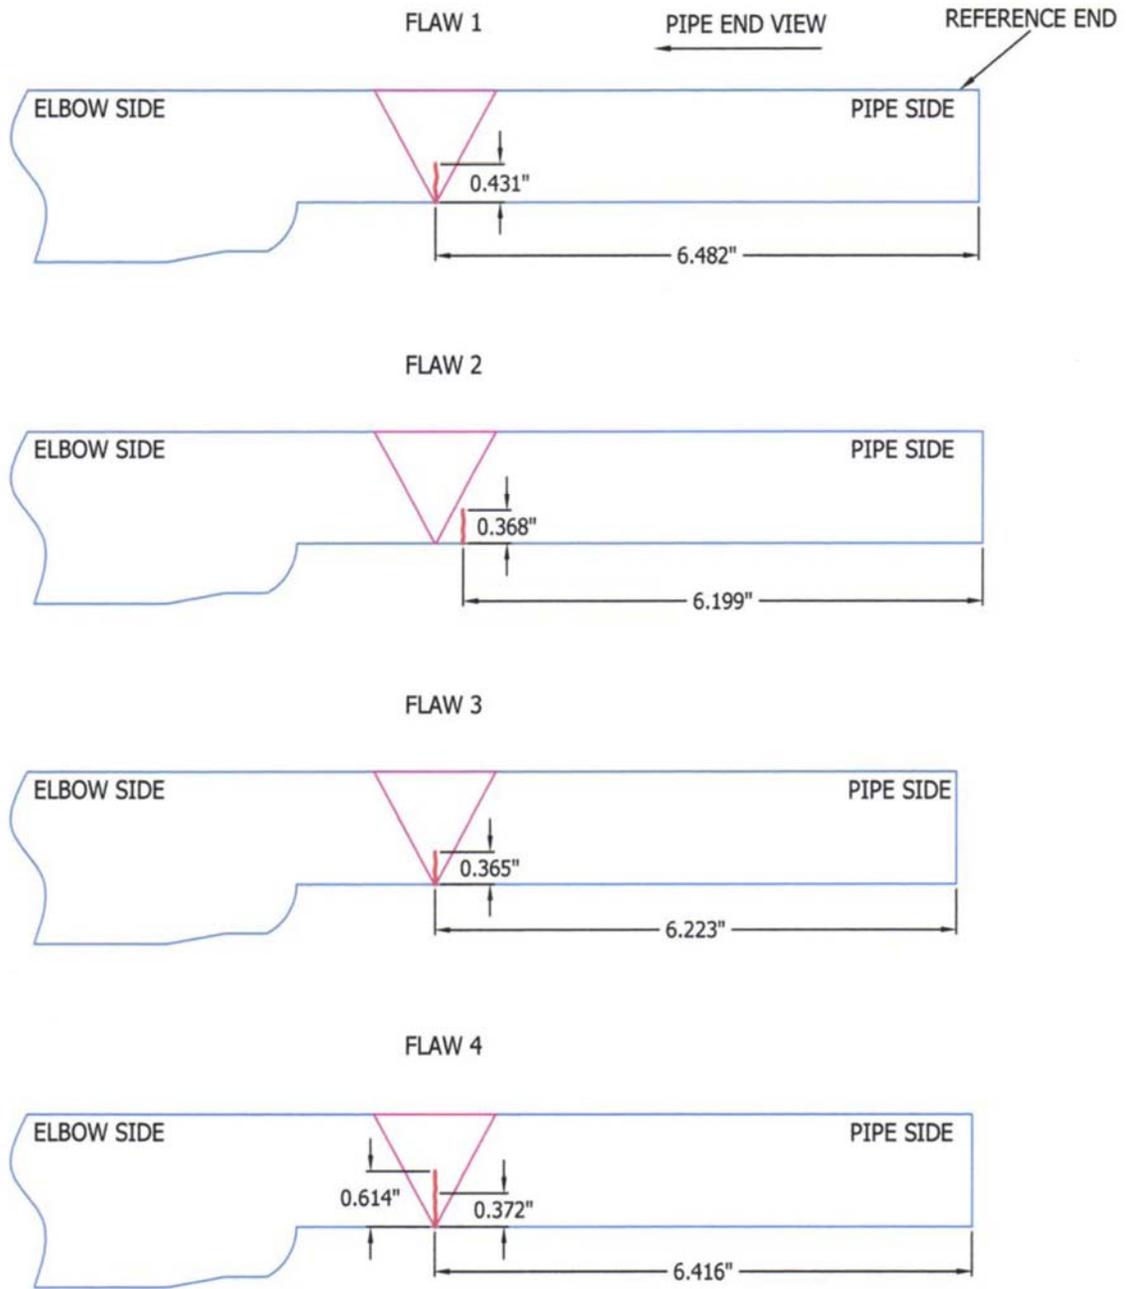
**Figure 6.2.** Side View Illustration of All Four Thermal Fatigue Cracks Implanted into PZR CASS Specimen 7C-059 (courtesy of FlawTech<sup>®</sup>, Inc.)

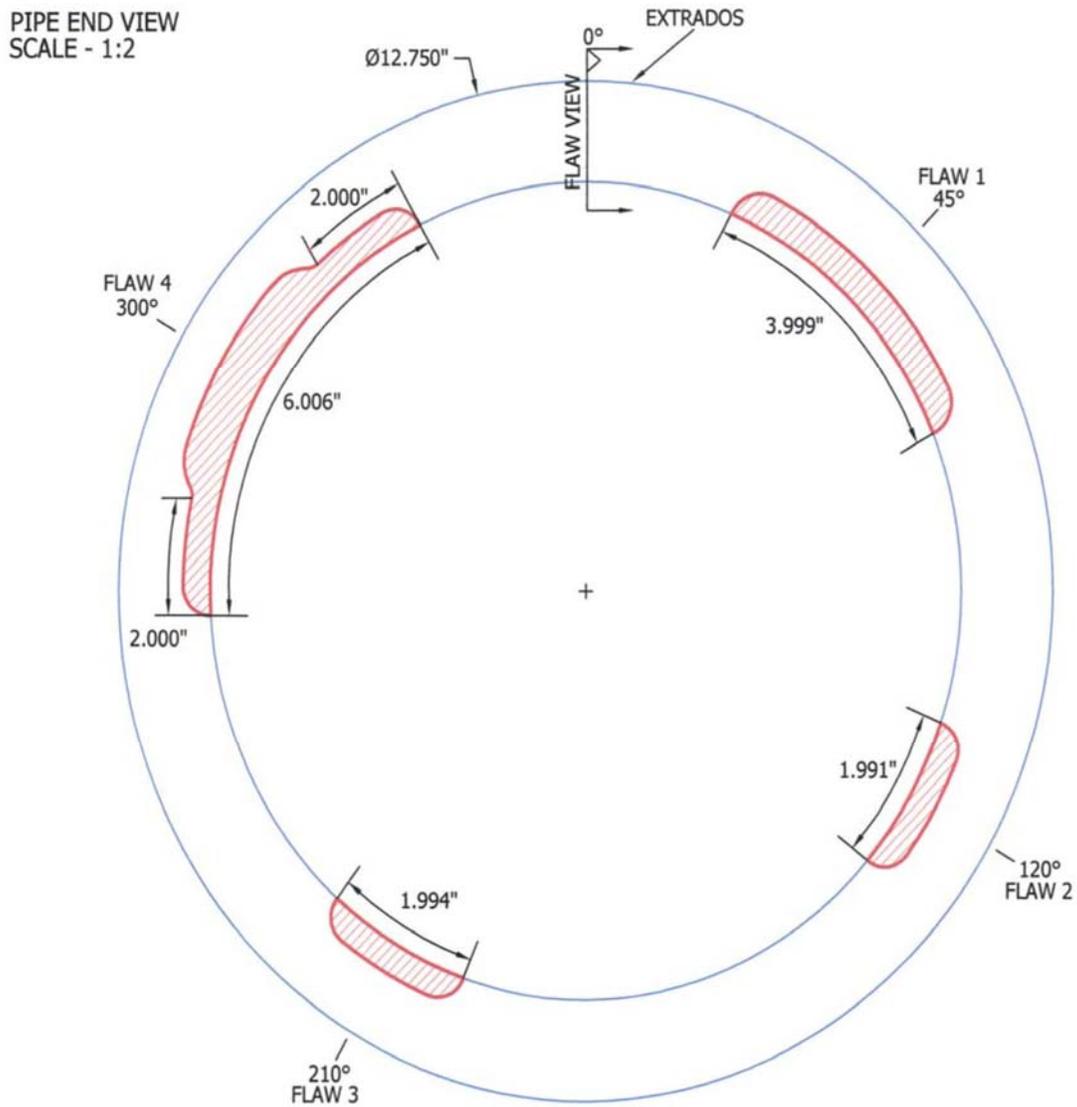
**Figure 6.3.** End View Illustration of All Four Thermal Fatigue Cracks Implanted into PZR CASS Specimen 7C-059 (courtesy of FlawTech<sup>®</sup>, Inc.).

Figure 6.3 shows a full circumferential view of all flaw positions and extents on specimen 7C-059. This pipe end-view depicts the circumferential extent (length) of the implanted ID surface-connected cracks, relative to the radial position along the pipe circumference.

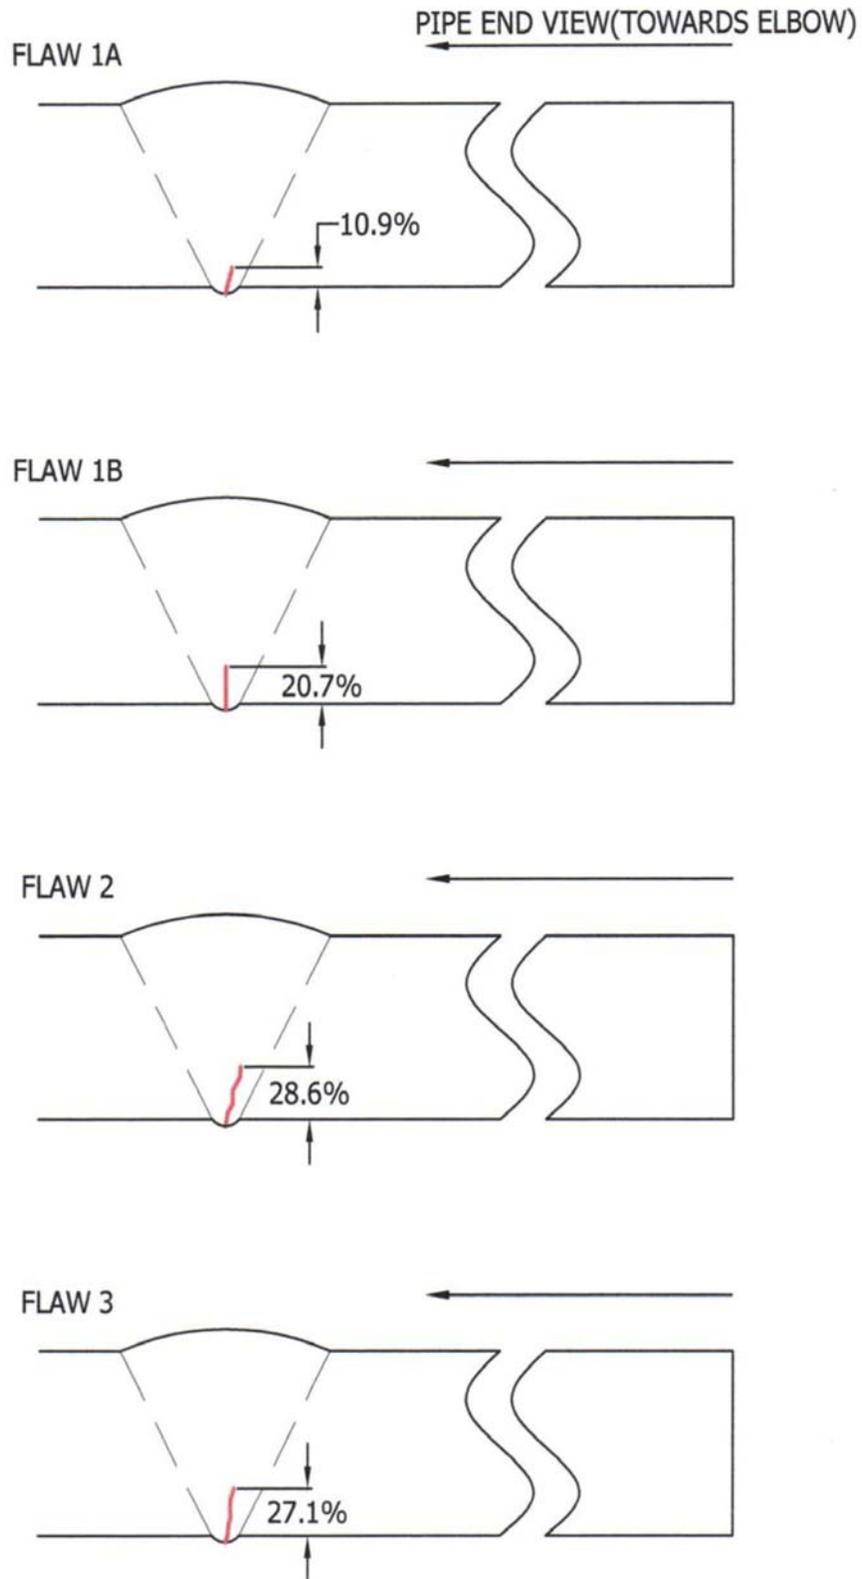
**Figure 6.4.** Side View Illustration of All Four Thermal Fatigue Cracks Implanted into PZR CASS Specimen 9C-001 (courtesy of FlawTech<sup>®</sup>, Inc.)

This CASS PZR surge-line segment is 12-in. Schedule 160 pipe, with a CCSS pipe segment welded to a SCSS elbow. This CASS PZR surge-line specimen is approximately 762 mm (30 in.) in length, 324 mm (12.75 in.) OD, and is approximately 31.8-mm (1.25-in.) in wall thickness on the centrifugally cast side of the weld (pipe side). This pipe-to-elbow specimen was cut from a longer segment of a surge line salvaged from Washington Nuclear Power, Unit 3 (WNP-3). FlawTech<sup>®</sup>, Inc. performed all crack implantations in this specimen. Three implanted TFCs were introduced. These cracks were inserted via a coupon-implant technique and were all circumferentially oriented flaws. A side view illustration of the three flaws depicting flaw position relative to the weldment and flaw depth is provided in Figure 6.4.

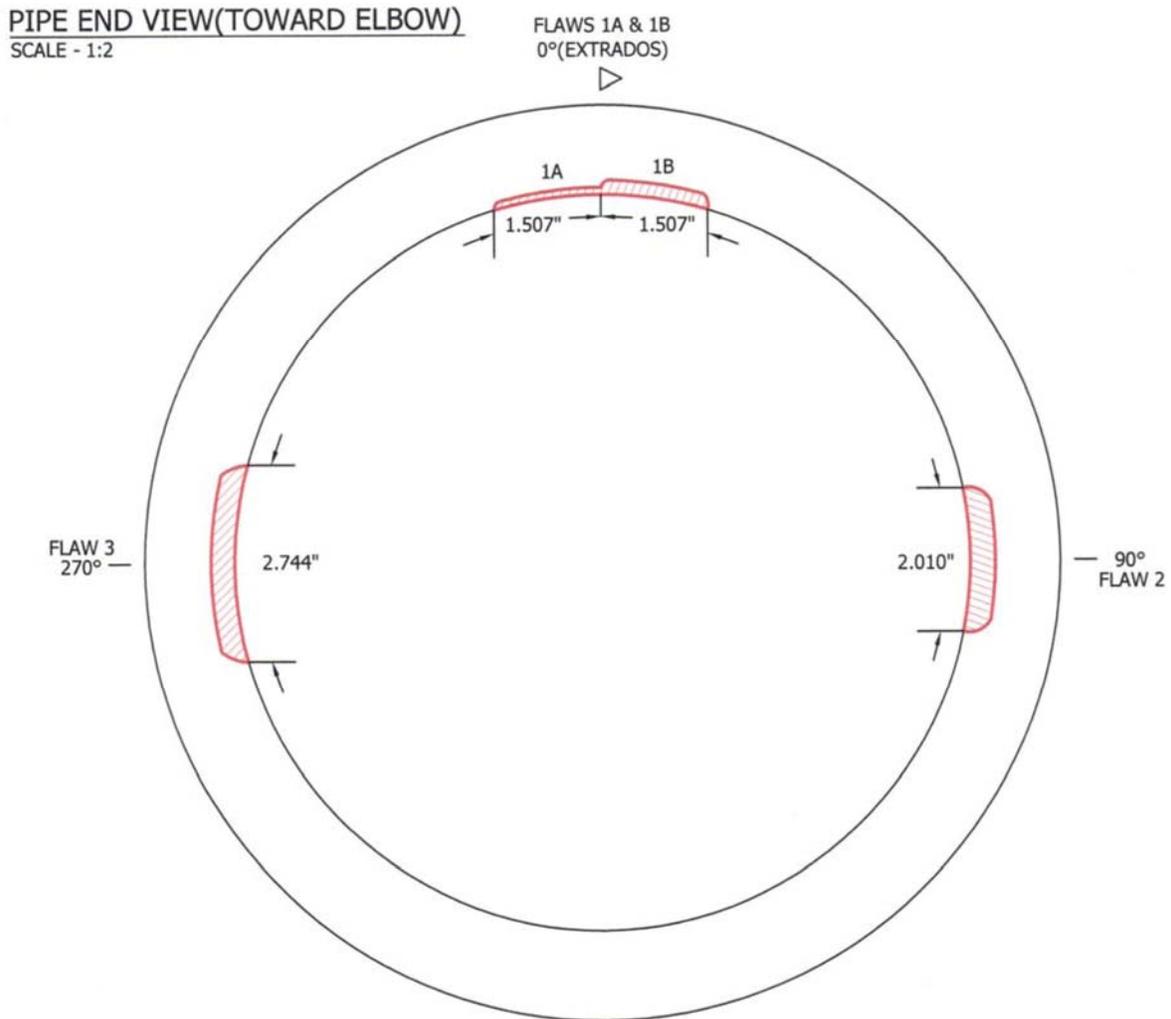
**Figure 6.5.** End View Illustration of All Four Thermal Fatigue Cracks Implanted into PZR CASS Specimen 9C-001 (courtesy of FlawTech<sup>®</sup>, Inc.)

Figure 6.5 shows a full circumferential view of all flaw positions and extents on specimen 9C-001. This pipe end-view depicts the circumferential extent (length) of the implanted ID surface-connected cracks, relative to the radial position along the pipe circumference.

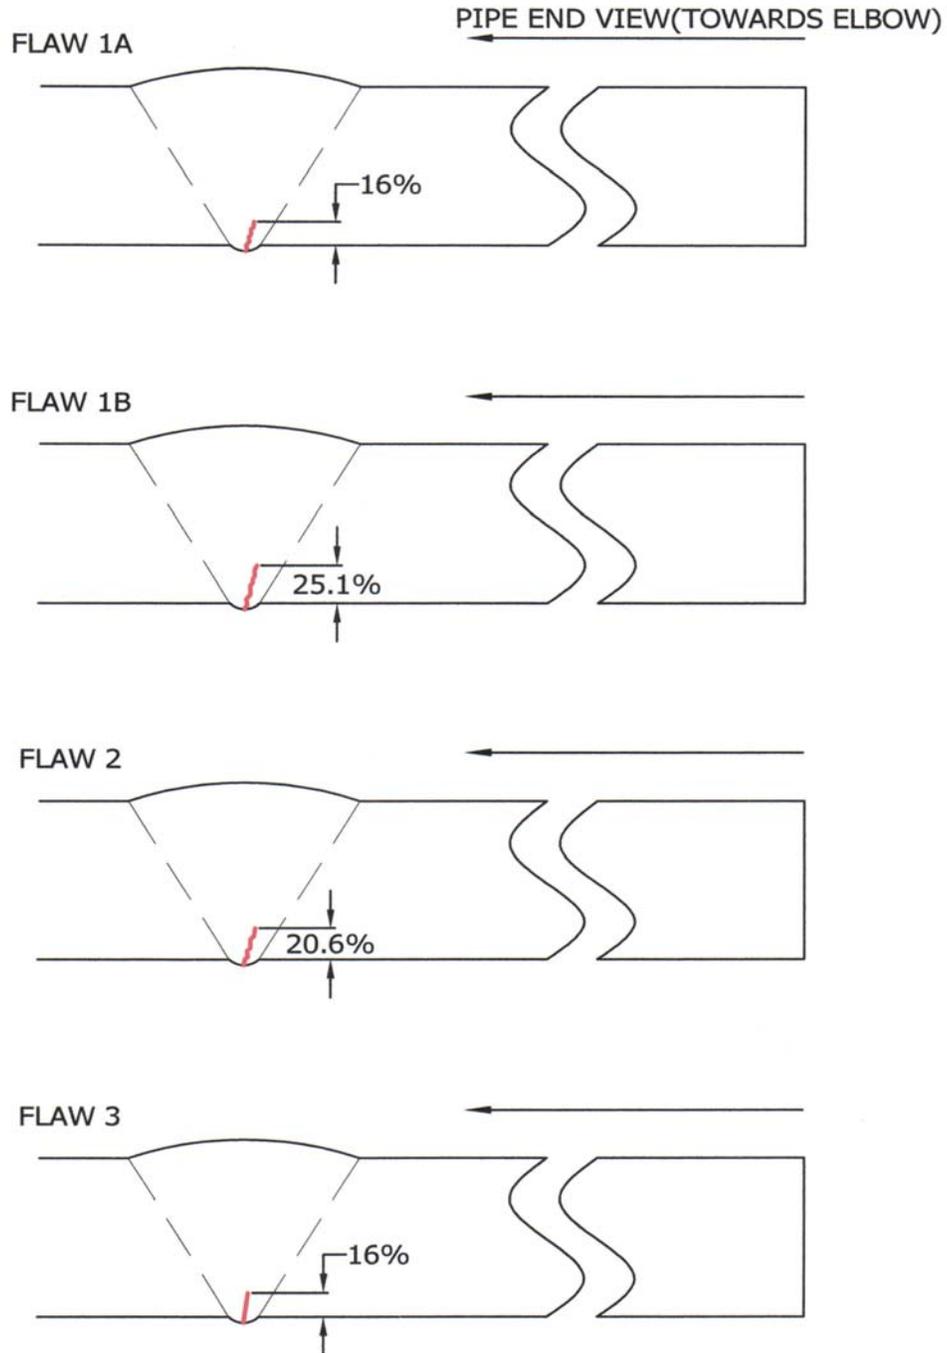
**Figure 6.6.** Side View Illustration of All Four Thermal Fatigue Cracks Implanted into PZR CASS Specimen 9C-002 (courtesy of FlawTech<sup>®</sup>, Inc.)

inserted via a coupon implant technique and were all circumferentially oriented flaws. A side view illustration of the three flaws depicting flaw position relative to the weldment and flaw depth is provided in Figure 6.6.

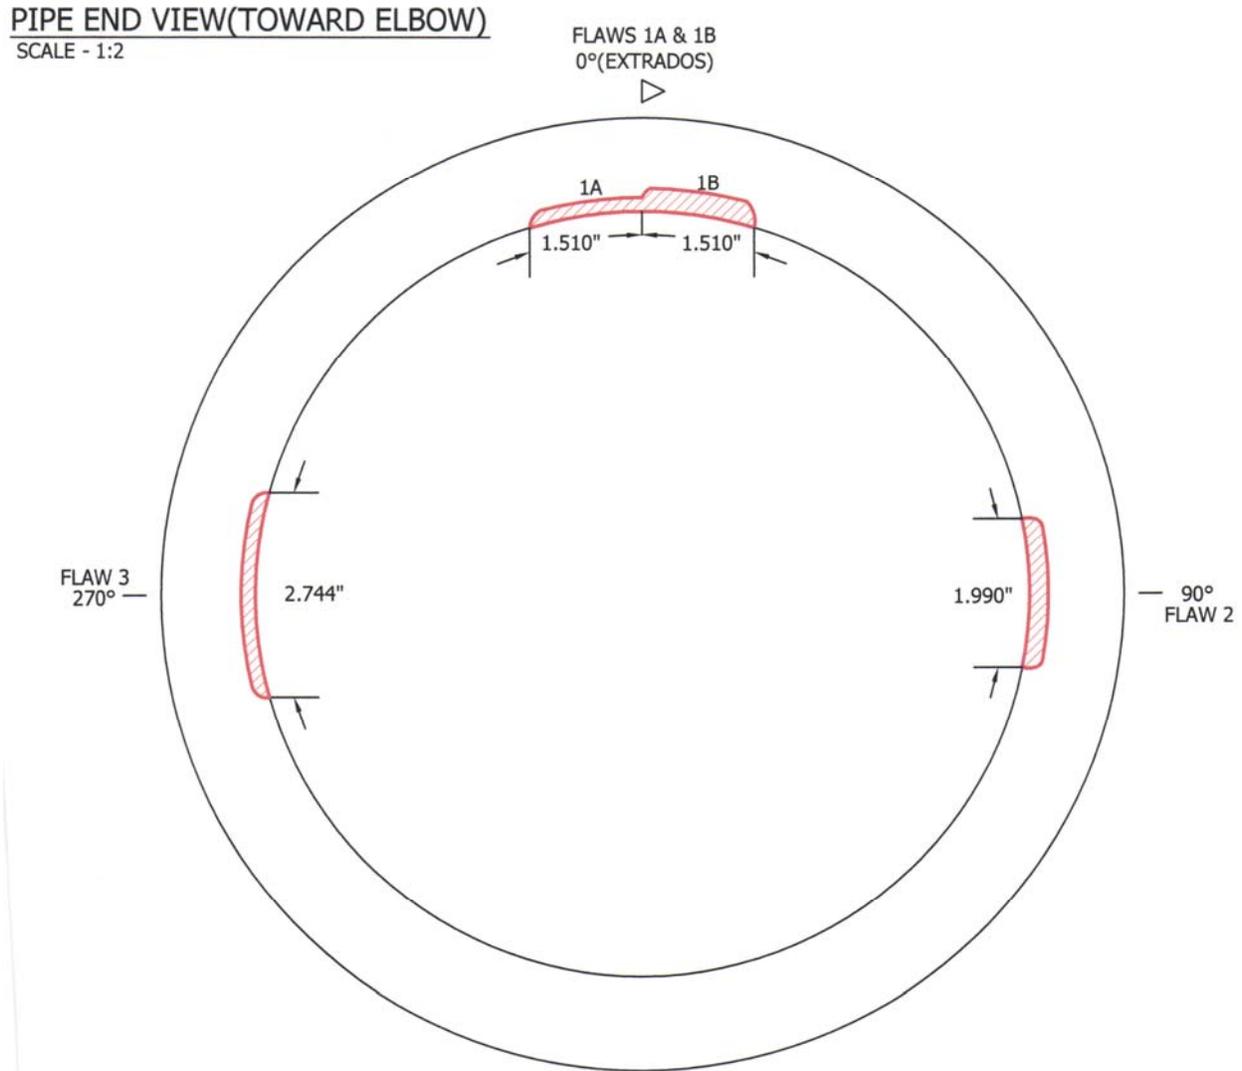
**Figure 6.7.** End View Illustration of All Four Thermal Fatigue Cracks Implanted into PZR CASS Specimen 9C-002 (courtesy of FlawTech<sup>®</sup>, Inc.)

Figure 6.7 shows a full circumferential view of all flaw positions and extents on specimen 9C-002. This pipe end-view depicts the circumferential extent (length) of the implanted ID surface-connected cracks, relative to the radial position along the pipe circumference.

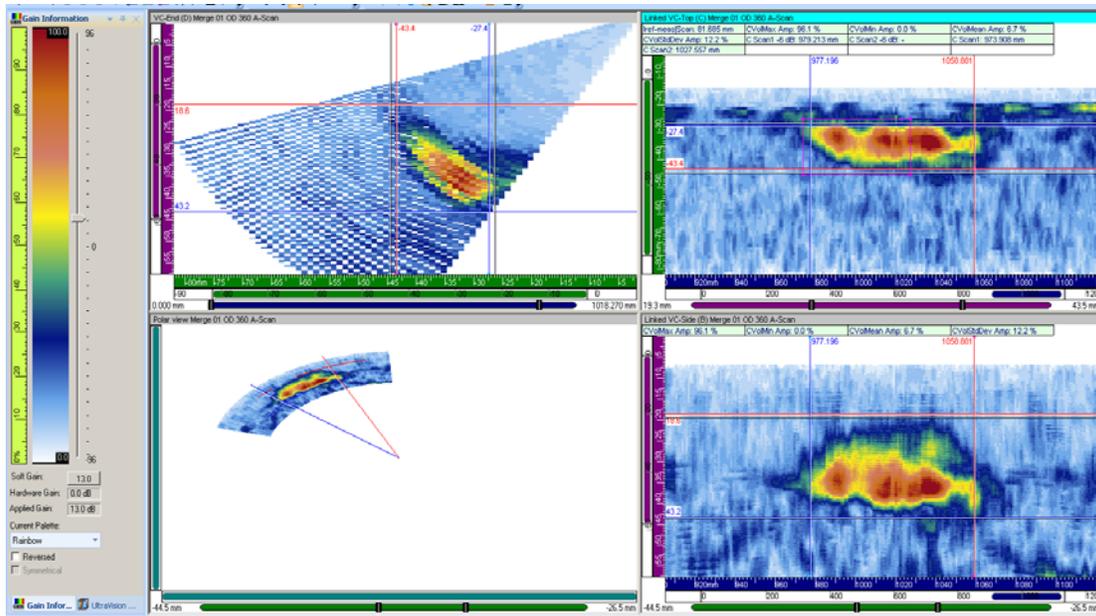
**Figure 7.1.** 800-kHz Data on Pipe Side of 9C-002, Flaw 1, Merged Image for Length Sizing

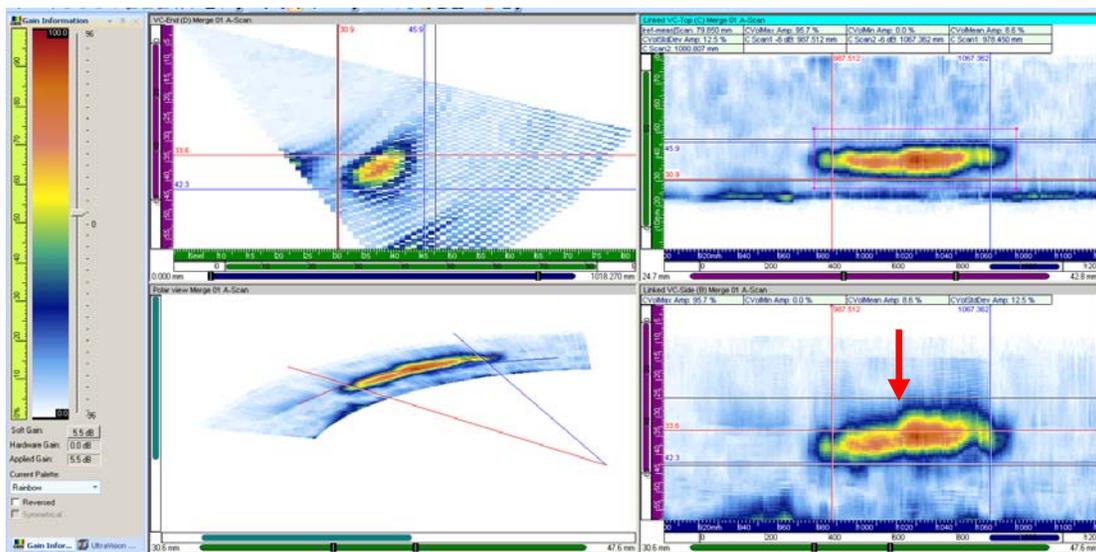
**Figure 7.2.** 800-kHz Data on Elbow Side of 9C-002, Flaw 1, Merged Image for Length Sizing
