PNNL-18596

## Technical Letter Report

# Assessment of Ultrasonic Phased Array Inspection Method for Welds in Cast Austenitic Stainless Steel Pressurizer Surge Line Piping

JCN N6398, Task 1B

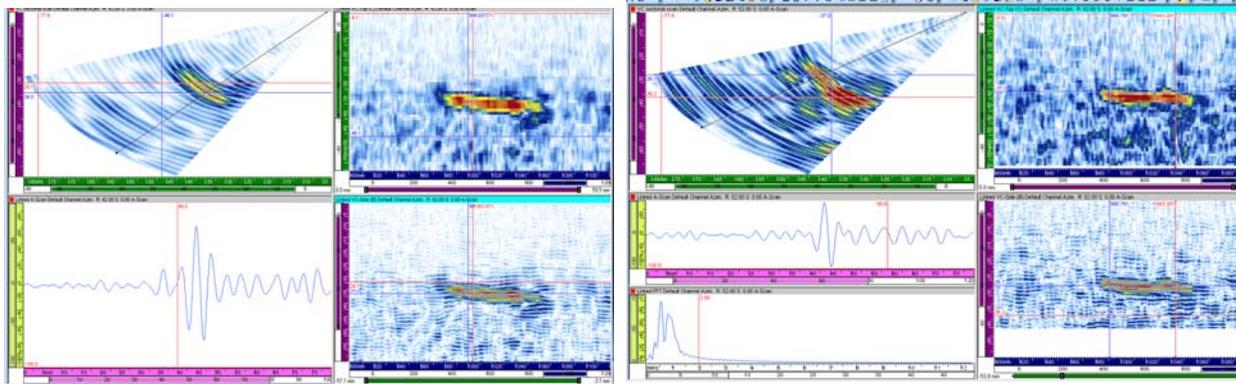
**Figure 7.3.** 0.8-MHz Data on Pipe Side of 9C-002, Flaw 1a on the Left and 1b on the Right for Depth Sizing

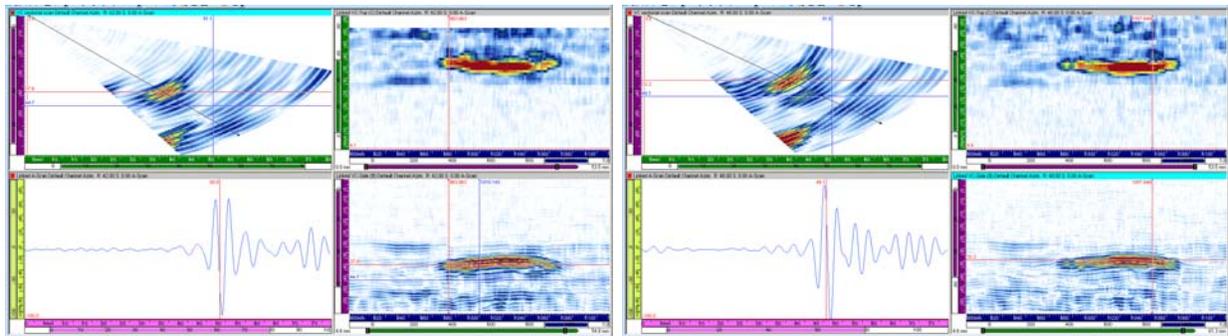
**Figure 7.4.** 0.8-MHz Data on Elbow Side of 9C-002, Flaw 1a on the Left and 1b on the Right for Depth Sizing

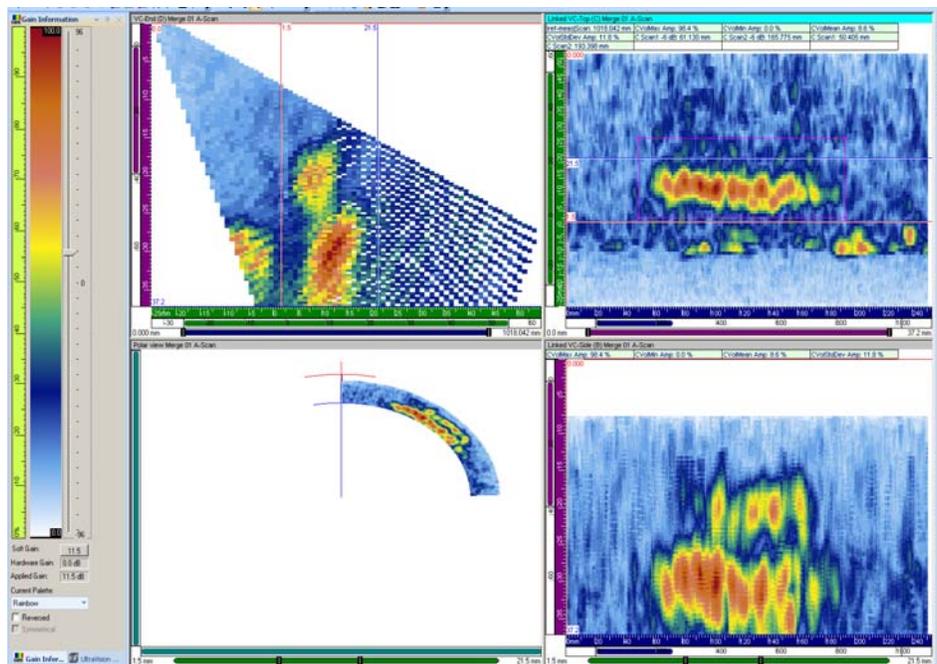
Figure 7.5. 1.0-MHz Data on Pipe Side of 7C-059, Flaw 1, Merged Image for Length Sizing

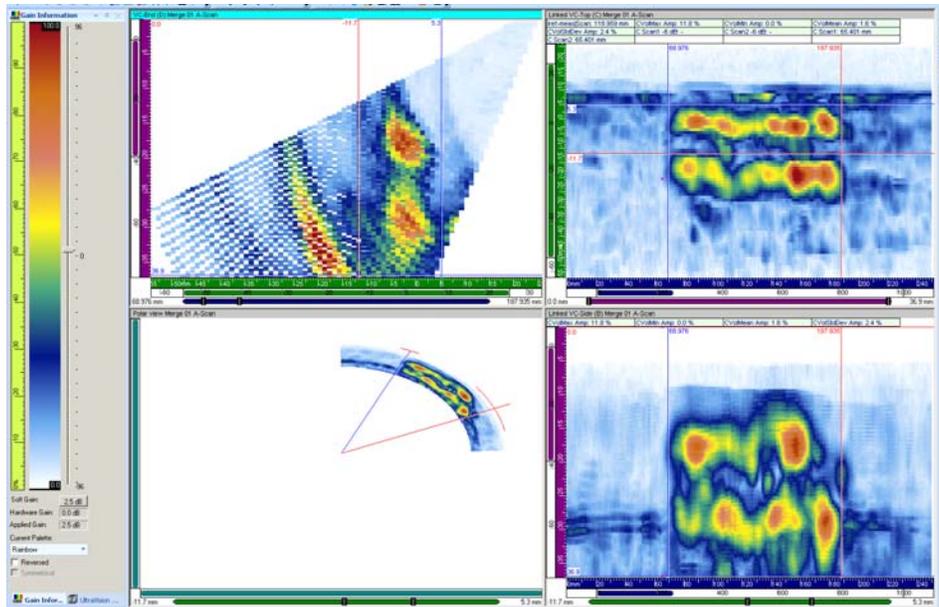
**Figure 7.6.** 1.0-MHz Data on Elbow Side of 7C-059, Flaw 1, Merged Image for Length Sizing

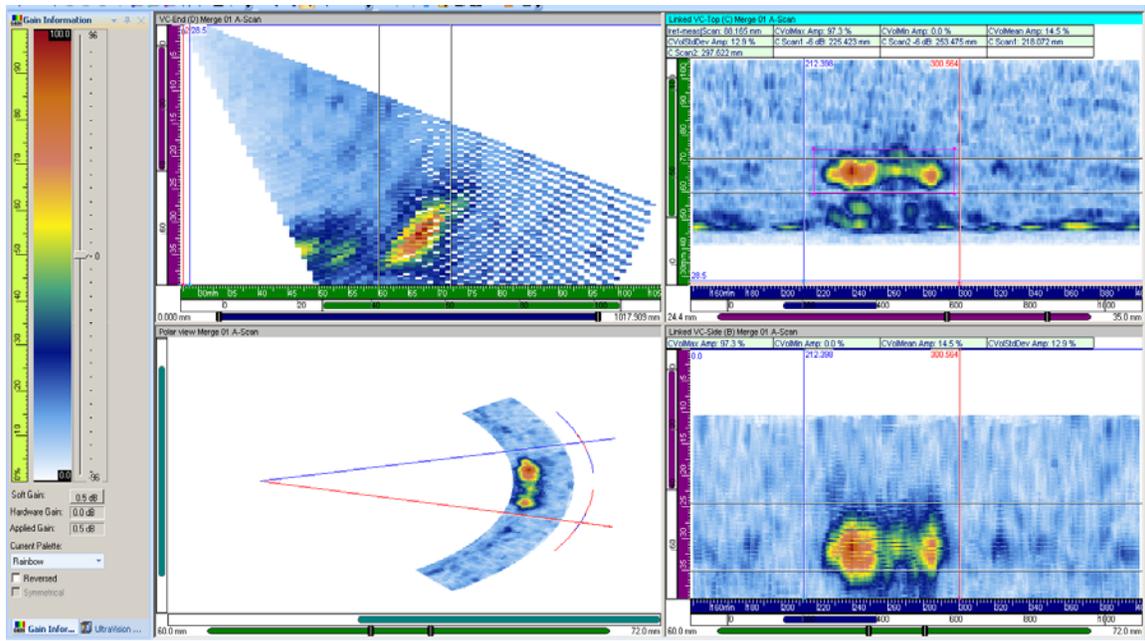
Figure 7.7. 1.5-MHz Data on Pipe Side of 9C-001, Flaw 2, Merged Image for Length Sizing

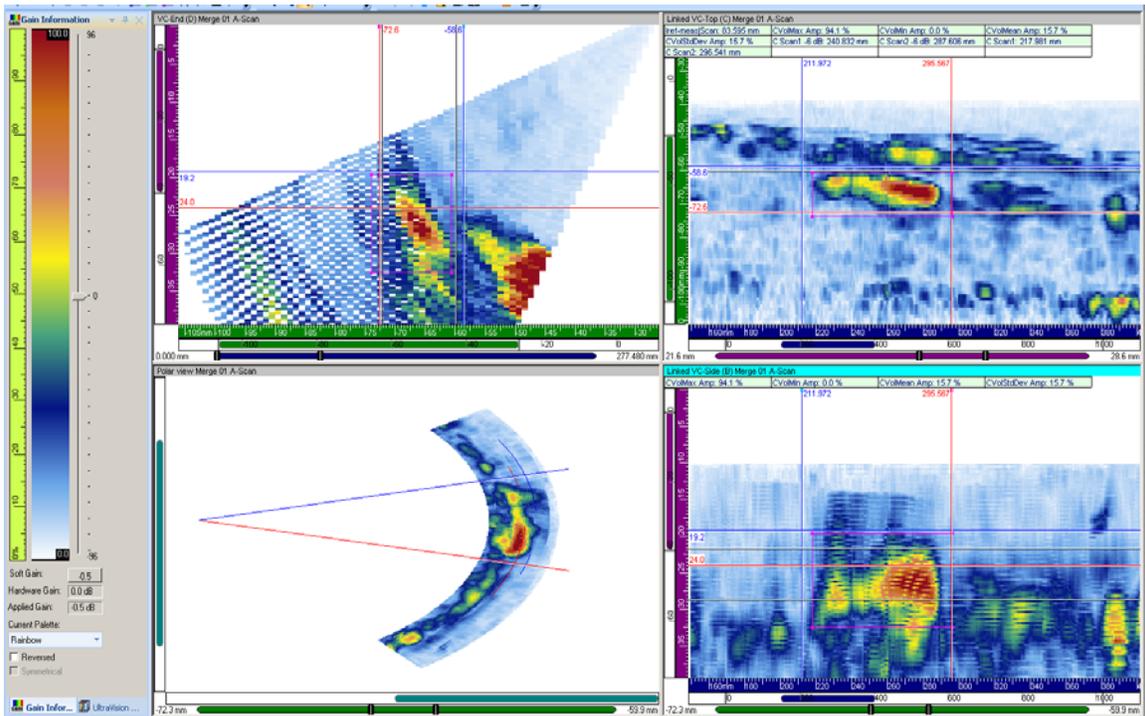
Figure 7.8. 1.5-MHz Data on Elbow Side of 9C-001, Flaw 2, Merged Image for Length Sizing

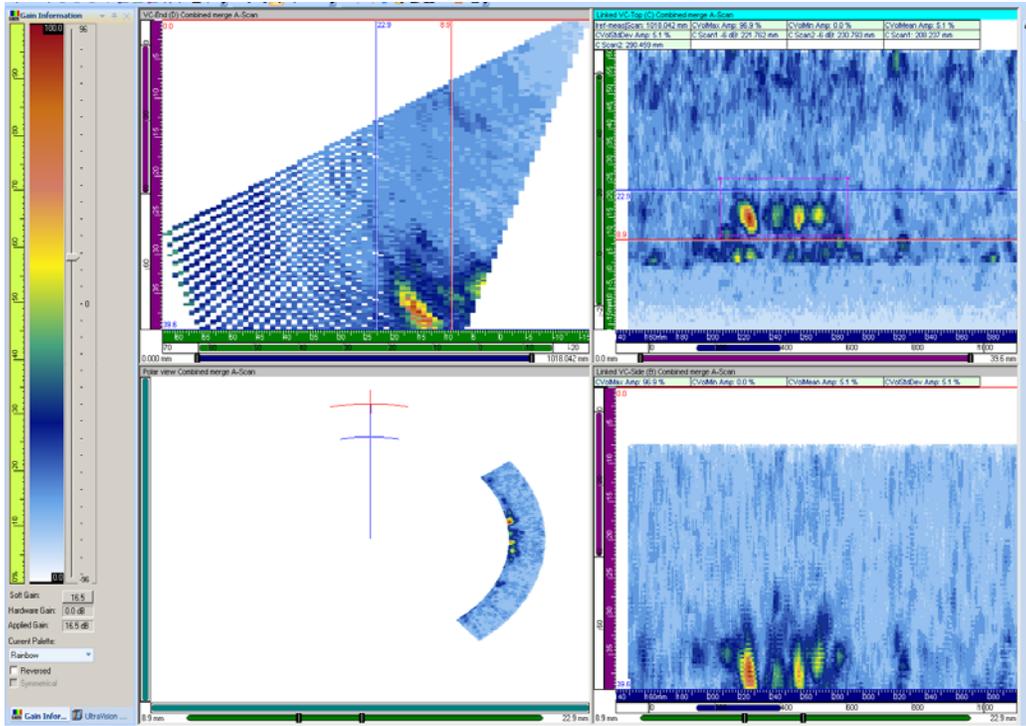
Figure 7.9. 2.0-MHz Data on Pipe Side of 9C-002, Flaw 2, Merged Image for Length Sizing

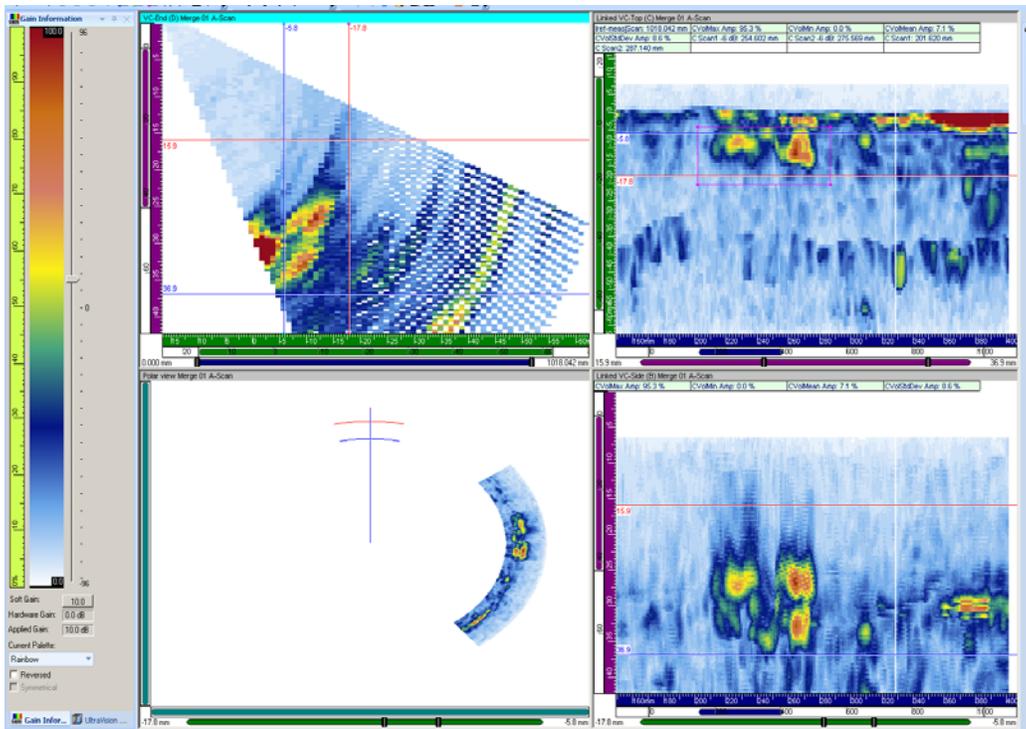
Figure 7.10. 2.0-MHz Data on Elbow Side of 9C-002, Flaw 2, Merged Image for Length Sizing

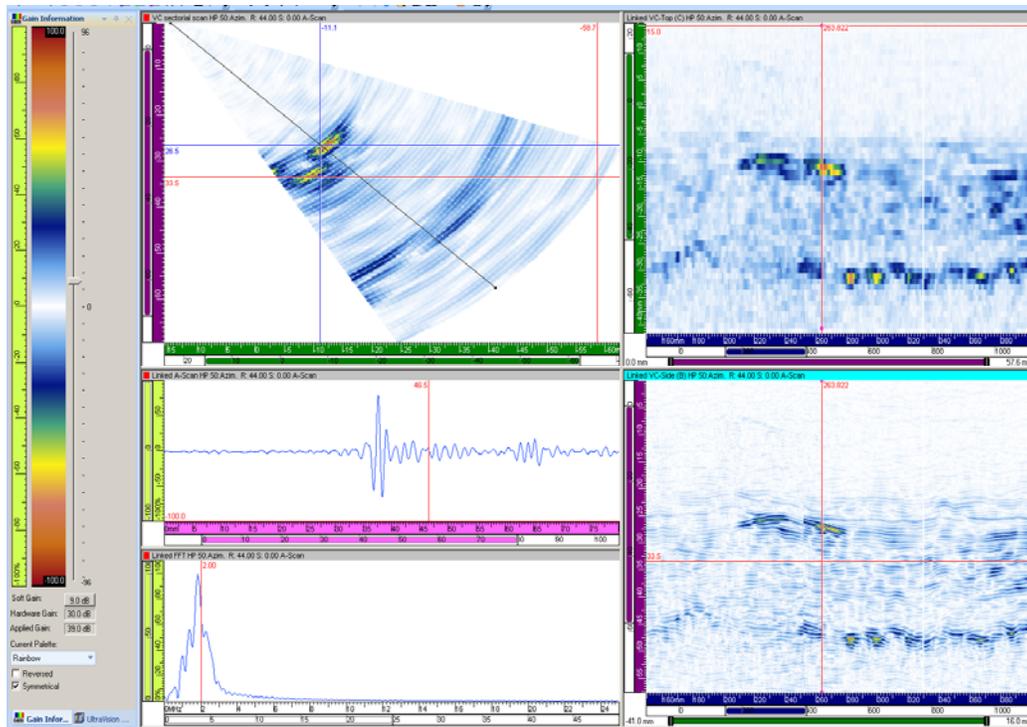
**Figure 7.11.** 2.0-MHz Data on Elbow Side of 9C-002, Flaw 2, for Depth Sizing

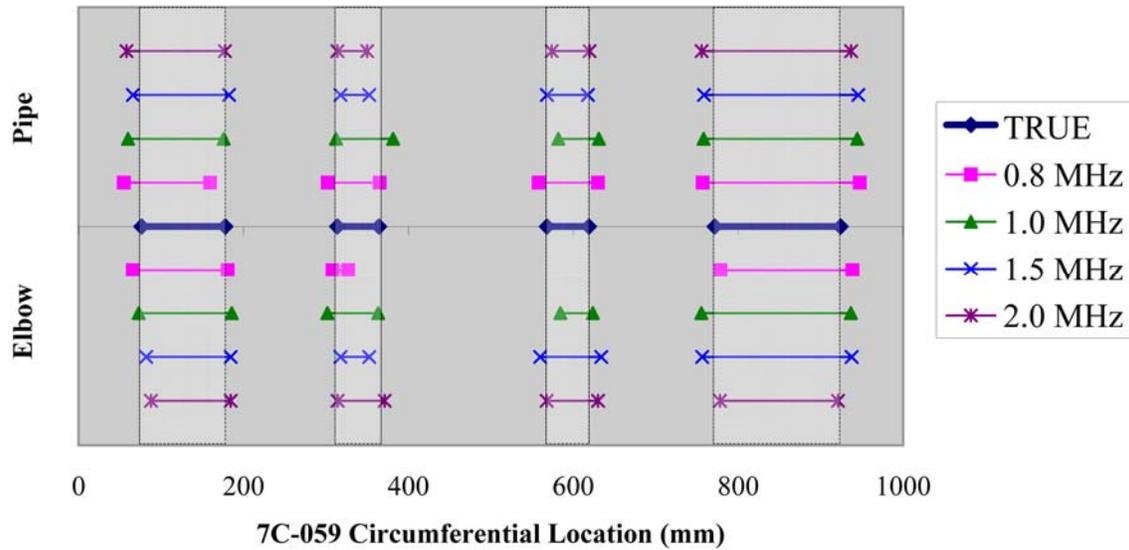
**Figure 7.12.** Map of True-State and Measured, Circumferential Flaw Localization Data for CASS PZR Surge-Line Specimen 7C-059

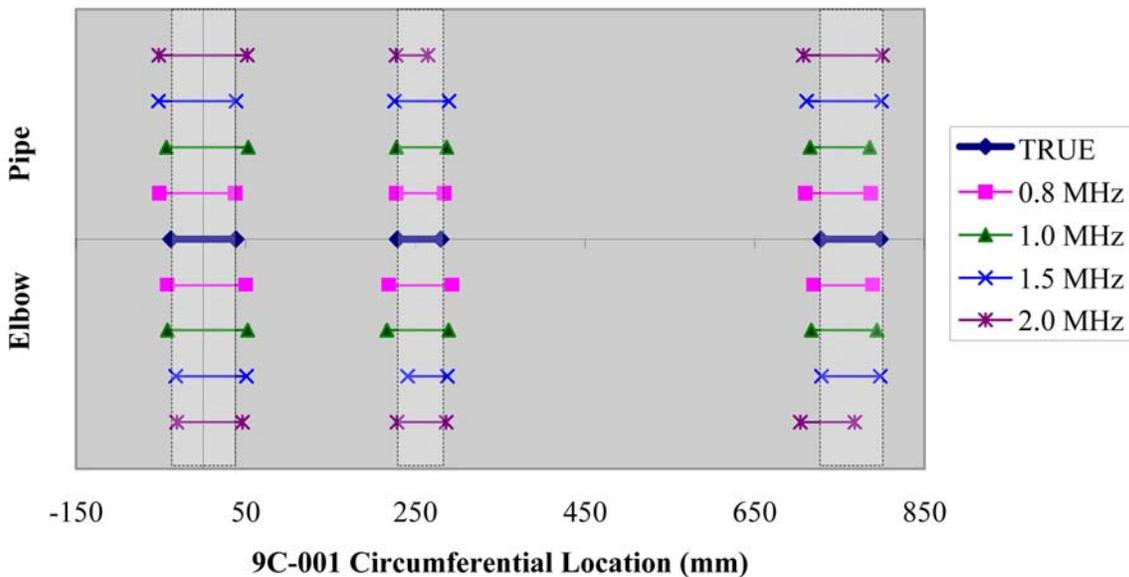
**Figure 7.13.** Map of True-State and Measured, Circumferential Flaw Localization Data for CASS PZR Surge-Line Specimen 9C-001

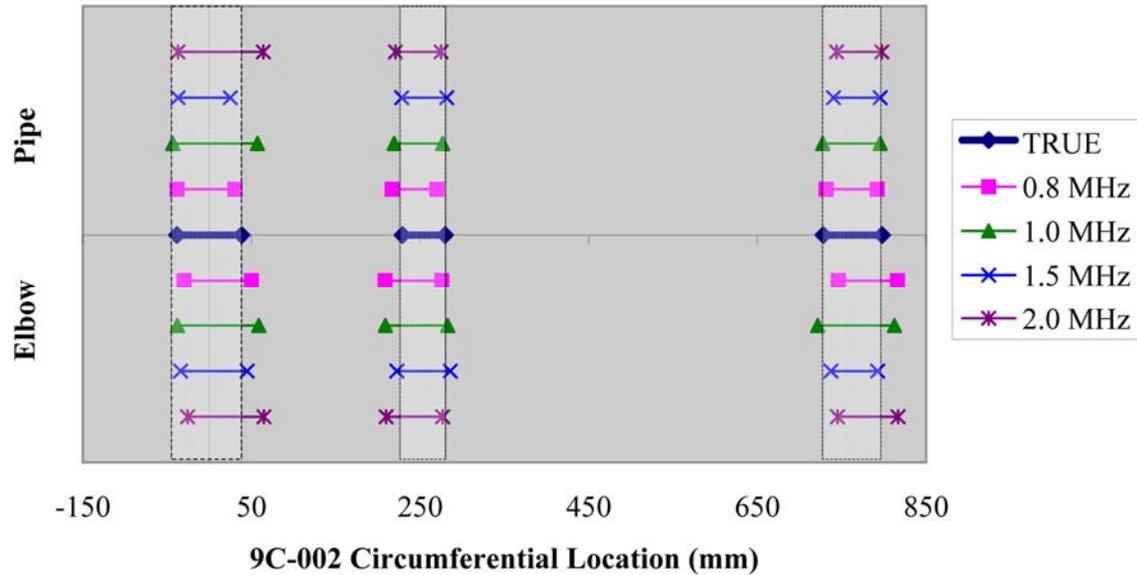
**Figure 7.14.** Map of True-State and Measured, Circumferential Flow Localization Data for CASS PZR Surge-Line Specimen 9C-002

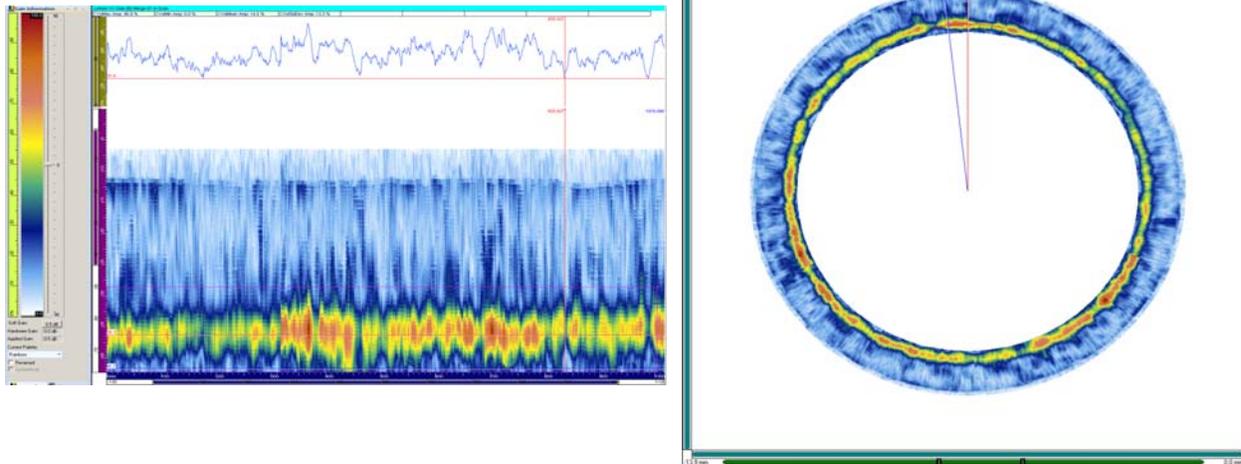
**Figure 7.15.** Pipe End Corner Response on 9C-001 at 800 kHz. The end view is on the left and the polar view on the right. A signal dropout of 0.2% is measured from the contour line in the end view.

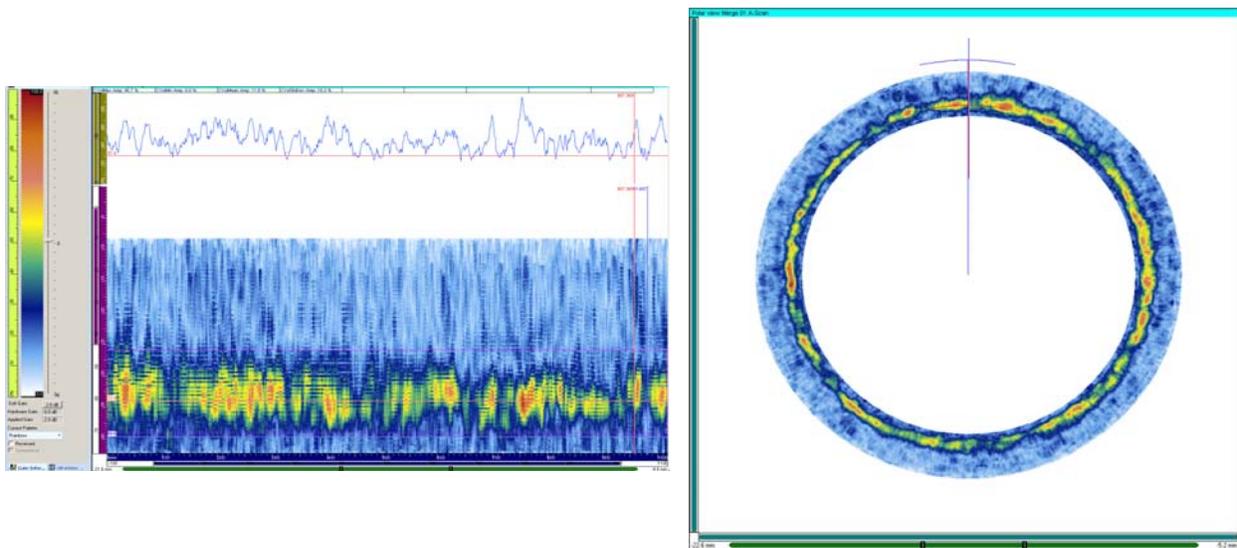
**Figure 7.16.** Pipe End Corner Response on 9C-001 at 1.5 MHz. The end view is on the left and the polar view on the right. A signal dropout of 5.2% is measured from the contour line in the end view.

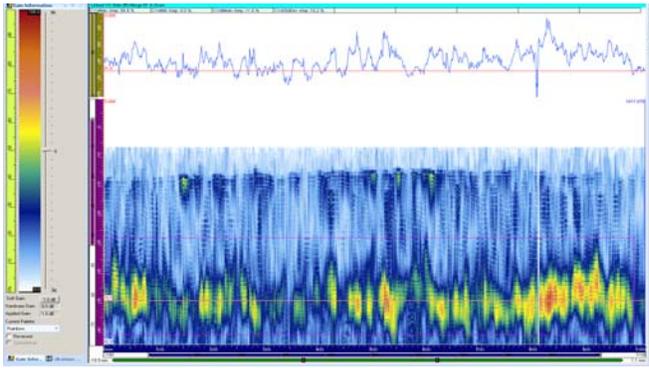
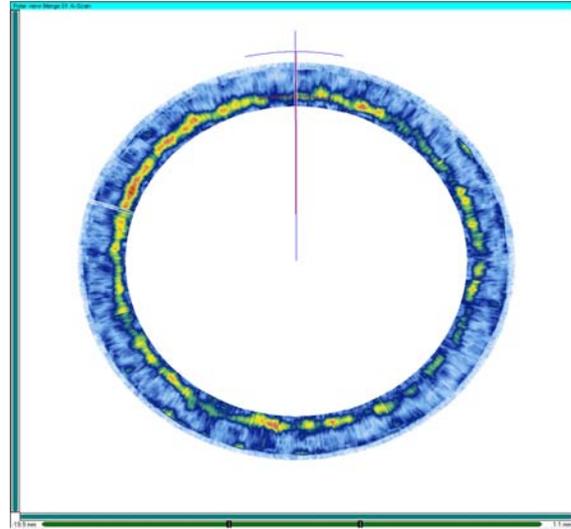
**Figure 7.17.** Pipe End Corner Response on 9C-002 at 800 kHz. The end view is on the left and the polar view on the right. A signal dropout of 14.4% is measured from the contour line in the end view.

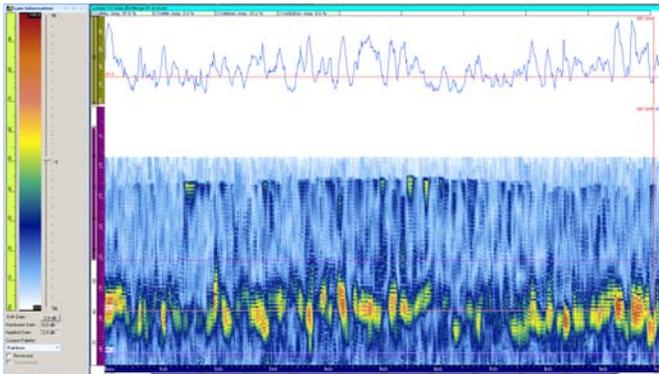
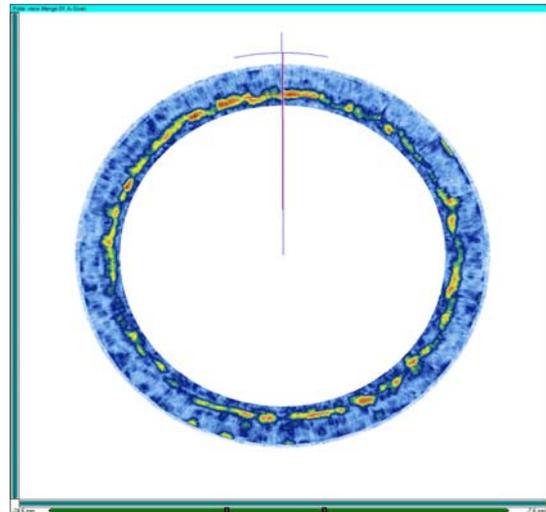
**Figure 7.18.** Pipe End Corner Response on 9C-002 at 1.5 MHz. The end view is on the left and the polar view on the right. A signal dropout of 27.9% is measured from the contour line in the end view.

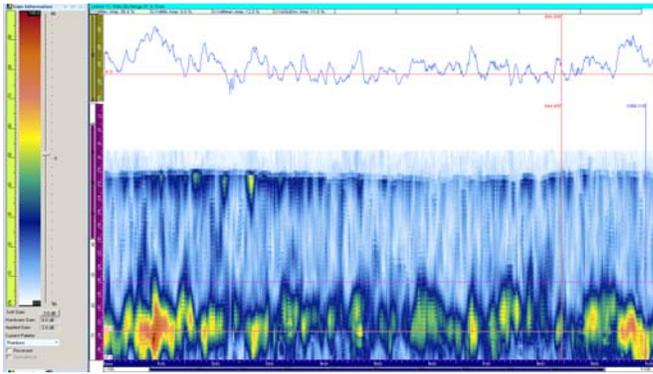
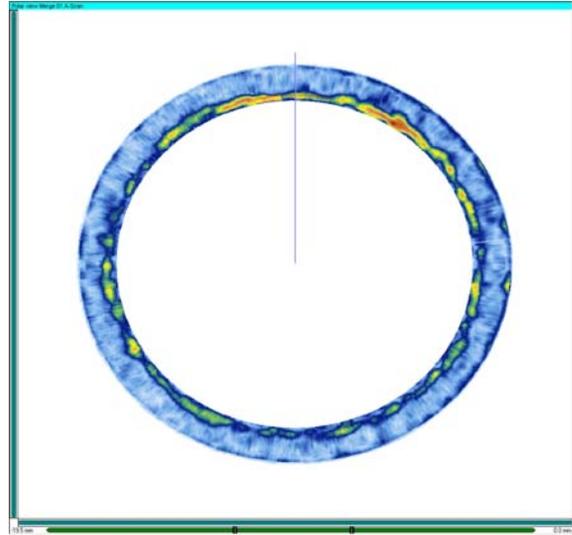
**Figure 7.19.** Pipe End Corner Response on 7C-059 at 800 kHz. The end view is on the left and the polar view on the right. A signal dropout of 22.5% is measured from the contour line in the end view.

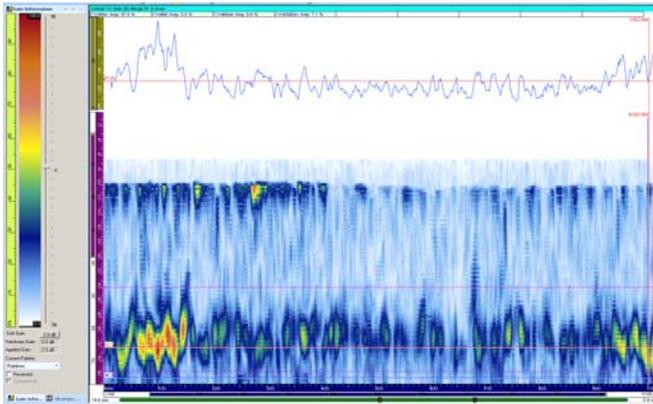
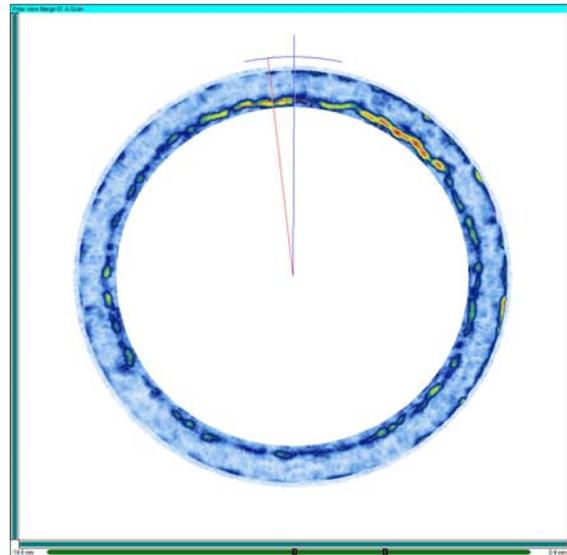
**Figure 7.20.** Pipe End Corner Response on 7C-059 at 1.5 MHz. The end view is on the left and the polar view on the right. A signal dropout of 60.9% is measured from the contour line in the end view at a  $-10$  dB level (0.31).

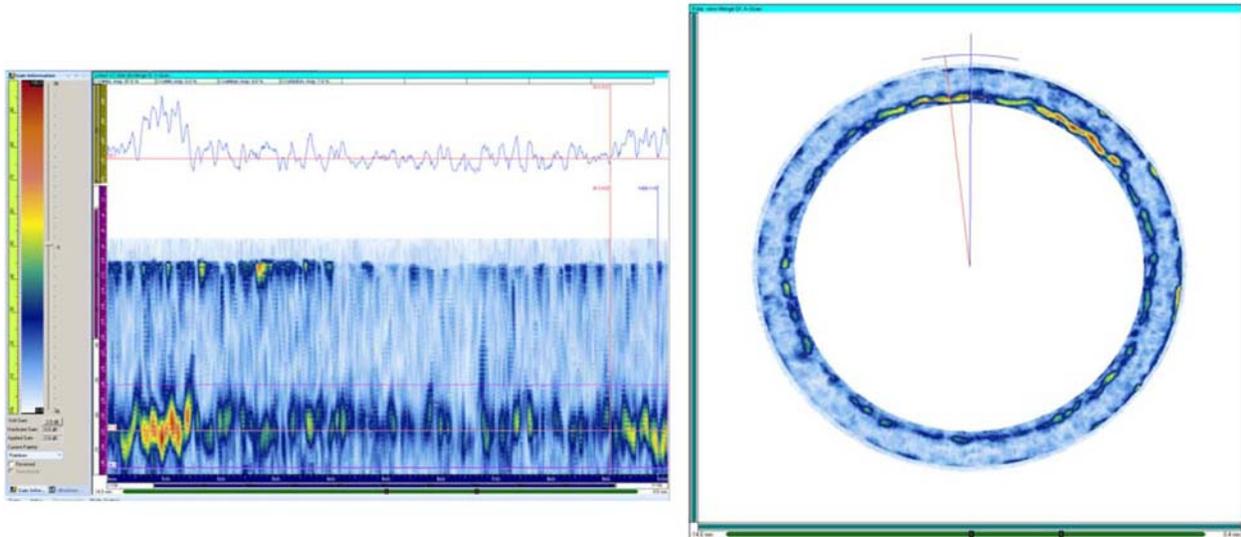
**Figure 7.21.** Pipe End Corner Response on 7C-059 at 1.5 MHz. The end view is the same as in Figure 7.20 but the threshold for the signal dropout measurements has been lowered to  $-12$  db (0.25 level). A signal dropout of 31.4% is measured at the  $-12$  dB level.
