PNNL-19010

Evaluation of Ultrasonic Measurement Variation in the Double-Shell Tank Integrity Project

AF Pardini
DR Weier
SL Crawford
JT Munley

January 2010

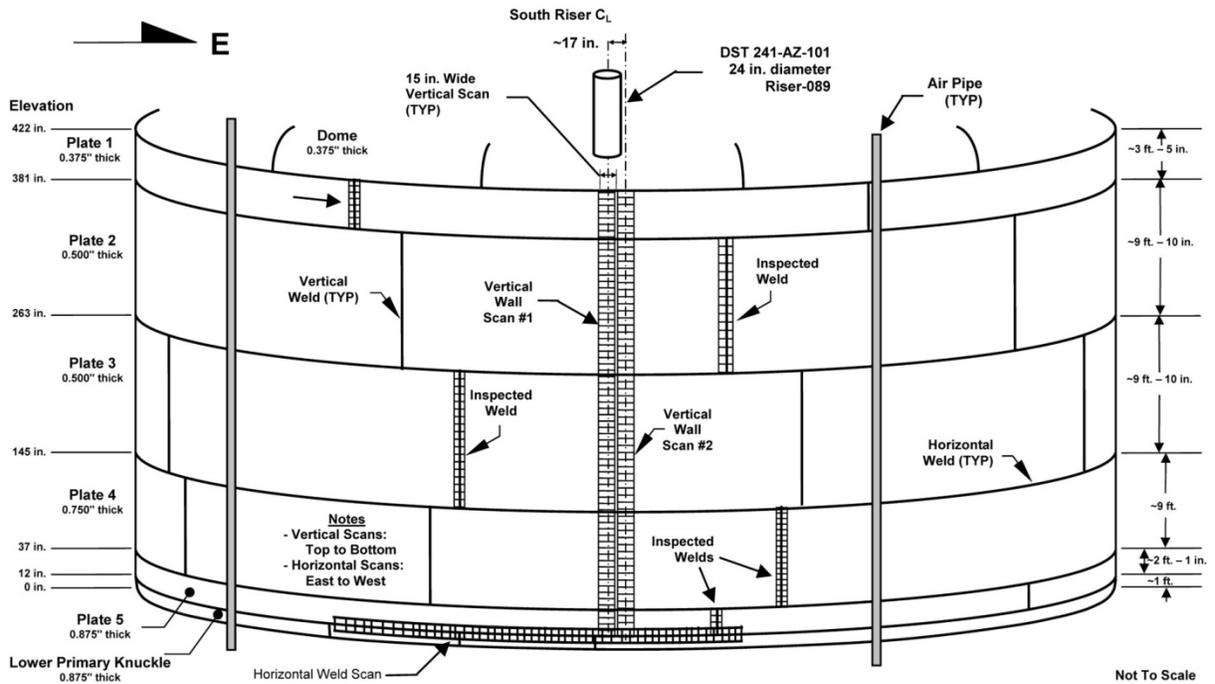
Figure 2.1. Typical Tank Examination Areas

The requirements for the UT inspections are defined in RPP-7574, *The Double-Shell Tank Integrity Program Plan* (Boomer, 2007). The primary tank wall examination consists of two vertical 15-inch-wide wall scans down the height of the tank along with vertical and horizontal welds areas. Additional scans of the tank knuckle are sometimes performed. The vertical wall scans are performed in both of the 24-inch risers for a total of four 15-inch strips and would provide the data necessary for corrosion comparisons. Figure 2.1 provides a graphic of a typical tank examination.

Typically, only one of the risers includes the weld scans and any knuckle scans. From Figure 2.1, it can be visualized that an additional two vertical wall scans would be completed in a riser that is diametrically opposite from the shown riser. The DSTs that have been UT scanned twice in approximately the same locations (as close as possible) to provide comparison wall thickness measurements are shown in Table 2.1.

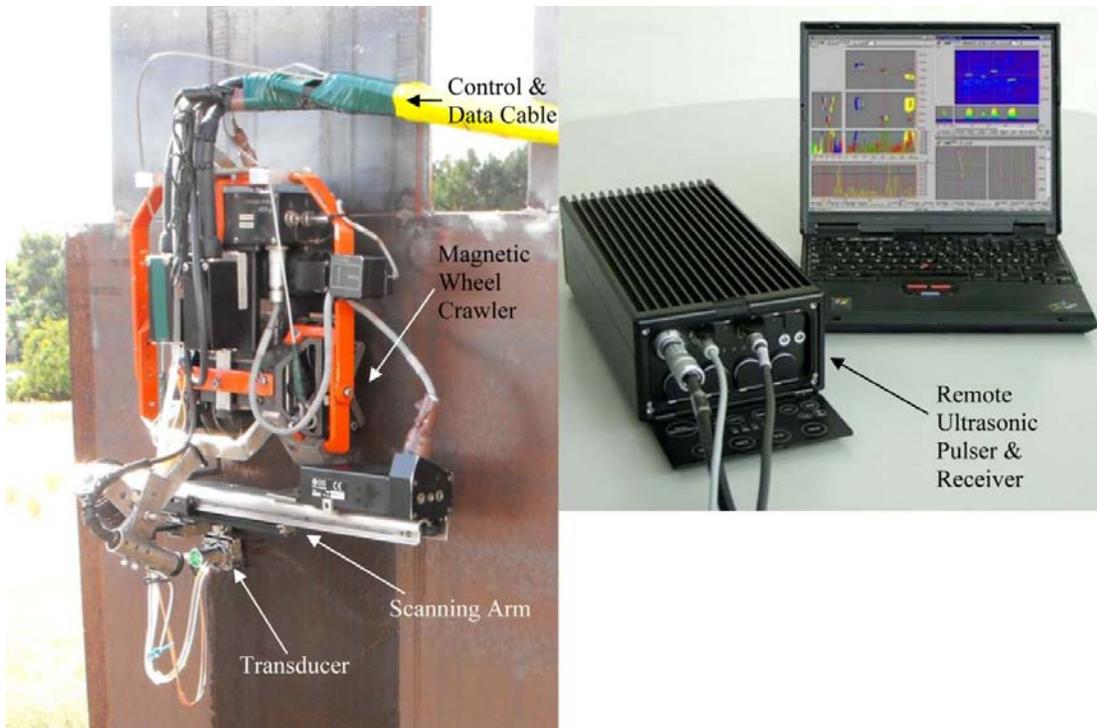
Figure 3.1. Ultrasonic Scanning System Used on Hanford Waste Tanks

The contractor AFS uses UT equipment designed and fabricated by Force Technology^(a) for the examination of the DSTs at Hanford. The ultrasonic pulser and receiver used in the initial scanning of the first four tanks shown in Table 2.1 is the PSP-3. The PSP-3 is the third-generation P-scan ultrasonic system developed and delivered by Force Technology. The rest of the remaining five tanks shown in Table 2.1 were scanned with the newer model PSP-4. The scanning system is comprised of the P-scan ultrasonic system and a Force AWS-5D magnetic wheel crawler and scanning arm. This crawler and scanning arm were used for all of the nine tanks shown in Table 2.1. Figure 3.1 shows a picture of the PSP-4 ultrasonic scanning system.

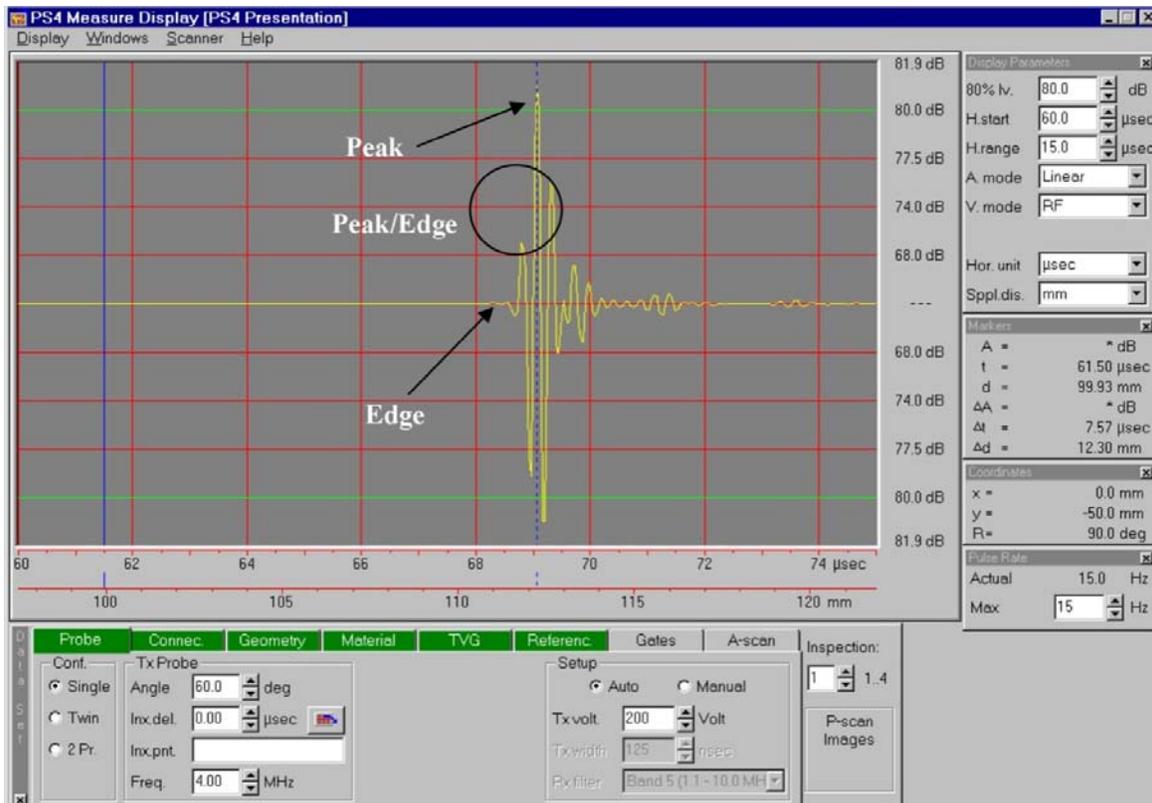
Figure 3.2. UT Signal Analysis on Back Wall Echo

It is important to understand that calibration of the system is the method used to verify that the system is measuring correctly. The portion of the signal that a UT operator is using whether it is the edge, peak/edge, or peak is calibrated using a known material of a specific thickness. This calibration procedure is done using the measurement mode of operation. The back-wall signal from the calibration standard is peaked and the index delay is set to provide the correct thickness. The setting of the index delay is based on whether you are calibrating using the edge portion of the signal, peak/edge portion of the signal, or the peak portion of the signal. Thus, it is important to know which portion of the signal is calibrated when analysis of the data takes place. If, for example, only the peak signal was calibrated prior to acquiring data and then the edge signal was used to analyze the data, a measurement error would occur as the edge signal is sooner in time and would provide a thinner measurement than what is the real thickness.

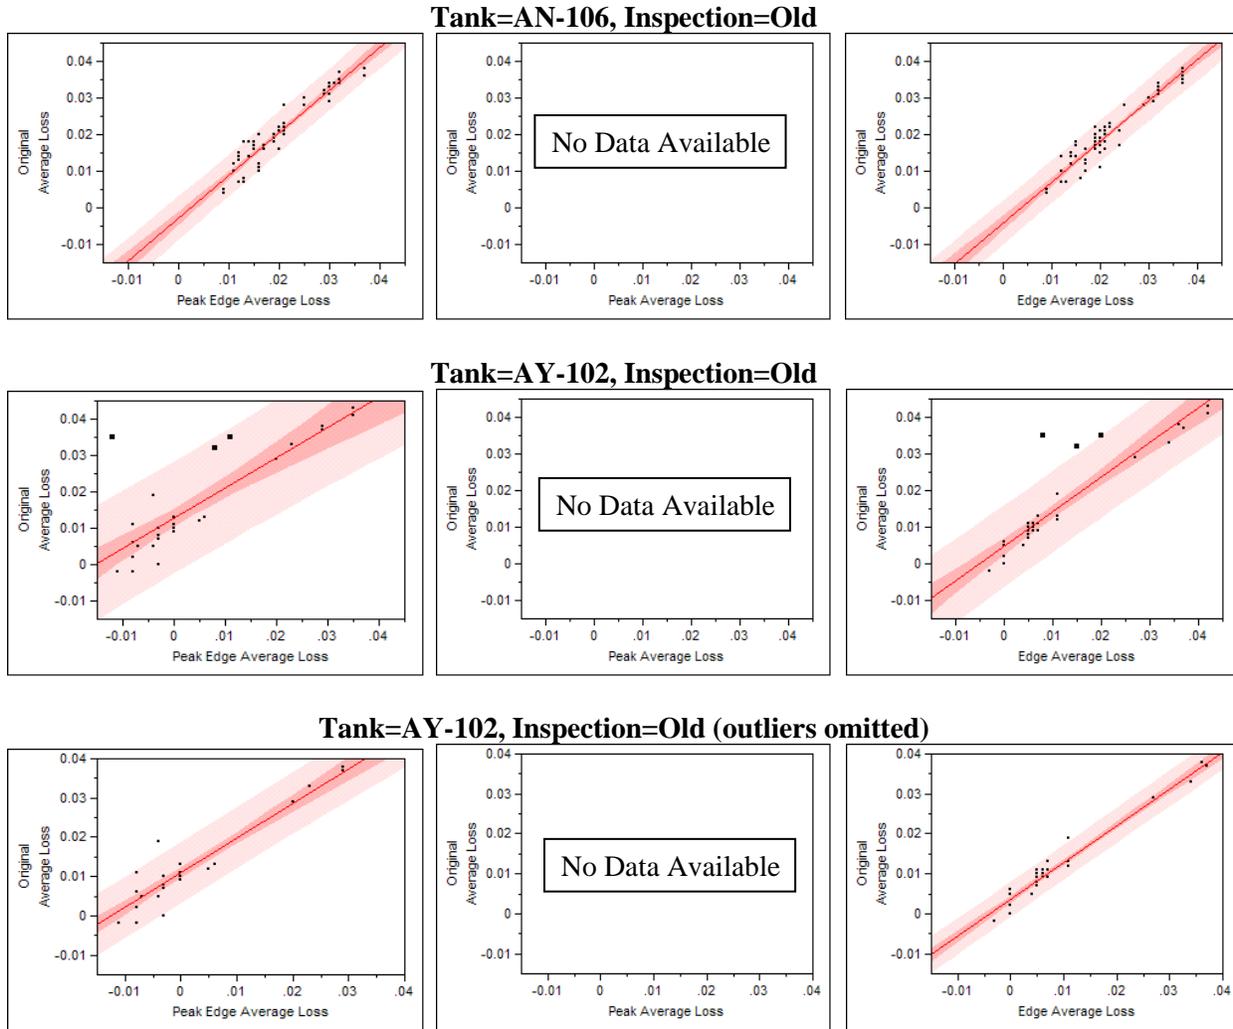
Figure 3.7. Tanks AN-106 and AY-102 Thickness over Nominal Original Method versus Peak/Edge/ Peak/Edge

Figure 3.7 was generated later for Tanks AN-106 and AY-102, for which re-analysis was done only for the old inspections. For AN-106, edge appears to only slightly have a better diagonal fit to the original analysis than does peak/edge; again edge is not available. For AY-102, three outlying values, indicated by the bold points, make it difficult to complete the comparison, so the three outliers are omitted in the final row of plots. Then again edge gives the better fit. These results are used to identify potential biases between old and new inspections and are given in a subsequent table.

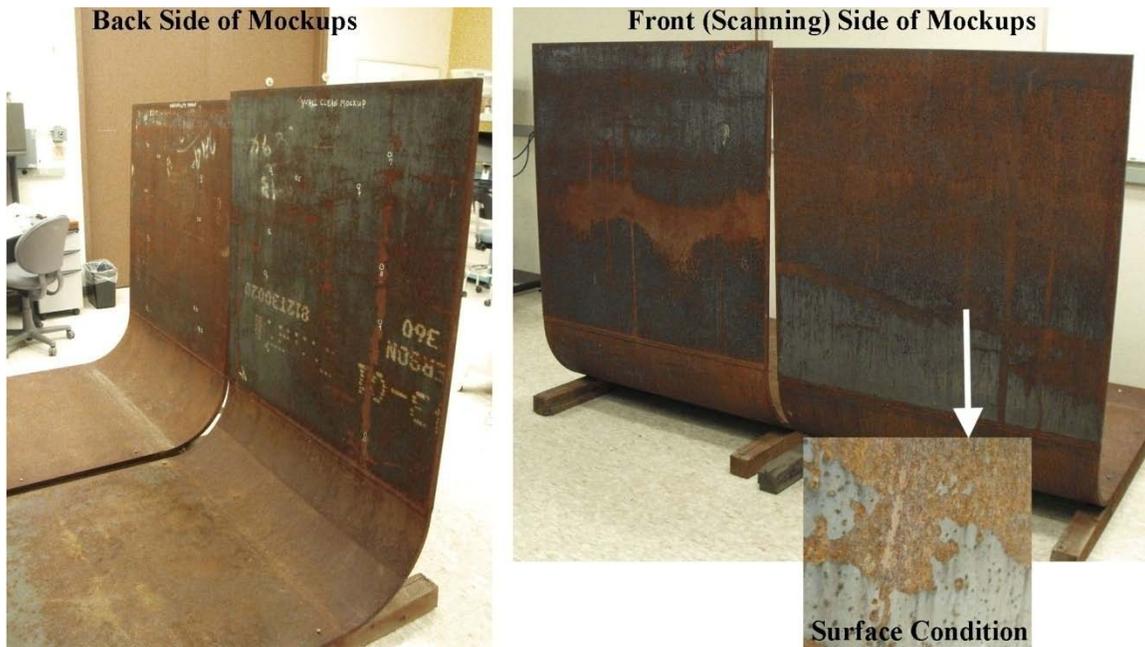
Figure 4.1. Mockups Used in the Study

Baseline measurements were made of both mockups used in this study. Figure 4.1 shows the two mockups that were used. The mockup shown on the left has been designated the Variability Study Mockup and the one on the right is the Wall-Cleaning Mockup. These measurements were made using a digital deep-throat micrometer and a digital ultrasonic instrument calibrated using an existing PNNL step wedge at room temperature.

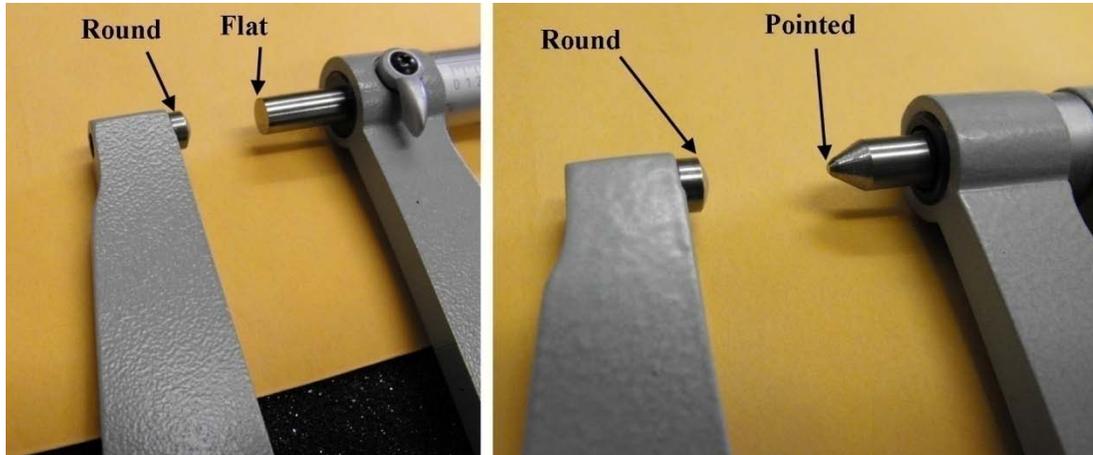
Figure 4.2. Machined Micrometer

The only available (within reason) digital deep-throat micrometer (12-inch throat) came with a rounded barrel on one side and a flat barrel on the other side and had an opening of 1.0 inch. Initial measurements were made using this approach. A second set of measurements were made after machining the flat-barrel side to a point. There was no room to add a precision machined bead, which is normally done. This addition would have provided a better point measurement on the corroded surface of the mockups. Figure 4.2 shows the micrometer prior to and after machining. The manual ultrasonic measurements were made using a small diameter (0.25-inch), 10-MHz transducer with a Krautkramer handheld UT instrument.

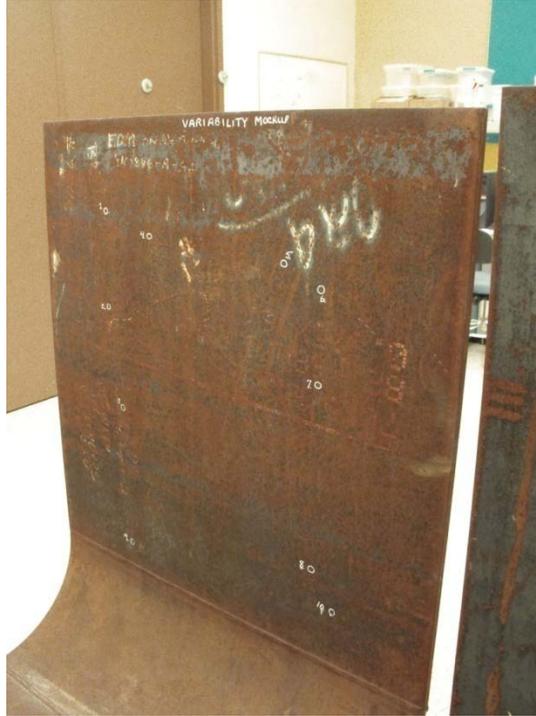
Figure 4.3. Variability Mockup

Figure 4.3 is a photograph of the Variability Mockup used in this study. Staff from PNNL and AFS used the deep-throat micrometer in areas that could be reached using the micrometer. These areas are highlighted with white circles in the photograph. Each is numbered for reference. Table 4.1 provides the measurement values for each of the areas.

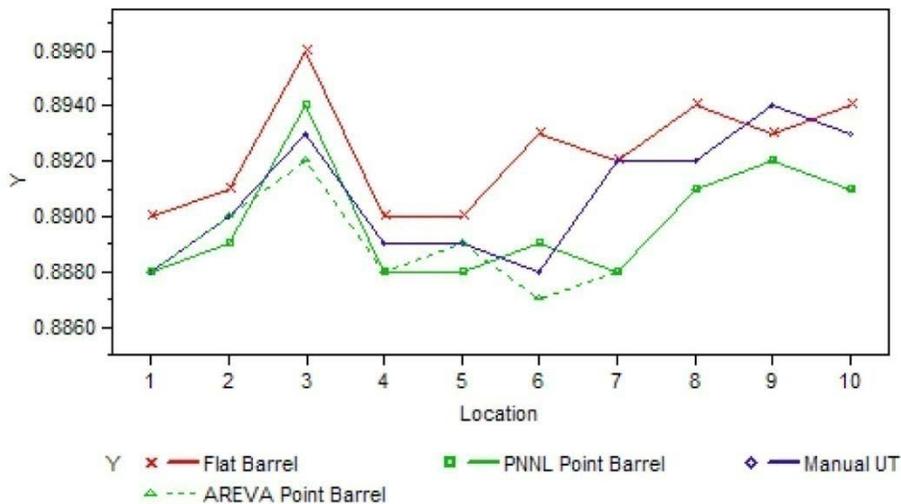
Figure 4.4. Variability Mockup Measurements

These measured thicknesses are displayed in Figure 4.4. The larger measurements due to using the flat-barrel micrometer (red line) rather the point-barrel (green lines) can generally be observed. As expected, very little difference is observed between the AFS and PNNL point-barrel measurements. Summary information is given in the next section following the similar plot for the cleaning study mockup.

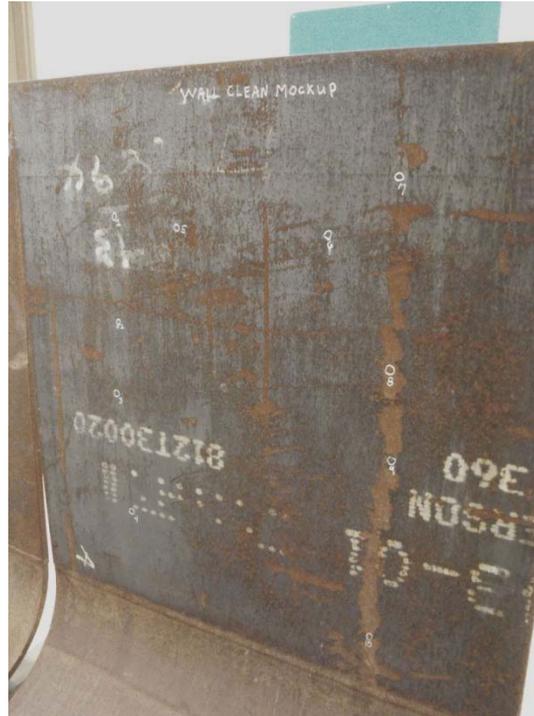
Figure 4.5. Wall-Cleaning Mockup

Figure 4.5 is a photograph of the Wall-Cleaning Mockup used in this study. Using the deep-throat micrometer, measurements were taken in areas that could be reached using the micrometer. These areas are highlighted with white circles in the photograph. Each is numbered for reference. Table 4.2 provides the measurement values for each of the areas.

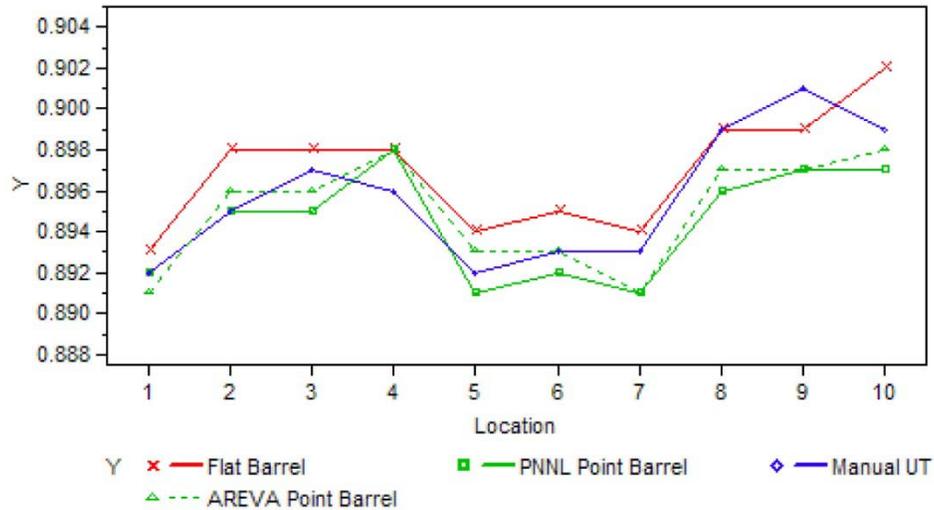
Figure 4.6. Point Study Mockup Measurements

These measured thicknesses are displayed in Figure 4.6. The larger measurements due to using the flat-barrel micrometer (red line) rather the point-barrel (green lines) can again be observed as was the case for the variability mockup in the previous section. And again, very little difference is observed between the AFS and PNNL point-barrel measurements.

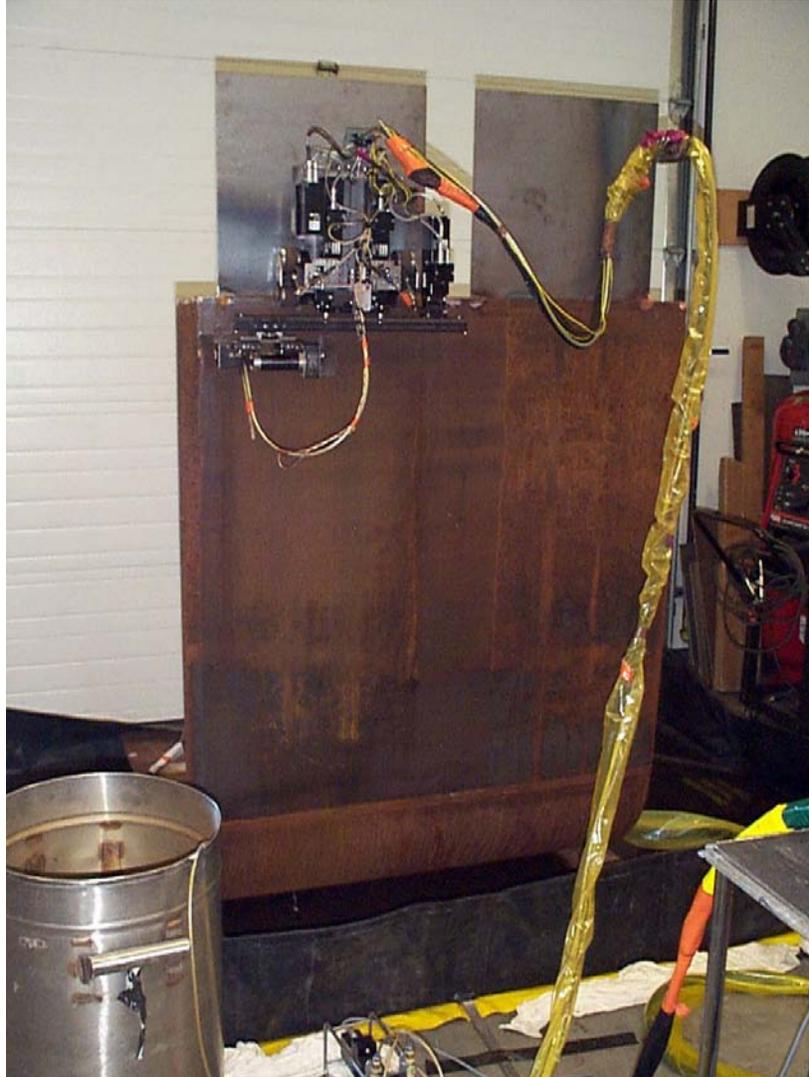
Figure 4.7. Tank Wall-Cleaning Apparatus in Place

Figure 4.7 provides an example of how the wall-cleaning apparatus works. A pneumatic motor rotates the wire brush wheel or, in the case of Figure 4.7, the flapper wheel at high RPM and the scanning arm translates the wheel along the surface. The crawler steps the wheel down the wall for cleaning. A close-up of the flapper wheel apparatus is shown in Figure 4.8. Note that two steel plates approximately 1.5-ft square were welded to the top of the mock-up. This extension was done to allow mounting the scanner so it could begin cleaning/scanning very nearly at the top of the mockup section.

For the stationary measurement indicated by the x's in Figure 4.7, some effort was expended to make sure the crawler was flat against the mockup/tank wall surface. This was more difficult to do for Tank 241-AW-105 due to its rougher wall surface. This also explains why in the Figure 4.7 plots, the greater red point difference is shown for Tank 241-AW-105; the rougher wall causes more lift-off, and it takes a longer time for it to flatten out than in Tank 241-AW-103. Note in Tank 241-AW-103 a brief, more extreme lift-off is shown in the opposite direction for the blue/green points. For the mockup, again the red point bias is more persistent, now across the entire width of the plot.

Overall the 4.6-mil bias caused by including the pixels represented by the red points was reduced to 1.3 mils, an insignificant quantity for indicating a potential difference between stationary and scan measurements. The analysis of bias reduction computations obtained by deleting the lift-off points have not been performed for the two tanks because this topic unexpectedly arose late in the data analyses associated with this report, and the rather involved computations were deferred until after the report draft was to be completed. However, the bias impact due to the red points was computed by including all pixels in the 3-inch square in comparison to the nine stationary points. Refer again to Figure 4.7 to observe the red points targeted for possible omission.

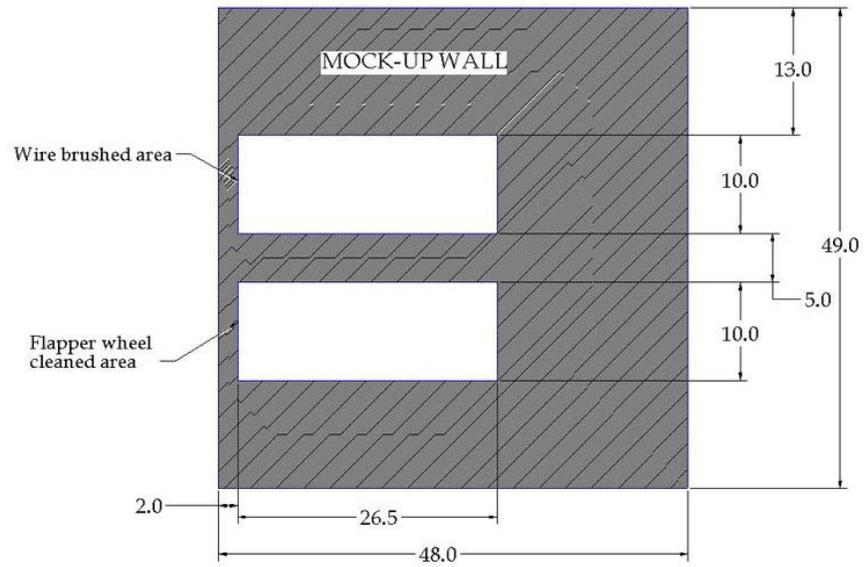
Figure 4.9. Wall-Cleaning Study Dimensions

A single operator, instrument, and transducer was used to inspect a vertical path 15-inch wide, and crossing the two cleaning sections. In this manner, it was intended that 15-inch \times 12-inch UT images would be generated within each area. However, when the analysis results were obtained, they were given in 12-inch vertical increments that did not perfectly match the intended areas. In Table 4.4, some small un-cleaned areas were in fact included in areas that were described as cleaned and vice versa. Pre- and post-cleaning averages for these somewhat mis-aligned UT images were generated and are shown. Initially, requests were going to be made for a new analysis that better fit the images to the cleaned/un-cleaned areas, but when the minimal average thickness differences were observed, little need for doing so was indicated. The data below were, therefore, used in spite of the minor “shifts” that had occurred.

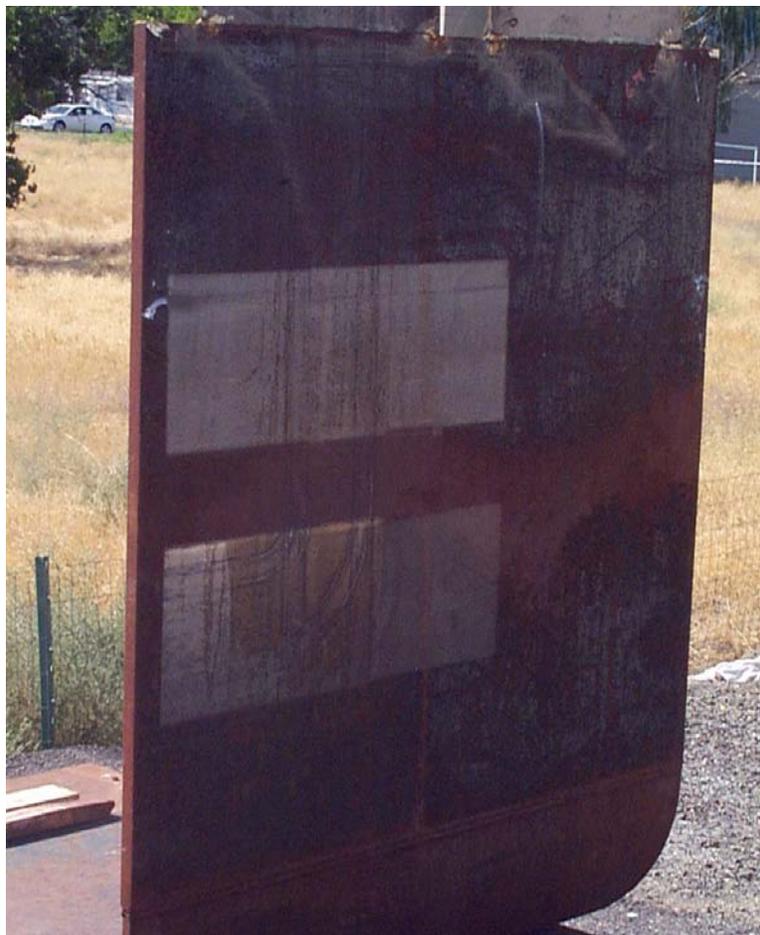
Figure 4.10. Results of Wall-Cleaning Activities

Figure 4.9 shows dimensional information relating to the actual wall-cleaning test. The cleaning of this test plate resulted in four horizontal bands from the top of the plate and down 45 inches. Figure 4.10 shows the actual mockup and the results of the wall-cleaning activities. The upper cleaned area was done using the rotating wire brush. The lower cleaned area was done using the flapper wheel.

A wall-cleaning study was performed in September 2009 to help understand whether cleaning of the tank wall could affect the UT thickness measurements. A well-rusted mock-up plate was used for this study.

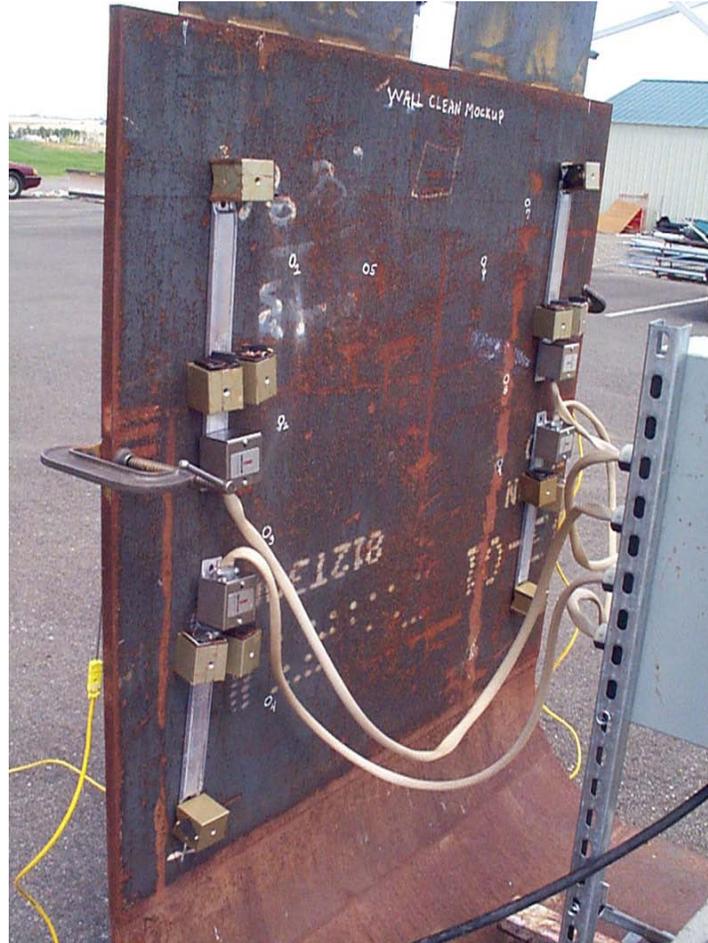
Figure 4.12. First Mockup Heater Configuration Using Four Heaters

To obtain the temperature for the test, high-wattage heaters were fastened by magnetic fixtures to the back of the mockup and used to heat the plate for this test. Initially four heaters were used (see Figure 4.12). Infrared images of the mockup showed that heat distribution with four heaters was localized and uneven after 18 minutes of operation. This configuration led to uneven heating, see Figure 4.13.

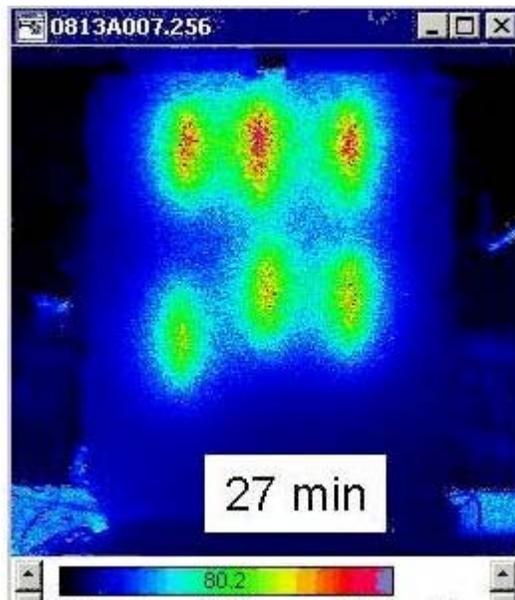
Figure 4.14. Six-Heater Distribution After 27 Minutes

In an effort to attain a more homogeneous heat distribution, two additional heaters were added to the center of the plate, the four outer heaters were moved closer to the center, and thermal insulating blankets were used to cover the plate back to limit heat losses. This configuration did improve the distribution of heat in the plate (Figure 4.14), but even with the six-heater configuration the distribution of heat was not satisfactory.

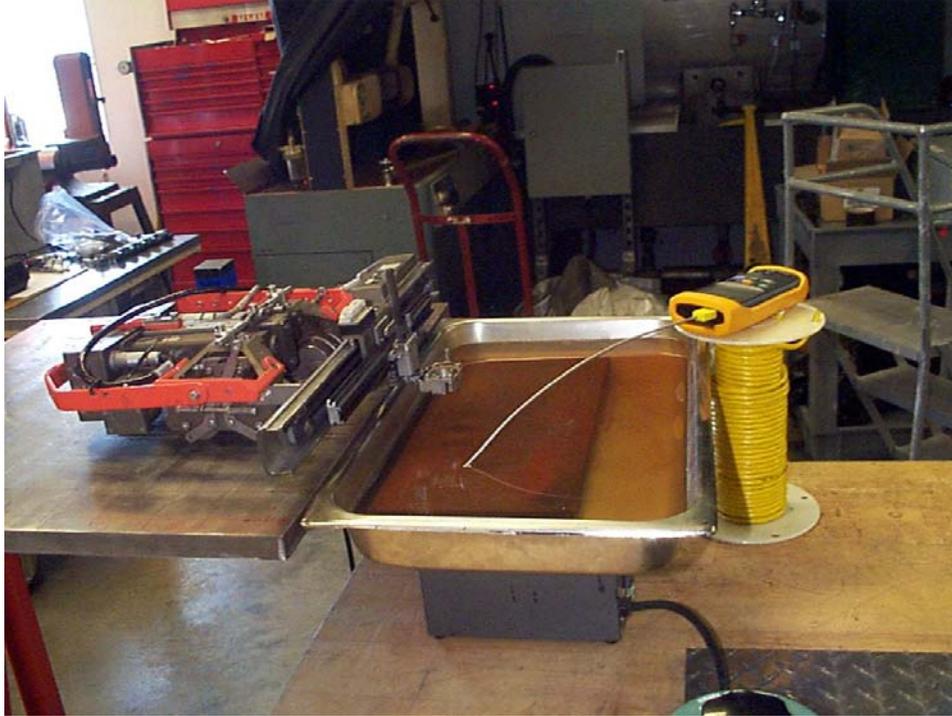
Figure 4.15. The Test Block in Heated Water Bath

So it was decided to reconfigure the experiment to utilize a single, much smaller plate (termed the test block in this section of the report) in a heated water bath (Figure 4.15). A laboratory hot plate was used to raise the test block/couplant bath temperature to the desired test points as reported by the thermocouple-type thermometer shown in the photo.

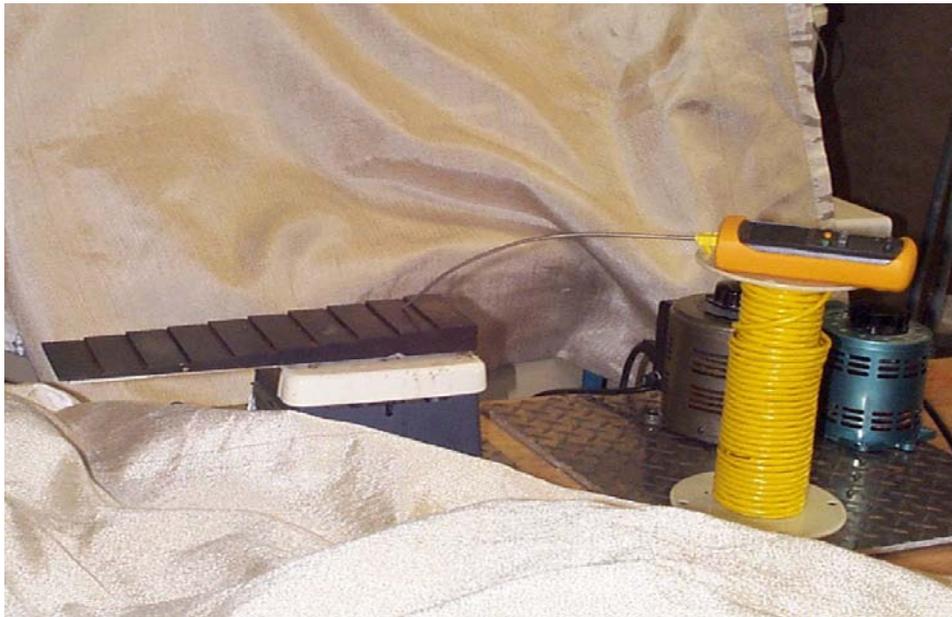
Figure 4.16. Heated Calibration Standard Being Monitored by Thermocouple

At the same time, a calibrated standard was raised to predetermined temperatures using a hot plate as shown in Figure 4.16.

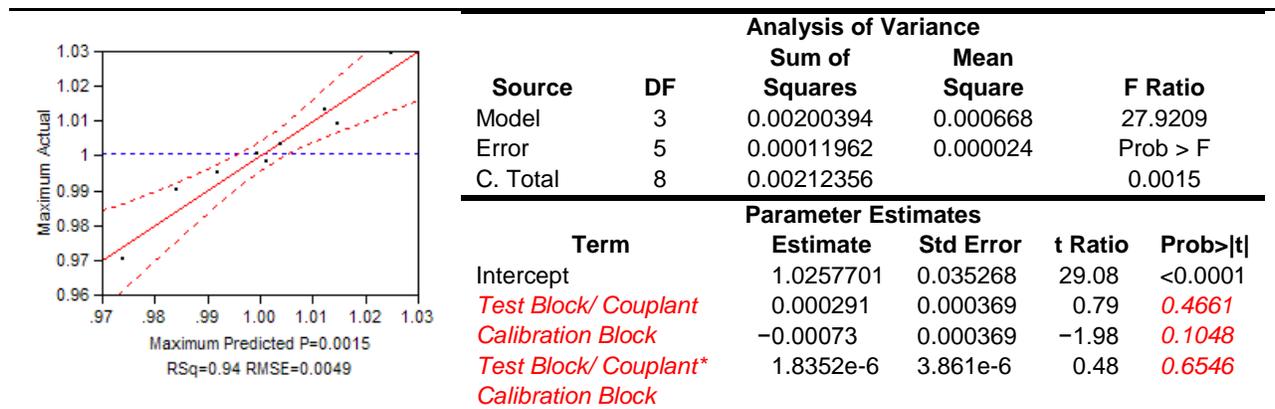
Figure 4.18. Response Maximum – with Interaction

A regression analysis was also performed for the maximum thickness shown in Figure 4.18. Results are very similar for both thicknesses.

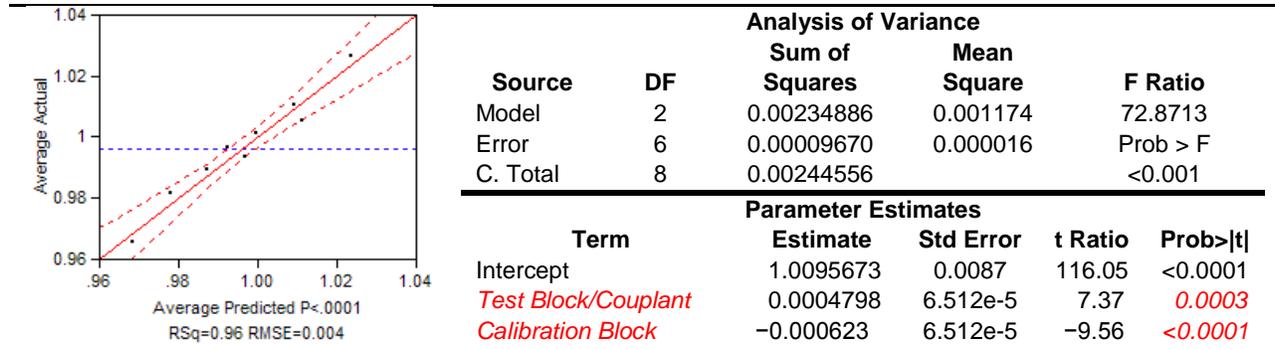
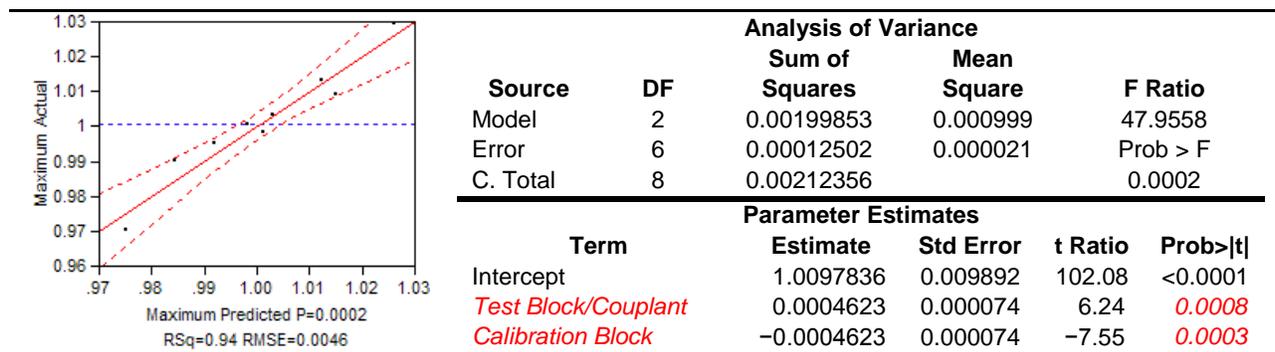
differences between the calibration block and the test block/couplant. That is probably the most important point of this whole topic. That analysis is presented following the no-interaction models in Figure 4.19 and Figure 4.20.

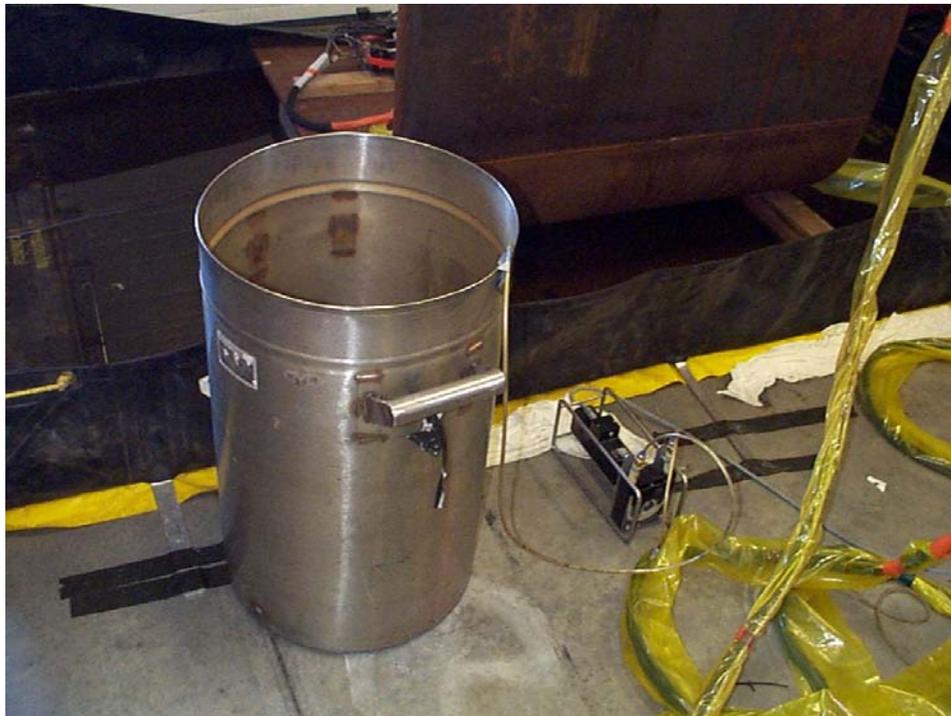
Figure 4.23. Reservoir Used to Control Couplant Temperature

In the study, heaters were used to control the test block and calibration block temperatures during testing. The couplant (water) was also varied to represent possible water temperatures that could be used during an examination. Figure 4.23 shows the reservoir used to control couplant temperature during this test.

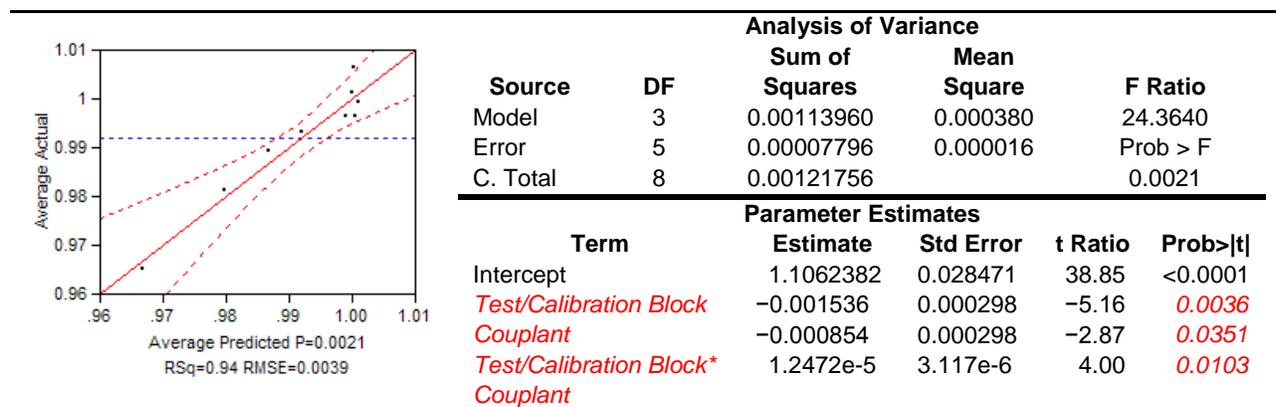
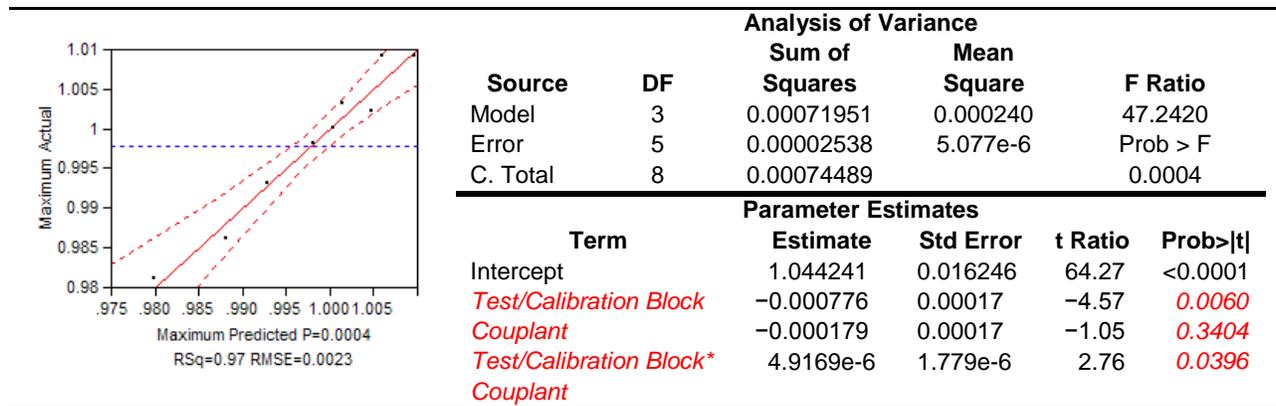
In Figure 4.24, for the thickness averages, the r-square value is 0.94 or 94%, so indeed most of the thickness changes are again related to temperature changes. The 6% of variability remaining unexplained is possibly due to actual wall thickness changes or other causes of measurement uncertainty/variability. The values under the column heading “Prob >|t|” are p-values that indicate the statistical significance of the amount of measured thickness variability explained by the associated terms listed under the “Term” column. P-values can range from 0.0 to 1.0 with small values indicating large contributions to explaining thickness variability. Figure 4.25 gives the same information for the maximum thickness where the r-square value is 97%.

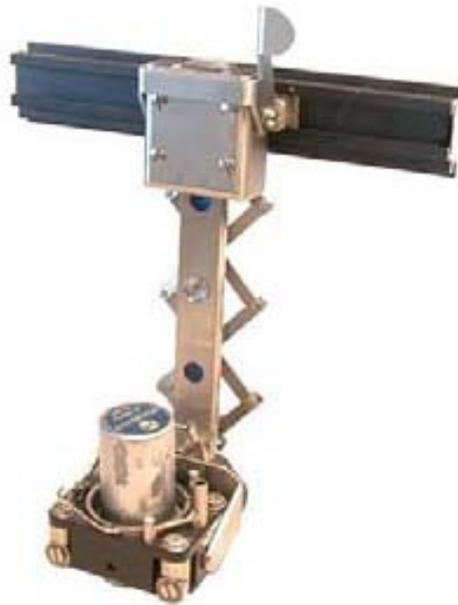
Figure 4.30. Transducer Holder Scissor Assembly

The impact on wall-thickness measurements was evaluated against the amount of tension in the scissor springs (Figure 4.30), which support the transducers. The mockup was scanned in a specific location to ascertain the effect of changing the spring tension. The scanning followed normal procedural steps such as calibration and scanning speeds. An analysis was performed to identify if any variations in the thickness measurements occur in the acquired data.

The transducer holder scissor assembly provides the needed pressure to couple the transducer to the inspection surface. Inadequate pressure could result in lift-off of the transducer and loss of data.

Excessive pressure could cause erratic movement and noise spikes in the data. The current scissor assembly has small springs (wire- and coil-type) attached on the back side of the scissor, which can be removed or added depending on inspection surface conditions. The intent of this test was to test all of the conditions to see what the effect would be on the measurements.

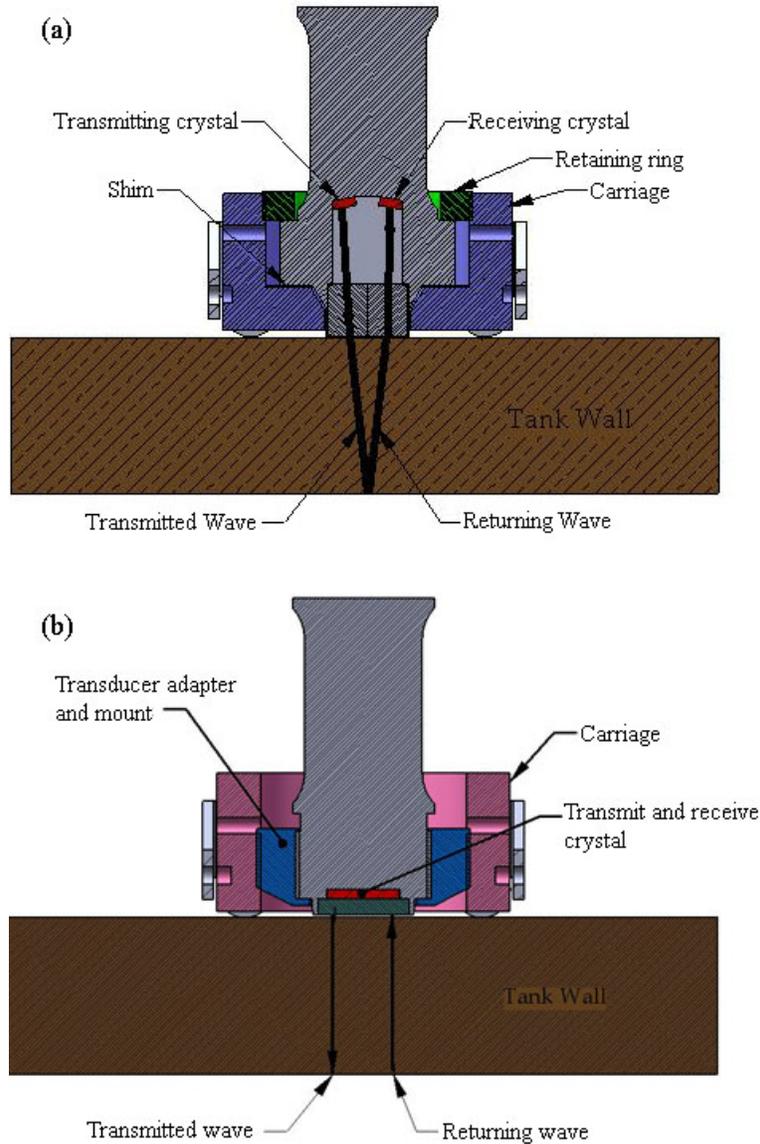
Figure 4.31. Ultrasonic Transducers: (a) dual-element and (b) single-element

evaluated in a laboratory environment with a pulser, receiver, and oscilloscope setup. Then the probes were evaluated with the P-scan system on the step wedge for comparison.

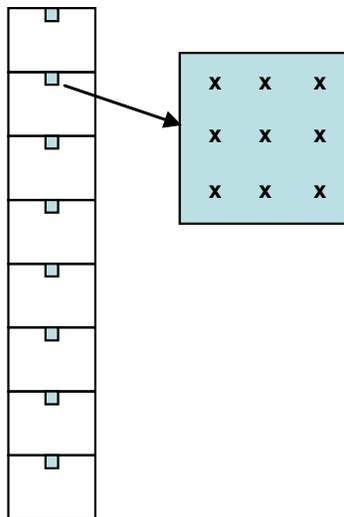
Figure 5.1. Inspection Path and Location of Point Measurements

Figure 5.1 represents a 15-inch wide vertical UT wall-thickness inspection path. On the mockup plate the vertical extent of the path was about 3.5 feet; on Plate 3 of tanks 241-AW-103 and 241-AW-105, this was about 8 feet instead.

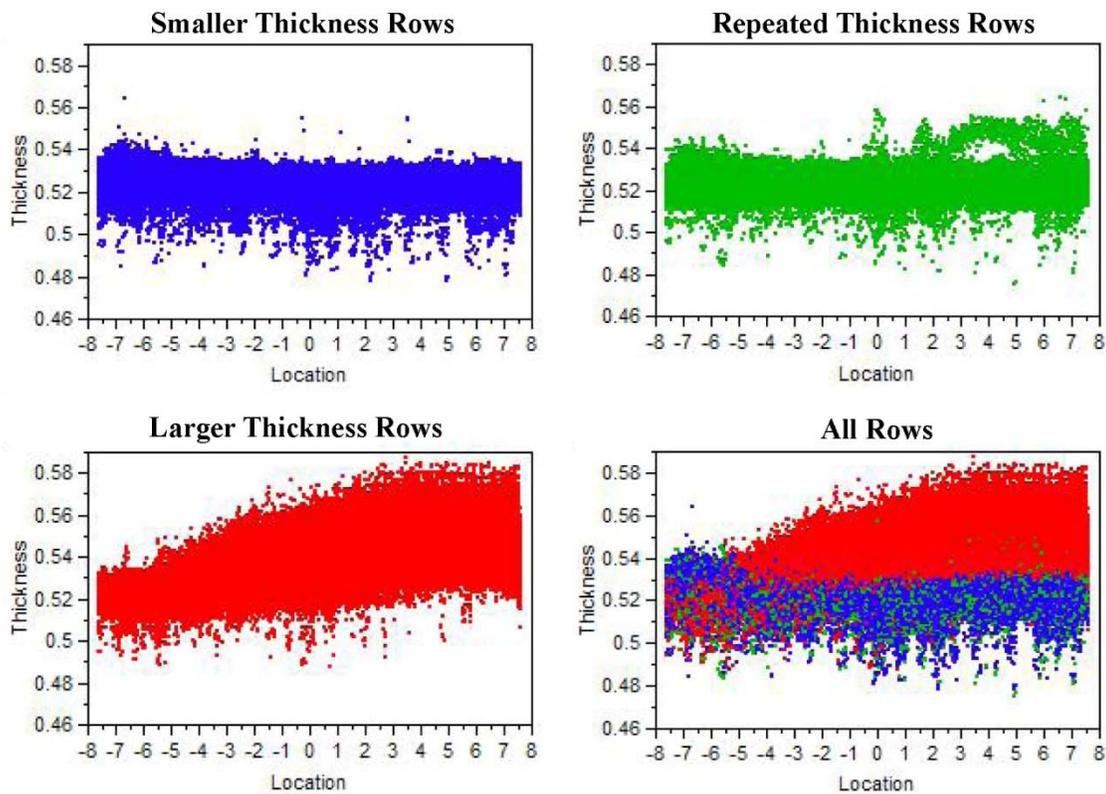
Figure 5.2. AW-105 Average Column Wall Thicknesses

These phenomena were discussed with the Level III inspectors. They said the four/six pattern was known by them and understood. It occurs due to hardware/software characteristics. As was suspected, the red points are caused by lift-off of the transducer when the direction of the scanner is reversed at the right edge of the scan plots shown in Figure 4.29. It gradually settles back down on the plots as the scanner moves left across the plots.

The green and blue points offer the better estimates of wall thickness. The Level III inspectors indicated the red points are not used in their analyses that generate the 12-inch \times 15-inch image minima, maxima, and average thickness. This was indeed observed by the authors when their visual analysis approach was demonstrated.

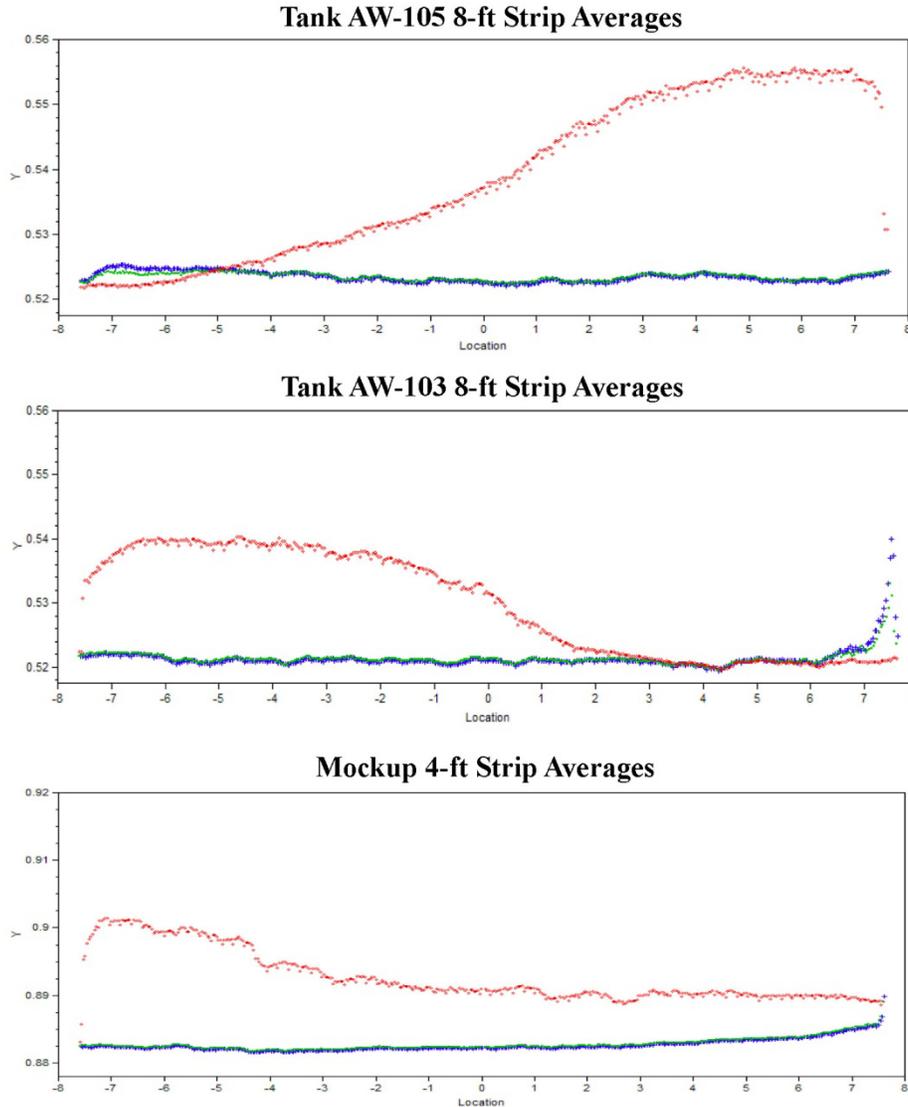
In the corresponding Tank 241-AW-103 and mockup plots in Figure 5.3, the more significant lift-off occurs in the opposite direction. The Level III inspector indicated this can indeed happen instead due to fixture changes. The magnitude of the lift-off wall thickness bias (the vertical distance between the red points and blue/green points) is only about one-half what it was for Tank 241-AW-105, from a maximum there of about 0.040-inch, down to about 0.020-inch.

Colors correspond to those in Figure 5.2.

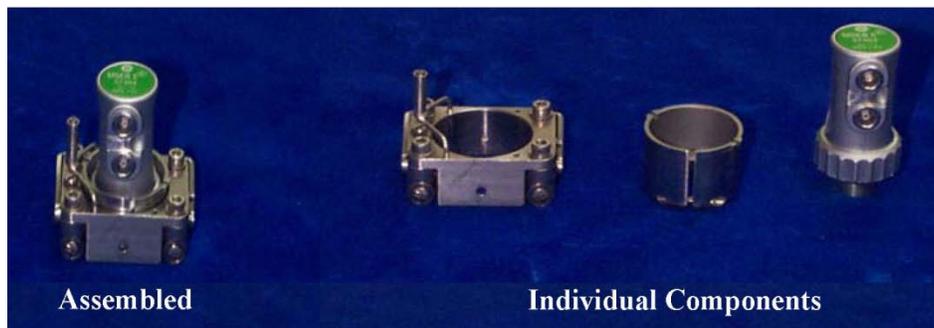
Figure 5.5. Original Transducer and Holder Assembly

In the case of the transducer mount/positioner, PNNL designed and fabricated a prototypical apparatus that used fewer parts and resulted in a much more rigid, stable, and reproducible mounting scheme. Figure 5.5 shows the original configuration assembled and in parts.
