PNNL-19010

Evaluation of Ultrasonic Measurement Variation in the Double-Shell Tank Integrity Project

AF Pardini
DR Weier
SL Crawford
JT Munley

January 2010

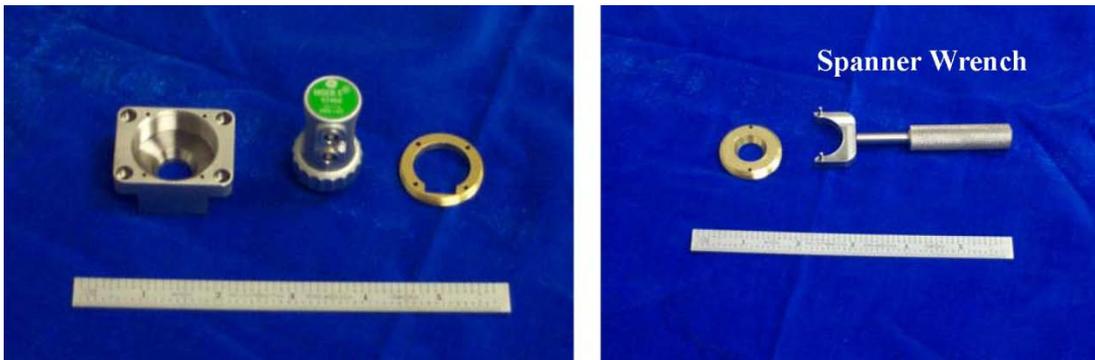
Figure 5.9. Components of the Fixed Position Apparatus and Associated Spanner Wrench

- In the single-ring design, the position of the transducer would be determined by a brass shim of known thickness. This shim would be placed between the bottom of the carriage and the transducer and the single locking ring tightened from the top via a spanner wrench (refer to Figure 5.10 for details).
- In the double-ring design, the position of the transducer is determined by the position of the lower lock ring, which can be adjusted over a range of positions using the same spanner. After the lower lock ring has been positioned, the transducer is installed and again held in place by the upper lock ring. If this position is found to be incorrect, it is a simple matter to reposition the transducer using the spanner to loosen or tighten the two lock rings as appropriate (see Figure 5.10 for details).

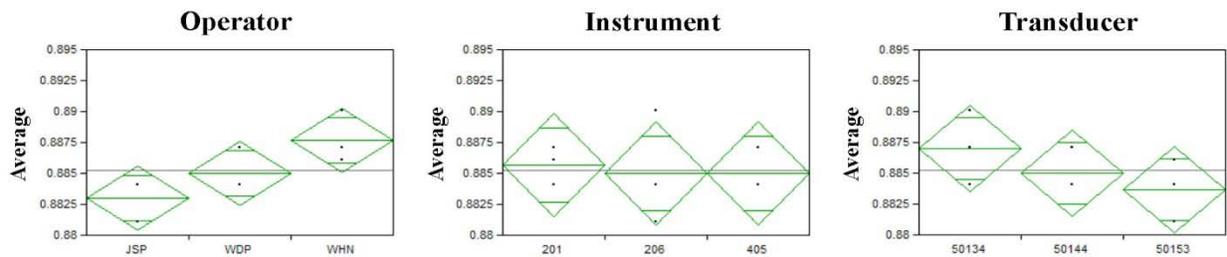
Figure 5.11. Mockup Variability Study Results

The usual visual data analysis was performed on the resulting nine 3-foot vertical paths, thereby generating 27 minimum, average, and maximum UT image wall thicknesses, three per inspection combination. In Figure 5.11 the mockup means of the UT image averages are compared; units are inches throughout with the thickness values shown on the vertical axes. The vertical extents of the green diamonds for each of the levels within the operator, instrument, and transducer factors represent confidence intervals for the means. If they do not overlap vertically, they would be considered statistically different from each other. Here the least difference is shown between the three instrument means because the three diamonds are almost perfectly level. This overlap for instruments alleviates the concern about the wear on the transducers potentially introducing differences between instruments as was discussed earlier.

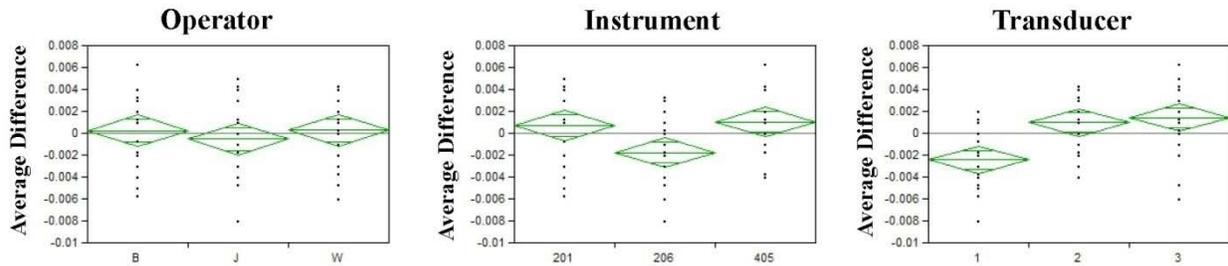
Figure 5.12. Tank Variability Study Results

The instrument and transducer difference would both be considered statistically significant due to their small significance levels in Table 5.6 and differing heights of the green diamonds in Figure 5.12. The instrument means differ by nearly 3 mil and the transducer means by nearly 4 mil. The greater statistical significance of such tank measurement differences as compared to that for the mockup is partially due to the fact that greater amounts of data are available for the tank study (seven UT images rather than only three).
