**Pacific Northwest  
National Laboratory**

**Ultrasonic Examination of Double-Shell  
Tank 241-AP-103 Examination  
Completed April 2003**

June 2003

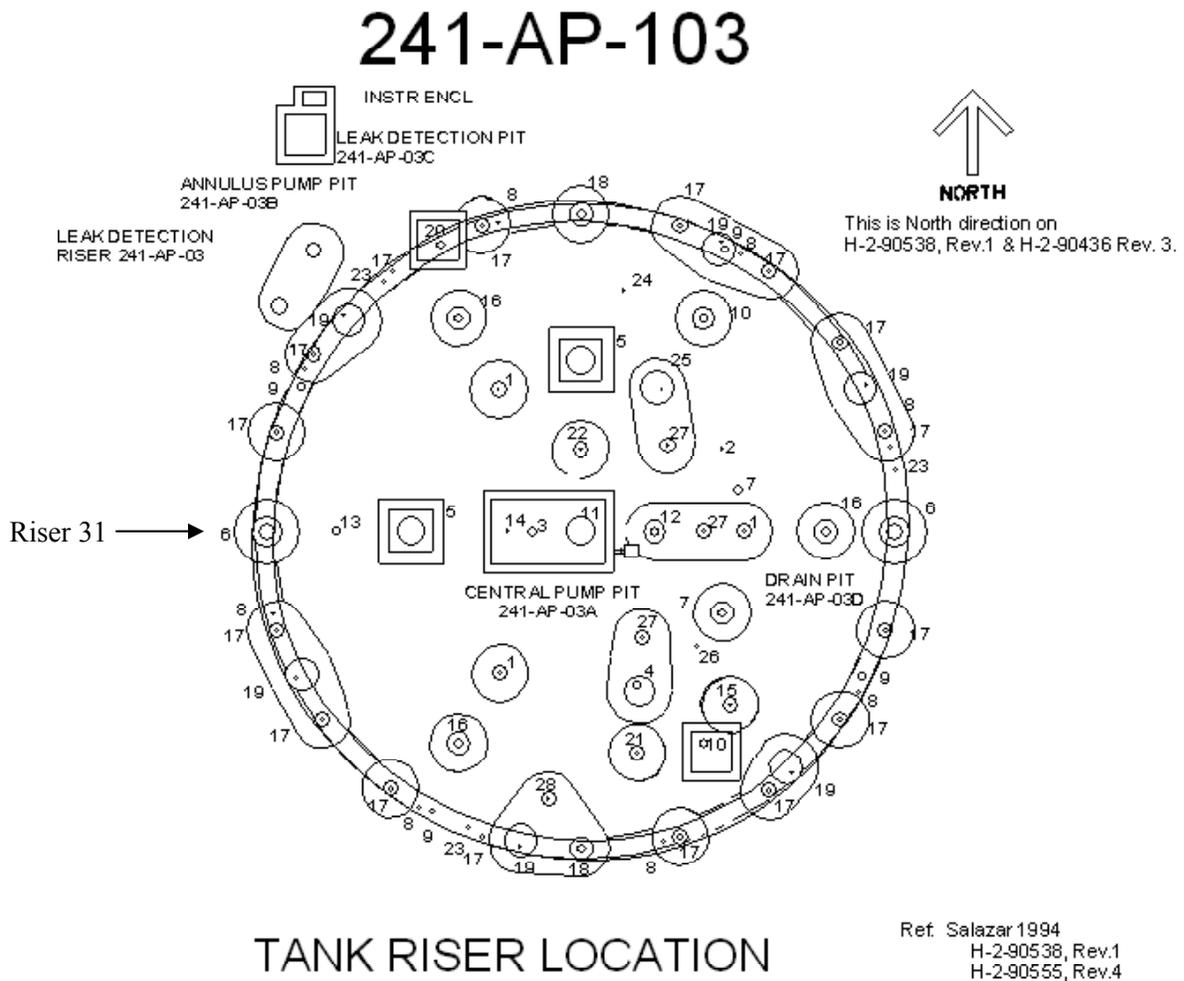
**Figure 4.1.** UT of 241-AP-103 from Riser 31

Tank 241-AP-103 is located in the Hanford 200 East area in AP Tank Farm. The crawler and associated scanner that hold the transducers were lowered into the 24-in. riser located on the west side of 241-AP-103 and designated as Riser 31. Riser 31 was originally called out as Riser 6 West. Figure 4.1 provides a graphic of the location of this riser.
