**Pacific Northwest
National Laboratory**

**Ultrasonic Examination of Double-Shell
Tank 241-SY-101 Examination
Completed March 2004**

A.F. Pardini
G.J. Posakony

May 2004

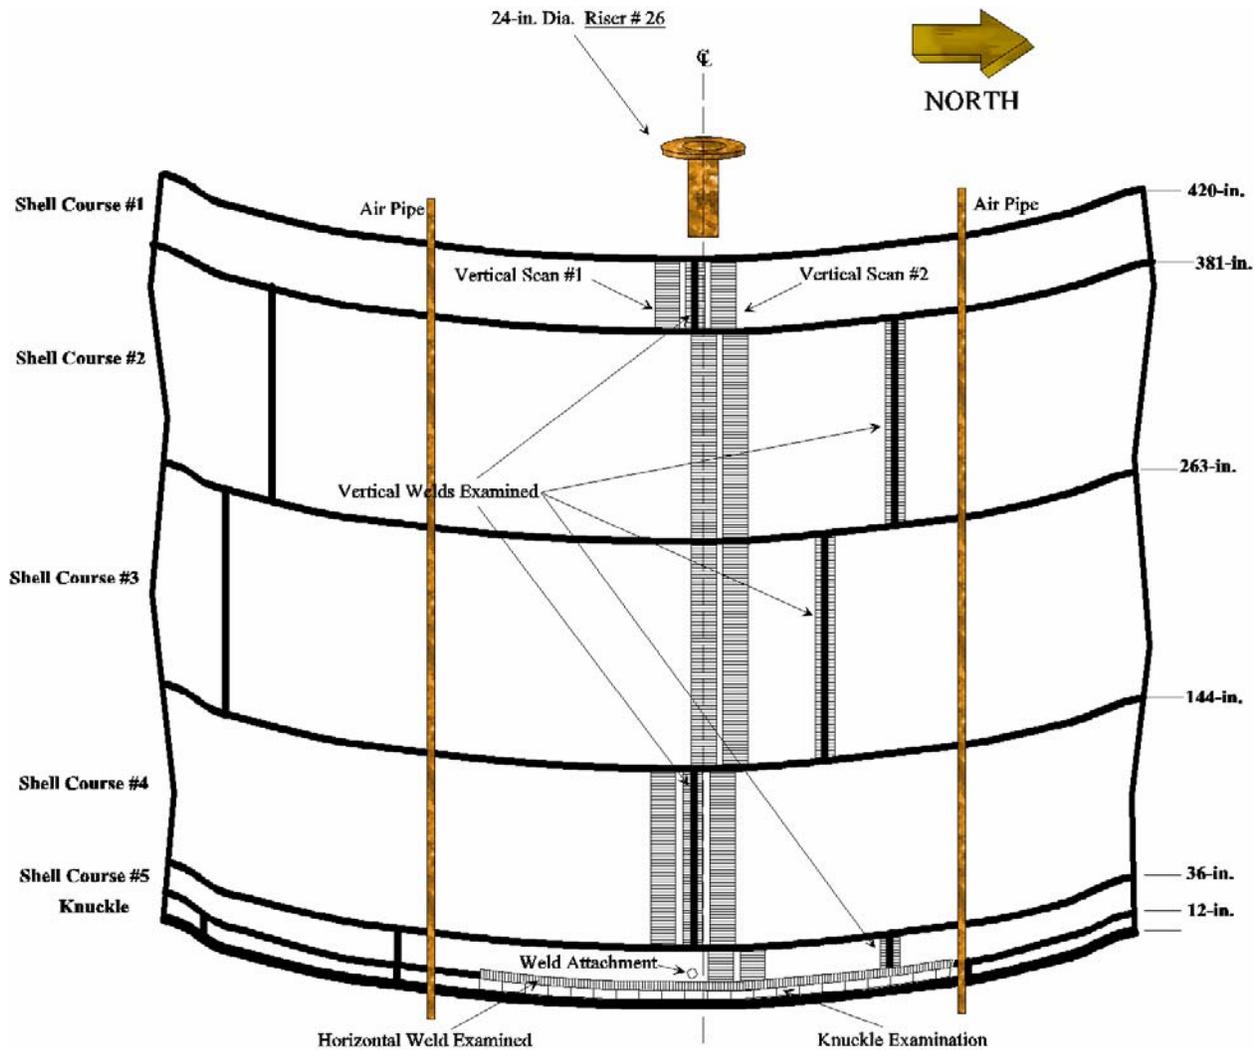
Figure 4.2. Sketch of Scan Paths on Tank 241-SY-101

Figure 4.2 describes the areas on the primary wall of Tank 241-SY-101 that were ultrasonically examined. Two 15-in.-wide vertical scan paths were performed on shell courses #1, #2, #3, #4, and #5 below the entrance to Riser 26. Vertical weld HAZ examinations were done on shell courses #1, #2, #3, #4, and #5, and the horizontal weld HAZ examination was done on the transition shell course #5 to knuckle weld. Examination of the upper portion of the knuckle was also performed.
