PNNL-17488 Rev.1

Ultrasonic Examination of Double-Shell Tank 241-AP-107 Examination Completed February 2008

September 2008

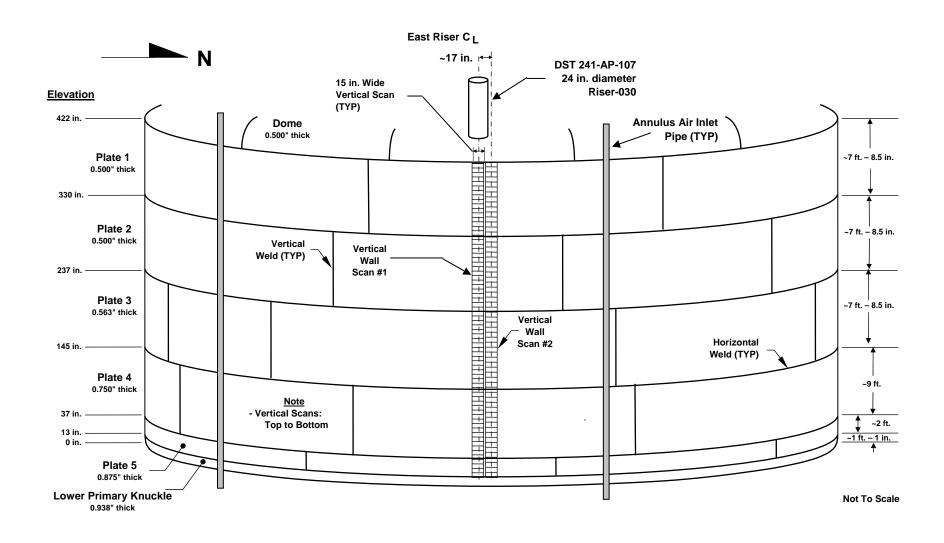
Figure 4.2. Sketch of Scan Paths on 241-AP-107 Primary Tank from Riser 30

Two 15-in.-wide vertical scan paths were performed on Plates #1, #2, #3, #4, and #5 from Riser 30. The plates were examined for wall thinning, pitting, and cracks oriented vertically on the primary tank wall. There were no areas of wall thinning that exceeded the reportable level of 10% of the nominal thickness. No pitting or vertical crack-like indications were detected in Plates #1, #2, #3, #4, or #5.

Figure 4.2 describes the areas on the primary wall of Tank 241-AP-107 that were ultrasonically examined from Riser 30 located on the east side of the tank. Two 15-in.-wide vertical scan paths were performed on Plates #1, #2, #3, #4, and #5 below the entrance to Riser 30.

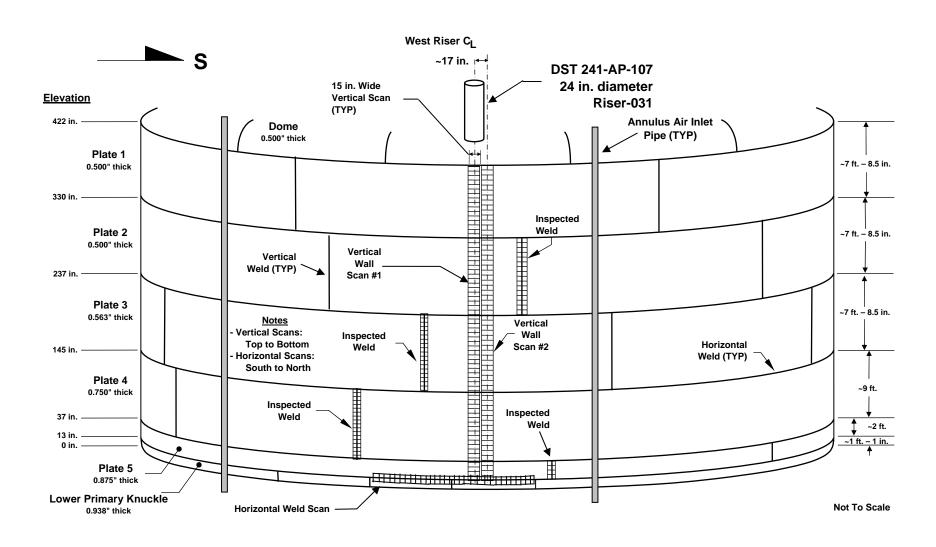
Figure 4.3. Sketch of Scan Paths on Tank 241-AP-107 Primary Tank from Riser 31

Two 15-in.-wide vertical scan paths were performed on Plates #1, #2, #3, #4, and #5 from Riser 31. The plates were examined for wall thinning, pitting, and cracks oriented vertically on the primary tank wall. There were no areas of wall thinning that exceeded the reportable level of 10% of the nominal thickness. No pitting or vertical crack-like indications were detected in Plates #1, #2, #3, #4, or #5.

Figure 4.3 describes the areas on the primary wall of Tank 241-AP-107 that were ultrasonically examined from Riser 31 located on the west side of the tank. Two 15-in.-wide vertical scan paths were performed on Plates #1, #2, #3, #4, and #5 below the entrance to Riser 31. Vertical weld HAZ examinations were done on Plates #2, #3, #4, and #5, and the horizontal weld HAZ examination was done on the transition Plate #5 to knuckle weld.
