PNNL-19018

# An Evaluation of Ultrasonic Phased Array Testing for Reactor Piping System Components Containing Dissimilar Metal Welds

JCN N6398, Task 2A

November 2009

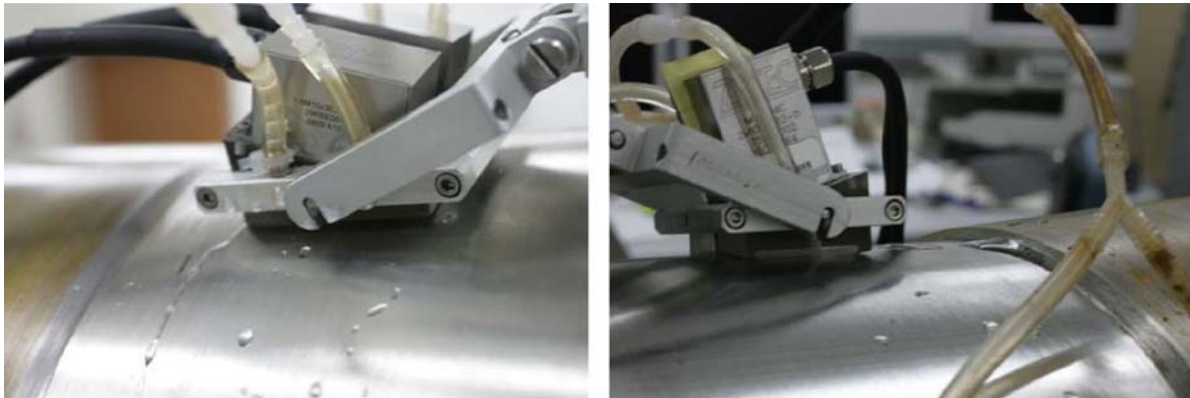
approximately 584.2 mm (23.00 in.) in length, with approximately 34.8-mm (1.37-in.) wall thickness at the flaw location within the DMW. Digital photographs of the mock-up are provided in Figure 7.10 and Figure 7.11. These photos show a significant difference in surface condition and subsequent access and transducer coupling efficiency between the specimen with and without the weld crown.

**Figure 7.11.** Photographs of the OD Surface of DMW Mock-up Specimen 9C-034 after Weld Crown Removal
