Characterization of Fish Passage Conditions through a Francis Turbine, Spillway, and Regulating Outlet at Detroit Dam, Oregon, Using Sensor Fish, 2009

Final Report

JP Duncan
TJ Carlson

May 2011

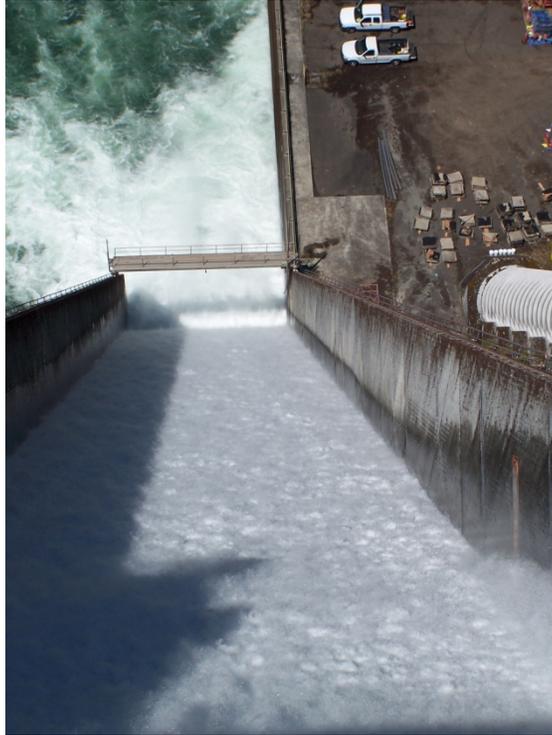
Spillbay 3 and Spillbay 6 were evaluated at two spillgate openings. The height and slope of the spillway chute contribute to deleterious exposure conditions observed during the study. Detroit Dam, completed in 1953, is slowly deteriorating due to age. The concrete surface of the spillway is rough from weathering (Figure 4.1), and the descending flow is irregular (Figure 4.2)—conditions that probably incrementally worsened spillway passage conditions.

In Spillbay 3, the unconfined spillway discharge spread rapidly once past the structure supporting the tainter gate hinge assemblies (Figure 4.3). In contrast, Spillbay 6 was confined from the tainter gate through stilling basin entry (Figure 4.2). Spillway flow velocities were estimated to exceed 150 fps before plunging into the stilling basin. Sensor Fish were often carried to depths of over 30 ft with spillway discharge, at times striking rocks or other unidentified objects as they were carried in turbulent flow through the stilling basin.

Figure 4.2. Spillbay 6, 3.5-ft gate opening (3090 cfs), showing walls confining the turbulent flow created on the rough spillway chute.

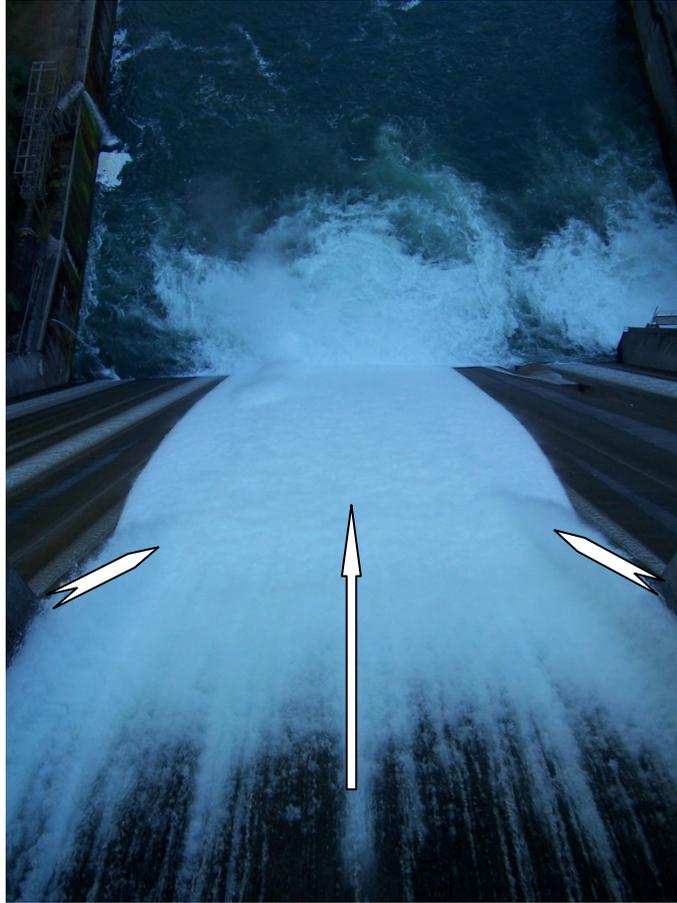
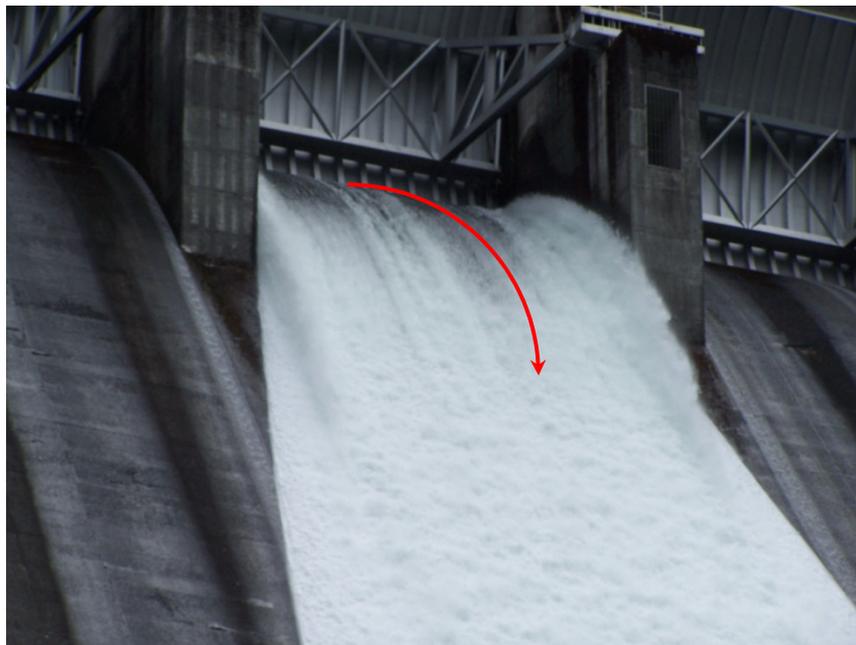
Figure 4.4. A hydraulic jump carries the Sensor Fish down the spillway chute as flow passes under the tainter gate in Spillbay 3 with the gate open 1.5 ft (1560 cfs discharge).

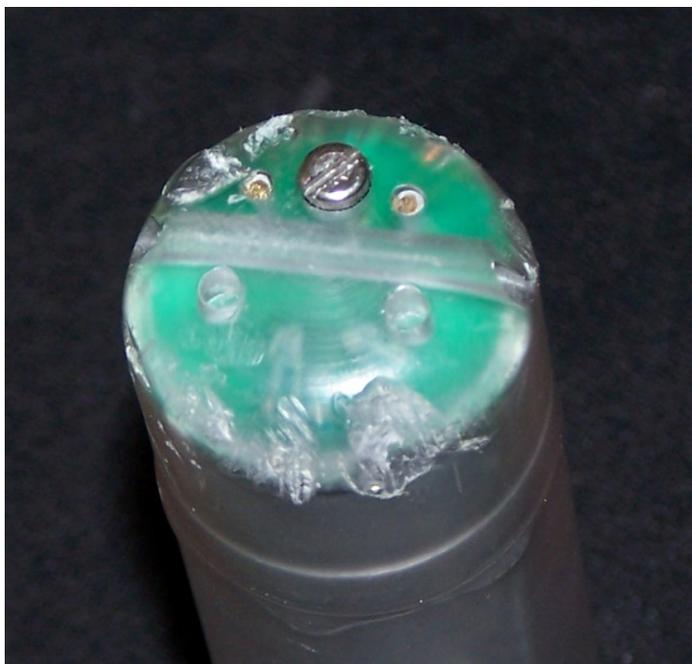
Several Sensor Fish recovered following passage through the spillway were noticeably damaged, with deep scratches and portions of the polycarbonate shell chipped away (Figure 4.5). Extreme forces are needed to fragment polycarbonate, a highly impact-resistant, low-scratch durable polymeric plastic. Although the Sensor Fish have been scratched and scraped during previous studies on the Columbia and Snake rivers, the damage observed on the casing following passage in spill at Detroit Dam was much worse.

Figure 4.5. Chips and scratches visible on the polycarbonate Sensor Fish casing.

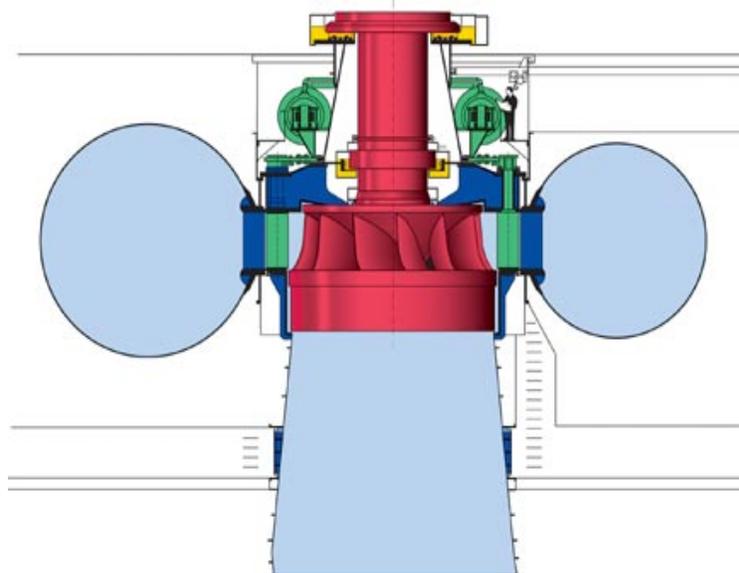
Figure 4.6. Cross section of a Francis turbine showing the midline of the scroll case (circular chamber shown in blue) and wicket gates (shown in green) at the same elevation as that of the outer edge of the turbine runner blades (shown in red).

The Francis turbine at Detroit Dam operates at 70,000 horsepower and 163.6 revolutions per minute. The runner diameter is 130 in., and the runner opening height is 49.5 in. The velocity of the periphery of the runner is 92.8 fps. Maximum discharge is 5340 cfs, and there are 13 blades and 24 wicket gates. Turbines at Detroit Dam operate almost daily, based on Bonneville Power Administration load demands. During the summer, water depth above the penstocks is approximately 157 ft. Winter drawdown lowers the submergence of the penstock to approximately 47 ft. It appears likely that a variable influencing the probability of entry of fish into Detroit turbines is the submergence depth of the turbine penstock.

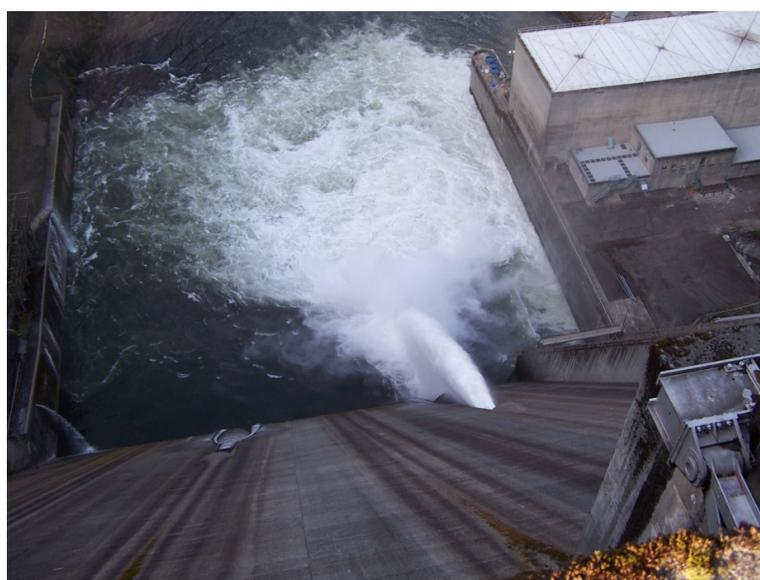
Figure 4.9. Regulating outlet discharge at Detroit Dam when the control gate was open 5 ft.

After passage under the control gate, RO discharge accelerates to approximately 45 fps and is relatively uniform laterally and vertically (Phillips 2010¹). (A slight decrease in flow velocities may be assumed for the study period, due to the lower forebay elevation [1441 ft MSL] compared to the forebay elevation used for CFD modeling [1450 ft MSL].) No collision or shear events were observed at injection of Sensor Fish into RO intake flow. In addition, the quality of flow was good upstream of the control gate in the RO conduit at the 5-ft control gate opening. Although there were no significant events at

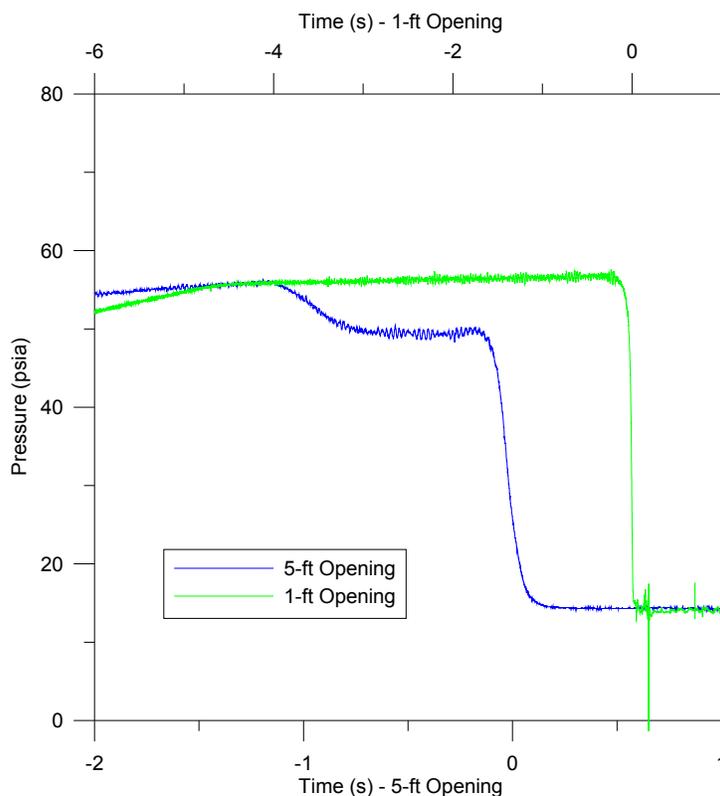
injection, Sensor Fish data showed a slight drop in pressure immediately following passage into RO flow, most likely the effect of slip velocity on the Sensor Fish pressure transducer. The pressure decrease was minor and also an artifact of the Sensor Fish measurement process and not a physical factor that would be a risk to fish health. Figure 4.11 Sensor Fish release pressure time histories for passage through the RO when the control gate was open 1 ft and 5 ft. The velocity of water through the RO conduit upstream of the control gate for the two gate settings and consequent discharges (approximately 30 fps with a discharge of 1900 cfs and 8 fps with a discharge of 500 cfs for the 5-ft and 1-ft openings, respectively) are evident in Sensor Fish travel times from injection to control gate passage, a distance of approximately 40 ft. These travel times were approximately 1.2 and 4.5 s for the 5-ft and 1-ft control gate openings, respectively.

Figure 4.11. Sensor Fish pressure time histories for passage through the RO from injection through passage under the RO control gate for control gate settings of 1 ft and 5 ft.

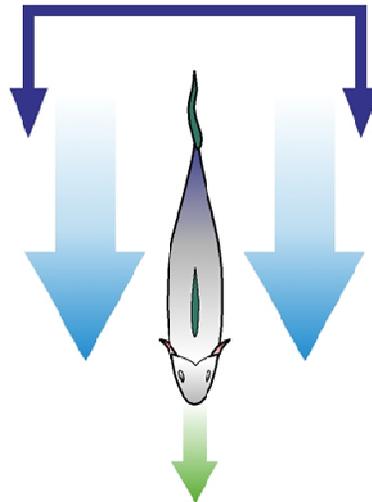
Although only one significant shear event was observed during Sensor Fish passage under the RO control gate when it was open 1 ft, a high rate of serious injury such as torn opercula and mortality by decapitation were observed for live fish passing under the same conditions (Normandeau 2010). Research has shown that the size of fish entrained in rapidly accelerating flow is a factor in their risk of injury. Because of their greater inertia, larger fish do not accelerate with the flow and are exposed to injury from water moving at a higher velocity than their body (see Figure 4.13 and Figure 4.14). The risk of injury is greatest for fish that have their heads pointed downstream. In this position, the opercula of the fish are raised and may be at an angle of almost 90 degrees to the body of the fish. The attitude of the opercula presents a large cross section that can be acted on by the force of the higher-velocity water passing around the fish. Laboratory studies have shown that the resulting force is strong enough to cause severe damage to the fish's opercula, gills, and isthmus. Tears to the isthmus can be severe, and decapitation is a likely outcome. Fish that are oriented into the flow are at a significantly lower risk of injury, the exception being damage to their eyes (Guensch et al. 2003). During the current study, live fish were placed tail-first into the injection system. Fish averaged 7.3 in. in length (ranging from 4.8 to

8.6 in.). Dependent on the elevation of passage prior to the gate, forces from rapid acceleration at the 1-ft opening may have drawn the fish tail first under the gate, catching or striking the head region on the gate. Bruising and scraping were observed on 13% of the fish, and 9% were decapitated or nearly decapitated following passage through the RO at the 1-ft gate opening (Normandeau 2010).

Figure 4.13. Large fish entrained within the force of rapidly accelerating water are exposed to injury from water moving at a higher velocity than their body.

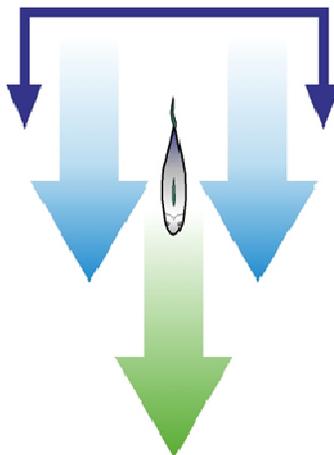
Figure 4.14. Small fish, with less inertia, are carried with the force of rapidly accelerating water surrounding their body.

The inertia of the Sensor Fish likely was small enough that the sensor was accelerated with the water passing under the RO control gate at both the 1-ft and 5-ft openings. As such, the Sensor Fish was not able to detect the conditions that resulted in the serious injury and mortality of the live test fish. This also makes the point that the injury types and rates of occurrence, in addition to the rates of mortality, are a function of fish size, and the results for one size group of fish cannot be extrapolated to another, particularly when the sizes of the fish differ significantly.
