**Results of Tank-Leak Detection
Demonstration Using Geophysical
Techniques at the Hanford Mock
Tank Site—Fiscal Year 2001**

D. B. Barnett
G. W. Gee
M. D. Sweeney

March 2002

Pacific Northwest National Laboratory
Richland, Washington 99352

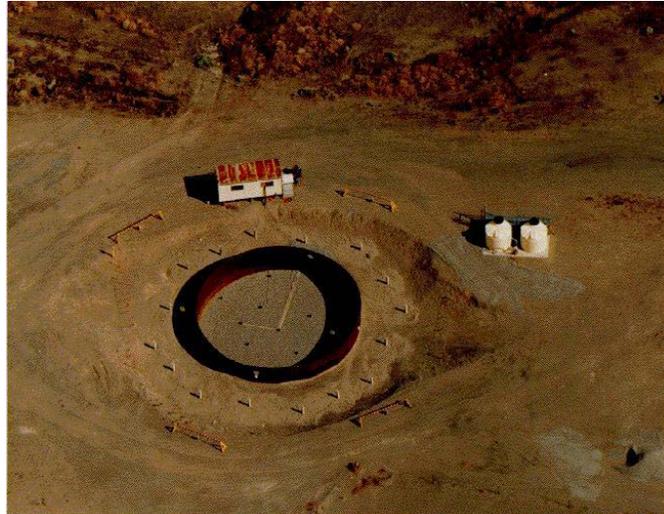
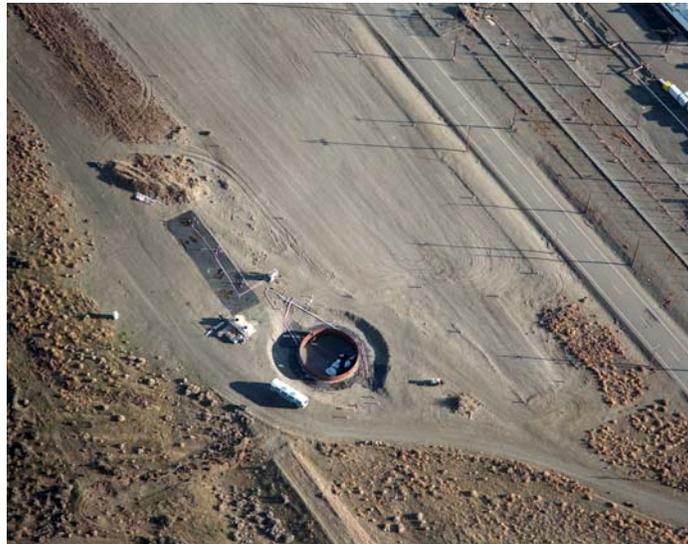
Figure 2. Top: The Mock Tank Site Before Start of FY 2001 Activities. Shown are the sixteen 1995 ERT arrays, the previous field laboratory, and two 9,464-L (2500-gal) tanks used in the 1995–96 experiments. Bottom: Oblique aerial view of the Mock Tank from the northwest following FY 2001 testing, showing the mobile geophysics laboratory (bus lower left of tank) and SAFE Development Area (SDA) (upper left of mock tank). A 15,140-L (4,000-gal) tank, which contained the sodium thiosulfate solution for the FY 2001 testing, had already been removed at the time of the photograph (see Section 2.4.4).

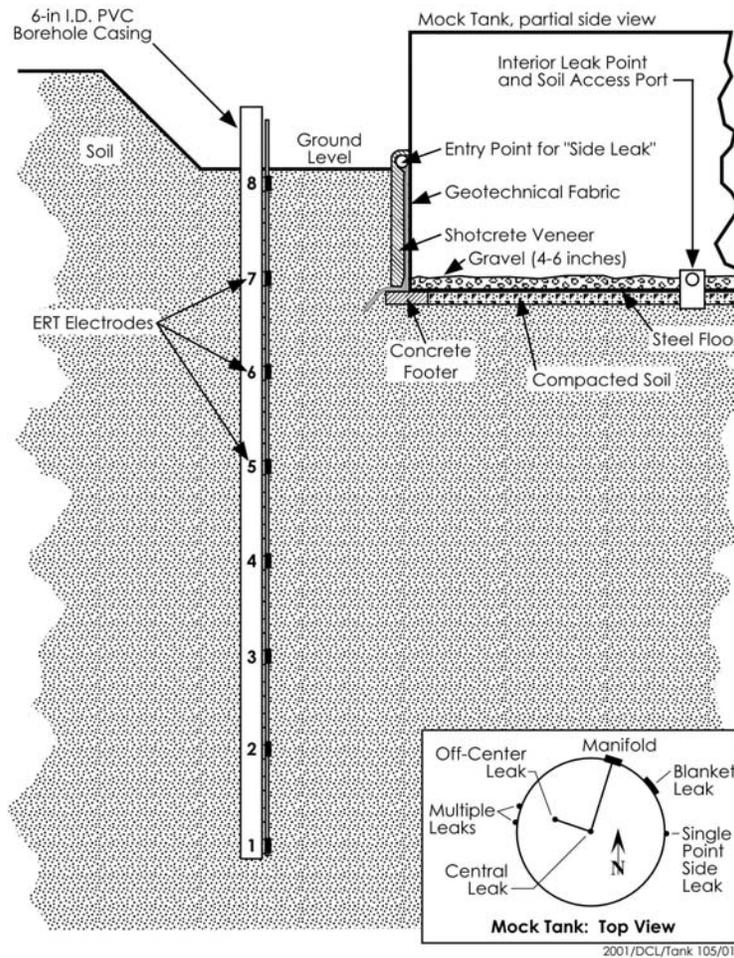
Figure 3. Details of the Mock Tank Construction in Relation to One of the 1995 ERT Installations. The Mock Tank is approximately 15.2 m (50 ft) in diameter; the ERT array extends to ~10.6 m (35 ft) below ground level, with an electrode every 1.52 m (5 ft).

Primary design features of the Mock Tank structure are illustrated schematically in Figure 3. The main function of the Mock Tank was to simulate leaks at various points around an SST. Thus, it was constructed with a distribution manifold of pipes that directed water or solutions to five separate leak-simulation ports. The interior leak points are short sections of steel casing protruding through the floor of the tank, with PVC plumbing leading to the distribution manifold on the outside of the tank (see Section 2.2.4). Two interior leak points, one central and one off-center (Figures 3 and 4), are plumbed from the manifold. Three exterior leak-simulation outlets were also installed to simulate a blanket leak, a point leak, and a closely spaced group of leaks. In addition to the interior leak points, 12 additional soil access ports (differing from the interior leak points only by the absence of plumbing to the manifold) are distributed around the floor of the tank (Figure 4). Only the interior, central leak point was used during FY 2001 testing.

The 0.32-cm (0.125-in.) steel wall of the tank is 15.24 m (50 ft) in diameter and rests on a 15.24-cm (6-in.) thick, 45.72-cm (18-in.) wide concrete footer that is approximately 1.5 m (5 ft) below grade. Some distortions (flat areas) of the sidewalls of the tank occur near the steel wall-footer junction. The tops of the tank walls are held true (kept in round) by an ~10-cm (~4-in.) steel ring welded to the top of the tank walls along the entire tank circumference. A layer of shotcrete and geofabric coats the lower portion of the tank wall and contains the plumbing for the exterior leak points.

Because the ERT method was the first to be considered for leak detection testing at the Mock Tank, many of the tank’s features were designed with that technology in mind. Most notably, the 0.32-cm (0.125-in.) steel floor of the tank was tack welded together to provide electrical continuity, and a 10-to-15-cm (4-to-6-in.) gravel layer was spread over the steel bottom to ensure contact with the compacted soil

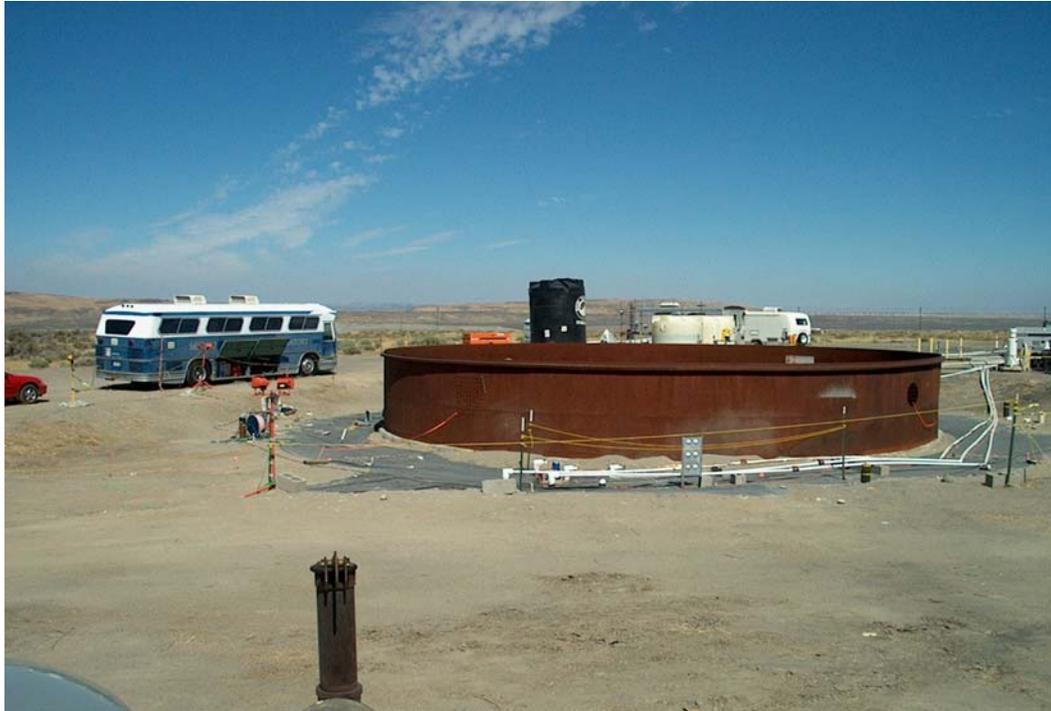
Figure 5. View Looking East at the Mock Tank During the FY 2001 TLDD Activities. Large PVC pipes are SAFE air-extraction lines. The bus at left is the mobile geophysics laboratory. The large black storage tank contains the sodium thiosulfate solution used to simulate a tank leak (see Section 2.4.4). The trailer and the RV to the right of the storage tank are the SAFE field laboratory.

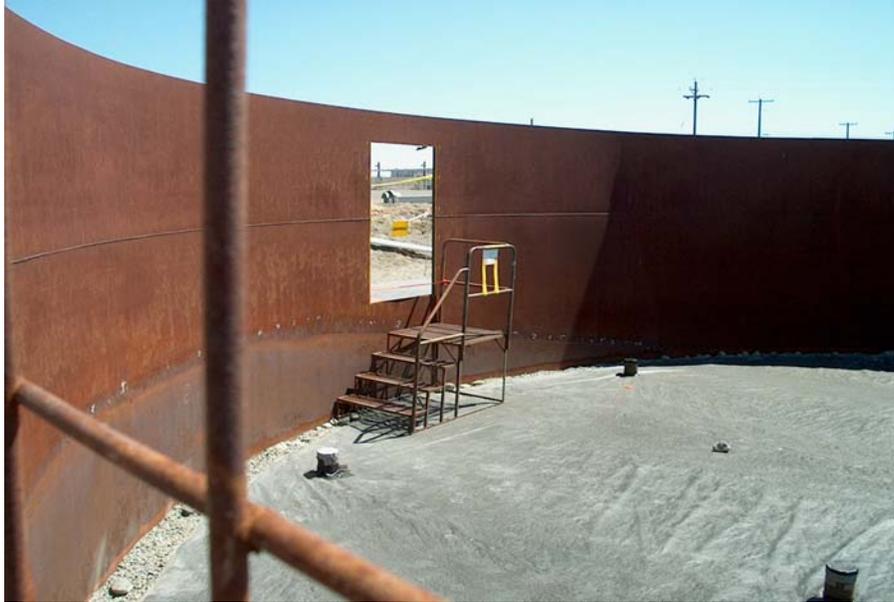
Figure 7. Interior Access to the Mock Tank. A door was cut in the east side of the tank and stairs installed to the floor of the tank (~0.9 m [~3 ft] below exterior grade). This allowed installation of instruments and monitoring of soil conditions beneath the tank floor. The covering on the floor prevents air leakage during SAFE operations. Three of the 12 soil access ports are shown protruding from the floor covering.

A doorway was cut into the east side of the tank to permit safe access to the interior (Figure 7). This was necessary to allow installation of instrumentation, to monitor fluid levels in access ports, and to seal the tank floor to ensure airtight coverage for SAFE operation. Several batteries of lights were deployed

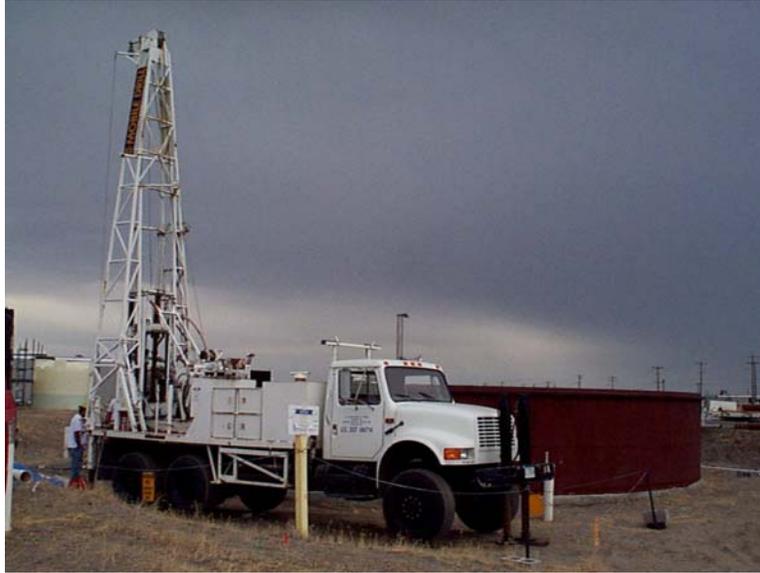
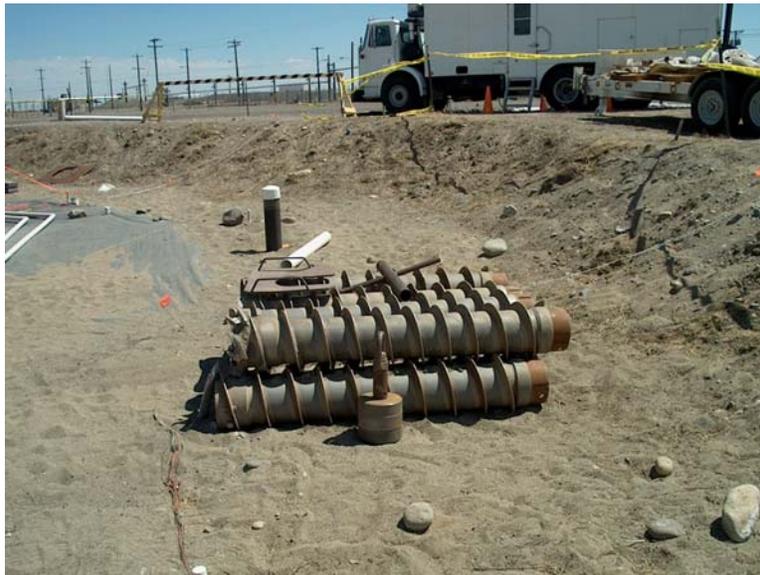
Figure 8. Drilling of the Mock Tank Wells for FY 2001 Using Hollow-Stem Auger Methods. Access to locations around the tank for drilling was difficult due to pre-existing well casings and limited maneuvering space. The preexisting casings were cut to near ground level to improve access.

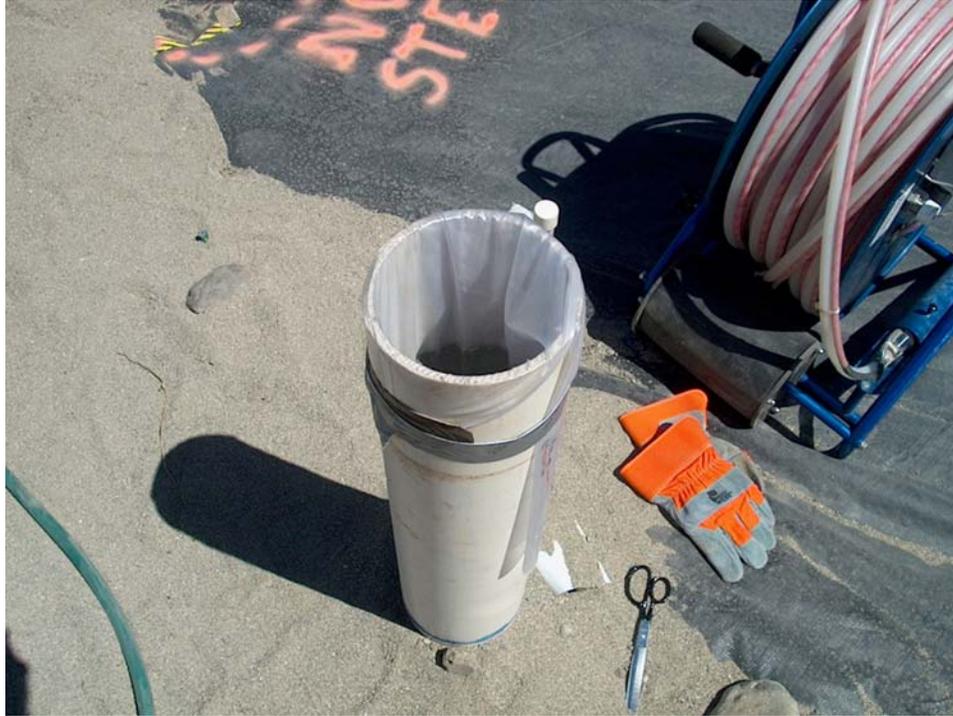
Figure 9. PVC Sealed Well Installed During FY 2001 with Liner Installed to Prevent Water Leakage. Seismic techniques require a water-filled well to provide sufficient coupling with the geologic formation and allow signal propagation.

liners in the wells that leaked (Figure 9). The liners reduced the rate of water loss to the soil but did not completely stop the leakage. The wells were filled with raw water just before the seismic hydrophones were deployed and pumped out immediately after the seismic data were collected to avoid introducing significant water to the test area, which might interfere with the electrical methods.

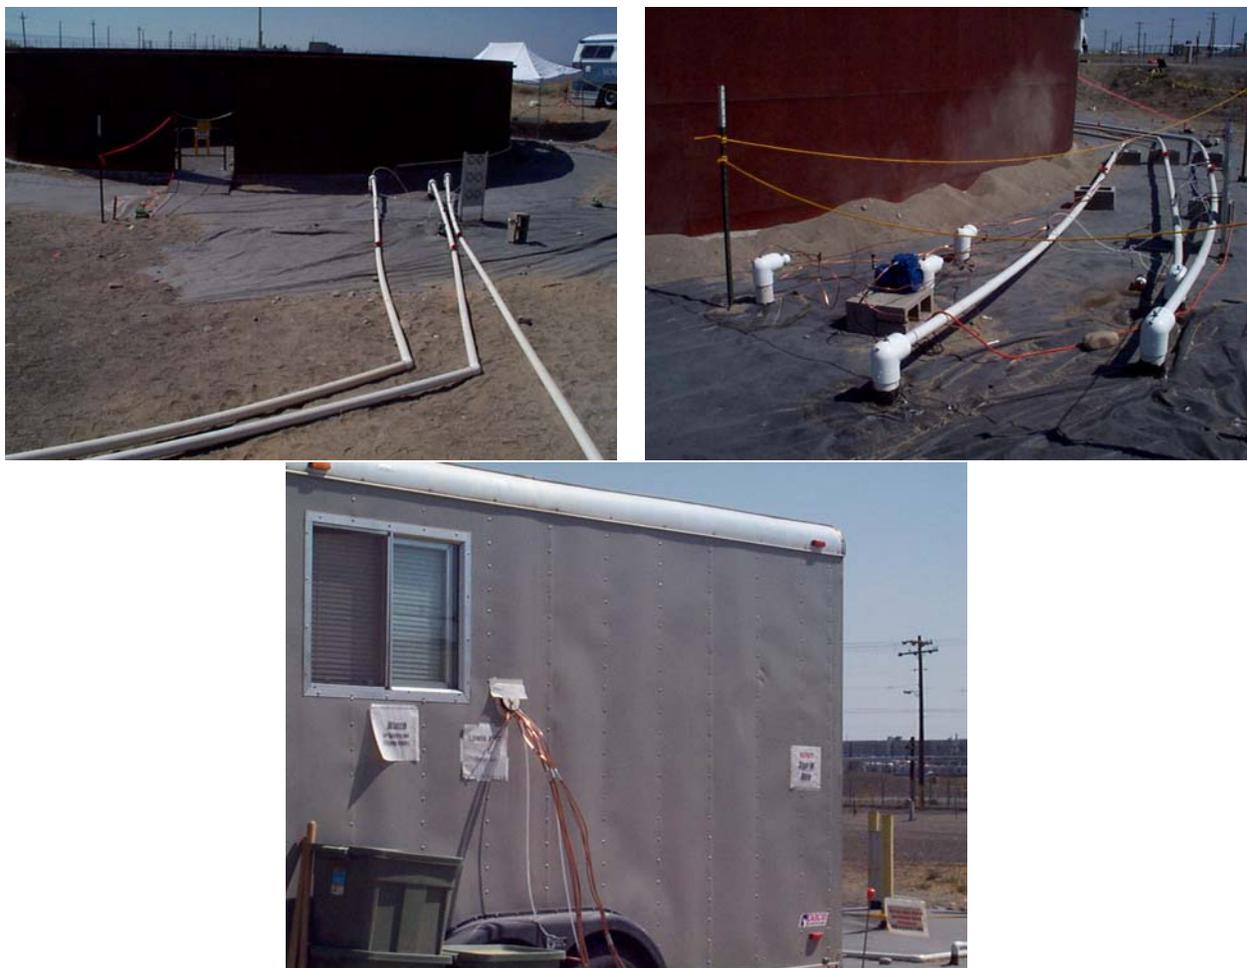
Figure 10. View of the SAFE Infrastructure Around the Mock Tank (top left and right), and Gas Monitoring and Sampling Lines Entering the SAFE Field Laboratory (bottom). Samples were analyzed by gas chromatography inside the laboratory. The SAFE experiments were conducted concurrently with the geophysical demonstrations.

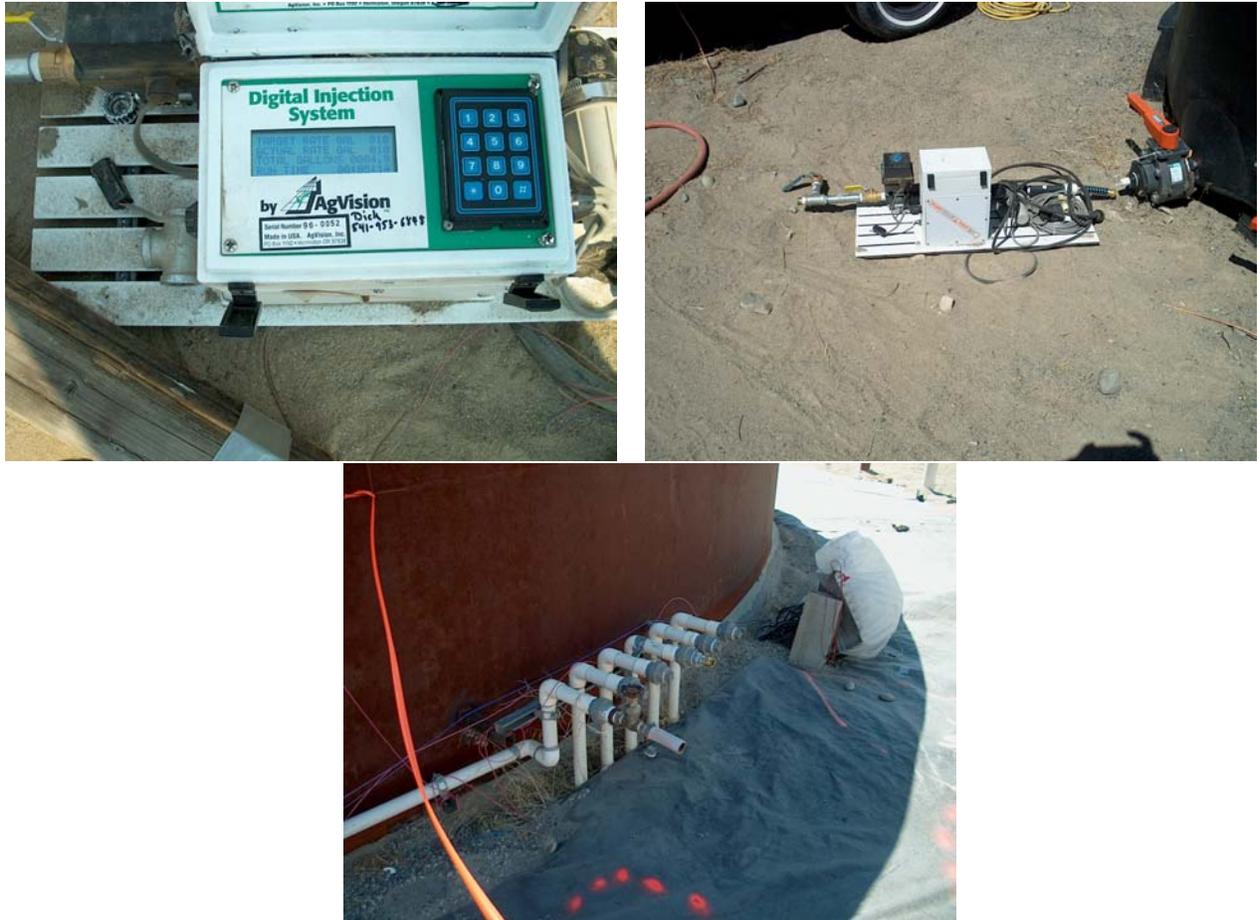
Figure 11. (Top and Middle) The Digital Flowmeter System Connected Directly to the 15,140-L (4000-gal) Sodium Thiosulfate Storage Tank; (Bottom) Existing Manifold System Used Initially to Deliver the Solution to the Central Leak Point in the Tank. This manifold was abandoned late in the test to circumvent suspected clogging.

For the FY 2001 TLDD testing, the sodium thiosulfate solution was delivered to the Mock Tank center leak point (Figure 3) via a digitally controlled flowmeter from the 15,140-L (4000-gal) storage tank. Some difficulty occurred with the pre-existing manifold at the tank (Figure 11), apparently blocking flow intermittently, and with operation of the flowmeter. These problems were circumvented by rerouting the delivery line directly to the infiltration point at the tank center through the access bar (bypassing the manifold) and by having a spare flowmeter on hand.

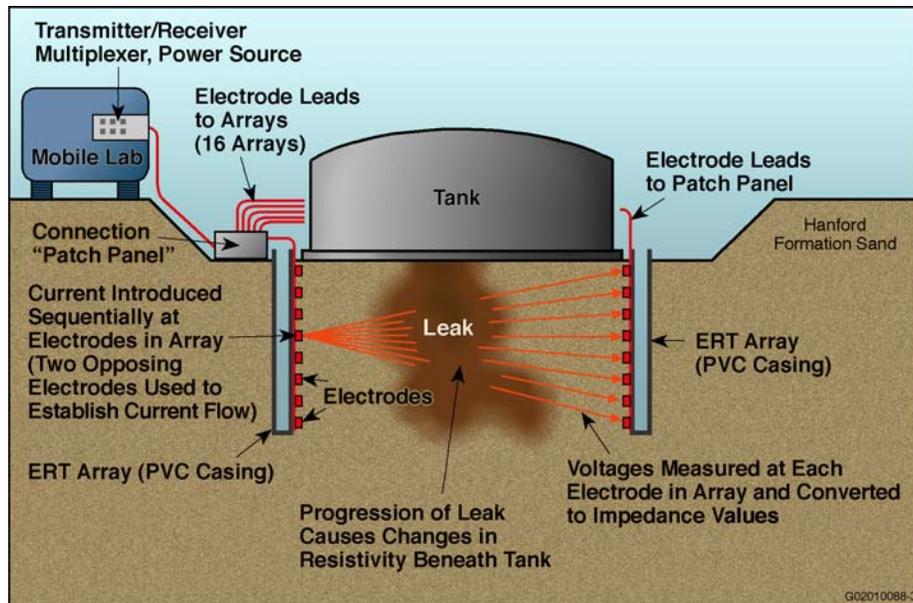
Figure 13. Configuration and Operating Principle of the ERT Method at the Mock Tank. Only one current electrode and one potential array (with eight electrodes) are shown activated in the figure, but 1,620 combinations using all 16 arrays are made during a full suite of measurements, requiring approximately 2 hours.

ERT has been demonstrated to be a useful characterization tool, providing details of the lithostratigraphy between wells (e.g., Newmark et al. 1994), subsurface processes such as fluid infiltration (Daily et al. 1992), and steam injection and ohmic heating (Ramirez et al. 1993) by mapping the spatial and temporal changes in soil resistivity resulting from changes in liquid saturation and temperature. Because tank wastes at Hanford are generally rich in high-ionic-strength electrolytes, resistivity is an ideal surrogate for locating difficult-to-detect contaminants. Typical electrode installations involve multiple electrodes strung on nonconductive casing (e.g., plastic or fiberglass) in conventionally installed boreholes, or as instrumentation strings installed using CPT. Both designs have been effective in shallow to moderate depths (most recently >395 m [1,296 ft]), but deeper installations require significant and more costly modifications. The ERT sensors consist of the 16 existing borehole electrode arrays surrounding the Mock Tank, with eight electrodes spaced 1.5 m (5 ft) apart vertically within each array (see Figures 3 and 4). The main components of the data collection and recording system are as follows: Zonge Engineering transmitter, multichannel receiver, multiplexer, isolation amplifier, a Hewlett Packard current monitor, and a DC power supply. A schematic representation of the ERT configuration and principle is illustrated in Figure 13. Connections to the 16 arrays are controlled manually via a patch panel (Figure 14).

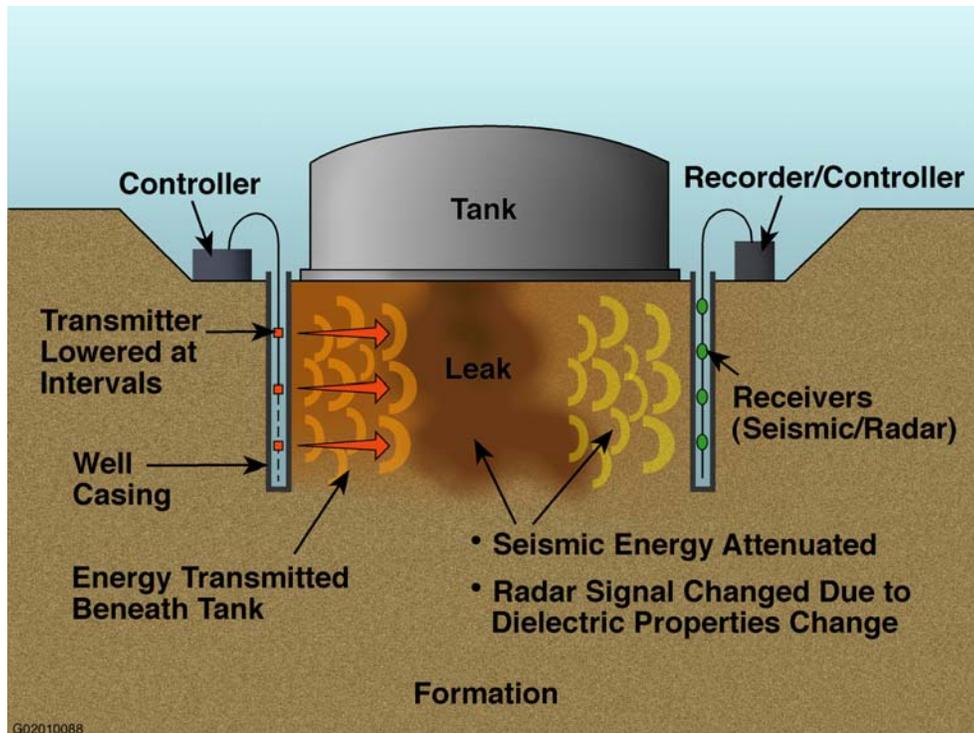
Figure 15. Principles of Operation for XBS and XBR Methods. The XBR receiving antenna (see Figure 16) is raised from the bottom of the borehole in parallel with the transmitting antenna located on the opposite side of the tank to interrogate multiple levels beneath the tank. For XBS, a string of hydrophones (Figure 17) is emplaced in the receiving borehole, and a vibrating energy source is raised incrementally in a borehole on the opposite side of the tank.

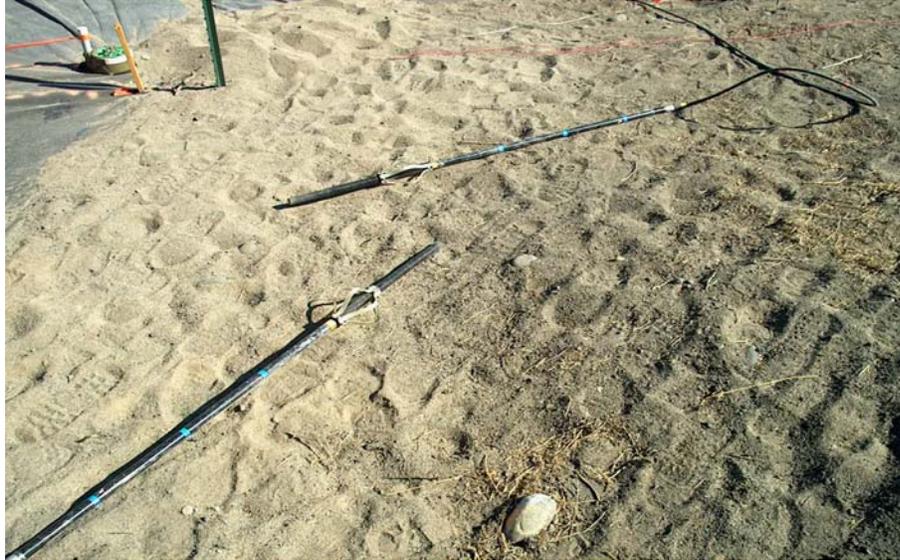
Figure 16. Antenna Configuration for XBR Measurements at the Mock Tank. Both transmitter and receiver are equipped with centralizers.

The downhole components of the XBR system consist of a dipole antenna(s) (transmitter in one borehole, receiver in another [Figure 16]) with lengths of 0.5 to 2.0 m (1.6 to 6.6 ft) depending on the frequencies used. The frequencies used in the Mock Tank study were 50, 100, and 200 MHz. The borehole selected for XBR deployment and ray-path geometry are presented in Appendix B, Figure 2. Measurement intervals in the boreholes are from 0.25 to 2.0 m (0.8 to 6.6 ft). Both antennas were moved down the boreholes incrementally and in multiple configurations to provide numerous receiver/transmitter ray paths. Deployment is limited to PVC-cased wells or open holes (cannot be used in metal casings).

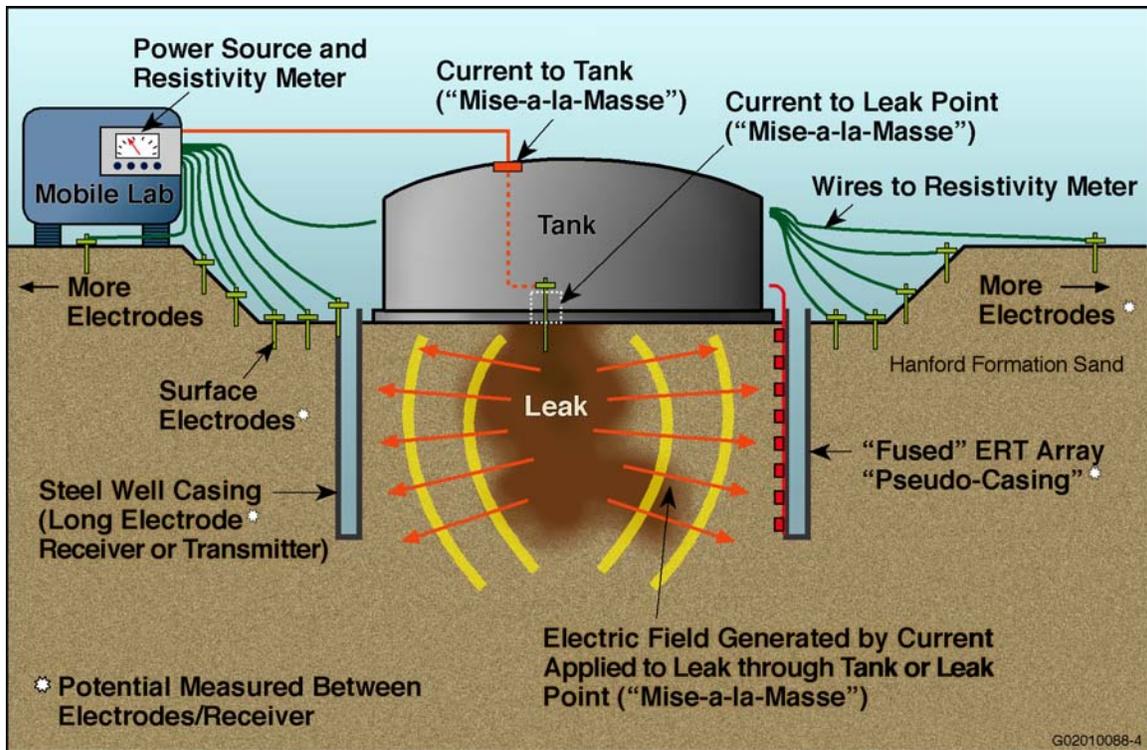
Figure 20. Schematic Illustration of HRR-SCRT Deployment. Several combinations of surface electrodes (61 of these), steel casings, fused ERT arrays, and connections to the Mock Tank itself were used to detect and image leaks. The most successful of these, Steel Casing Resistivity Technology (SCRT) or excitation of mass is emphasized in the figure.

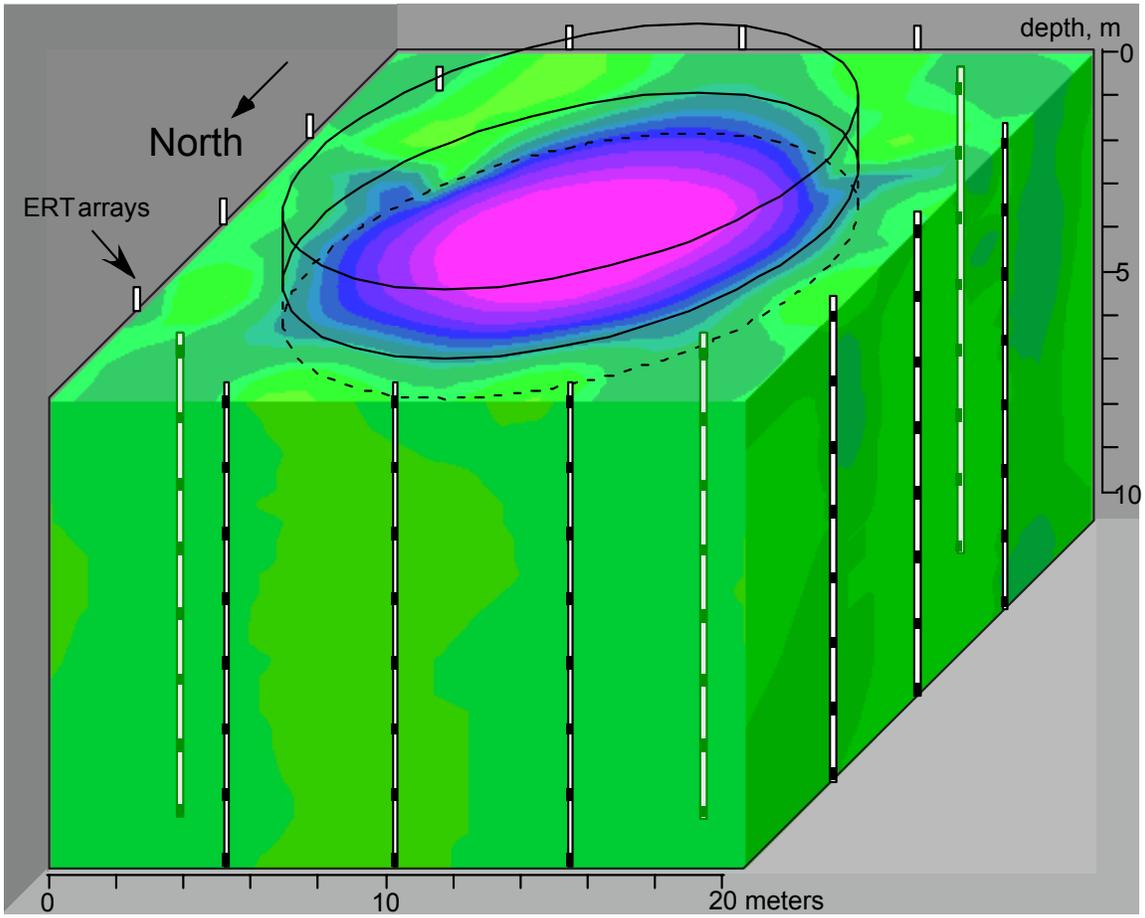
Figure 1. The point electrode model for the mock test site. The image shown is a 3D reconstruction of baseline conditions.

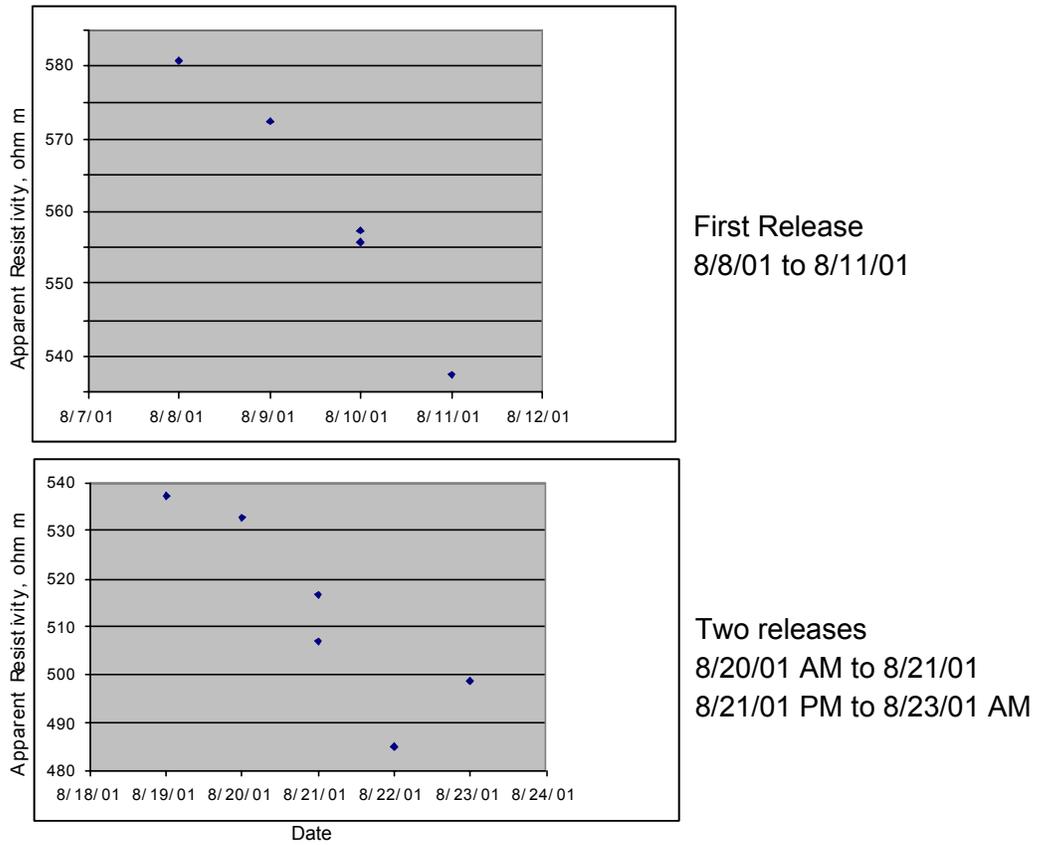
Figure 2. The figure shows the geometric mean of apparent resistivity beneath the Mock Tank during the two separate releases.

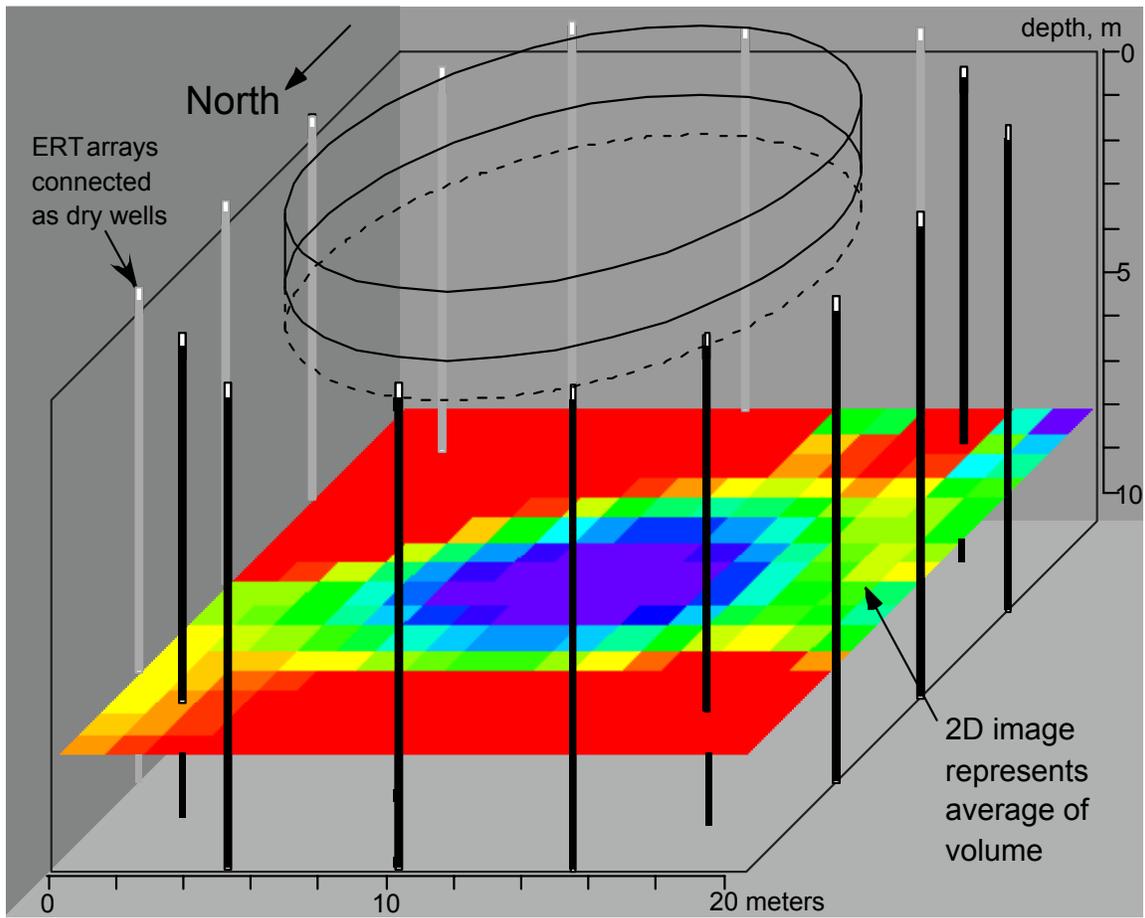
Figure 3. The dry well model for the mock tank test site. The image is shown as a plane but is actually an average of volumetric resistivity.

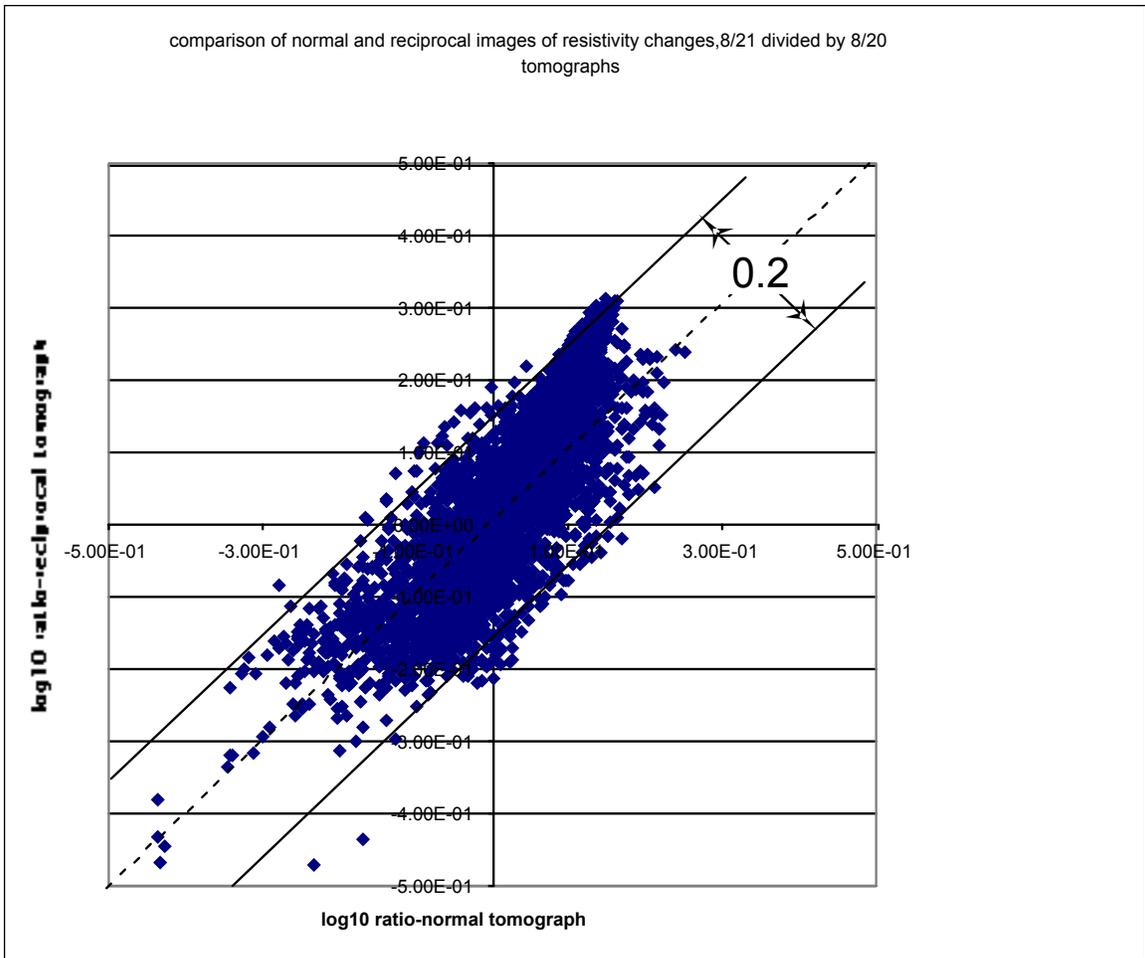
Figure 9. Error analysis for the 3D ERT reconstructions. Axes are the reconstructed ratios for the normal and reciprocal data. A reasonable error in the logarithm of the resistivity ratio is about +/- 0.1 (0.2).

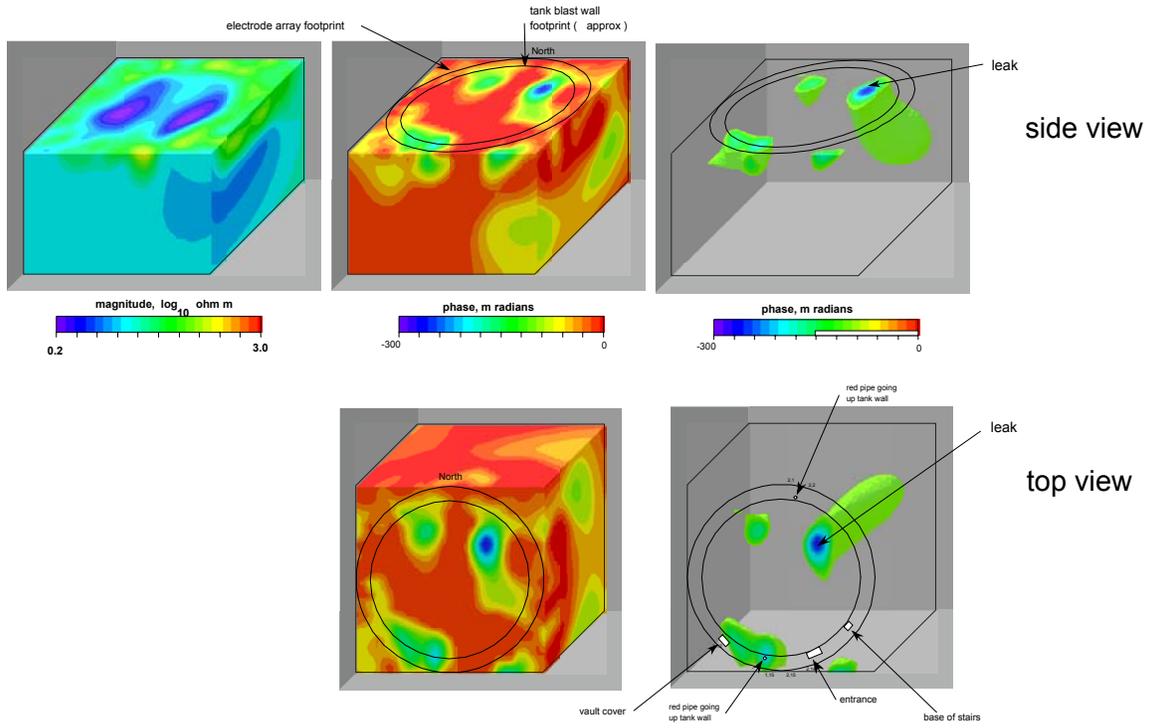
Figure 10. ERT image under a surface fuel storage tank using a ring of electrodes on the ground surface around the tank.

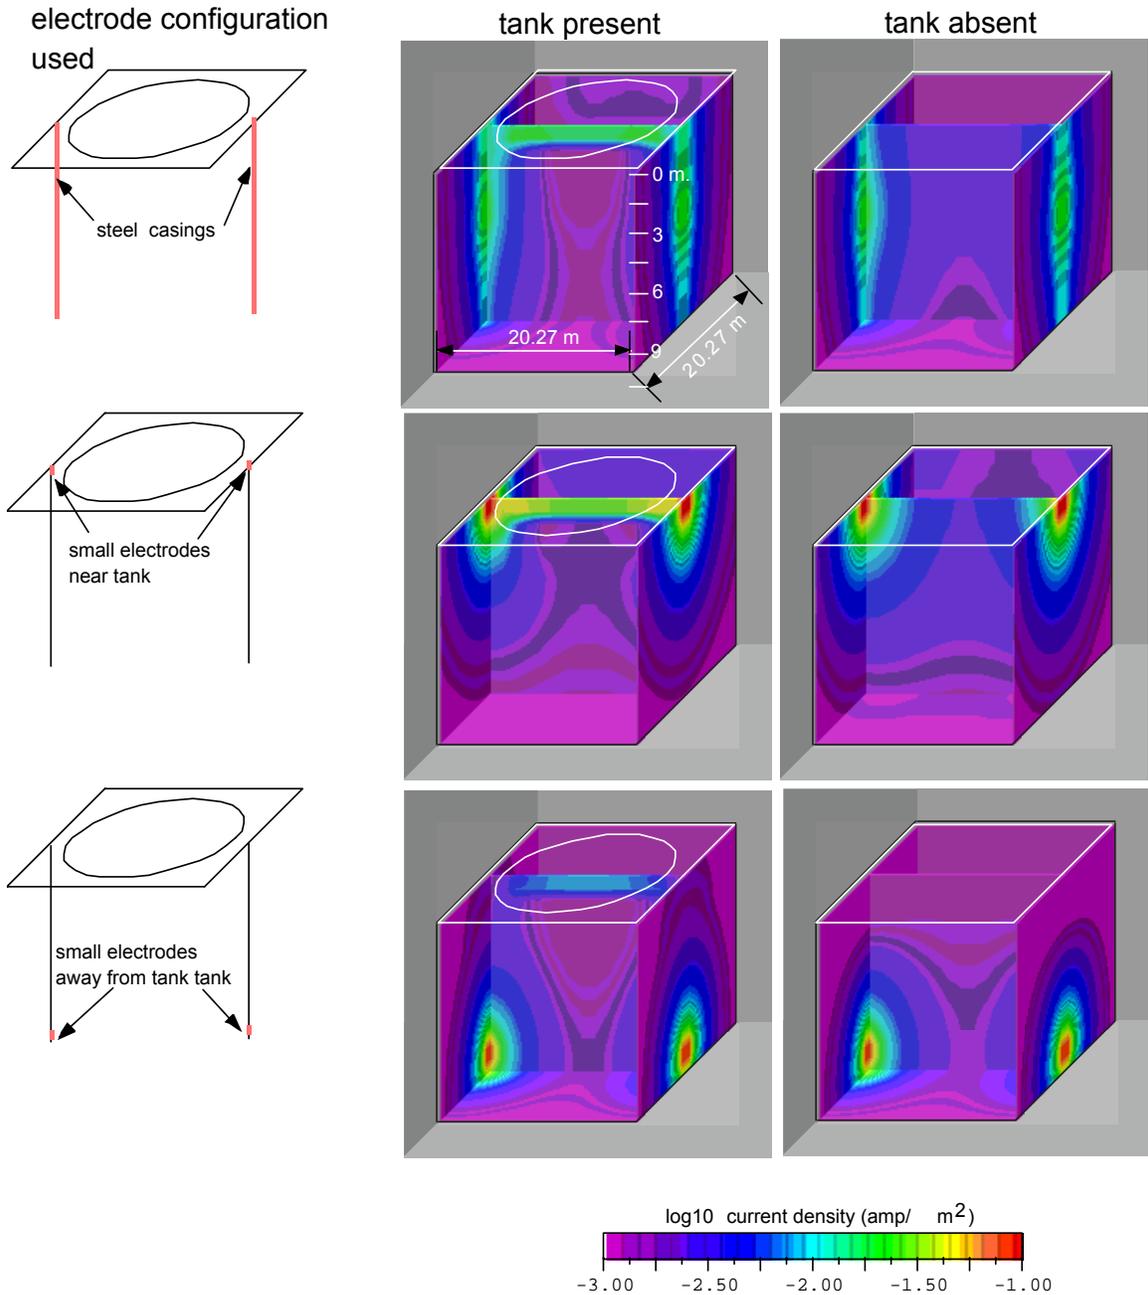
Figure 12. Numerical modeling results showing the current densities associated with three different electrodes configuration. Scenarios with and without the tank are considered. Regions of high current density (shown in the warmer colors) indicate regions to which the measurements have the highest sensitivity.

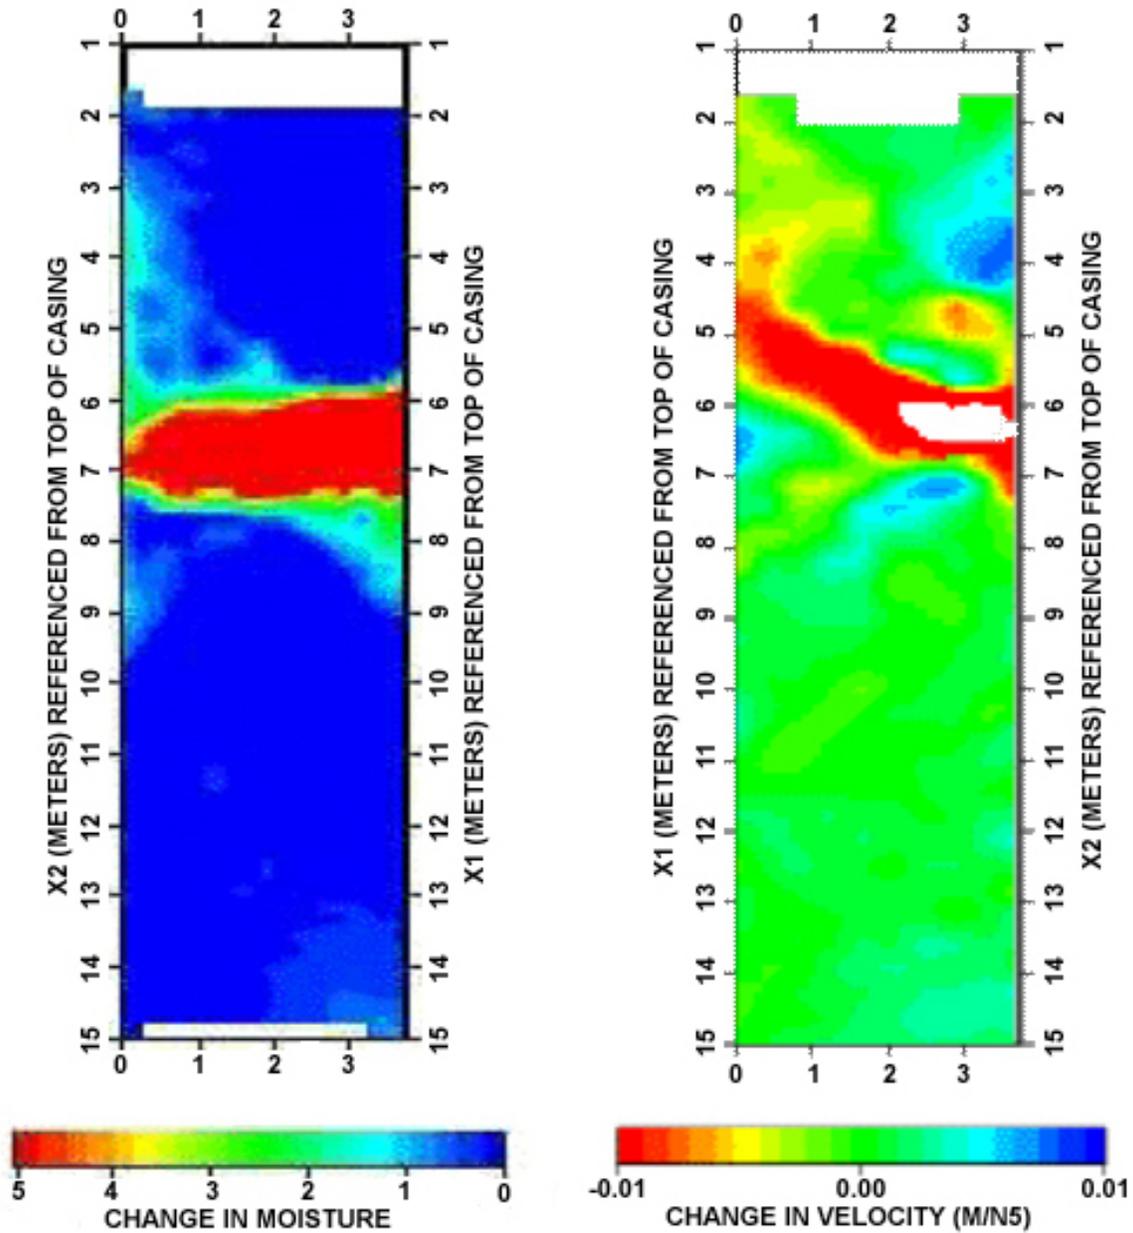
Figure 1. The 2000 and 2001 radar results after 500 gallons of water (2000) and sodium thiosulfate (2001) were injected approximately 1 meter behind the plane of the well pairs. The objective of this effort was to test the sensitivity of the two methods at a scale larger than the Sisson and Lu scale, rather than do a comprehensive mapping of the release of the sodium thiosulfate beneath the mock tank. In any “real” application of the method it is unrealistic to expect to have a large number of boreholes available to perform cross well tests. In fact, the number of boreholes available to the seismic test at the mock tank site was even less (3) than the radar, (6) making the lack of holes a particular constraint in the seismic tests.
