**Results of Tank-Leak Detection
Demonstration Using Geophysical
Techniques at the Hanford Mock
Tank Site—Fiscal Year 2001**

D. B. Barnett
G. W. Gee
M. D. Sweeney

March 2002

Pacific Northwest National Laboratory
Richland, Washington 99352

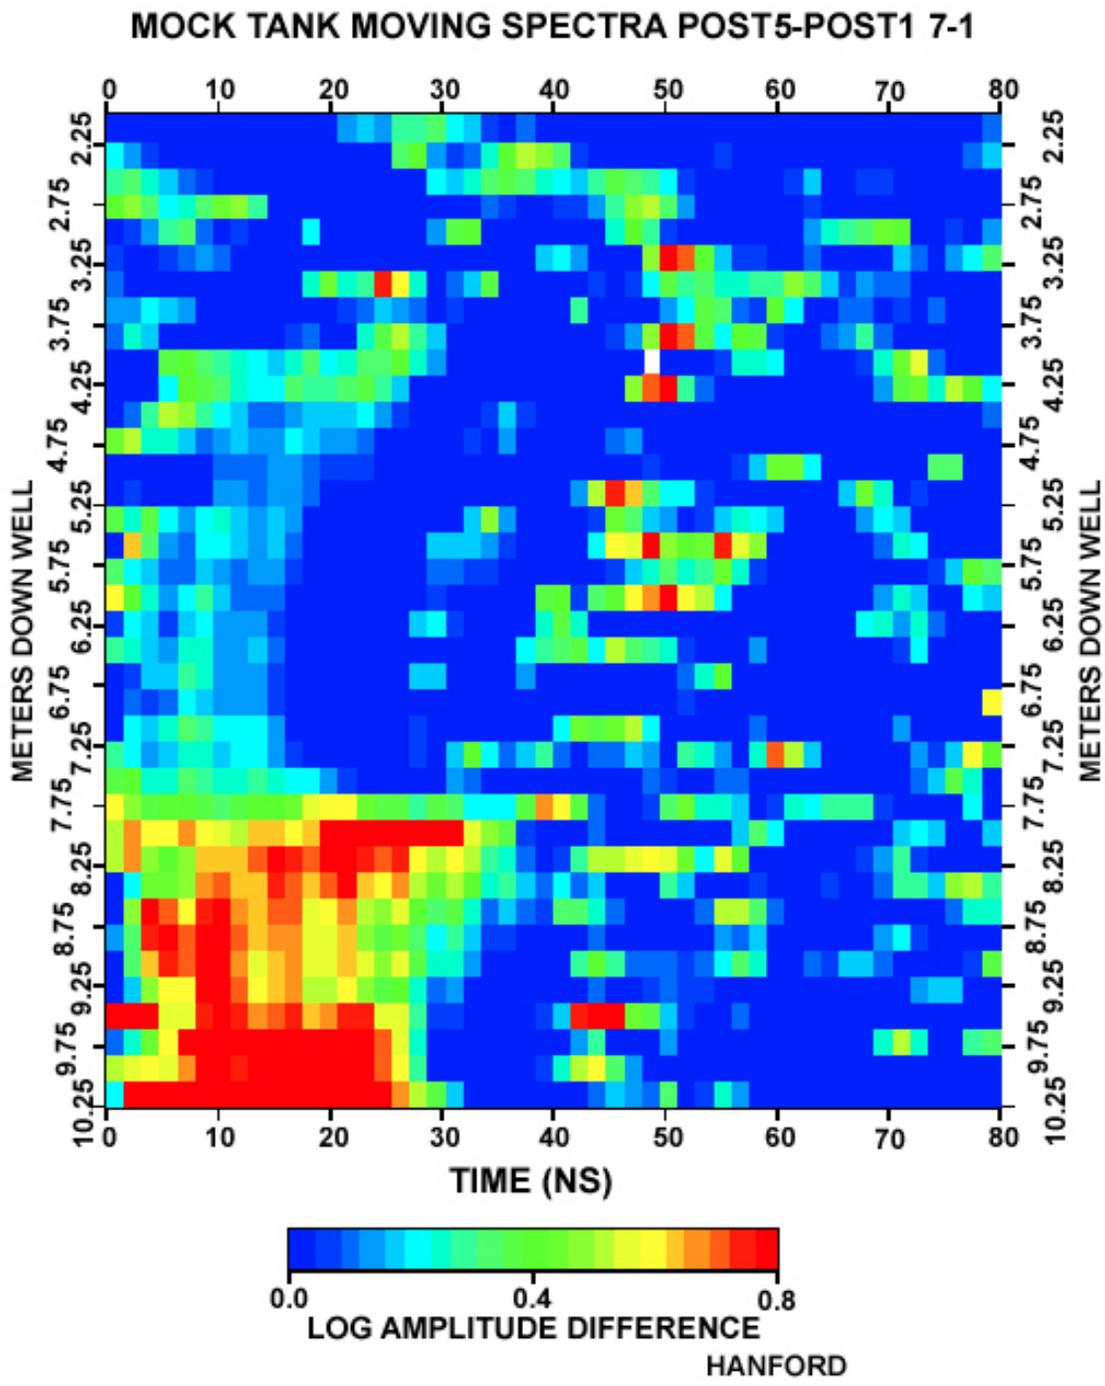
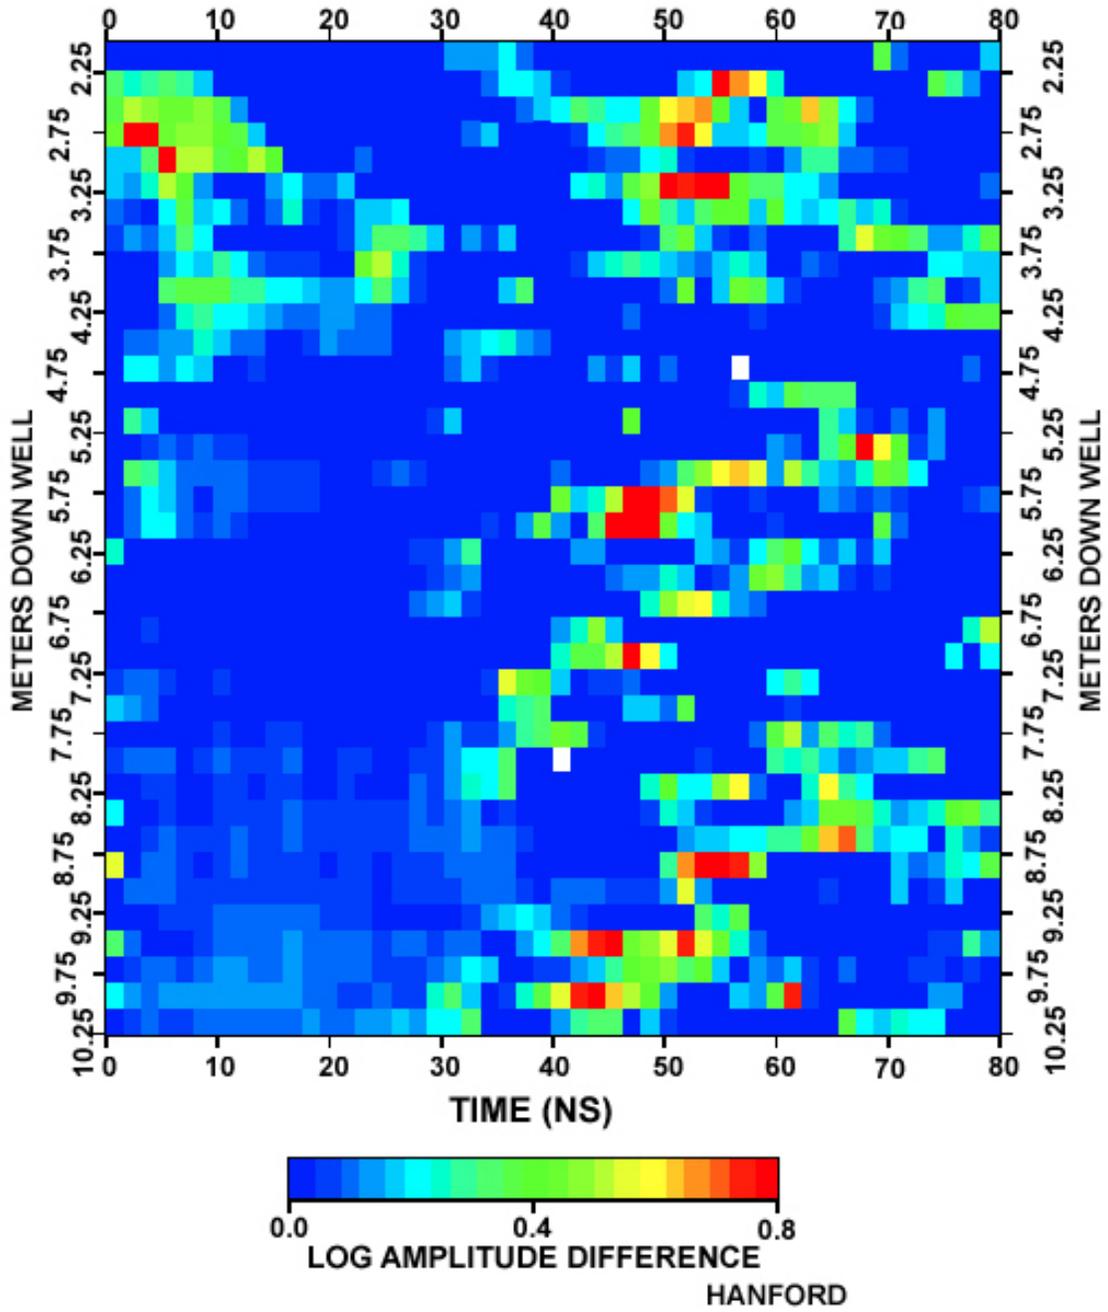
Figure 7. Time lapse of the change in radar amplitude as a function of depth for wells 7 and 1

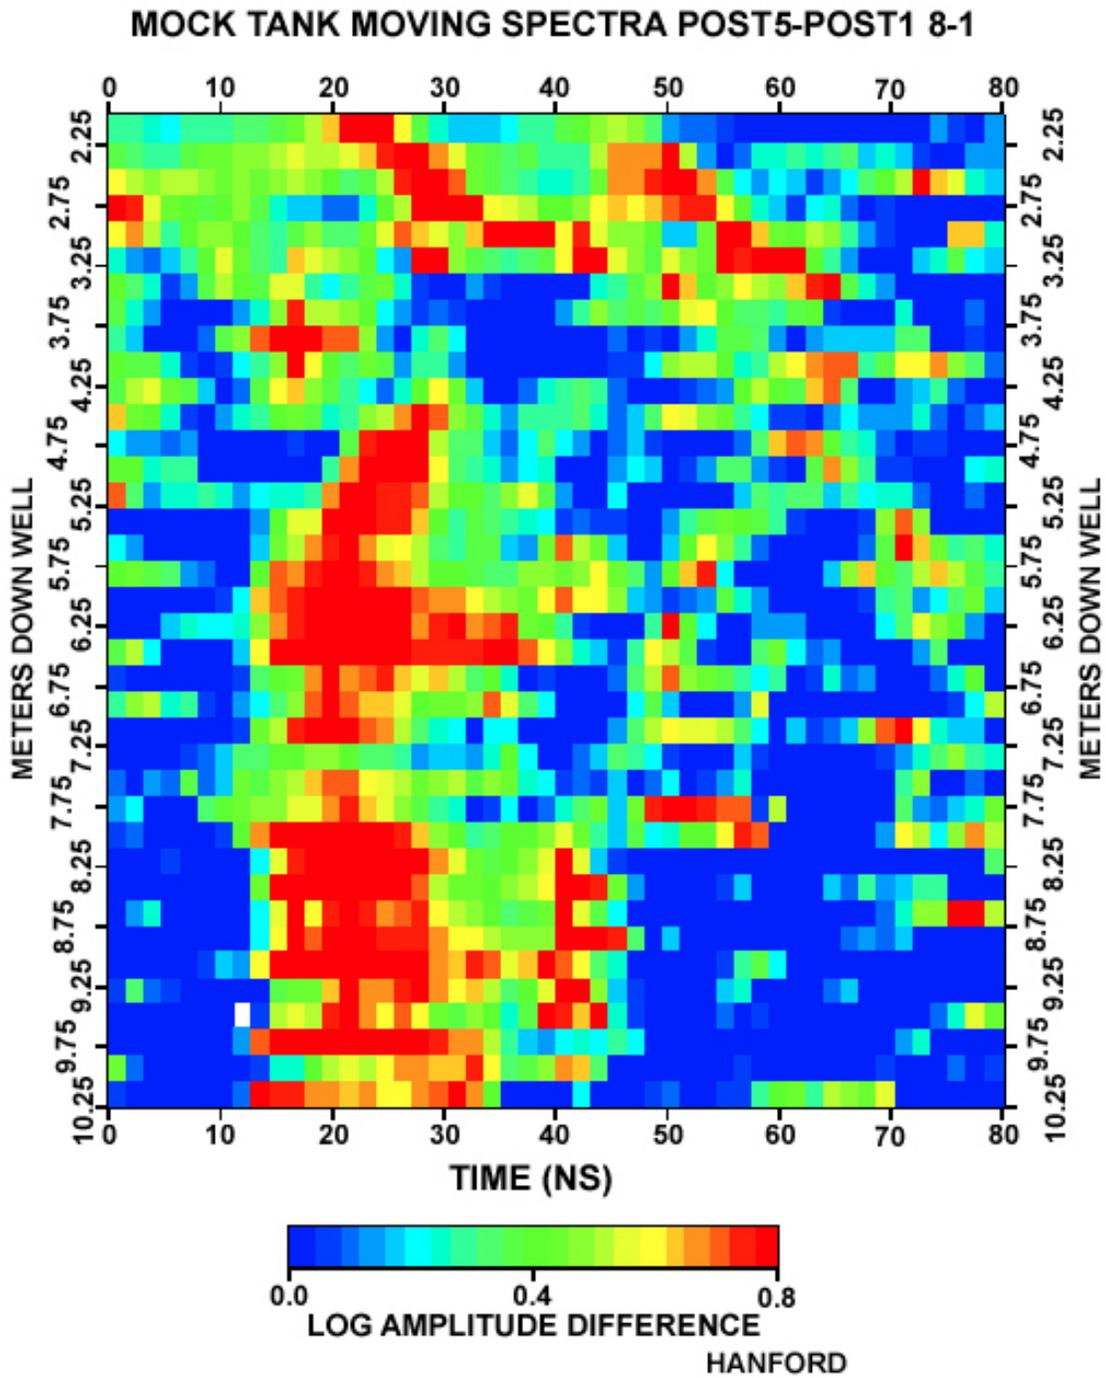
Figure 8. Time lapse of the change in radar amplitude as a function of depth for wells 8 and 1.

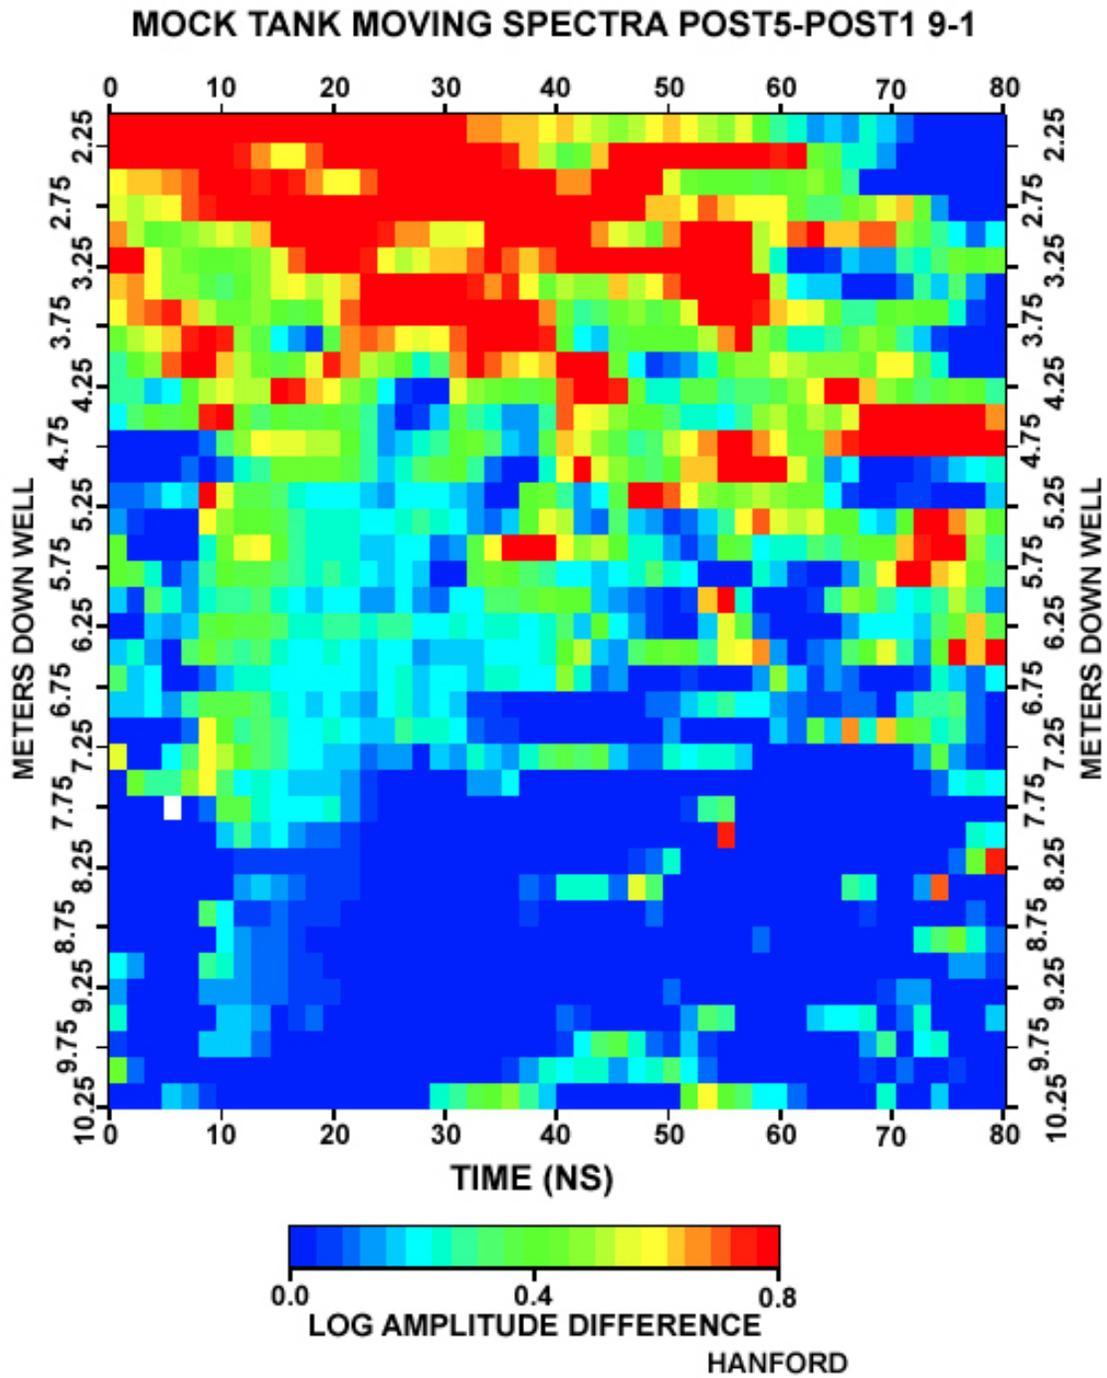
Figure 9. Time lapse of the change in radar amplitude as a function of depth for wells 9 and 1.

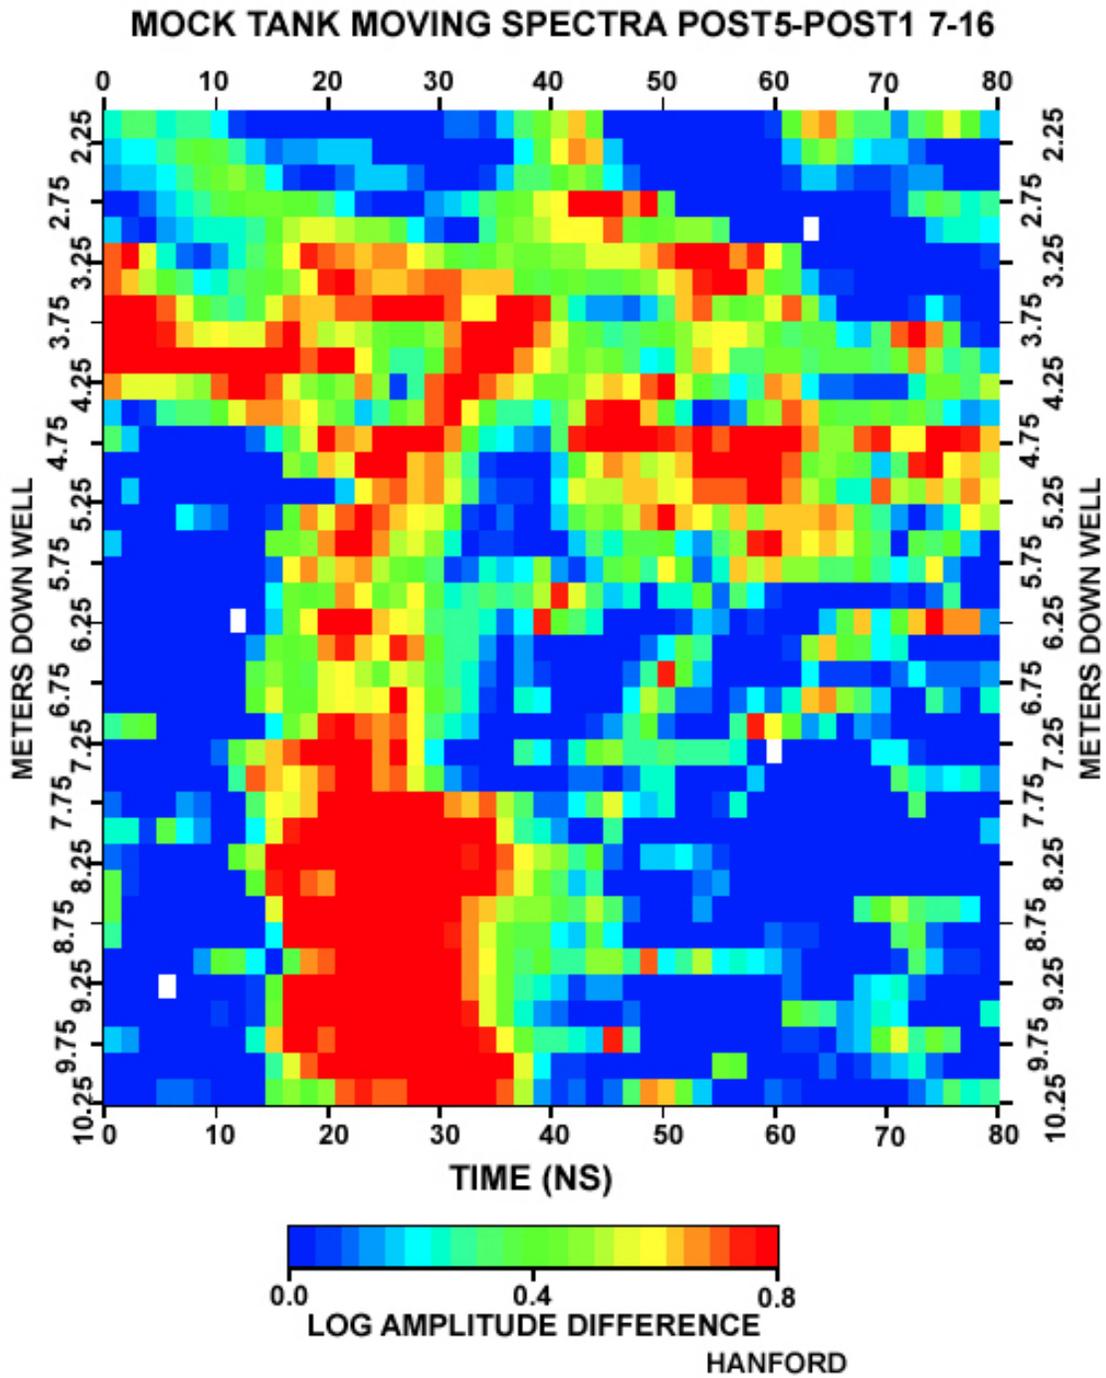
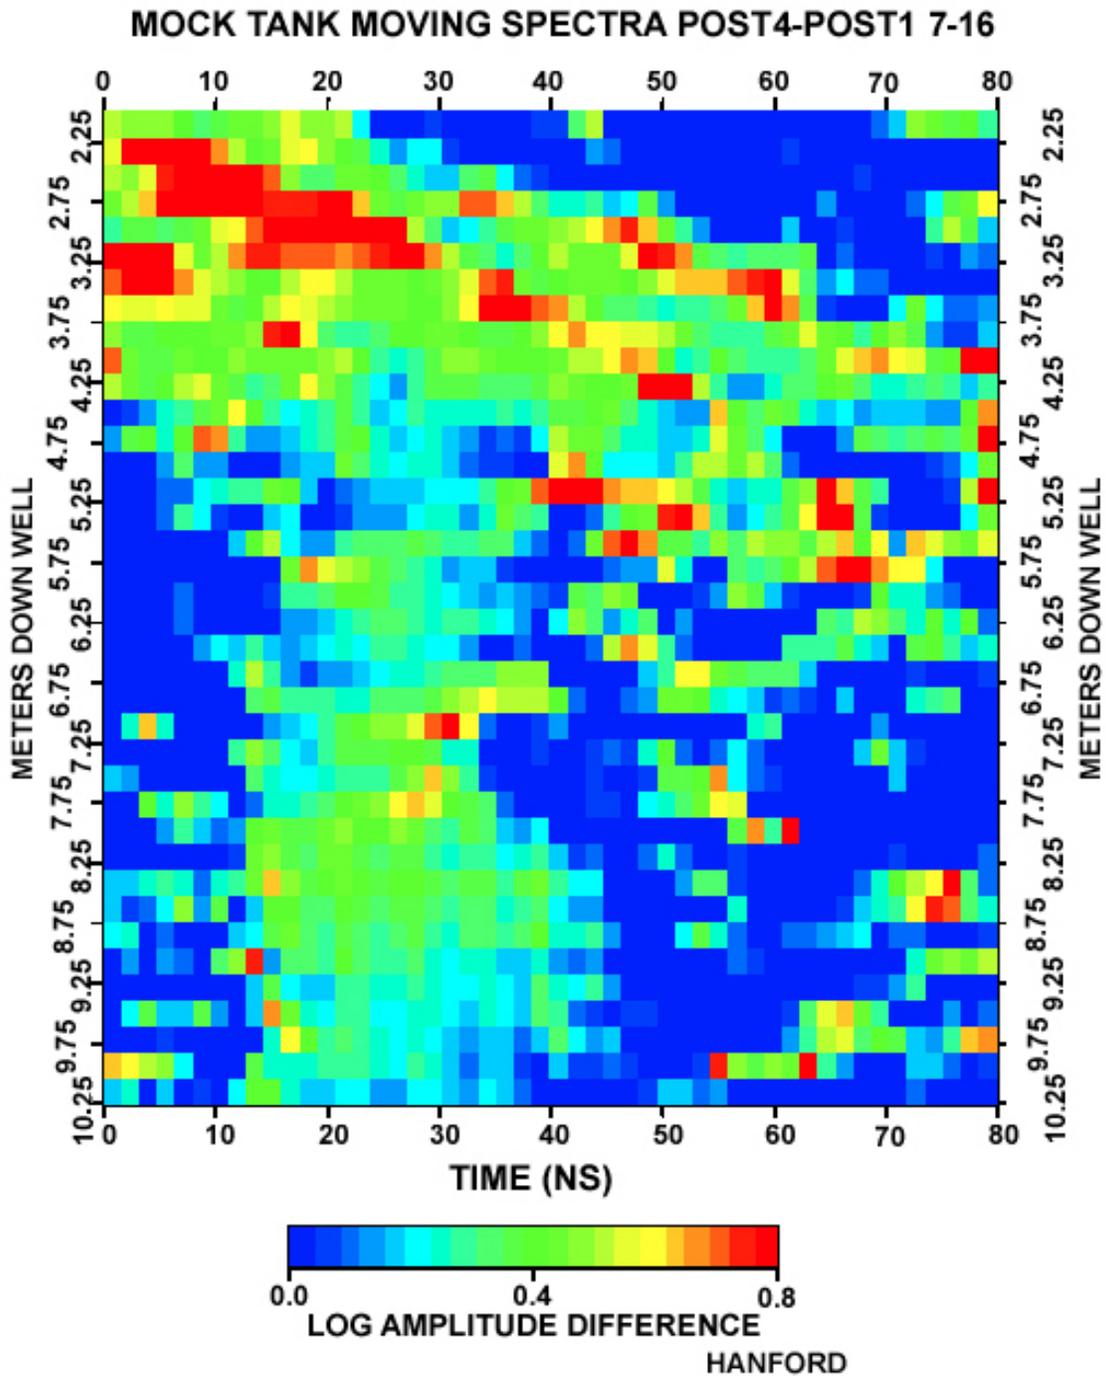
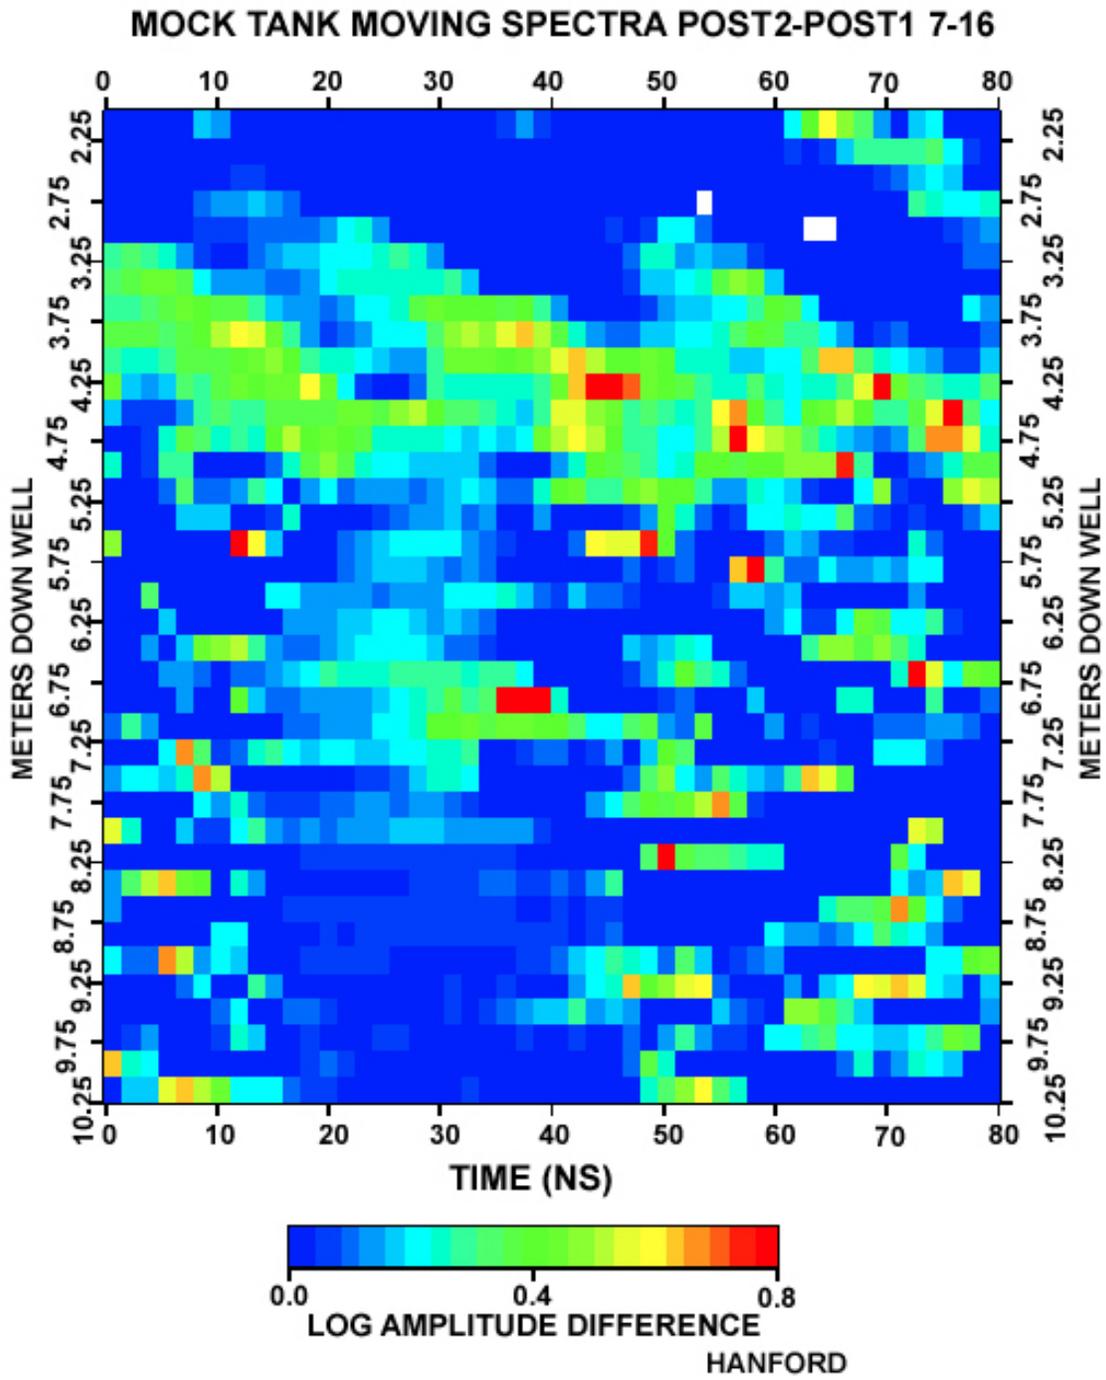
Figure 10. Time lapse of the change in radar amplitude as a function of depth for wells 7 and 16.

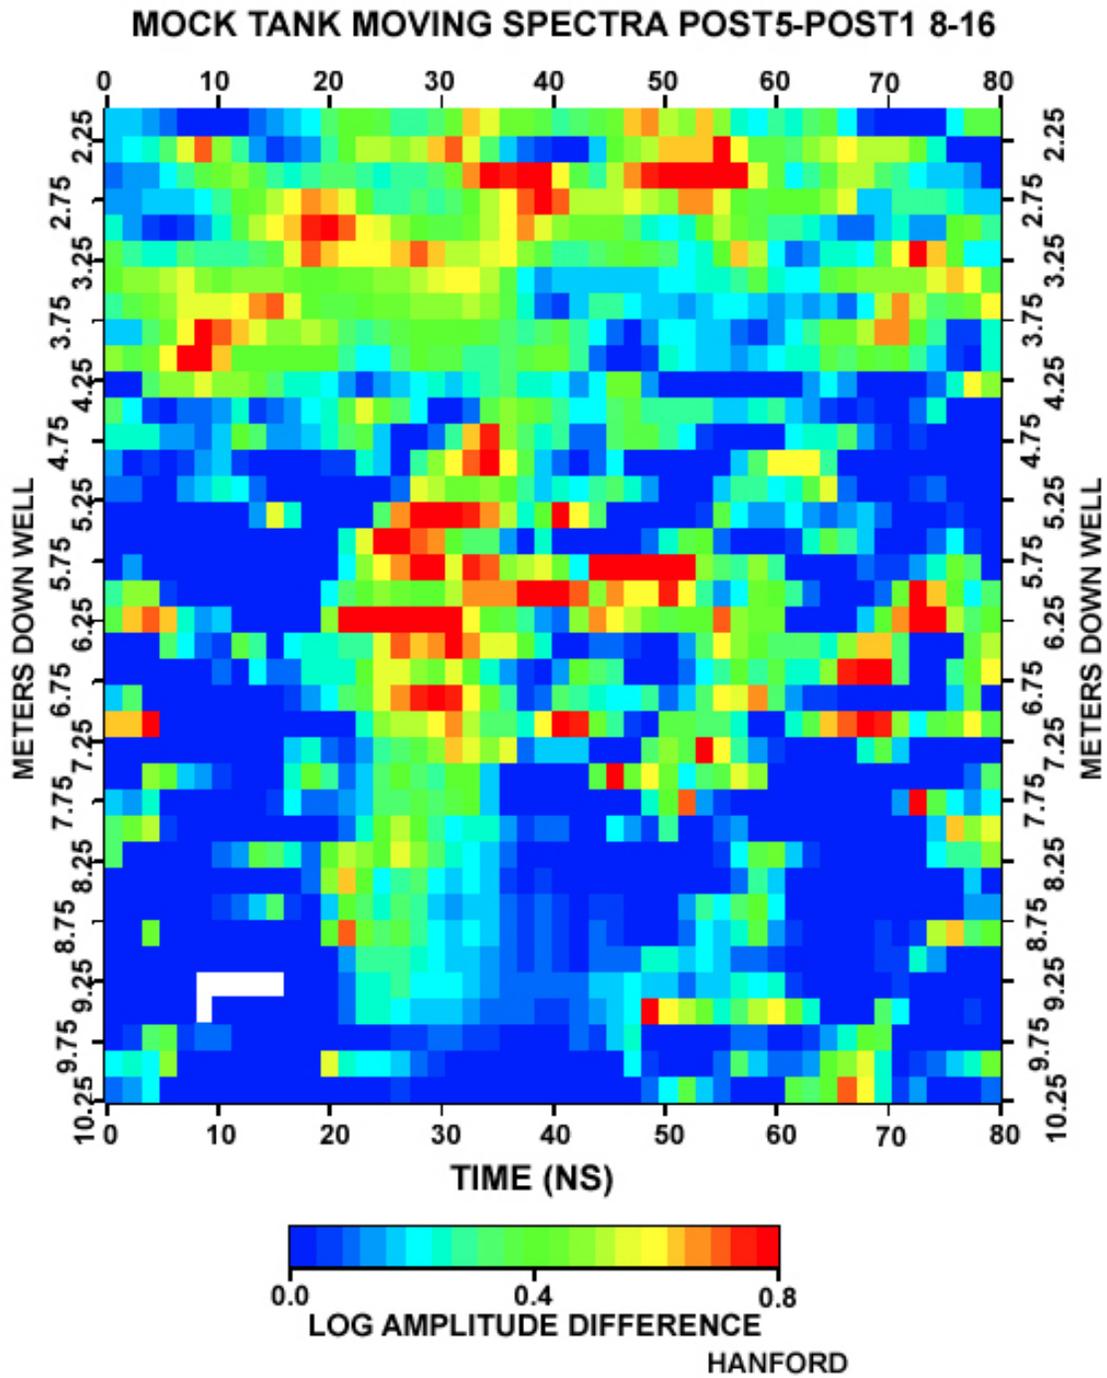
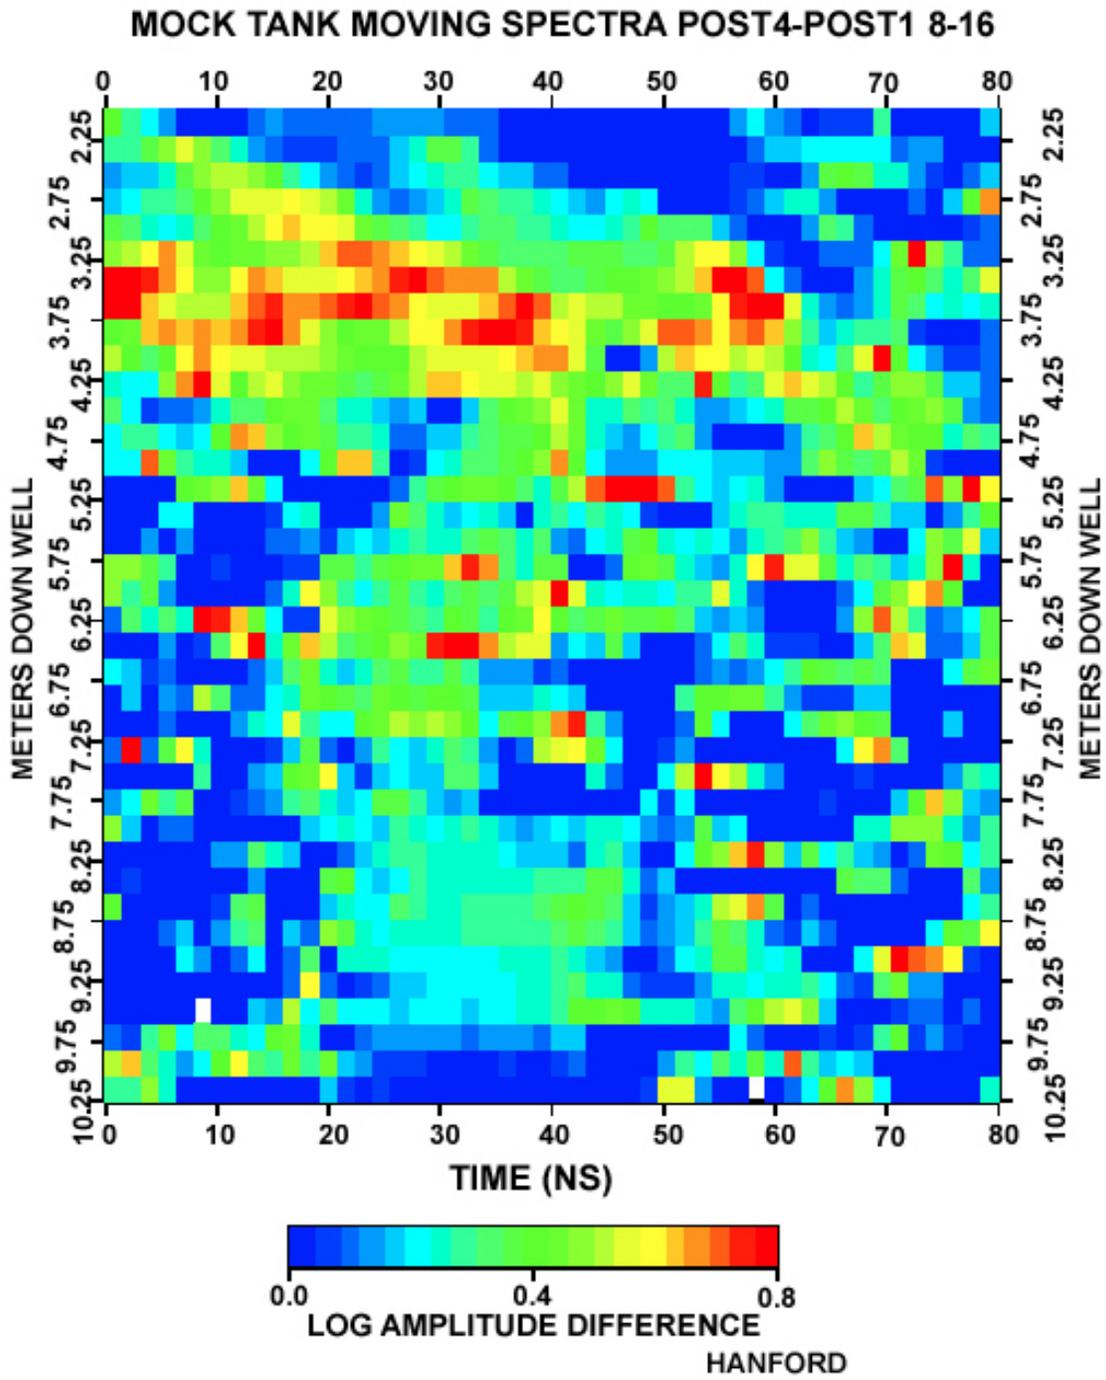
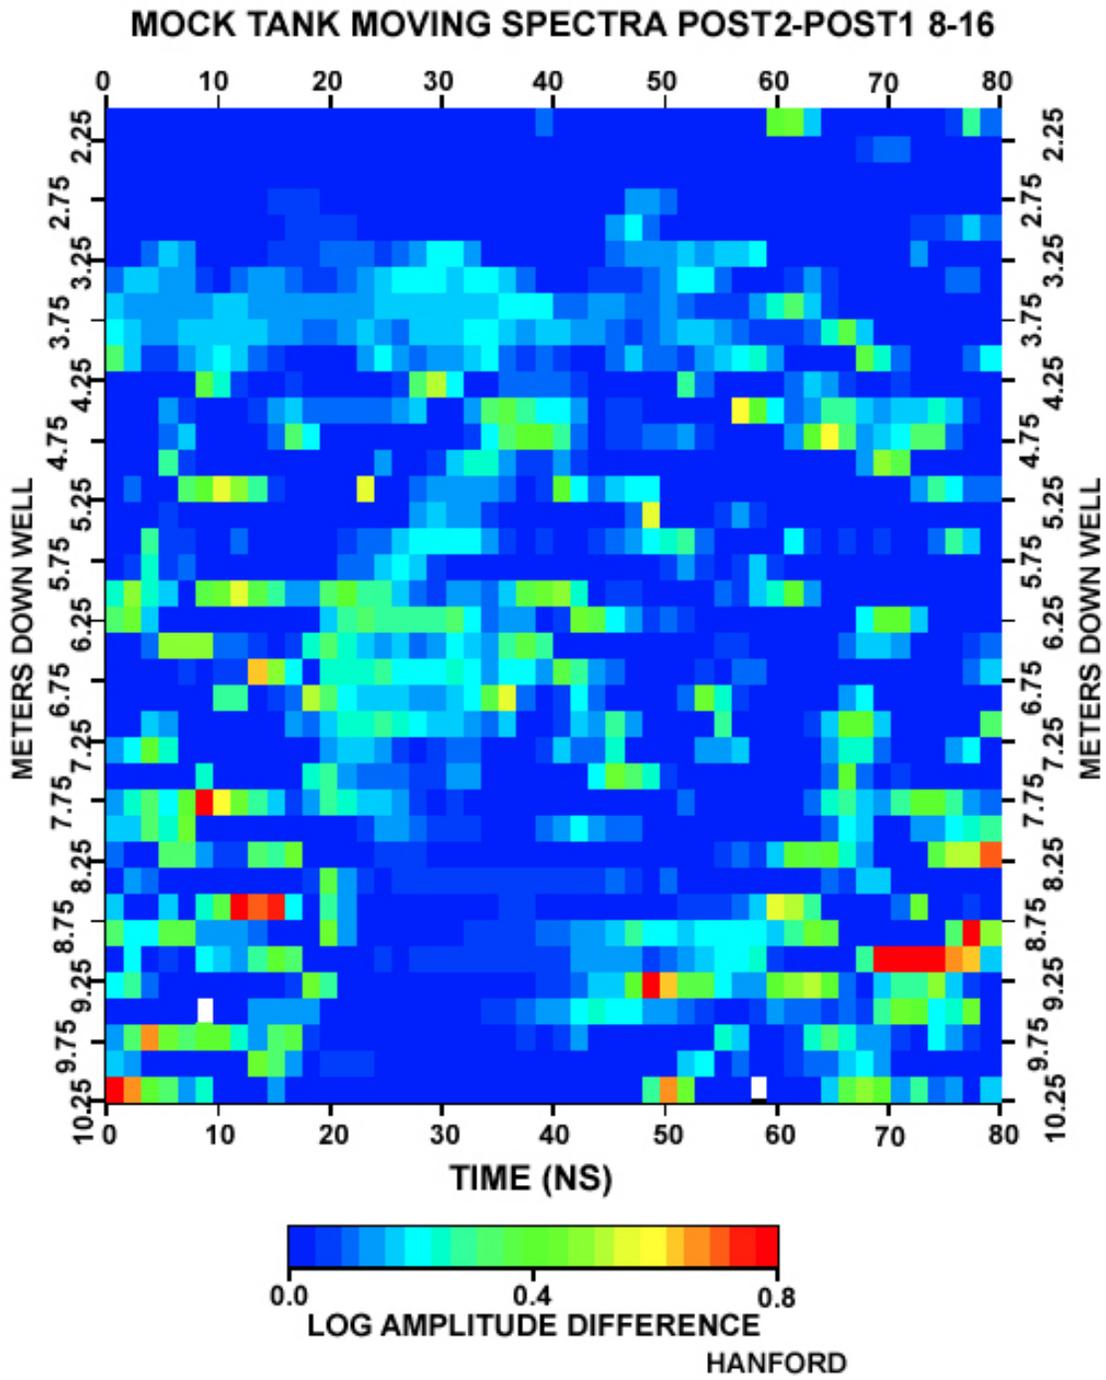
Figure 11. Time lapse of the change in radar amplitude as a function of depth for wells 8 and 16.

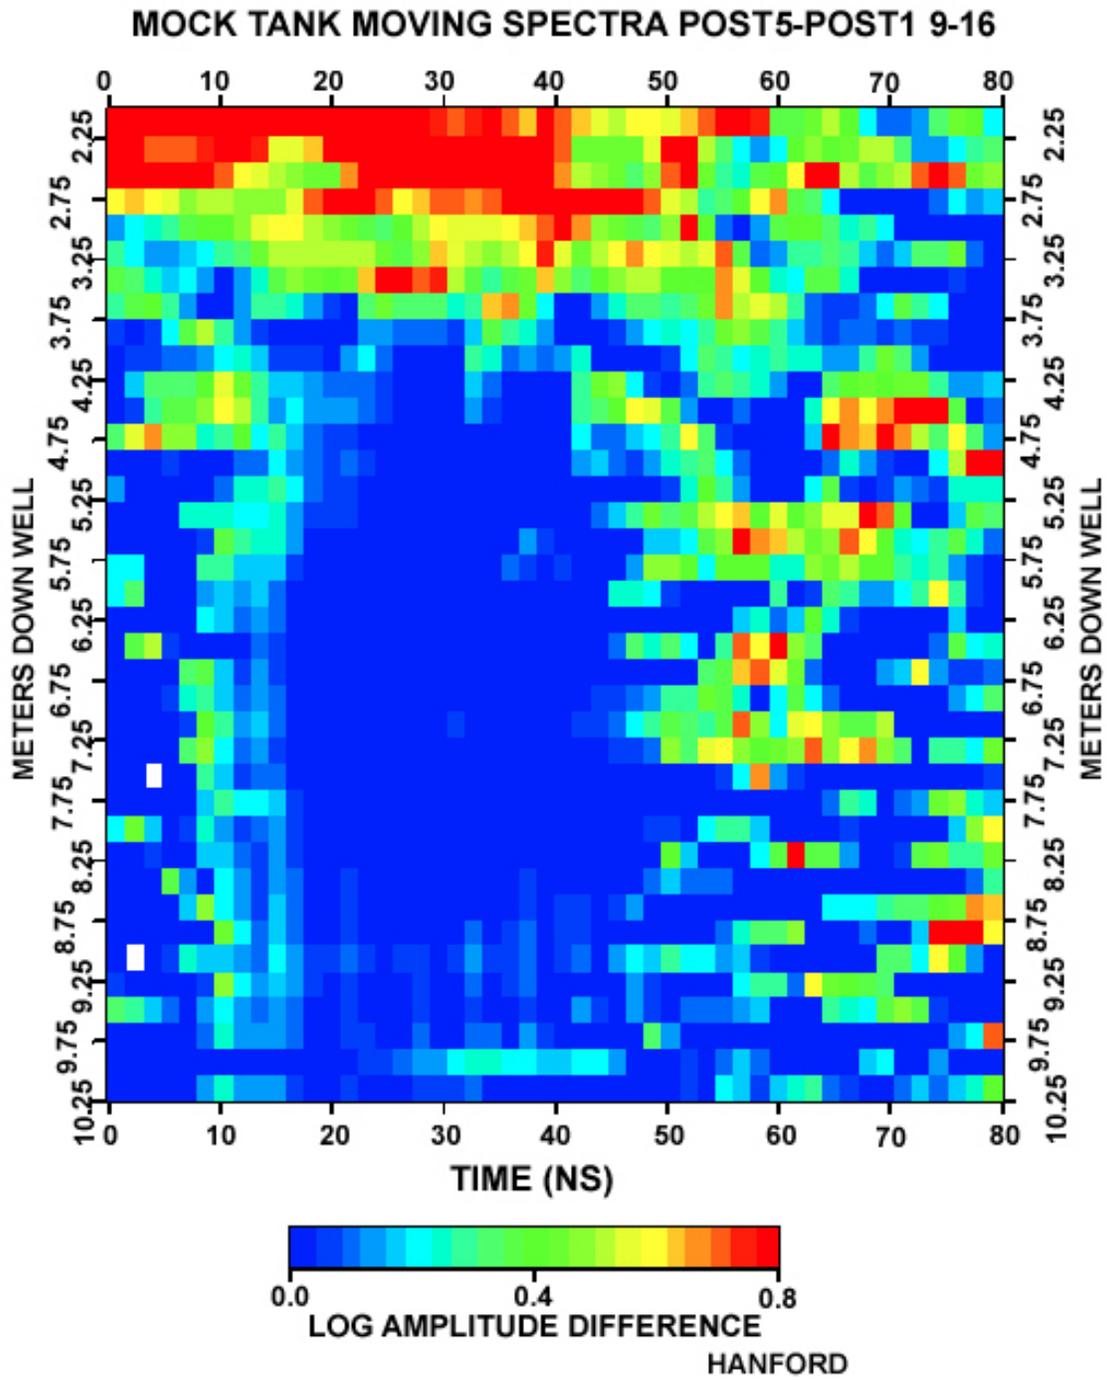
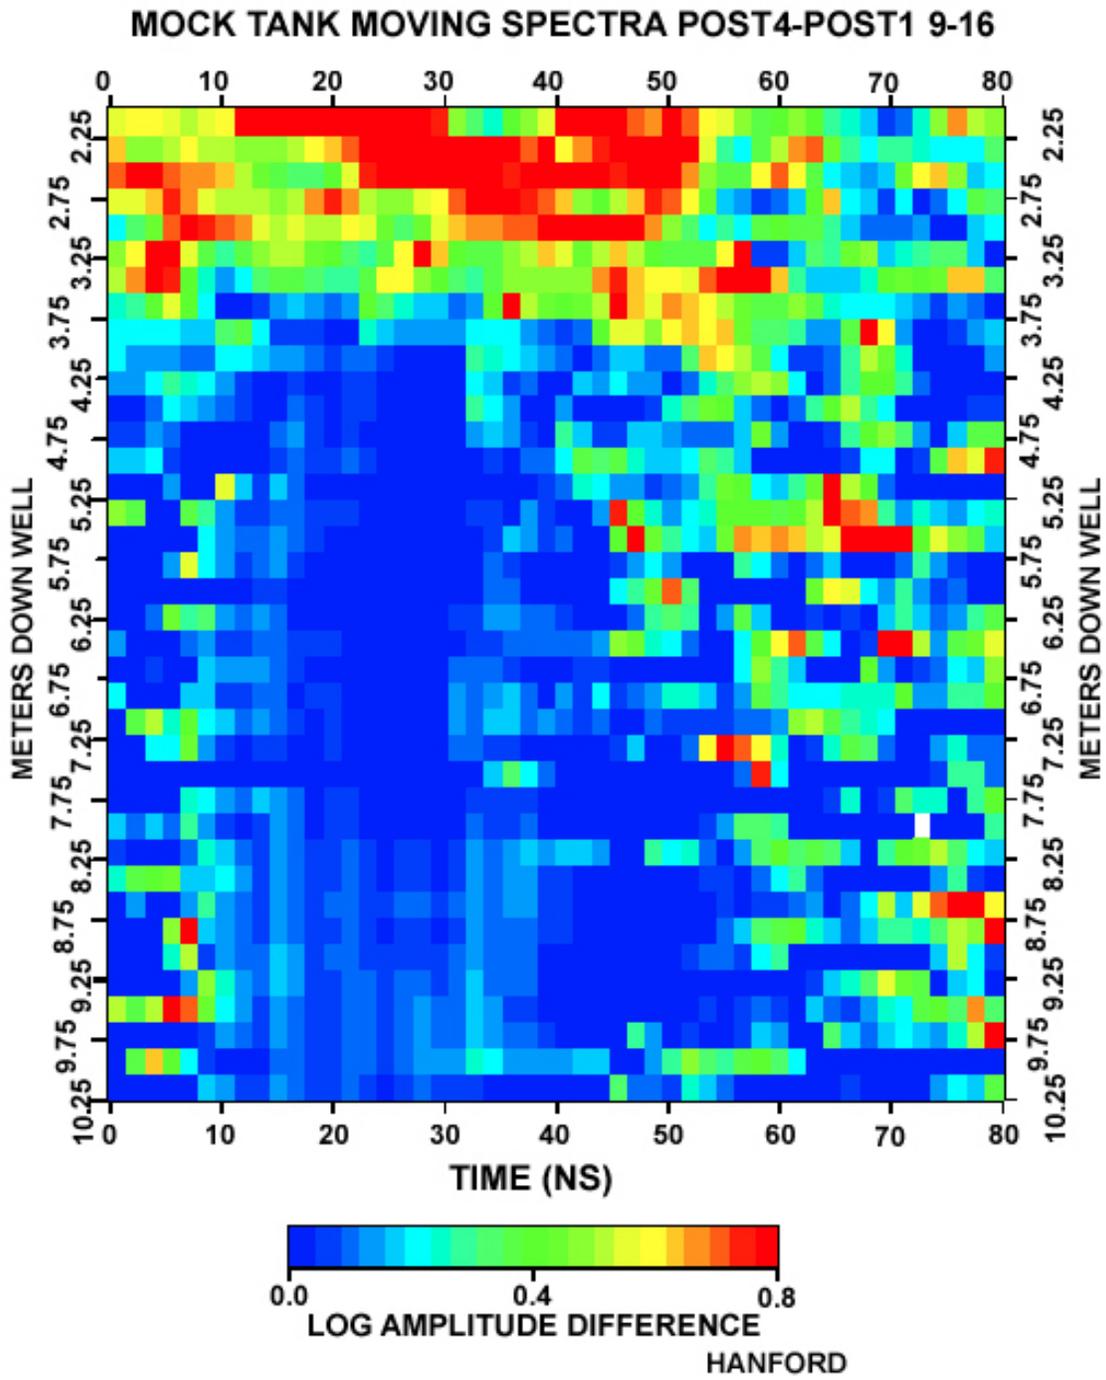
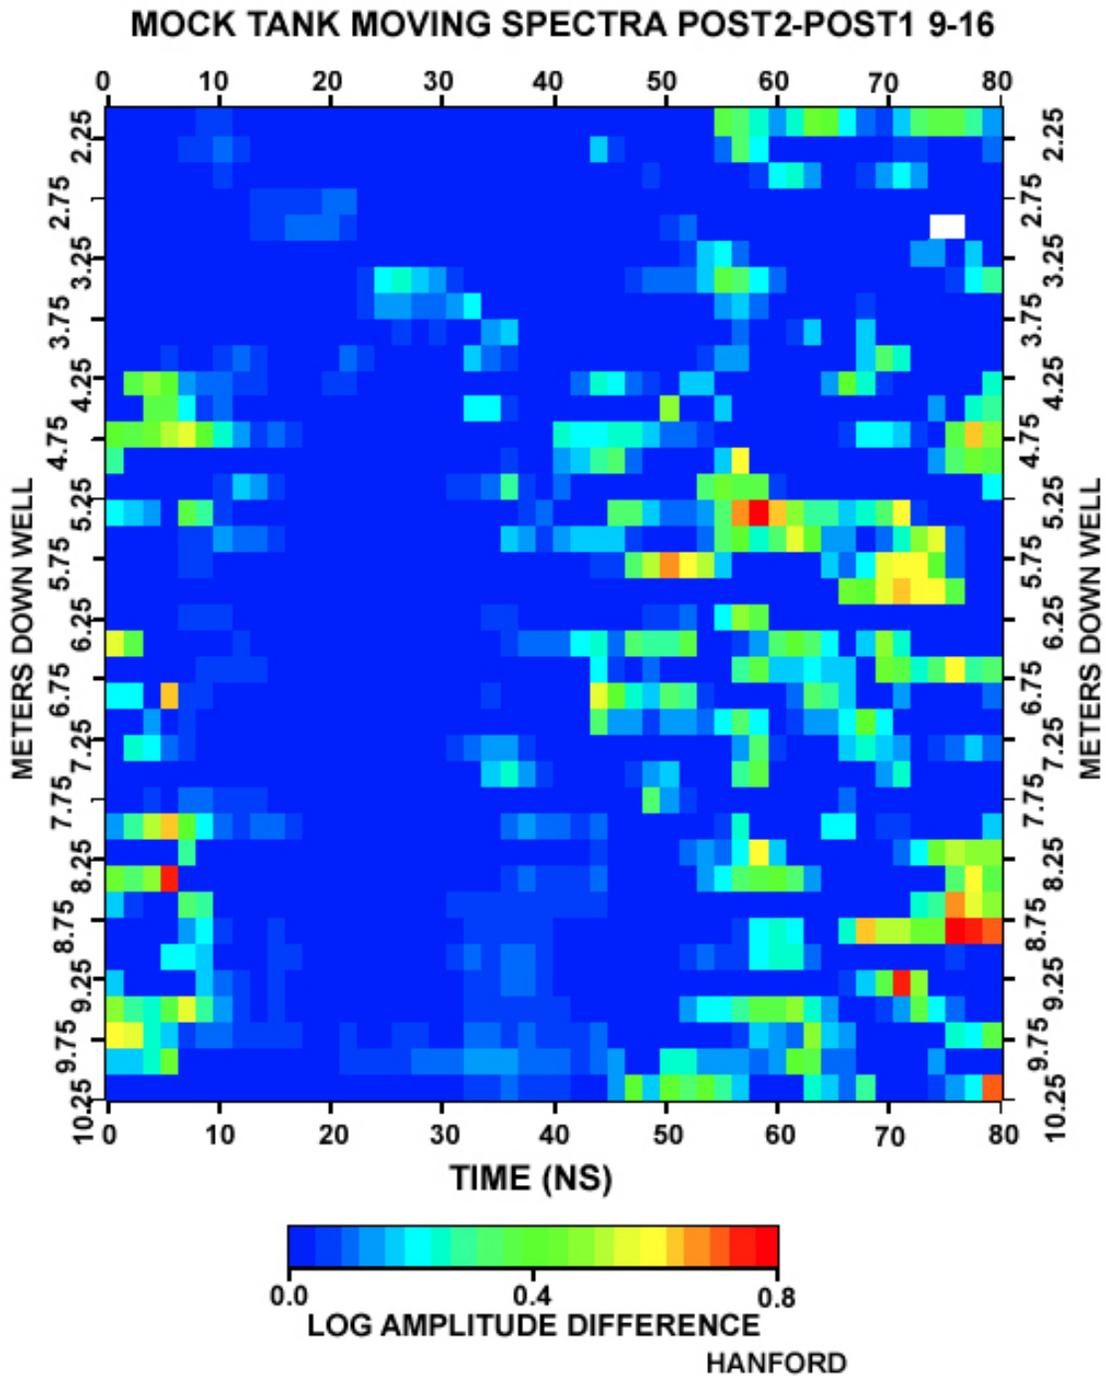
Figure 12. Time lapse of the change in radar amplitude as a function of depth for wells 9 and 16.
