**Results of Tank-Leak Detection
Demonstration Using Geophysical
Techniques at the Hanford Mock
Tank Site—Fiscal Year 2001**

D. B. Barnett
G. W. Gee
M. D. Sweeney

March 2002

Pacific Northwest National Laboratory
Richland, Washington 99352

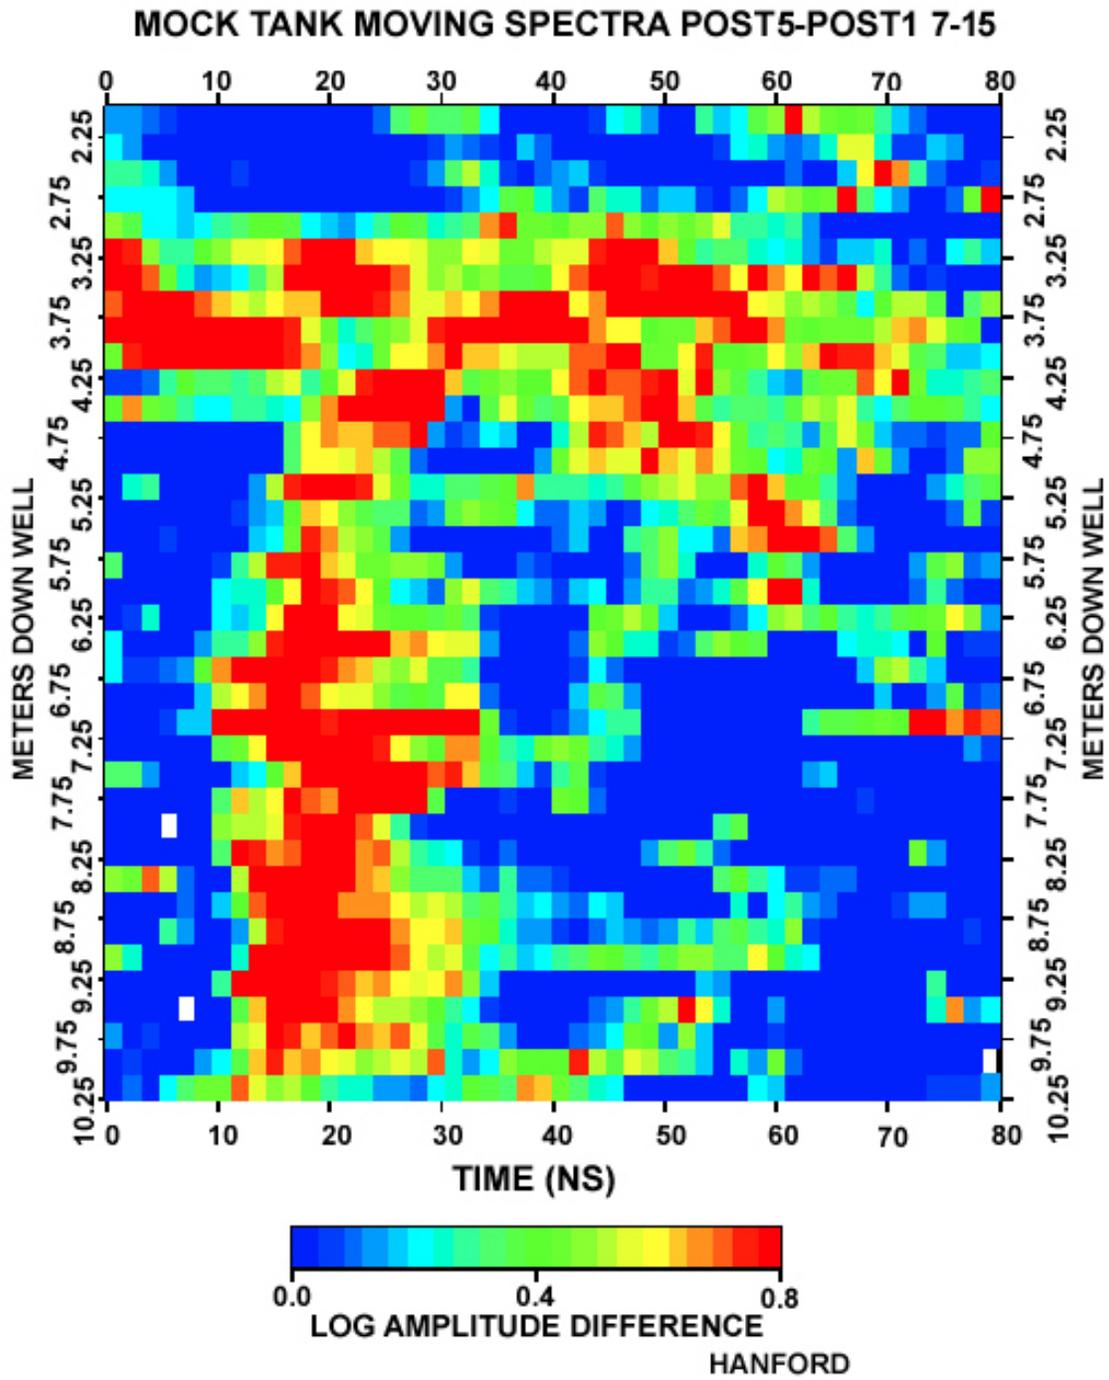
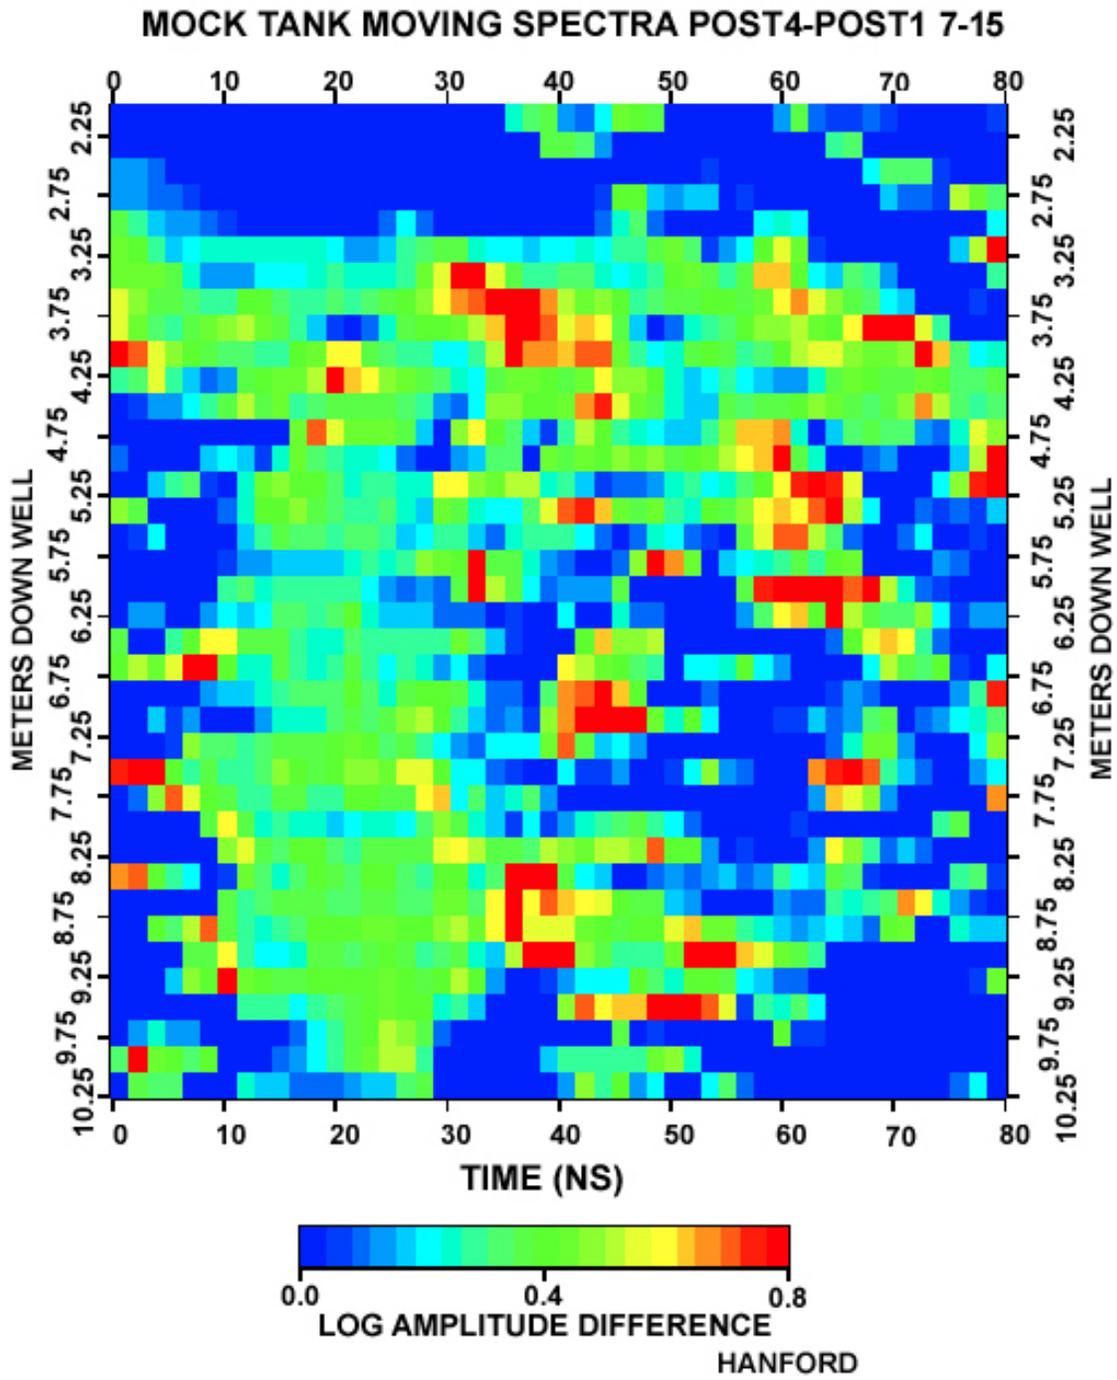
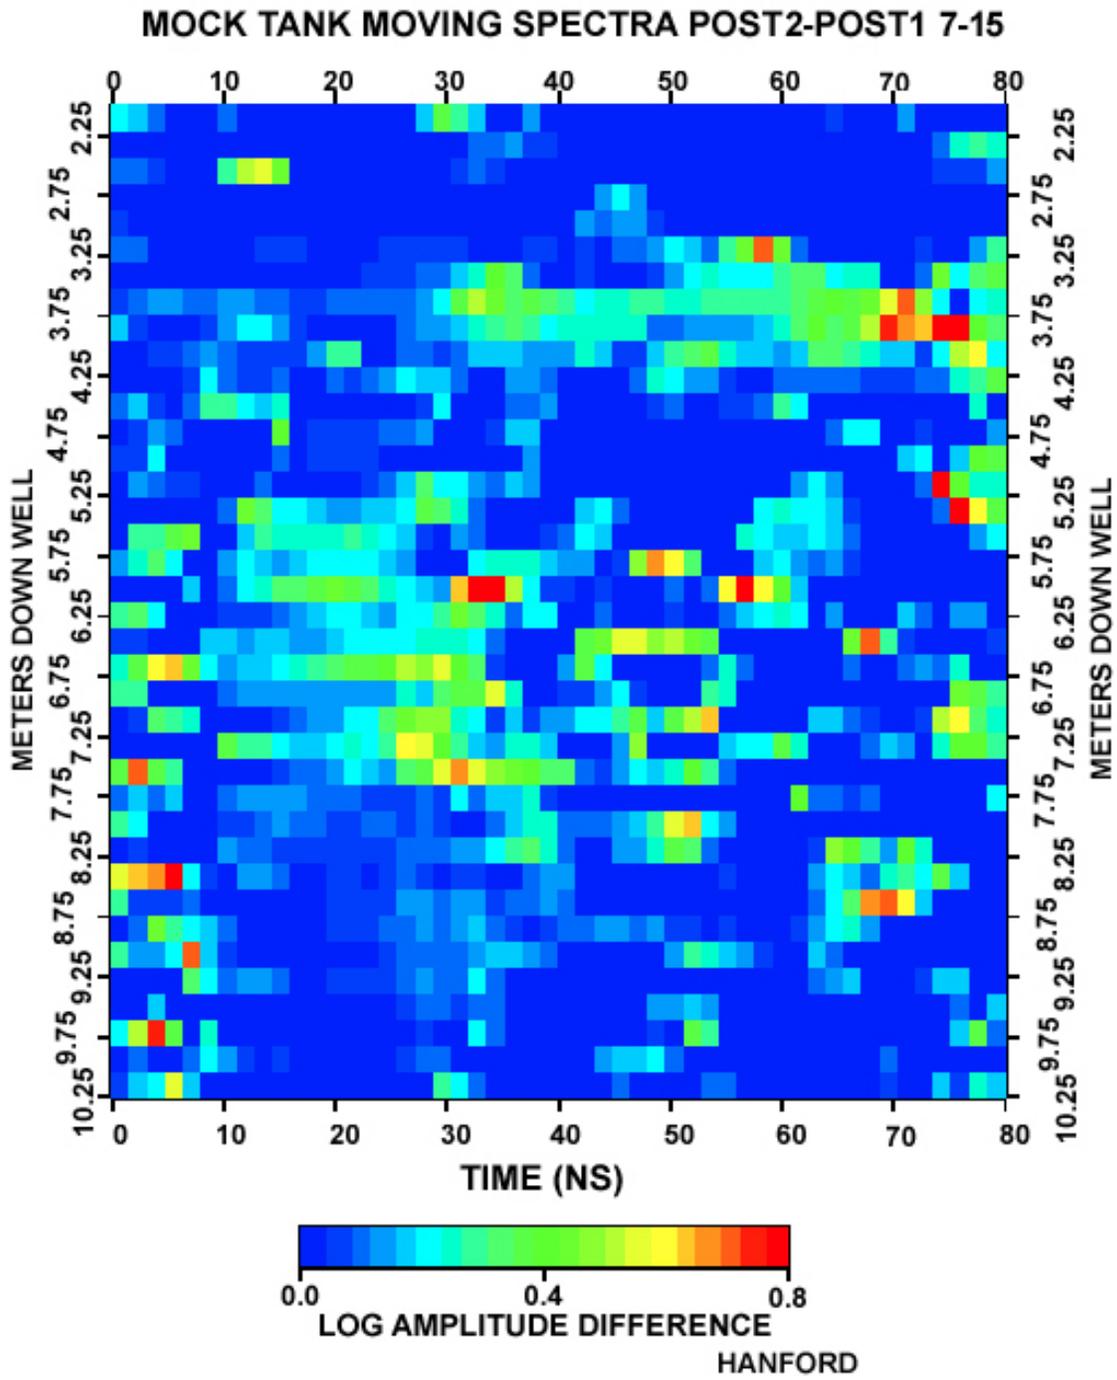
Figure 13. Time lapse of the change in radar amplitude as a function of depth for wells 7 and 15.

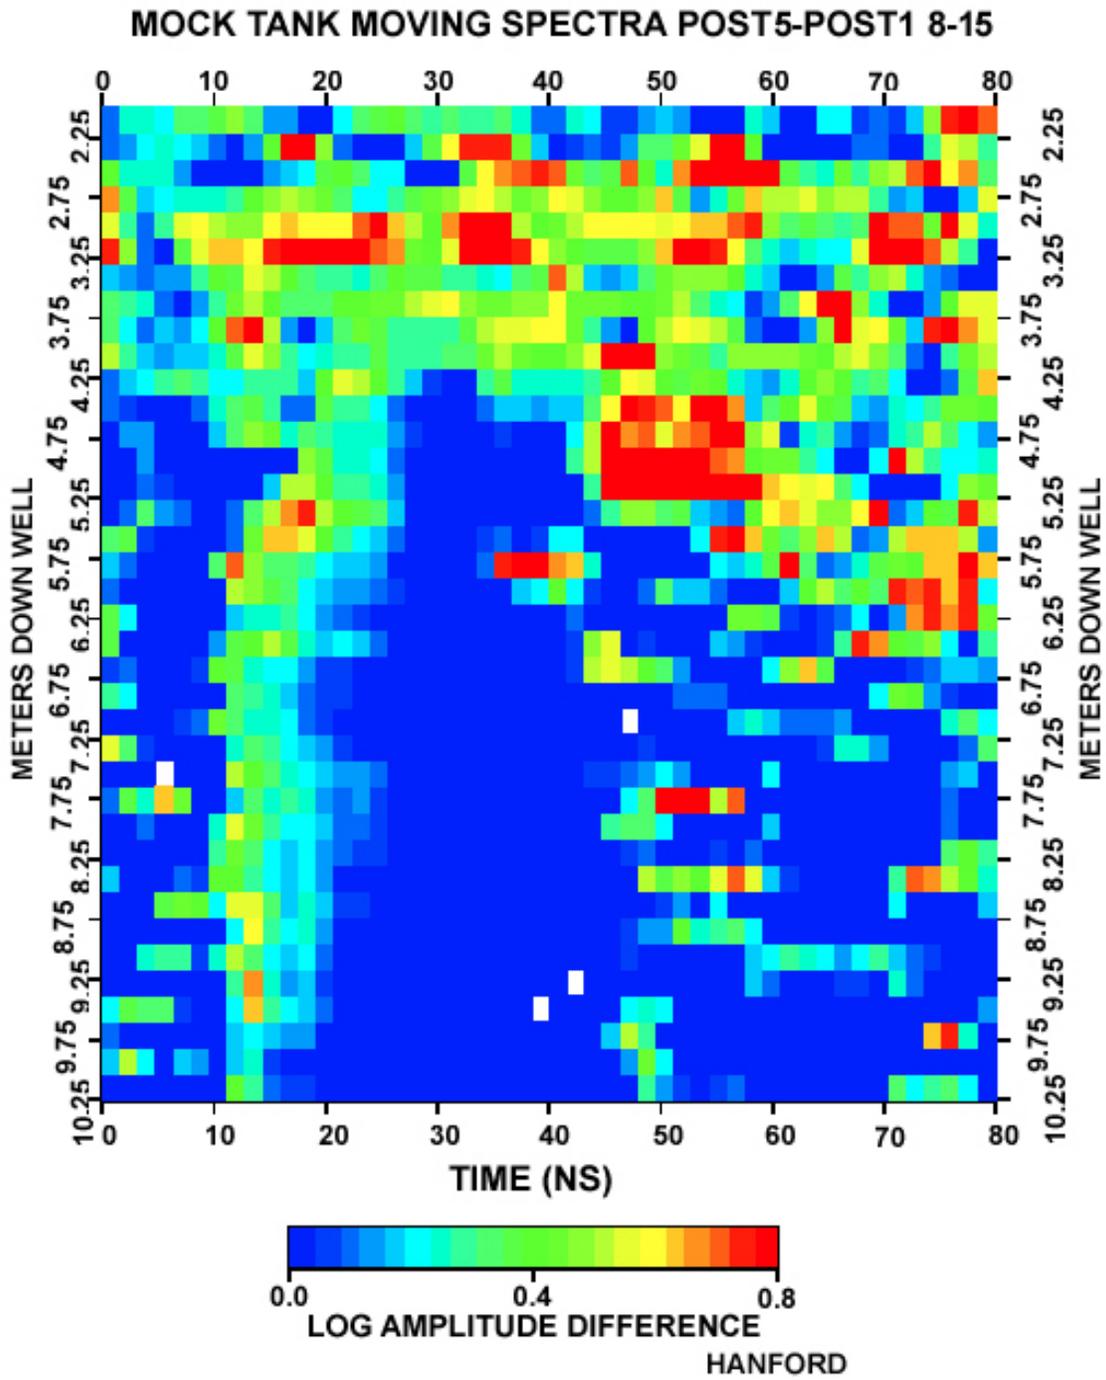
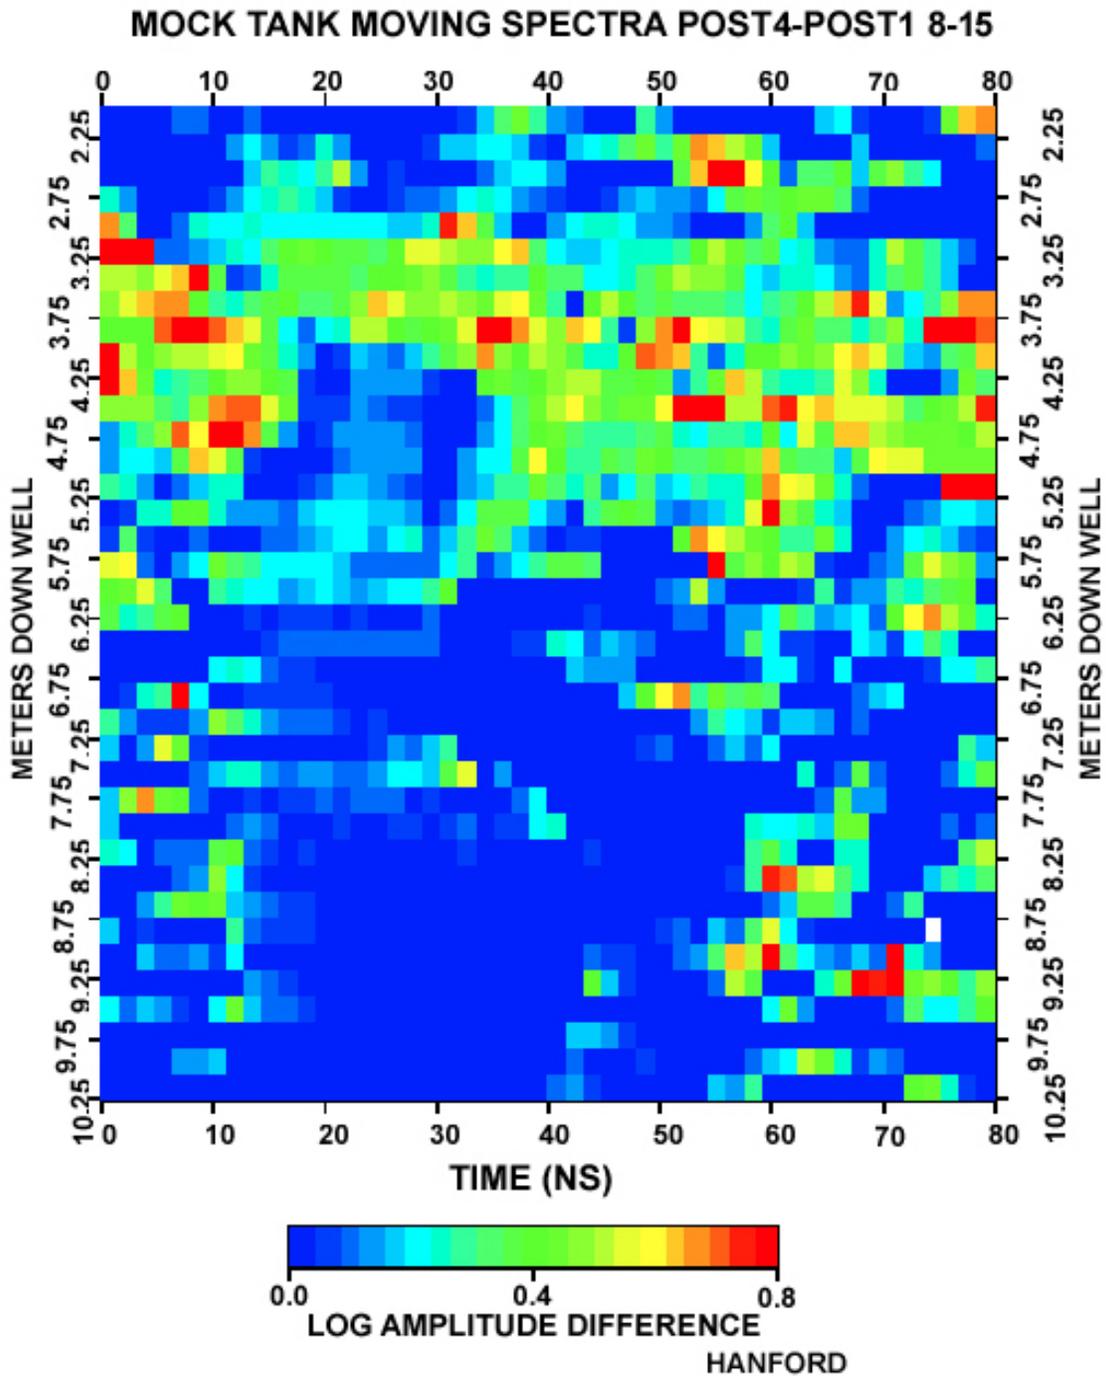
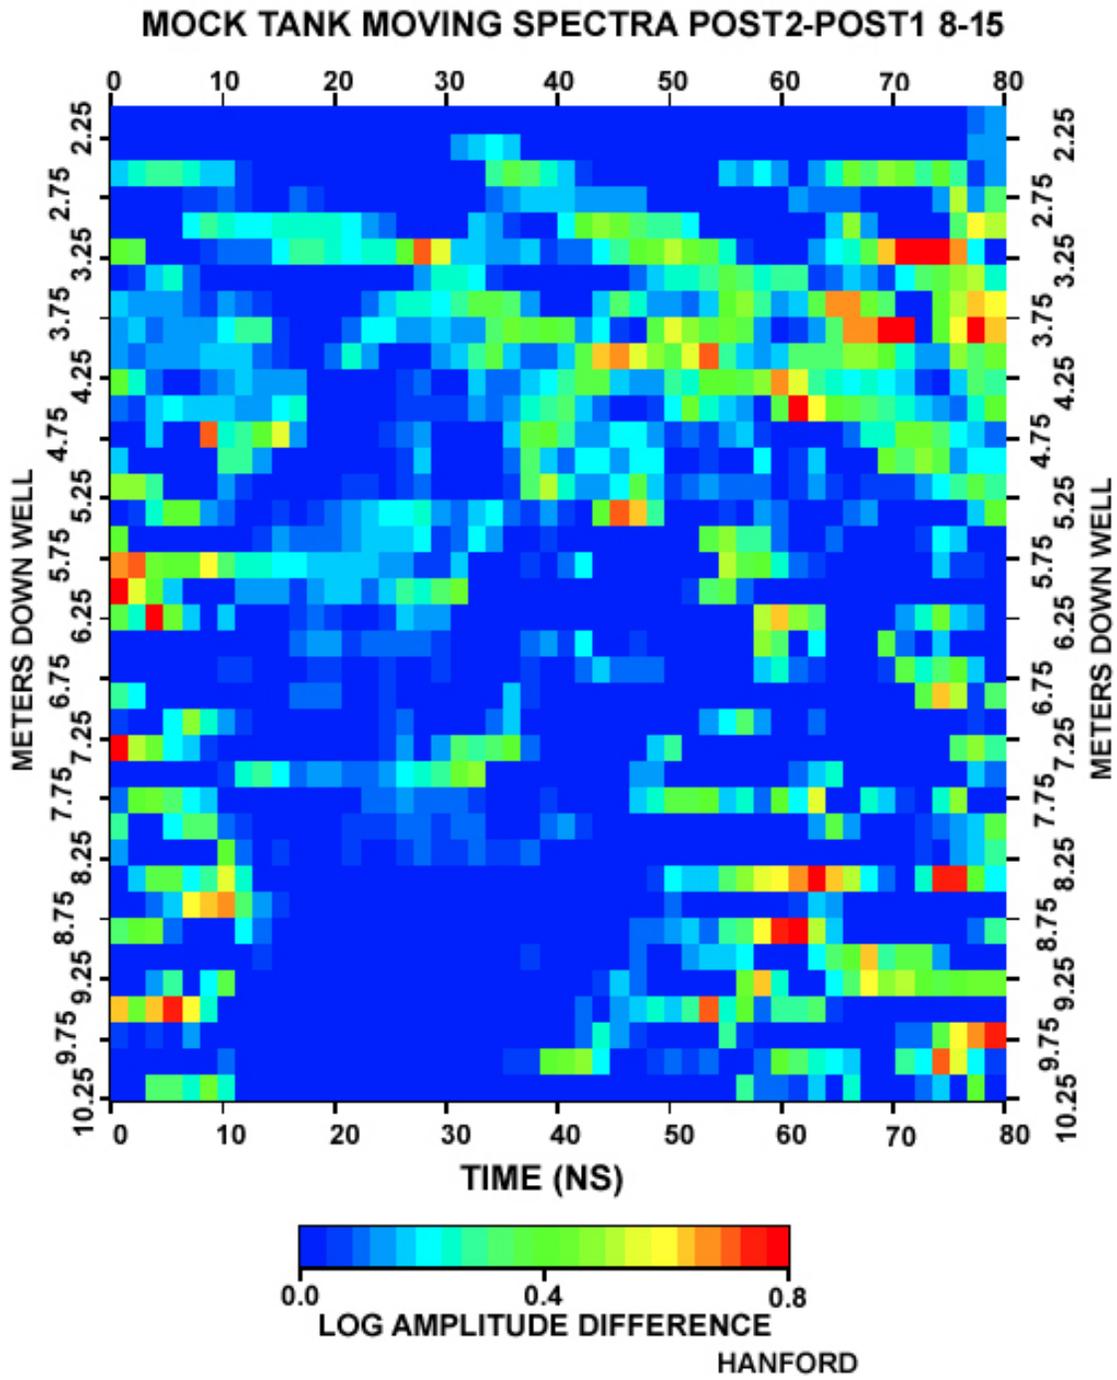
Figure 14. Time lapse of the change in radar amplitude as a function of depth for wells 8 and 15.

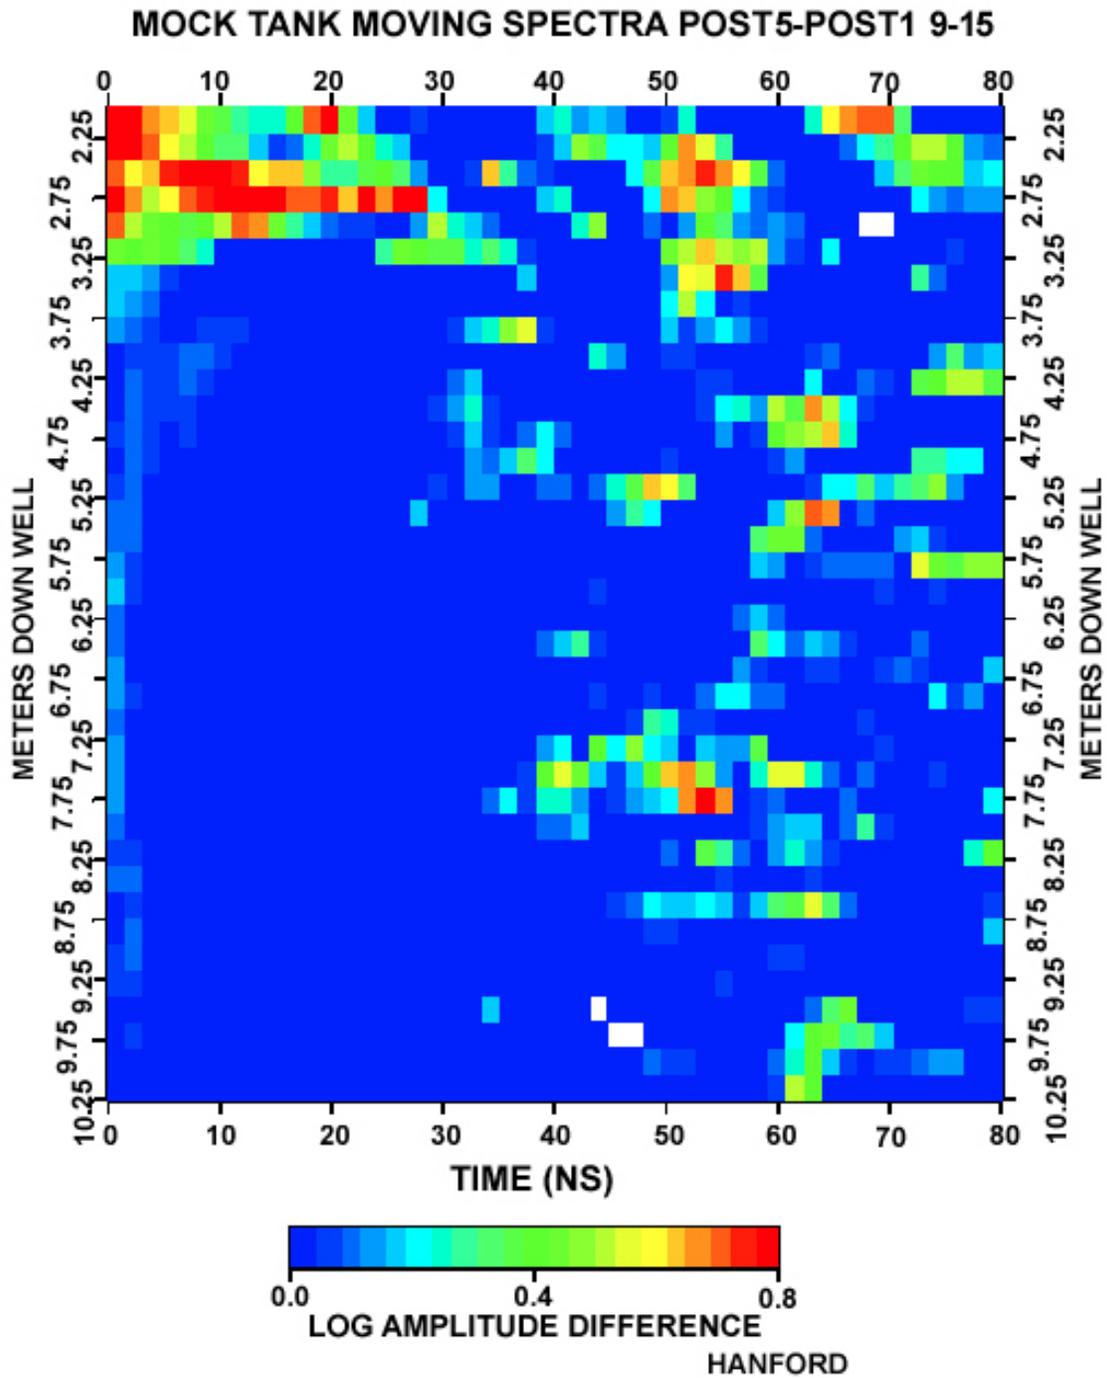
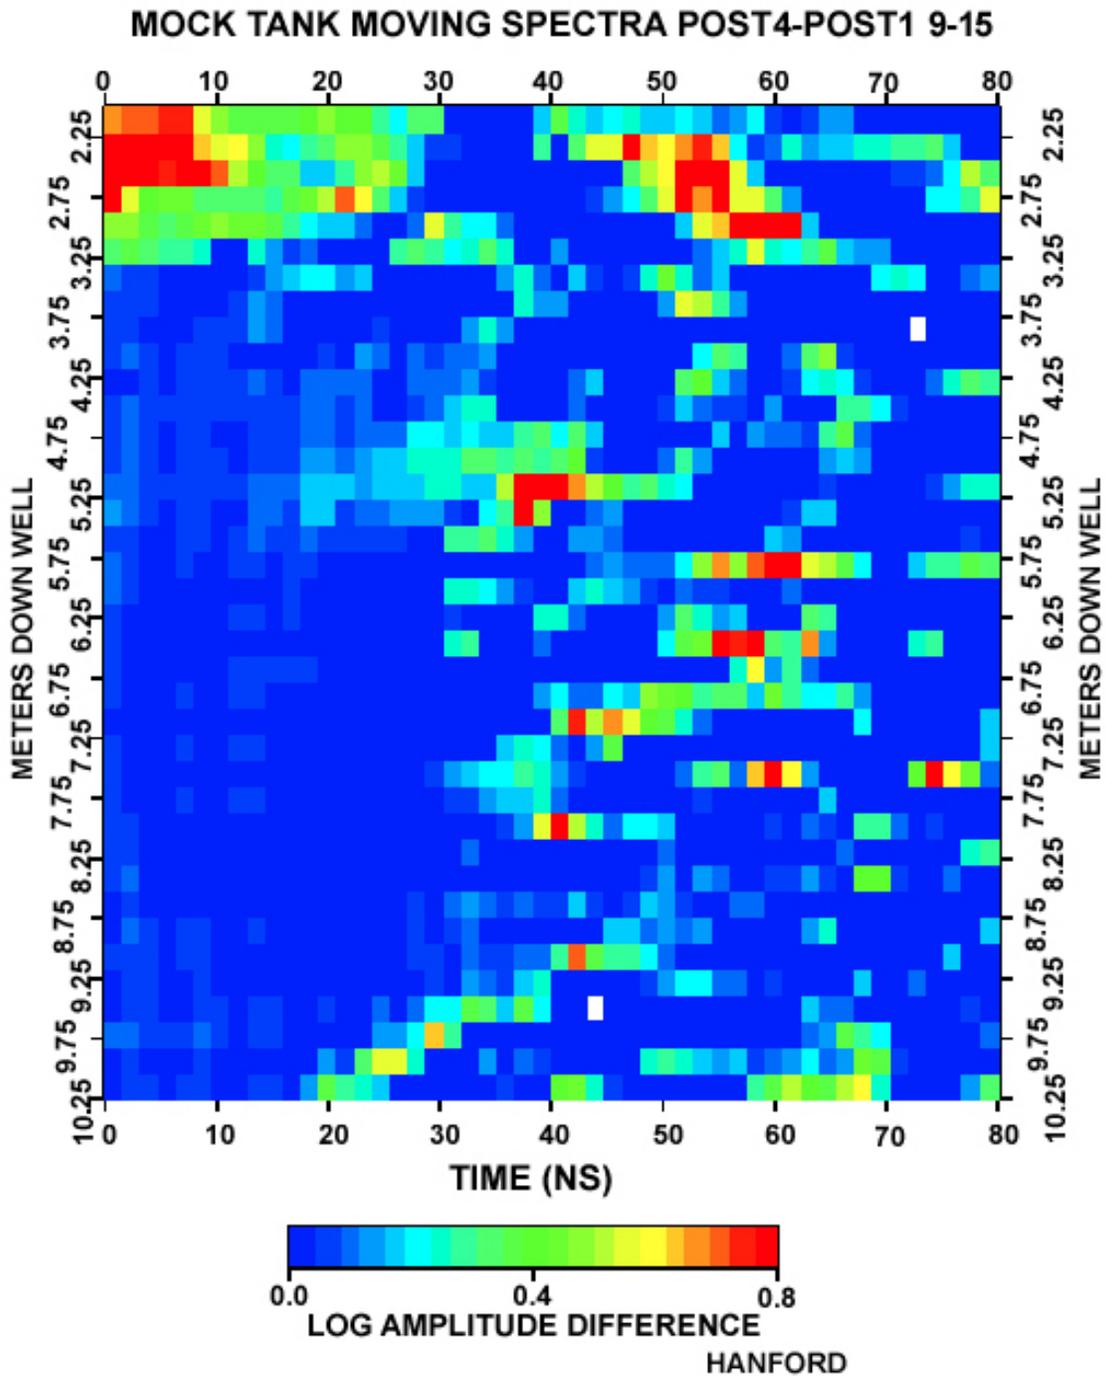
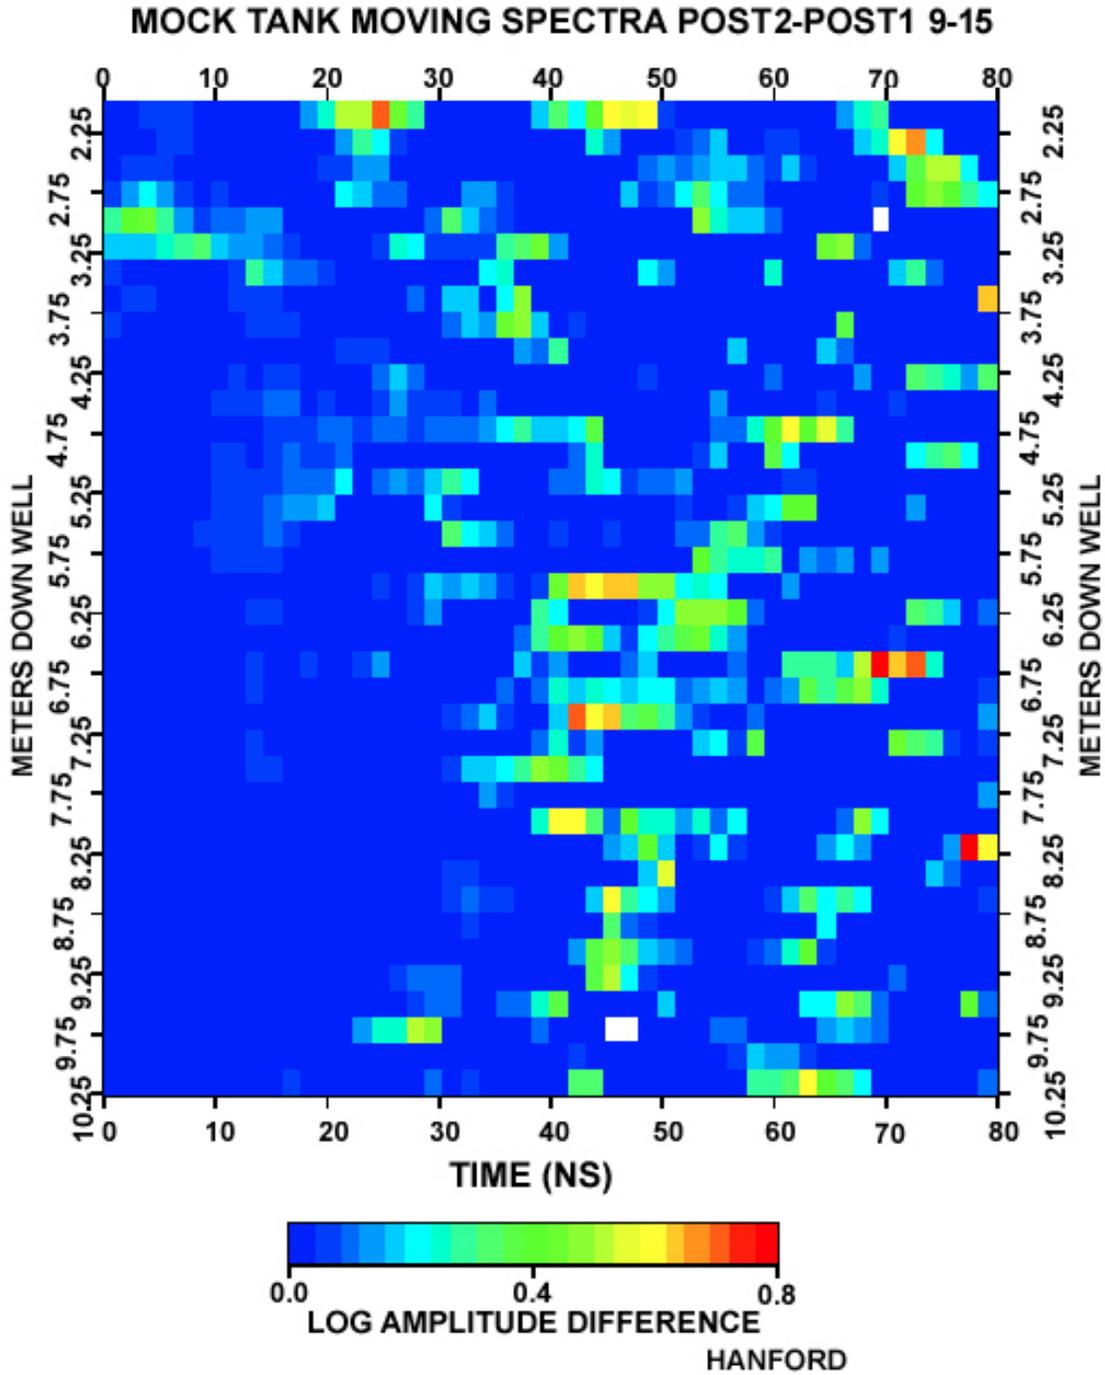
Figure 15. Time lapse of the change in radar amplitude as a function of depth for wells 9 and 15.

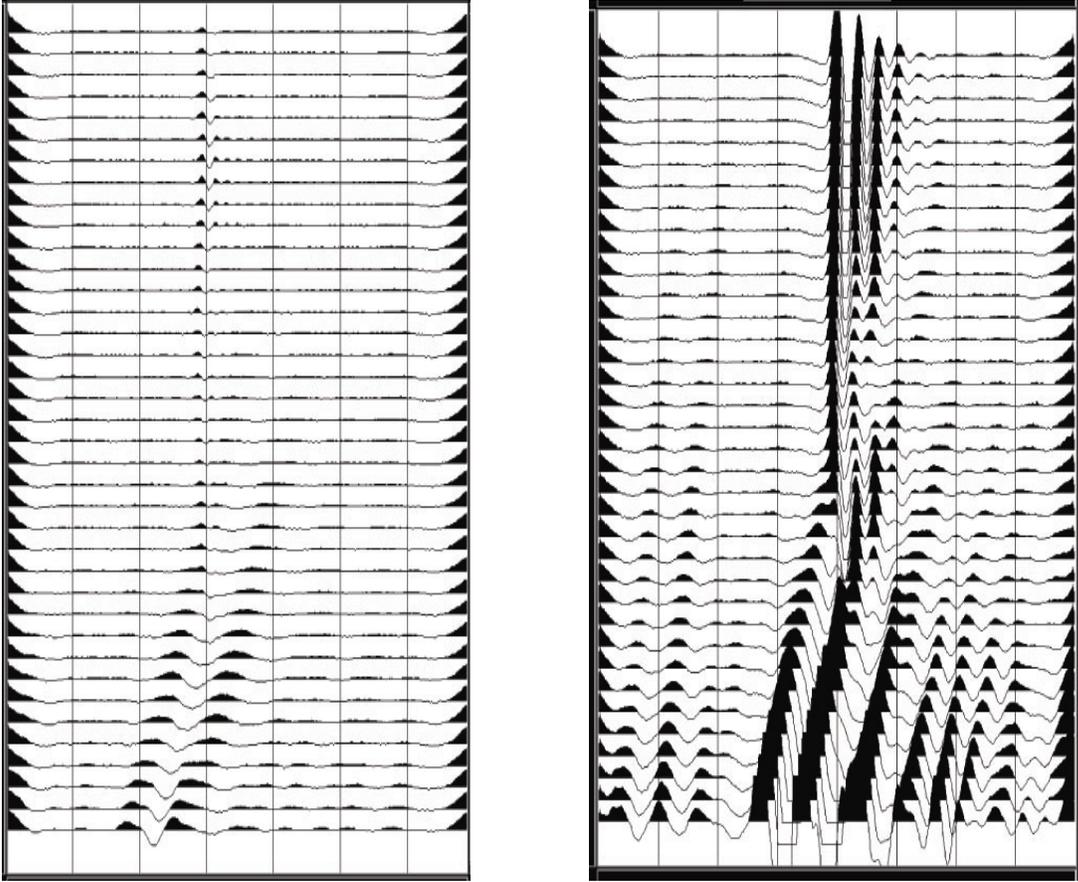
Figure 16. Crosswell data for the 100 Mhz. (left panel) and the 50 Mhz. radar (right panel) data for the well pair 8 to 16. The amplitude difference (and signal to noise ratio difference) is about 10 to 1. Shown are the true amplitude sections with no automatic gain control applied. The top of the hole is the bottom of the figure.

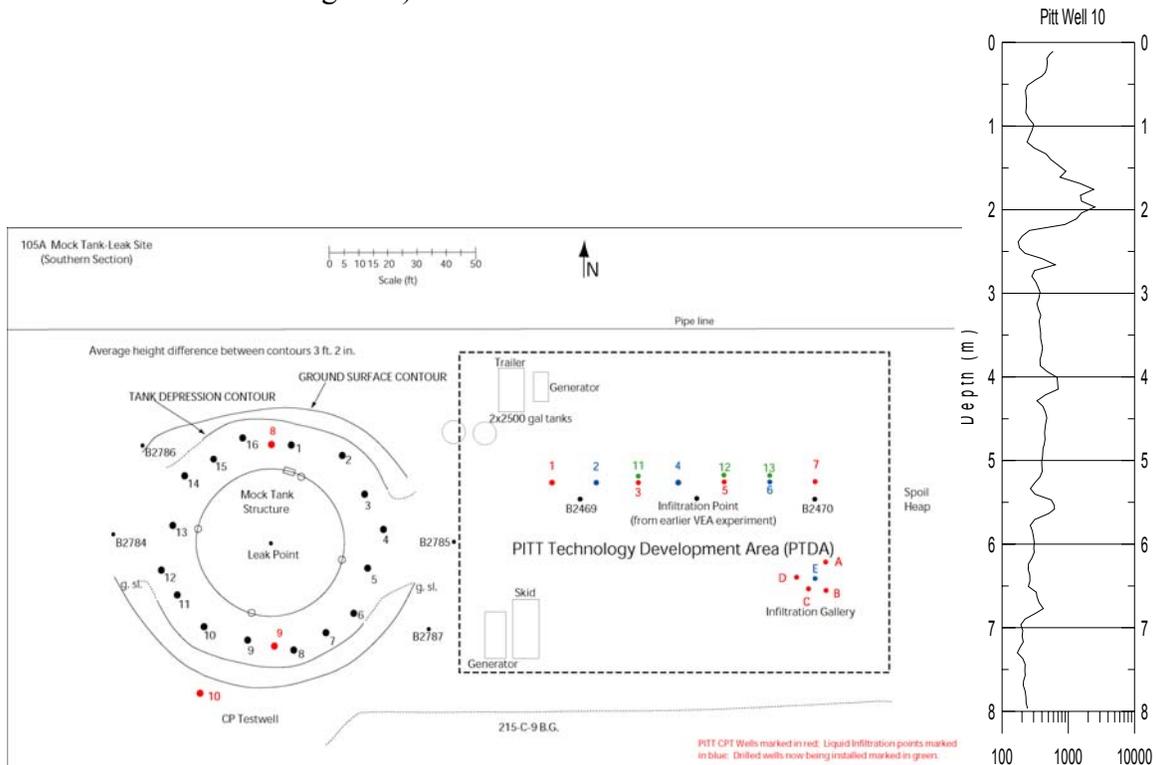
Figure 1. Diagram of LDMM PITT well field (left) and Pitt-10 resistivity log (right). PITT CPT wells marked in red; liquid infiltration points marked in blue; drilled wells now being installed marked in green. Wells 1-16 around mock tank (black) are ERT wells from previous experiment.

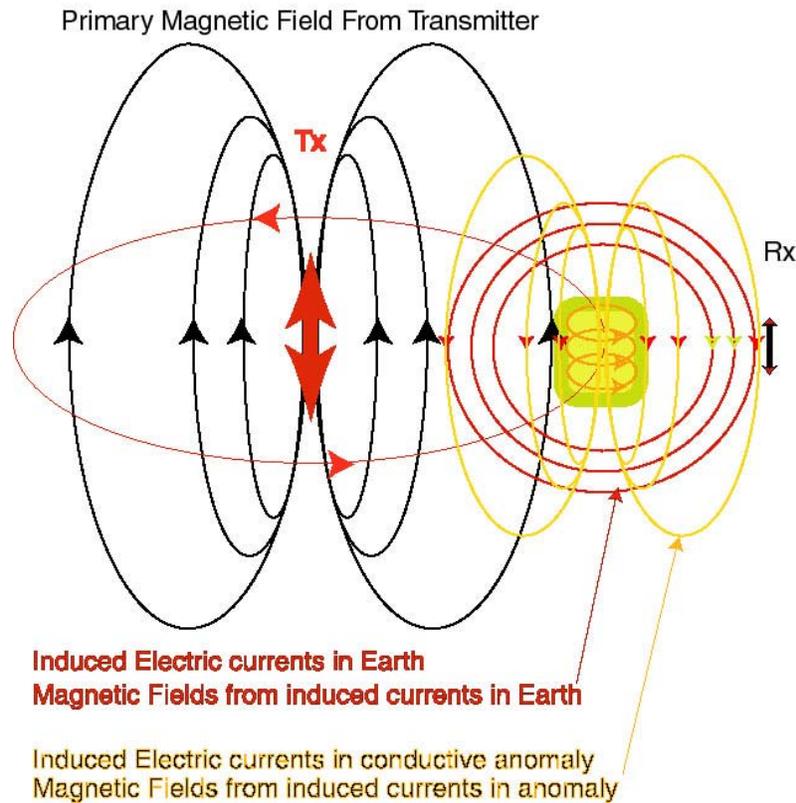
Figure 2: *Magnetic and electric fields associated with a time-varying magnetic dipole source in a crosswell configuration within the earth.*

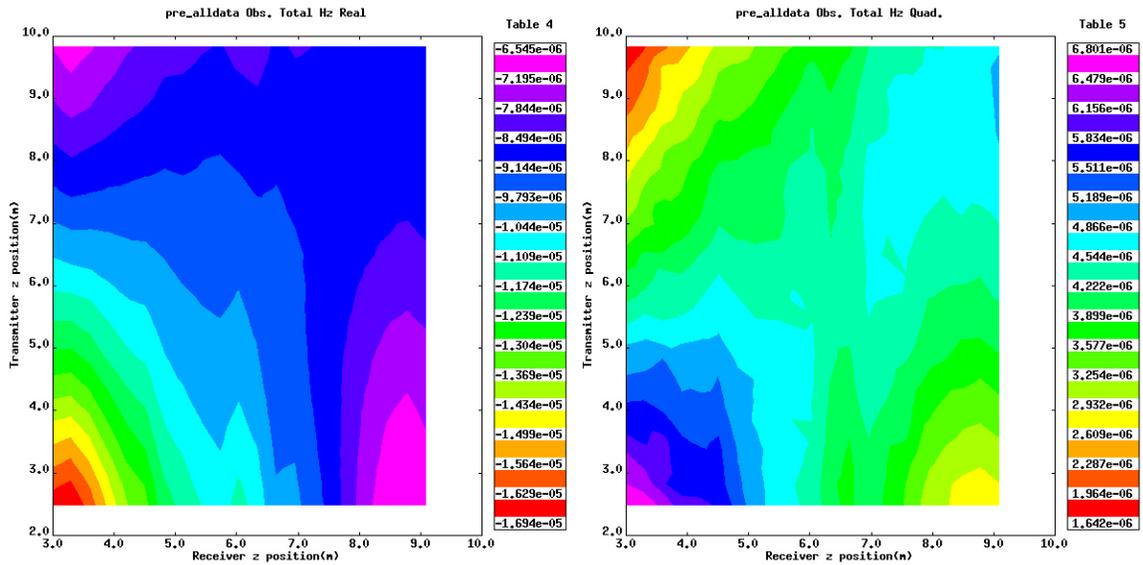
Figure 10: Real (left) and Quadrature (right) vertical magnetic field from Transmitter Tx3 and receiver well ERT-6.

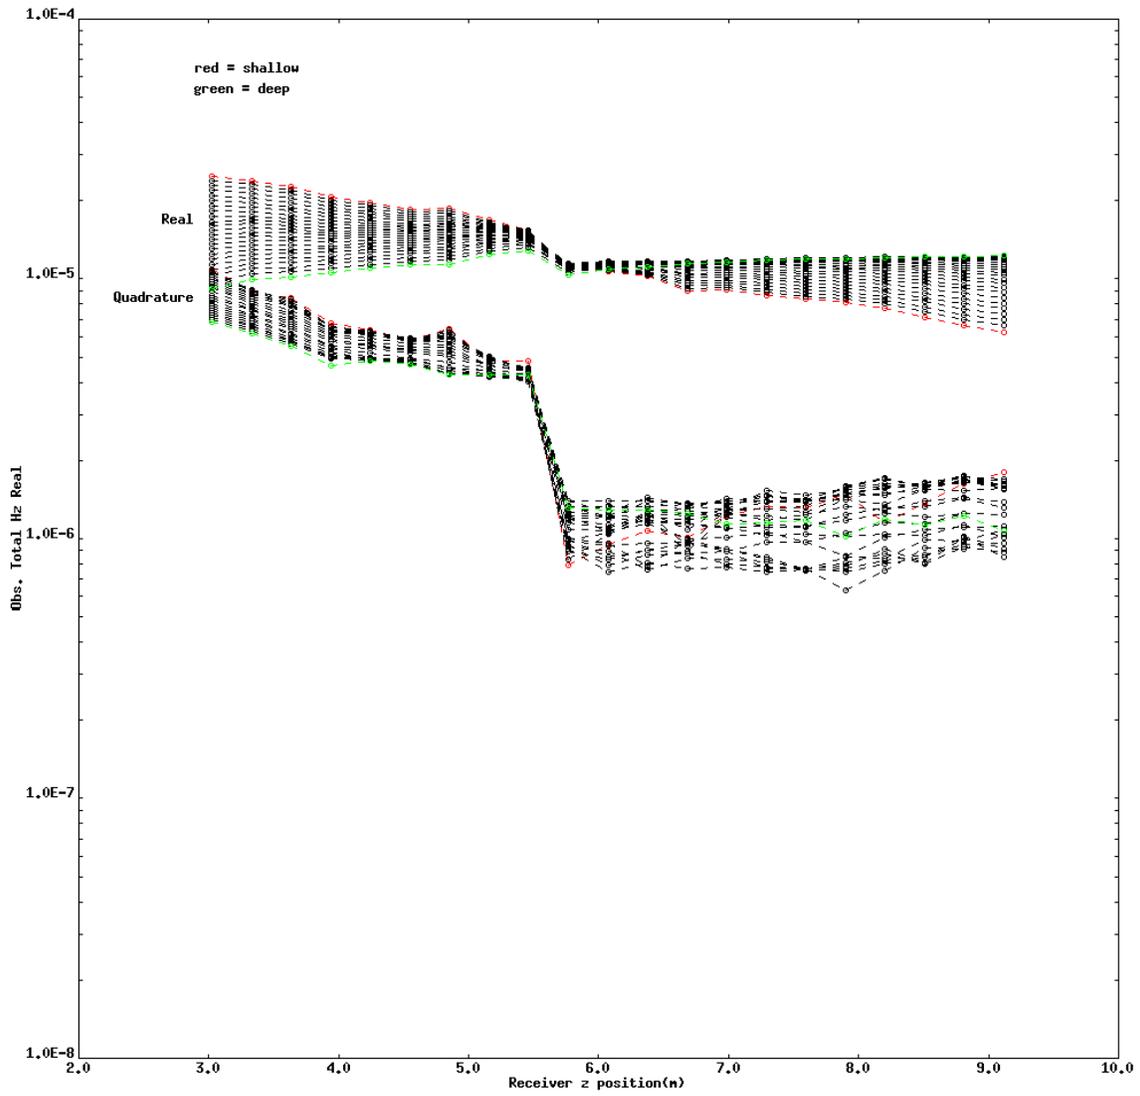
Figure 11: Real and quadrature magnetic field strengths. Upper set of curves is the real component and lower set is the quadrature component. Horizontal axis is depth in the receiver well that is directly opposite to the transmitter well. Above panel is on August 13 between tx1 and the opposite ERT-14. Subsequent panels (pages C-12 through C-14) are for August 14-17.

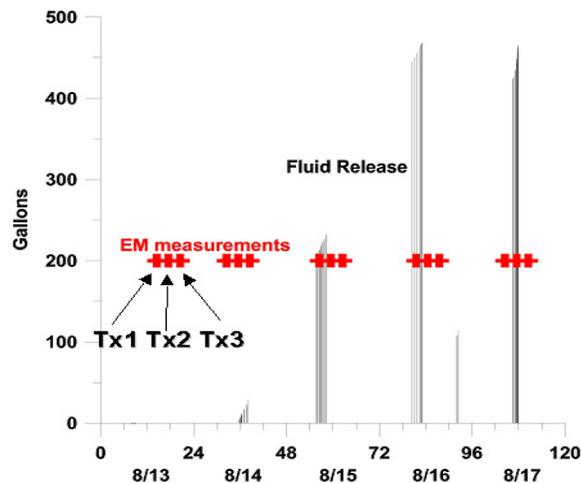
Figure 14: Leak release schedule and EM measurement times. Each red cross represents measurements from a separate EM transmitter well.

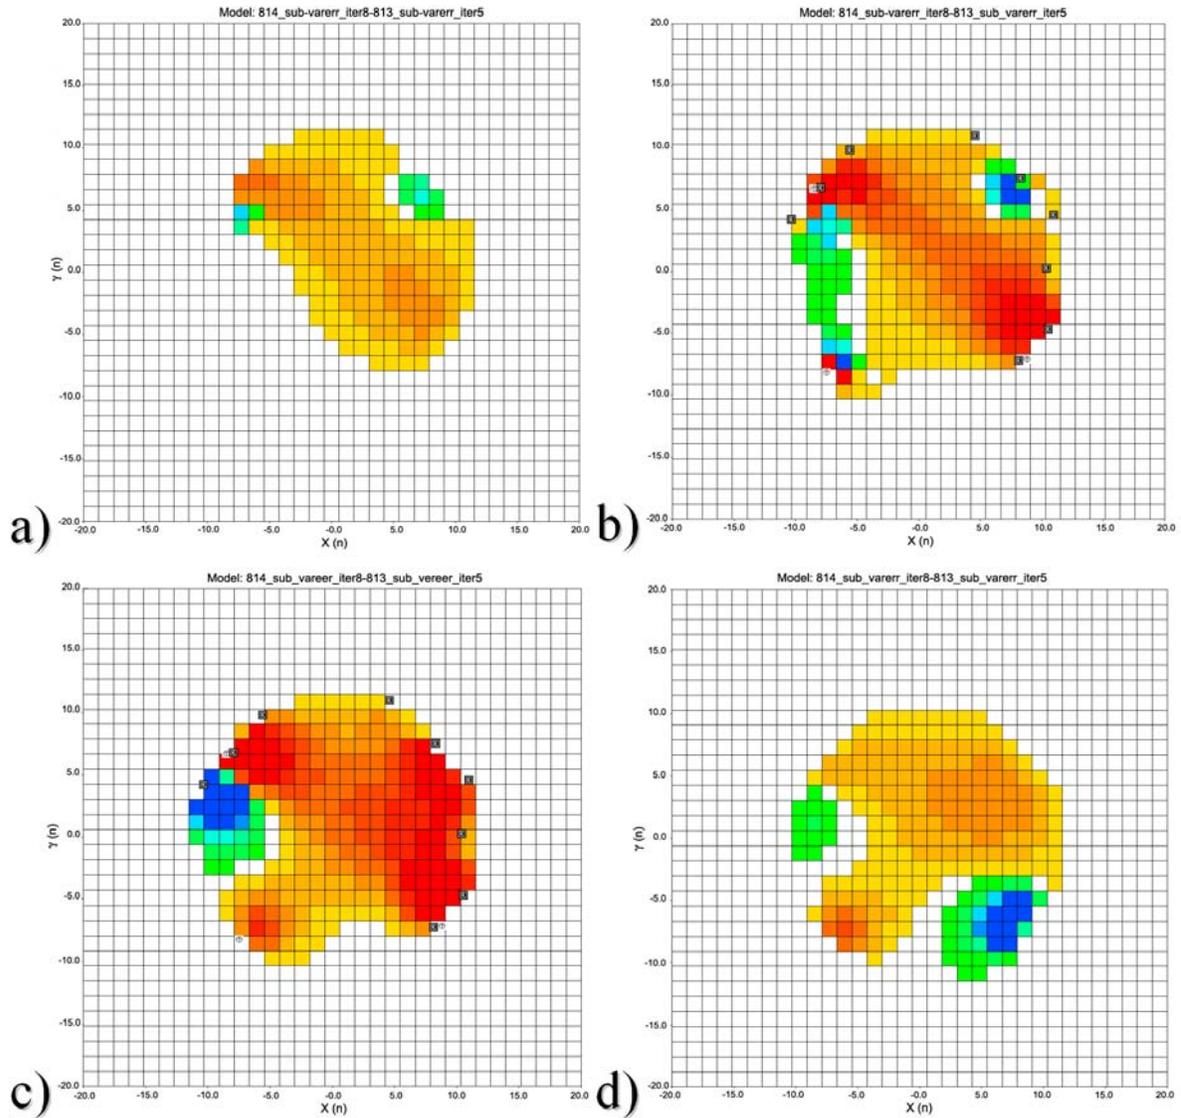
Figure 15: Time-lapse conductivity difference between August 14 and 13. a) depth 1.2m, b) depth 3.6m, c) depth 7.0m, d) depth 10m. Red= +0.001 S/m, Blue = -0.001S/m. Note the large increase in σ to the east and southeast. The horizontal scales are from -10 to $+10$ meters, with the tank centered on $(0,0)$.

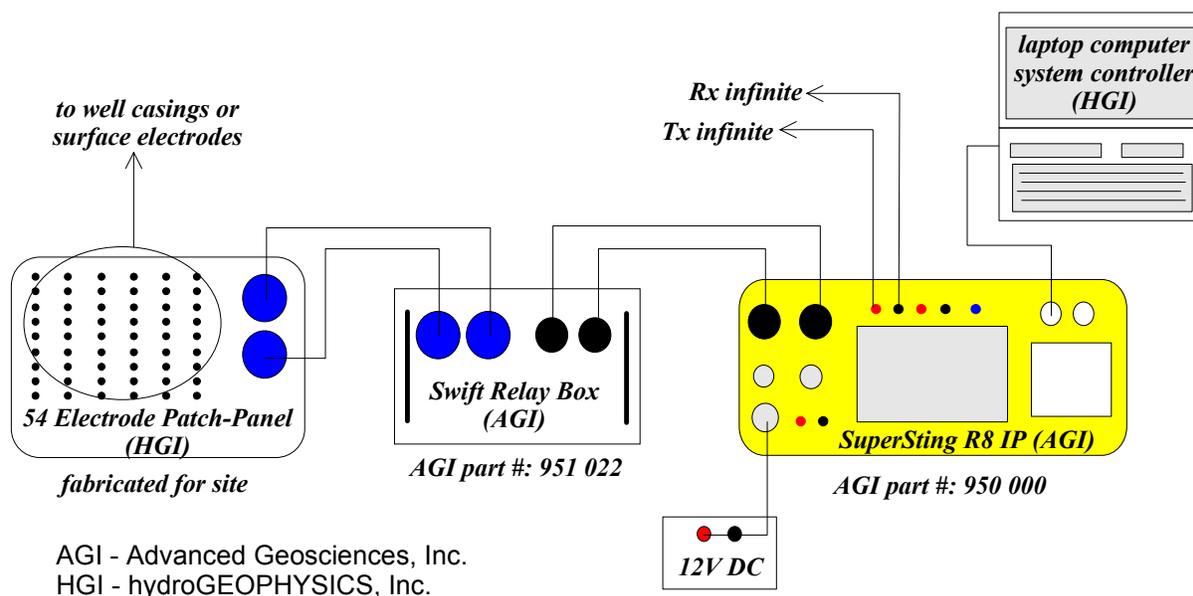
Figure 2: Geophysical equipment connection schematic

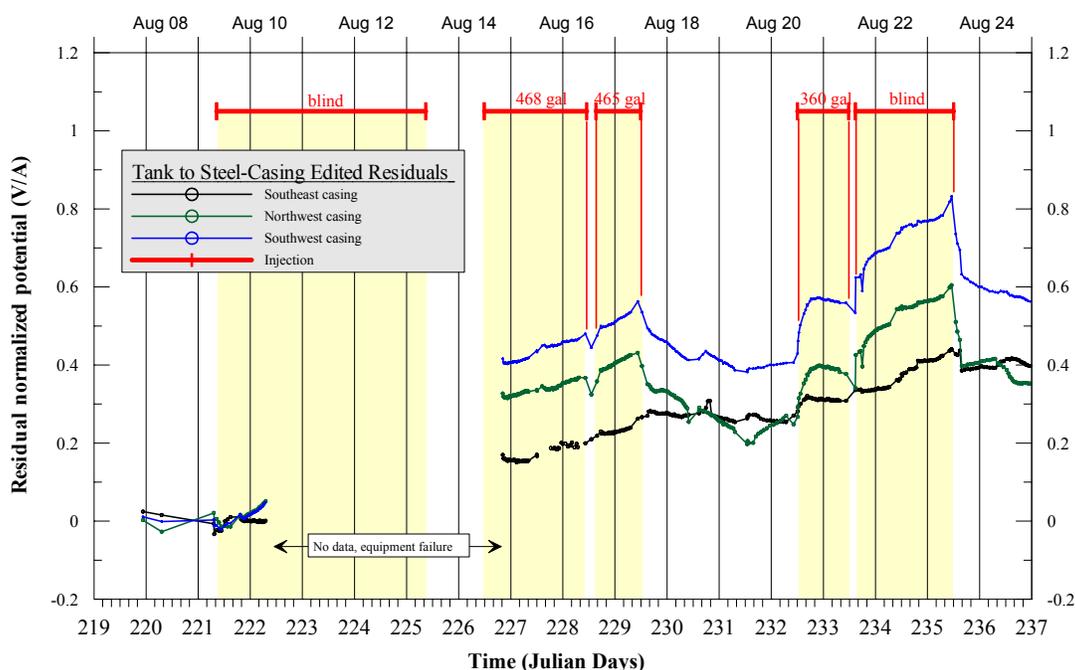
Figure 3 – Residual-normalized potentials versus time using the tank as a transmitter and the steel casings as receivers.

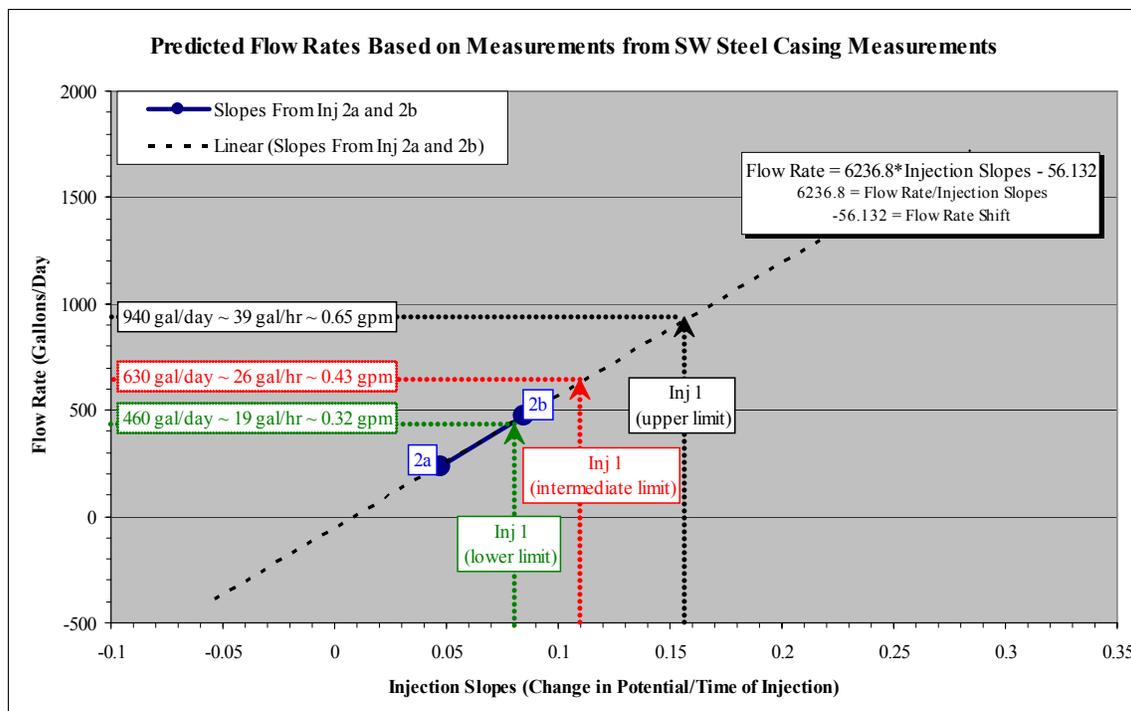
Figure 4 – Flow rates vs. injection slopes
