**Results of Tank-Leak Detection
Demonstration Using Geophysical
Techniques at the Hanford Mock
Tank Site—Fiscal Year 2001**

D. B. Barnett
G. W. Gee
M. D. Sweeney

March 2002

Pacific Northwest National Laboratory
Richland, Washington 99352

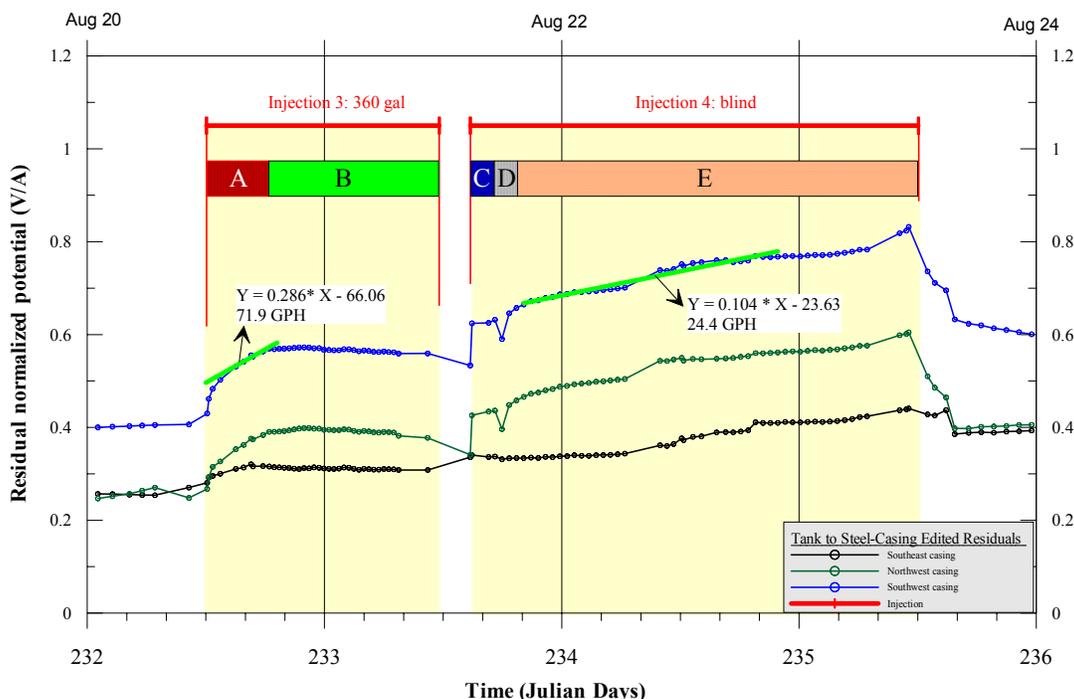
Figure 7 – Expanded view of injections 3 and 4 for all three casings. Residual-normalized potential versus time using the tank as a transmitter and the steel casings as receivers.

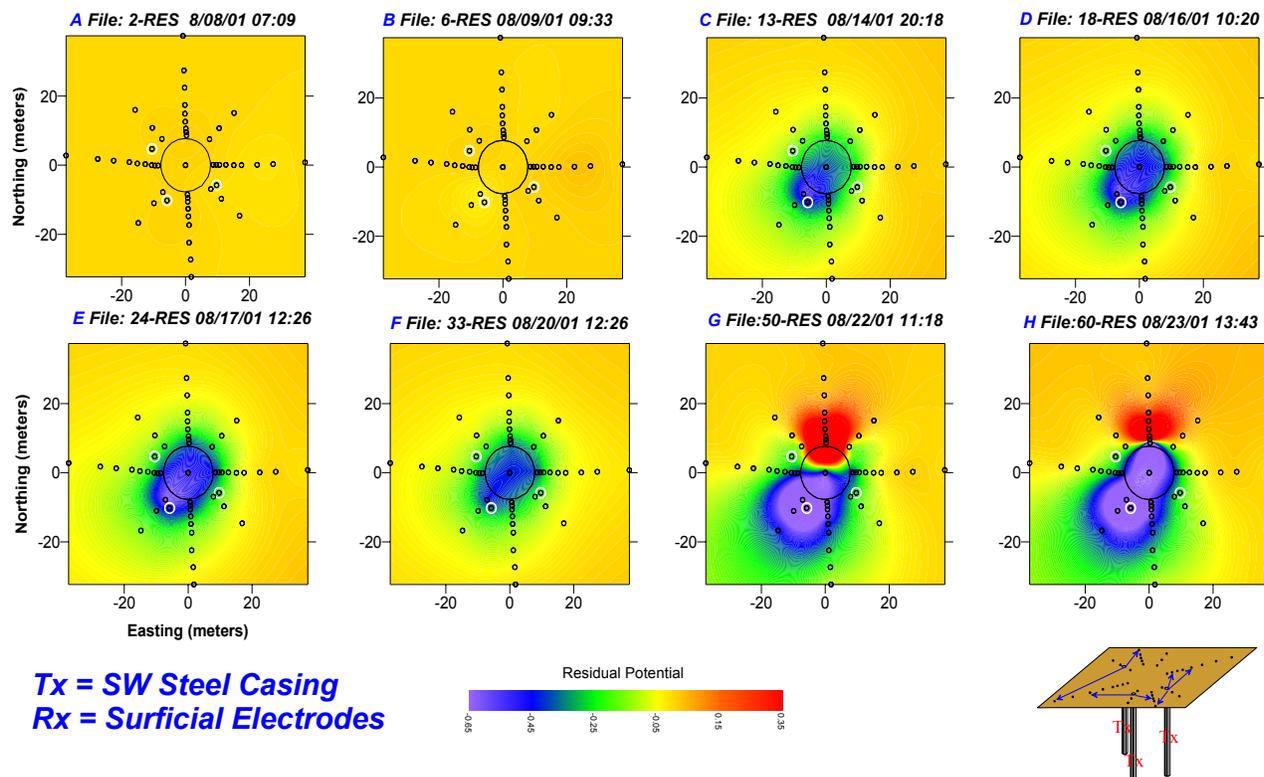
Figure 11 - Residual potential map for different times during the study:

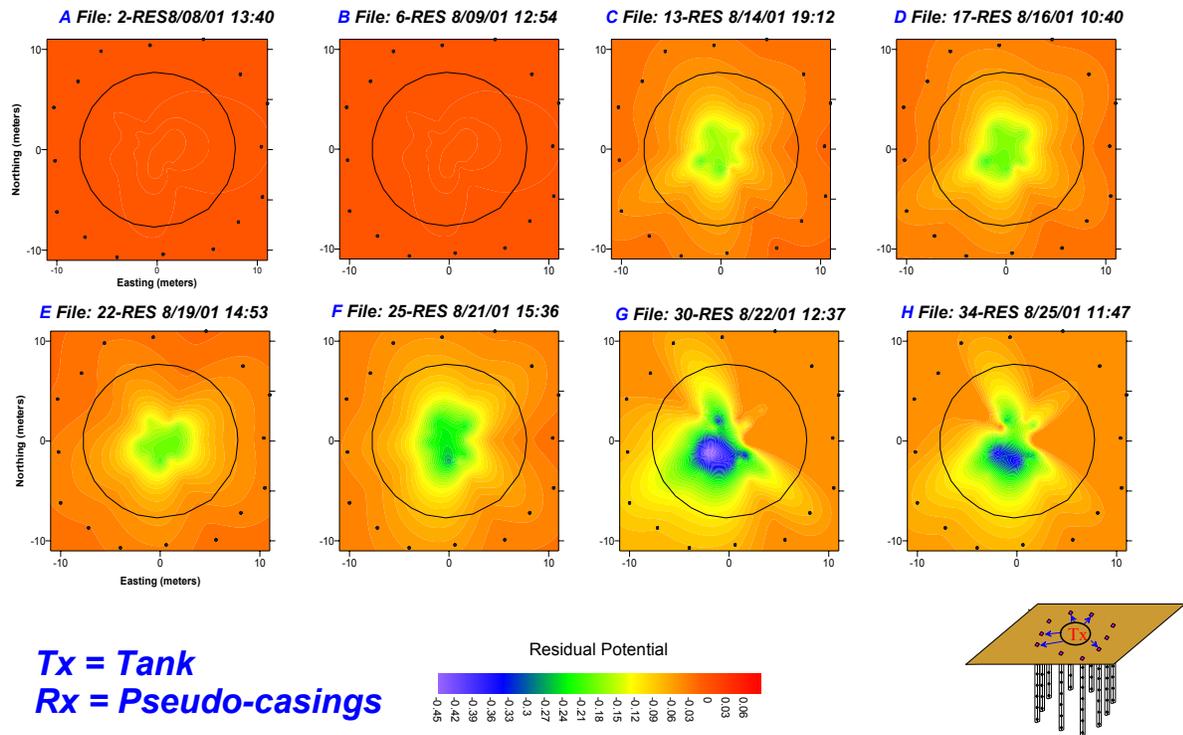
Figure 14 - Residual potential map for different times during the study

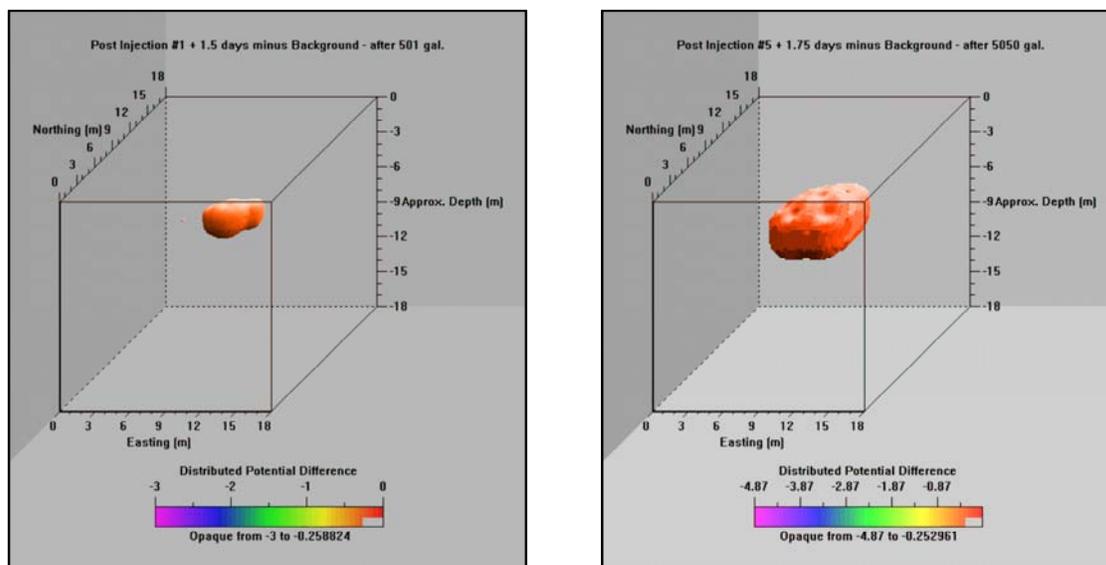
Figure 16 - A comparison of two time-snapshots of dynamic changes in volume produced by distribution function modeling of well-casing electrical measurements. After 501 gallons (left), after 5050 gallons (right).

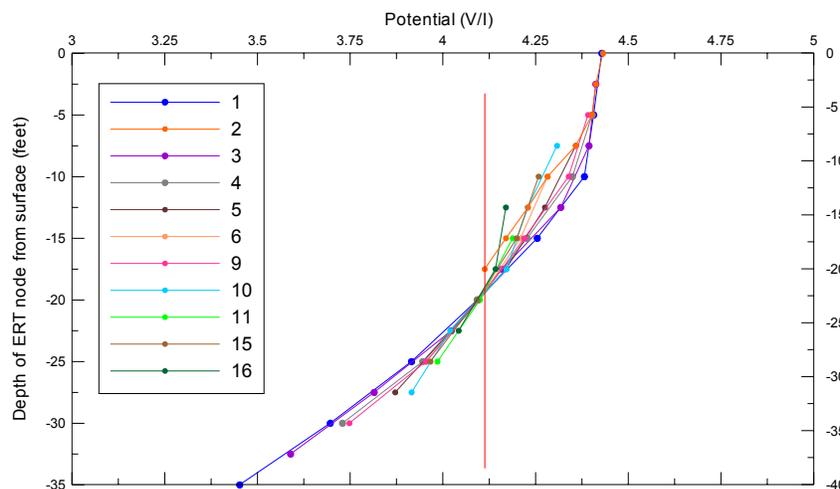
Figure 18 – discrete point vertical distribution of ERT nodes (legend numbers correspond to fused groupings listed on Figure 3)

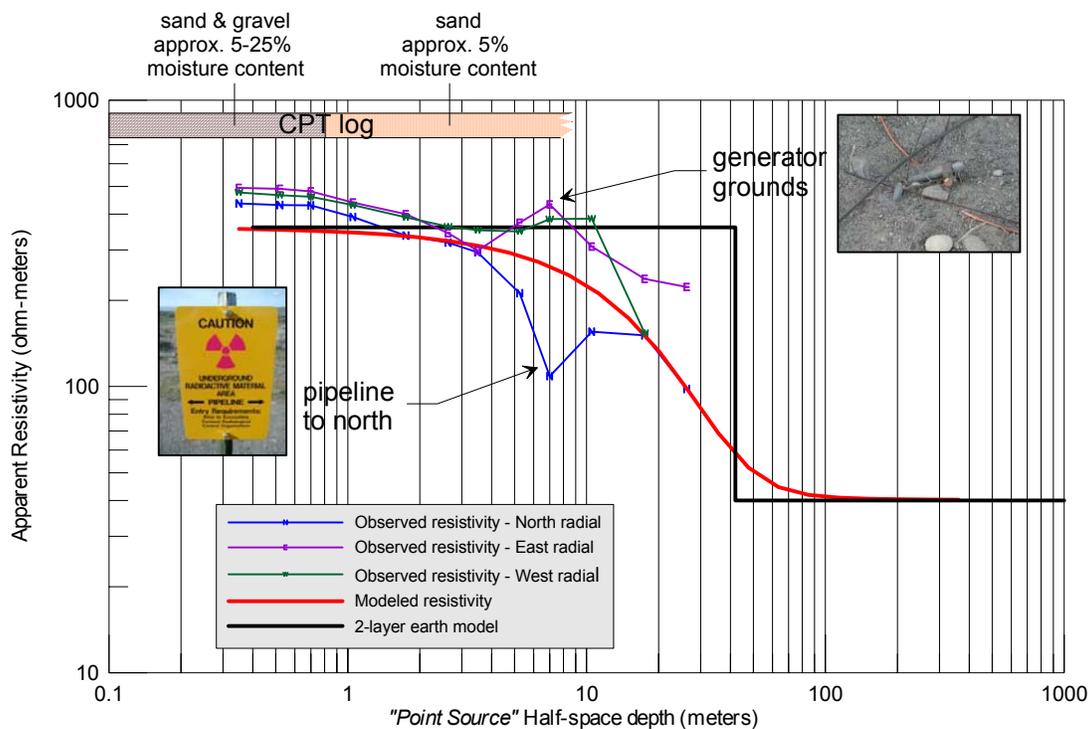
Figure 19 – 1D resistivity inversion

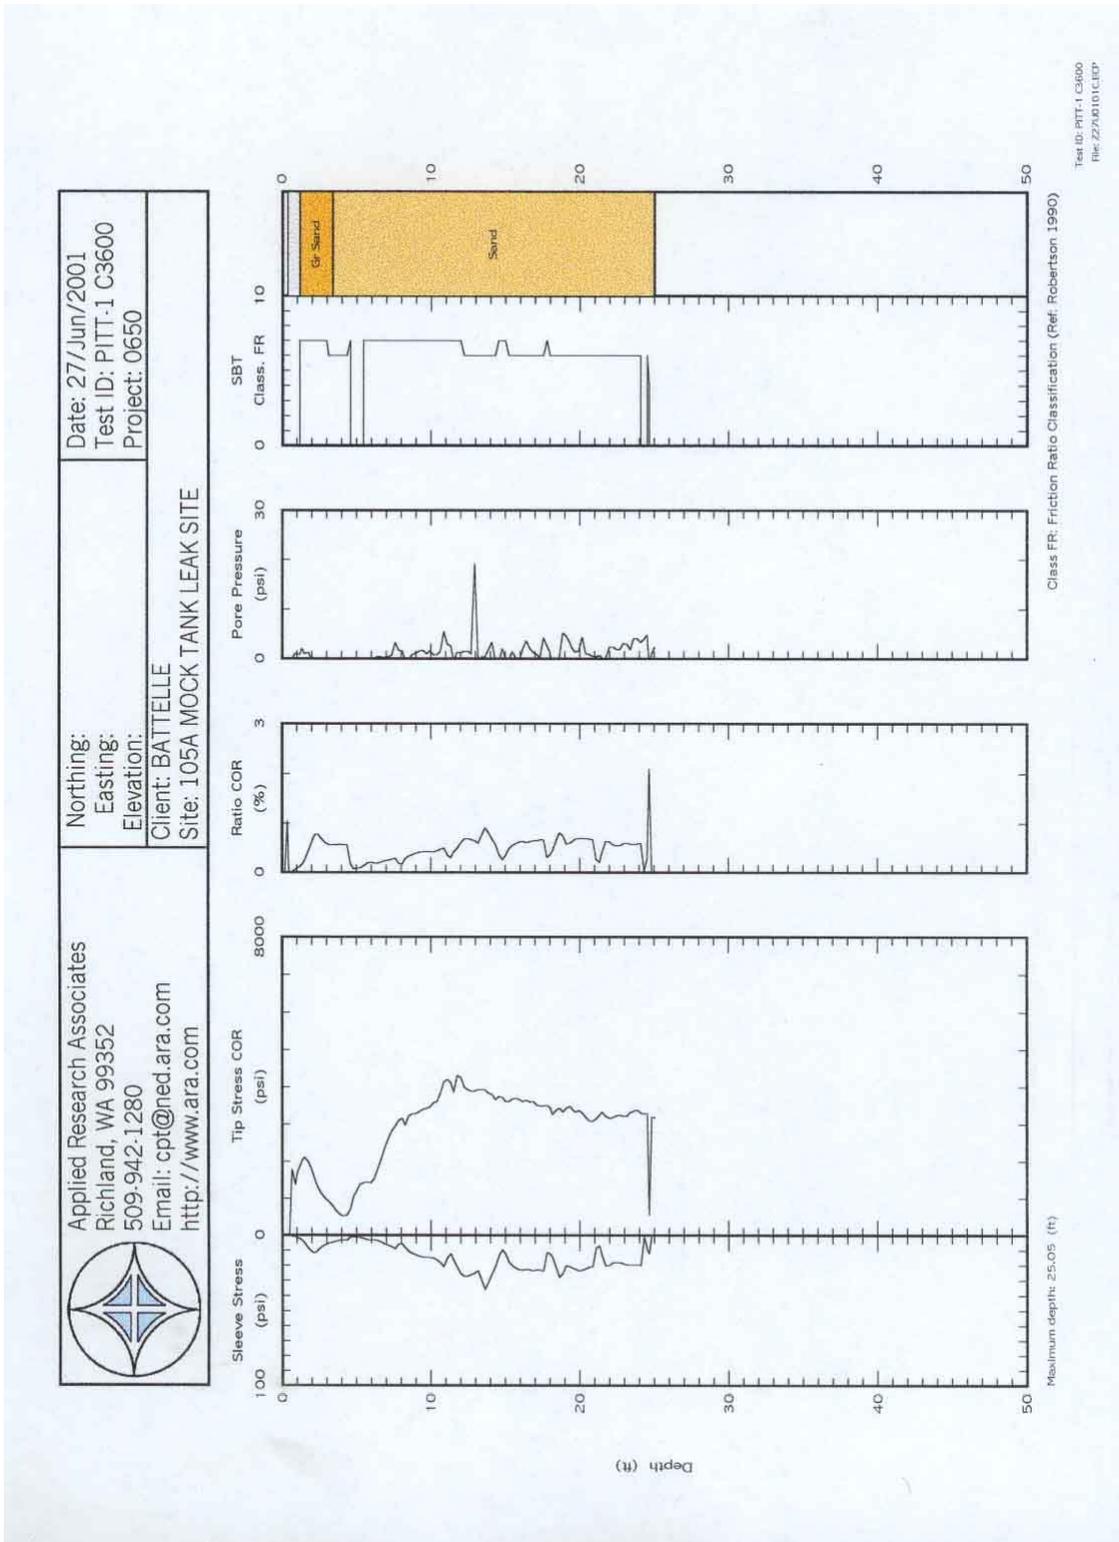
Figure E.2. Cone Penetrometer Characterization Data

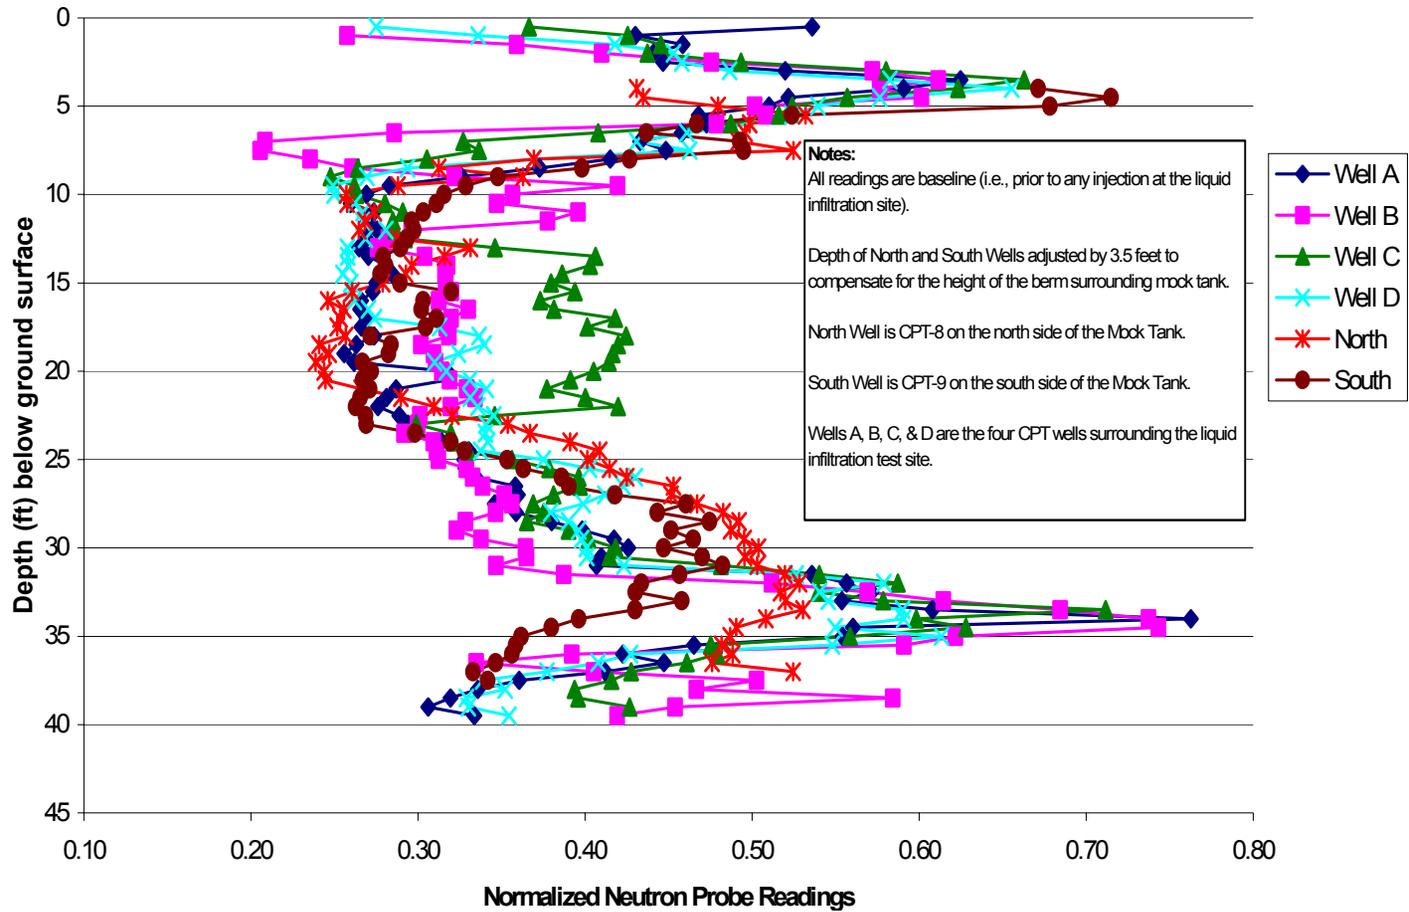
Figure E.5. Baseline Neutron Probe Readings as a Function of Depth Below Ground Surface (Relative Soil Moisture) in the Vicinity of the Mock Tank Site (Cameron et al. 2002)
