# Evaluation of Fish Losses through Screen Gaps at Modified and Unmodified Intakes of Bonneville Dam Second Powerhouse in 2003

FINAL REPORT

May 2004

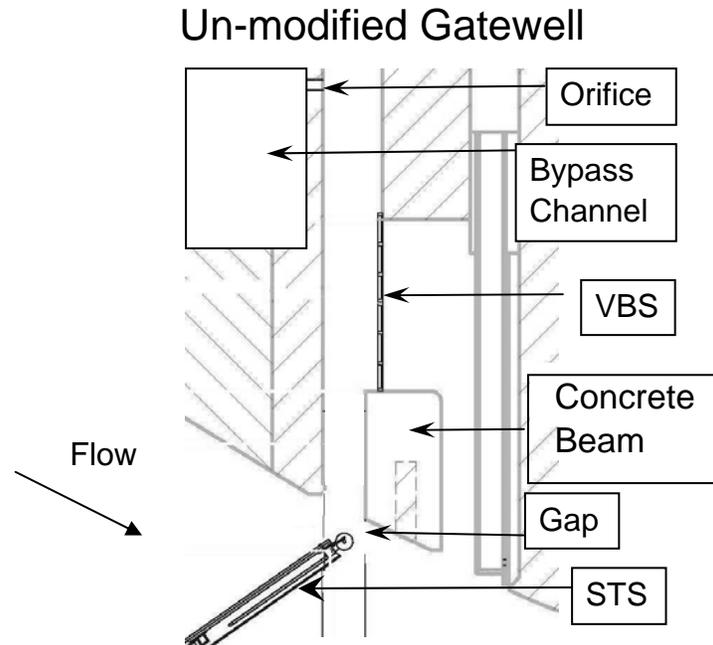
**Figure 1.1.** Cross section through unmodified gatewell slot of B2 intake. Abbreviations are as follows: VBS = vertical barrier screen; STS = submerged traveling screen. Modified features include the VBS, concrete beam, turning vane, and gap-closure device.

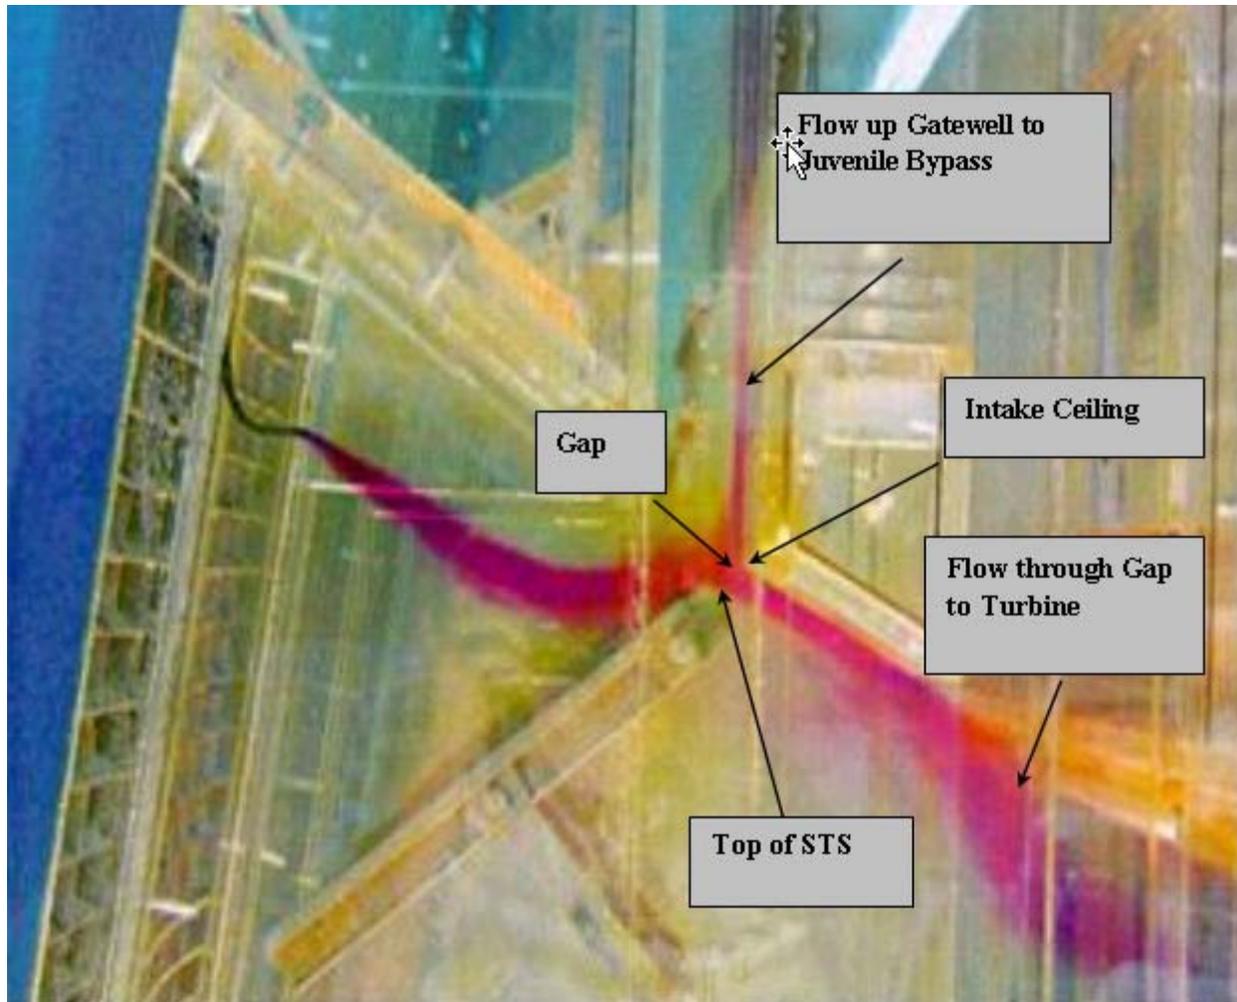
**Figure 1.2.** Cross-section view of red dye passing through trash racks (at extreme left) into an unmodified intake, gatewell, and Submerged Traveling Screen (STS) gap in a 1:25 scale model at the Engineering Research and Development Center (ERDC), Vicksburg, MS. The relatively high proportion of dye passing through the gap between the top of the STS and the intake ceiling raised concerns for smolt passage. The model was built by the Hydraulics Laboratory at the ERDC. Flow into the intake model is from left to right.

The modifications generally have been successful at increasing gateway slot flow and FGE, but little is known about the effects of the gateway modifications on gap losses. Most fish guided by an STS pass up into gateway slots where they find an orifice leading to a bypass channel, but some proportion of the guided flow and fish are lost to the gap that exists between the top end of the STS and the intake ceiling (see red dye trace in Figure 1.2).

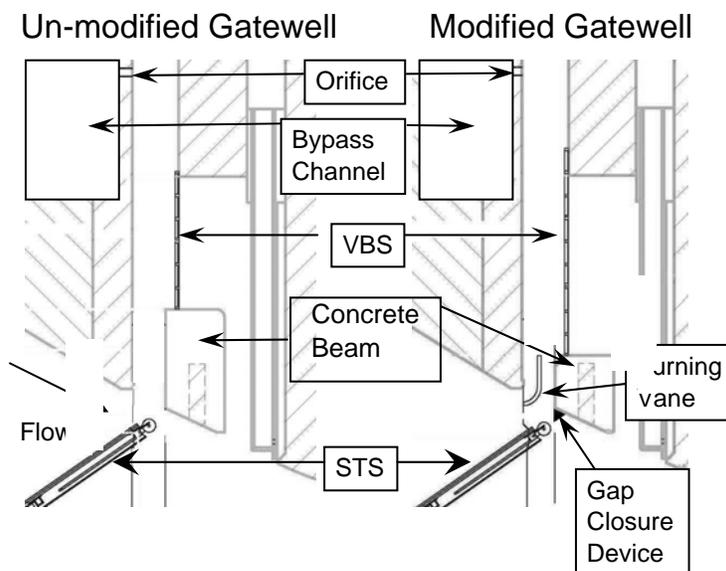
**Figure 1.2.** Cross-section views of unmodified (left) and modified (right) gateway slots of B2 intakes. Abbreviations are as follows: VBS = vertical barrier screen; STS = submerged traveling screen. Modified features include the VBS, concrete beam, turning vane, and gap-closure device.

Figure 1.3 shows schematic drawings of the unmodified and unmodified turbine intake. In the modified intake view on the right, the top part of the concrete beam has been removed and the vertical barrier screen (VBS) has been extended downward to increase the screened area and facilitate upward flow. A curved turning vane extending across the intake width also was added to turn flow upward. A gap closure device has been attached to the intake ceiling, covering about 12 inches of the 18-inch gap that exists in an unmodified unit.

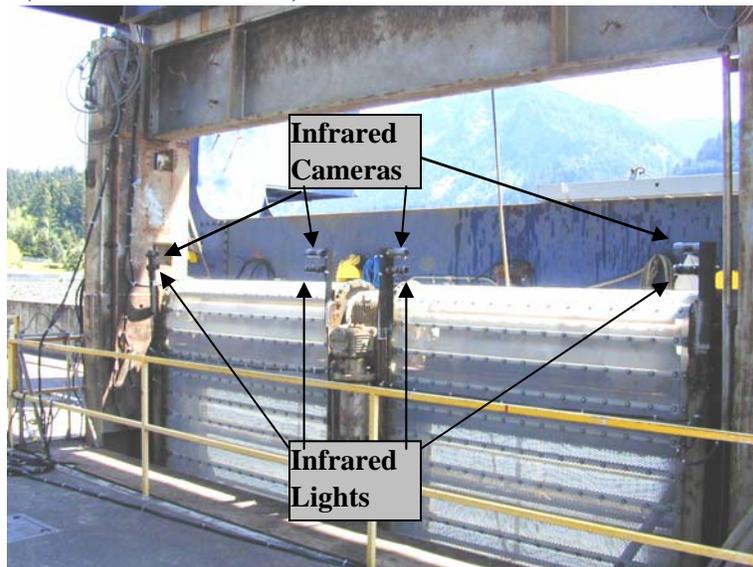
**Figure 2.1.** Four pairs of optical cameras and associated infrared lights were mounted on steel angle iron at the top of an STS at unmodified Unit 13. The cameras were located 9 inches above the top of the STS and aimed horizontally across the top of the STS so that they would be in the middle of the gap when the STS was deployed in an intake.

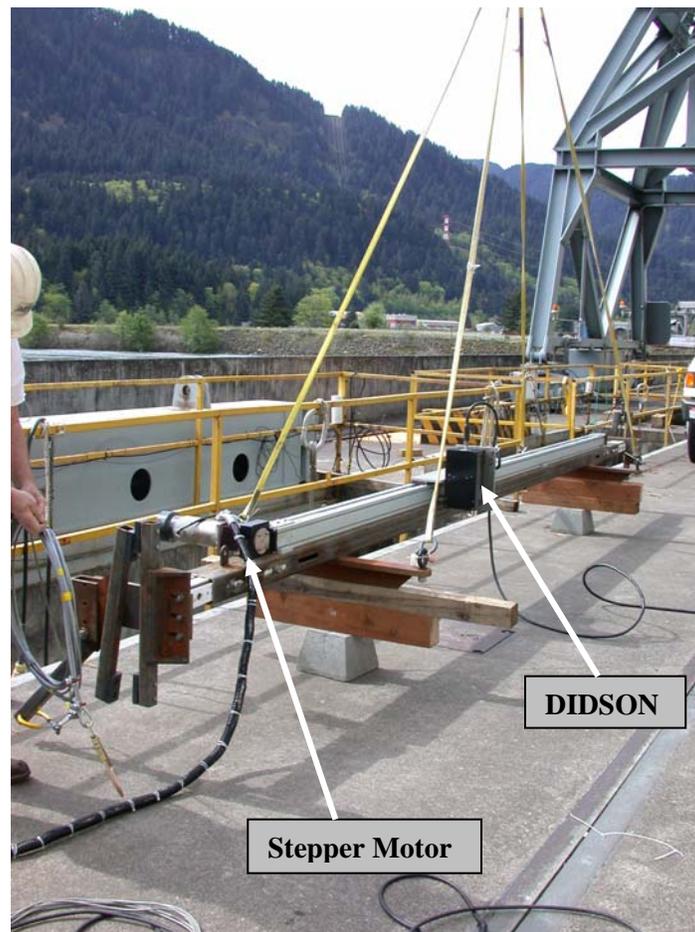
**Figure 2.2.** Beam used to deploy the DIDSON in gatewell slots of intakes in unmodified Unit 13 and in modified Units 15 and 17. The stepper motor that moved the DIDSON along the beam is on the left and the moving plate with the DIDSON attached is in the middle of the beam. The beam was deployed by riggers using the turbine-intake-extension crane.

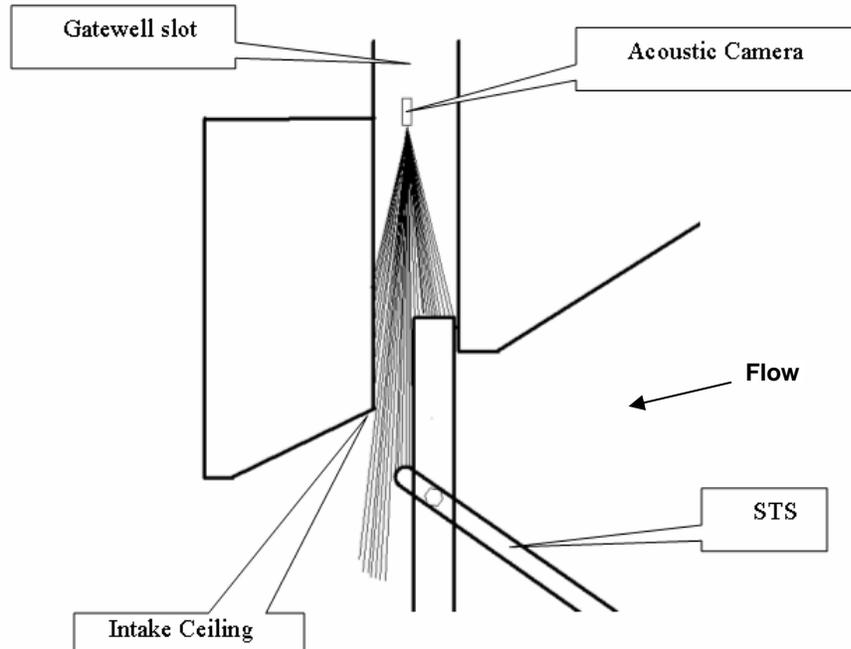
**Figure 2.3.** Cross-sectional diagram of an unmodified gateway slot of Unit 13 at B2 showing the DIDSON deployment. Flow would be entering the intake from the right side.

The DIDSON was aimed downward in the gateway slot, and the fan of 96 0.3°-wide and 12°-deep beams was oriented in an upstream-downstream direction (Figure 2.3). The DIDSON images fish in two dimensions, either moving toward or away from the device (up or down) or laterally across the array of beams. Water flow is from right to left and splits just upstream of the intake ceiling and gap. The DIDSON produces images that look like medical ultrasound images as shown in Figure 2.4.

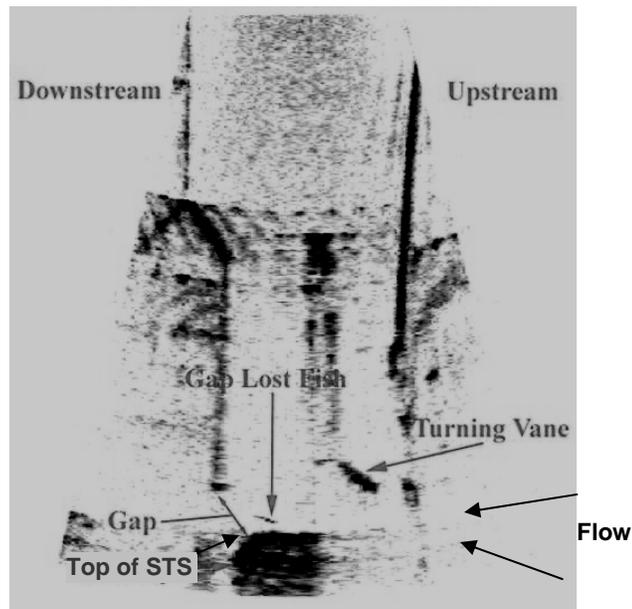
**Figure 2.4.** Image from the DIDSON Deployed in Modified Gateway 17C of B2. Flow is moving from right to left below the tip of the turning vane and upward above the tip of the vane.

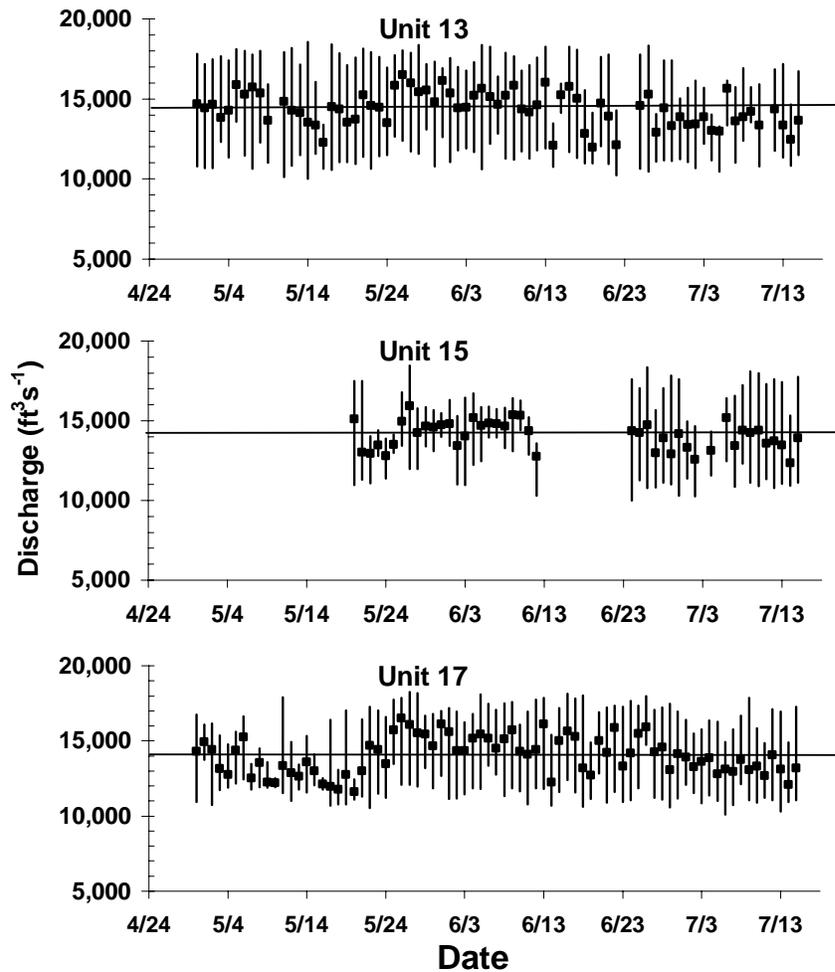
**Figure 3.1.** Plots of the mean and range in discharge by date for unmodified Unit 13 and modified Units 15 and 17 in spring and summer 2003. June 3rd roughly divides the spring and summer seasons. Squares depict daily averages and vertical bars indicate the range in discharge each day. Horizontal lines represent the average discharge for the hours sampled.

The within-day ranges in daily turbine discharges were quite large, often exceeding the range in mean daily discharge over the course of the study (Figure 3.1). The two modified turbines (Units 15 and 17) were run at the lower end of the one percent efficiency range in spring to reduce strain on the fine mesh vertical barrier screens, but the lower discharge is only noticeable for Unit 17 before Julian day 142 (May 22).

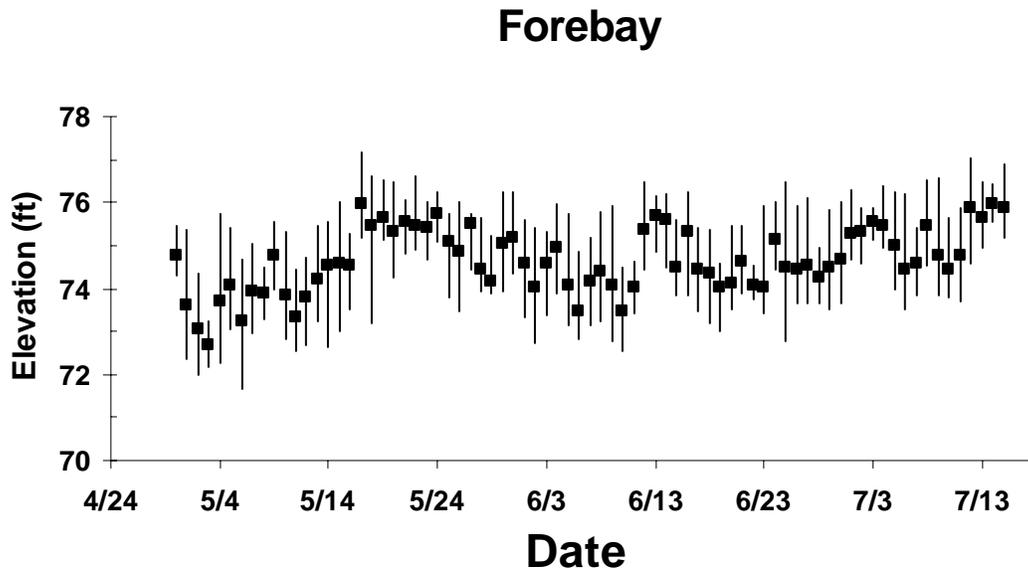
**Figure 3.2.** Plot of the mean and range in forebay elevation at B2 in spring and summer 2003. June 3<sup>rd</sup> roughly divides the spring and summer migration seasons. Squares depict daily averages and vertical bars indicate the range in forebay surface elevation each day.

The B2 forebay surface elevation varied by as much as 3 ft each day (Figure 3.2), and there usually was a consistent pattern within days (Figure 3.3). The diel evaluation of gap loss began at midnight on

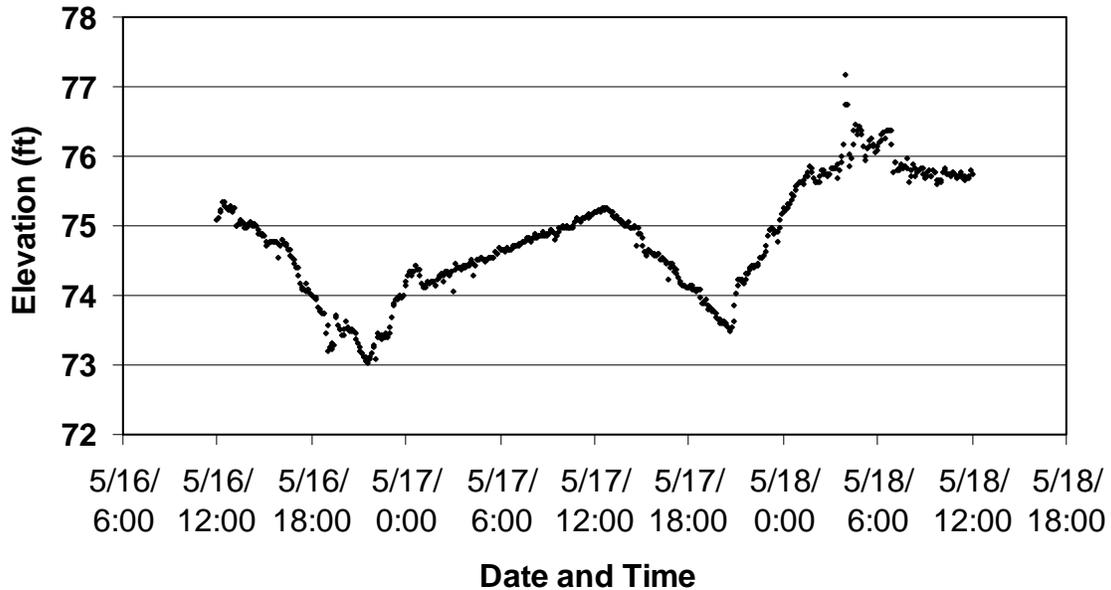
**Figure 3.3.** Plot of the B2 forebay elevation by 5-minute interval over 2 days. These elevation data were provided by the Project. Diel sampling with the DIDSON was conducted from midnight on May 17, 2003 until midnight on May 18.

May 17, 2003, when forebay surface elevation was 74.2 ft mean sea level (MSL). Forebay surface elevation generally increased from 0000 hours through 1300 hours when it peaked at 75.2 ft and then declined from 1300 hours through 2045 hours when it reached the minimum of 73.5 ft for the day.

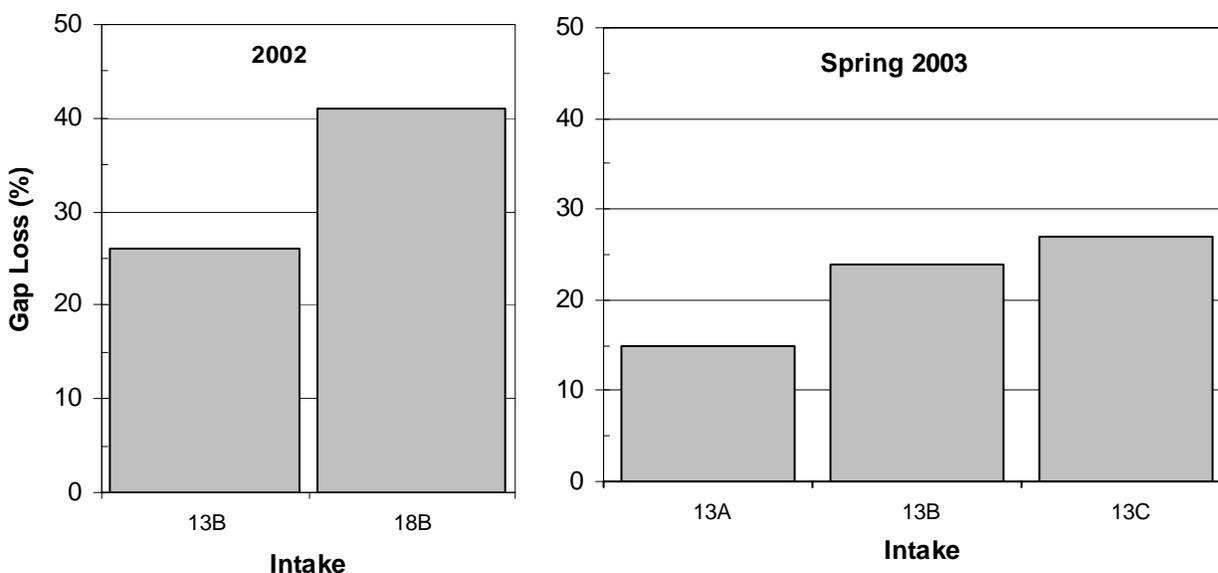
**Figure 3.4.** Bar charts showing unfiltered gap-loss percentages in unmodified intakes of Unit 13 in spring 2003 and in 2002.

Preliminary estimates of gap-loss percent based on unfiltered expanded counts for unmodified intakes were high in both 2002 and 2003 (Figure 3.4). However, multiplying those estimates by the 2003 fraction of optical camera detections that could have been fish reduced the unfiltered estimates to within 3% to 6% of filtered estimates for Unit 13 intakes in 2003 (Table 3.1).

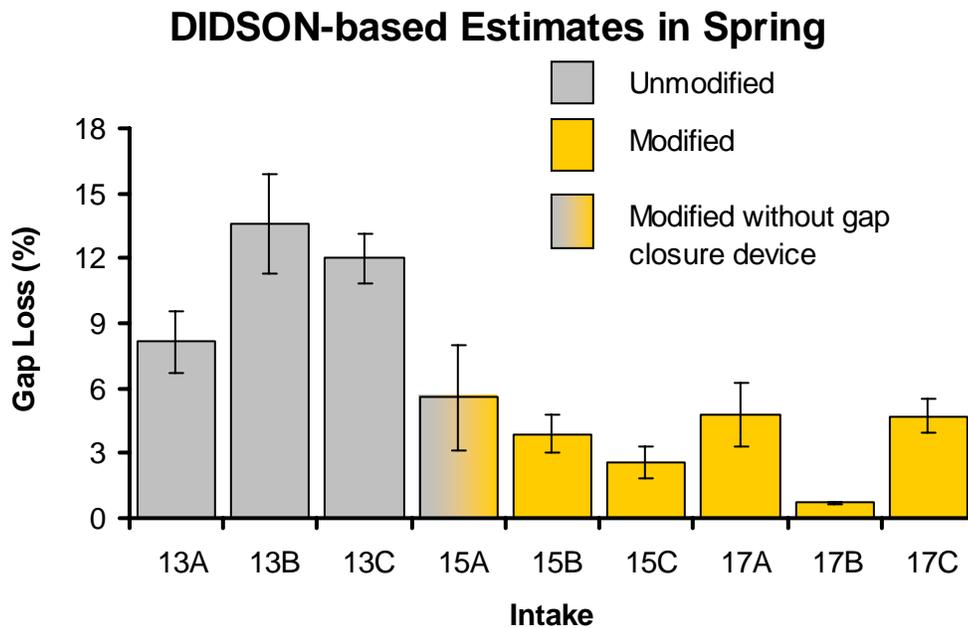
**Figure 3.5.** Gap loss as a percent of gatewell and gap-loss passage at nine intakes sampled three nights each in spring 2003. Vertical bars are 95% confidence intervals about the mean.

A plot of mean gap loss of filtered data (N = 3 nights) by intake sampled in spring 2003 (Figure 3.5) suggests that at least two of the three unmodified intakes at Unit 13 had higher losses than all other intakes and that Intake 13A losses also were higher than those of all modified intakes, except perhaps 15A (Figure 3.5). Intake 15A had all gatewell modifications to increase flow up the slot except for a gap-closure device.

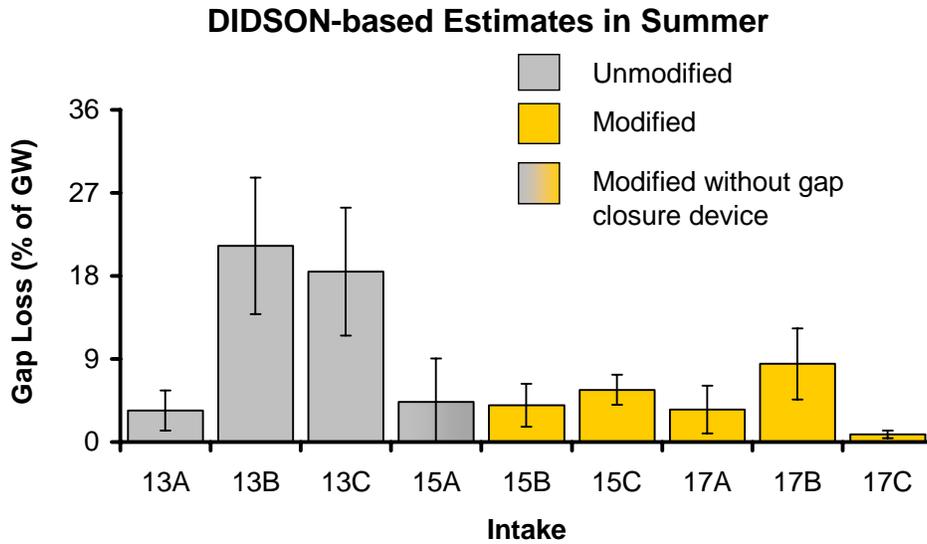
**Figure 3.6.** Gap loss as a percent of gatewell and gap-loss passage at nine intakes sampled three nights each in summer 2003. Vertical bars are 95% confidence intervals about the mean.

A plot of mean gap loss (N = 3 nights) by intake sampled in summer 2003 suggests that two of the unmodified intakes at Unit 13 had higher losses than all other intakes and that most other estimates, except perhaps that of 17C, which was very low, probably did not differ significantly (Figure 3.6).

During summer sampling at Intake 17C, turbine 17 was operated at low and high discharge levels associated with the lower and upper end of the 1% operating efficiency range to see whether discharge affected gap loss. There were three nights of low-discharge operations and four nights of high-discharge, but we found no significant difference in gap loss as a fraction of gatewell and gap passage (Table 3.3). Intake 17C had the lowest gap loss of any intake sampled in summer and variability among days was low (Figure 3.6).

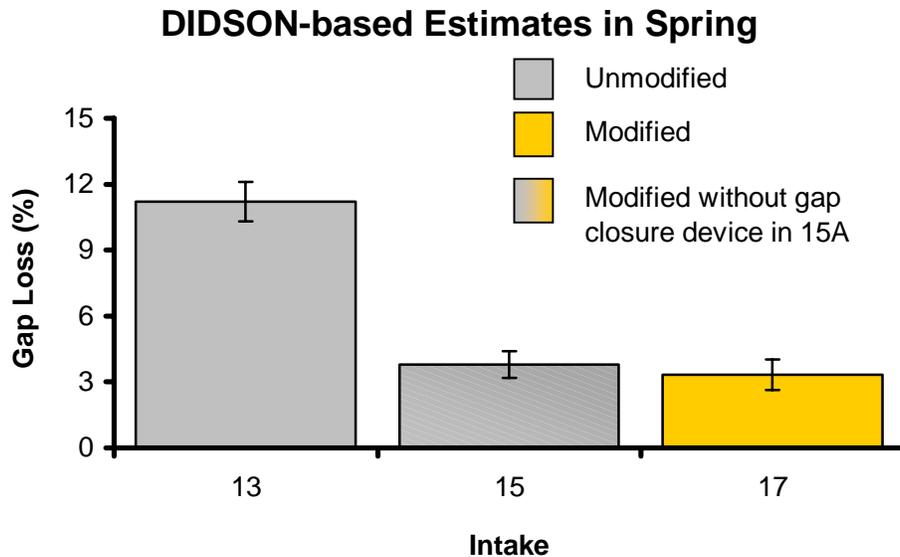
**Figure 3.7.** Gap loss as a percent of gatewell and gap-loss passage at three turbine units sampled nine nights each in spring 2003. Vertical bars are 95% confidence intervals about the mean.

A plot of mean gap loss (N = 9 nights) by turbine unit sampled in spring 2003 indicated that Unit 13 with an unmodified gatewell slot had significantly higher gap loss estimates than did Units 15 and 17, which had modified gatewell slots (Figure 3.7; Table 3.2). Similarly, a plot of mean gap loss (N = 9 nights) by unit sampled in summer 2003 showed that Unit 13 with an unmodified gatewell slot had significantly higher gap loss than Units 15 and 17, with modified gatewell slots (Figure 3.8; Table 3.2).

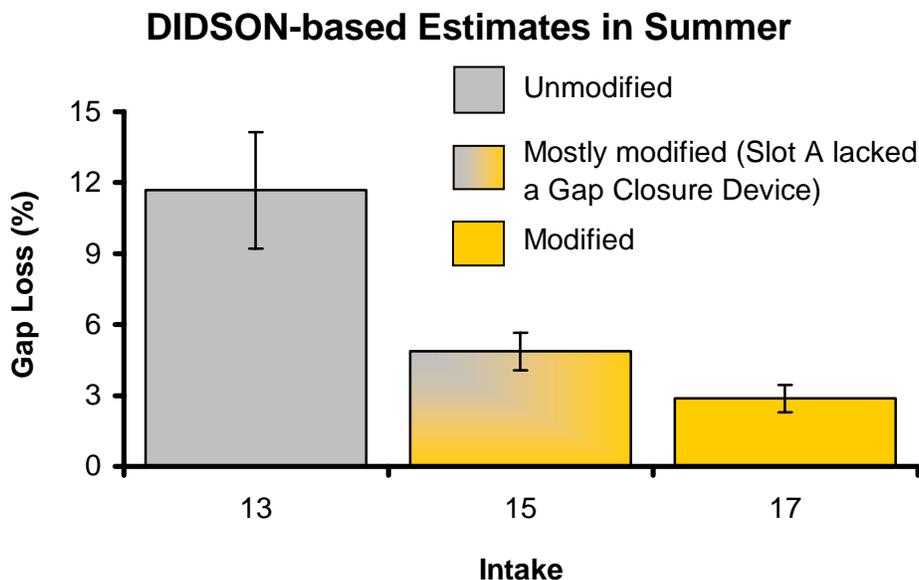
**Figure 3.8.** Gap loss as a percent of gatewell and gap-loss passage at three turbine units sampled nine nights each in summer 2003. Vertical bars are 95% confidence intervals about the mean. GCD = Gap Closure Device

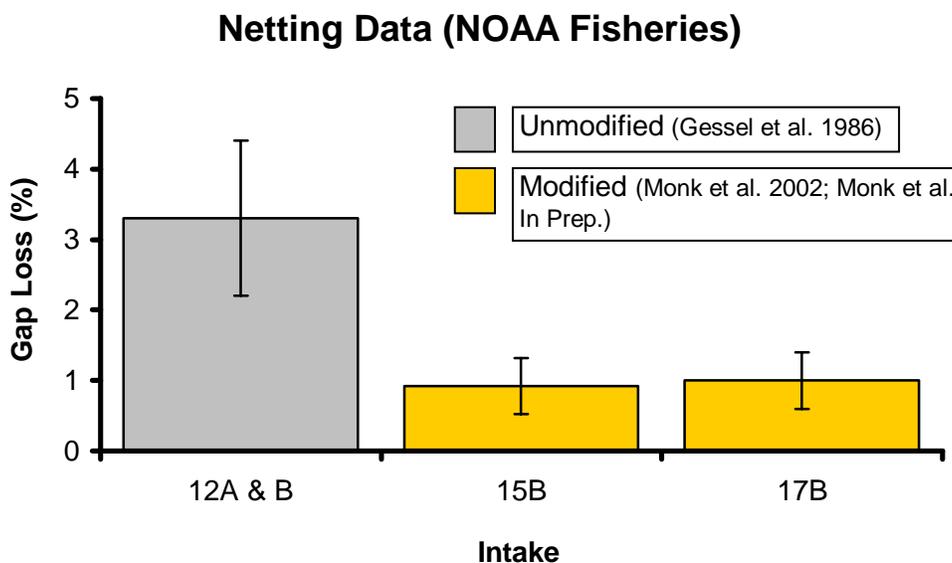
**Figure 3.9.** Gap loss as a percent of gatewell and gap-loss passage at turbine intakes with modified and unmodified gatewell slots as determined by netting in 1985, 2001, and 2002 by NOAA Fisheries. Vertical bars are 95% confidence intervals about the mean.

Given the patterns observed in DIDSON-based estimates of gap loss among units with modified and unmodified gatewell slots, we also graphed gap-loss estimates as a percent of gatewell and gap passage based upon netting data collected by NOAA Fisheries (Figure 3.9). The netting estimates of gap loss were about one-third of the DIDSON-based estimates, but the pattern of reduced gap-loss at modified intakes relative to unmodified intakes is similar. Both sets of data indicate that modified units have gap losses that are about 30% of those observed at unmodified units.

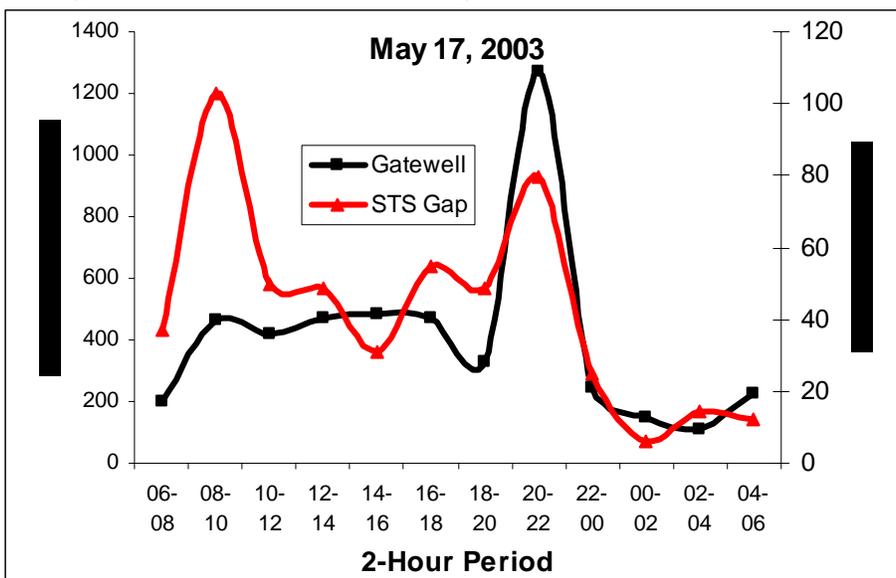
Figure 3.10. Plot of the diel trend of fish passage into the gatewell and gap on May 17, 2003.

Given the uncertainties in discriminating between fish and non-fish in DIDSON images during summer, we limited our examination of diel and horizontal distribution to data acquired in spring 2003. The diel distribution of fish passage into the gatewell slot at Intake 13B peaked at about sunset (2000-2200 hours). Except for the peak at sunset, gatewell passage was consistently higher during the day than it was at night (Figure 3.10). Gap passage tended to be higher from 0600 through 2200 than it was from 2200-0600 hours, and there were two distinct peaks, one at 0800-1000 hours and another from 2000-2200 hours. Gap loss as a percent of gatewell and gap passage averaged 9.9% with no strong diel pattern, except that it was higher from 0600 to 1000 hours (Figure 3.11) than at other times.

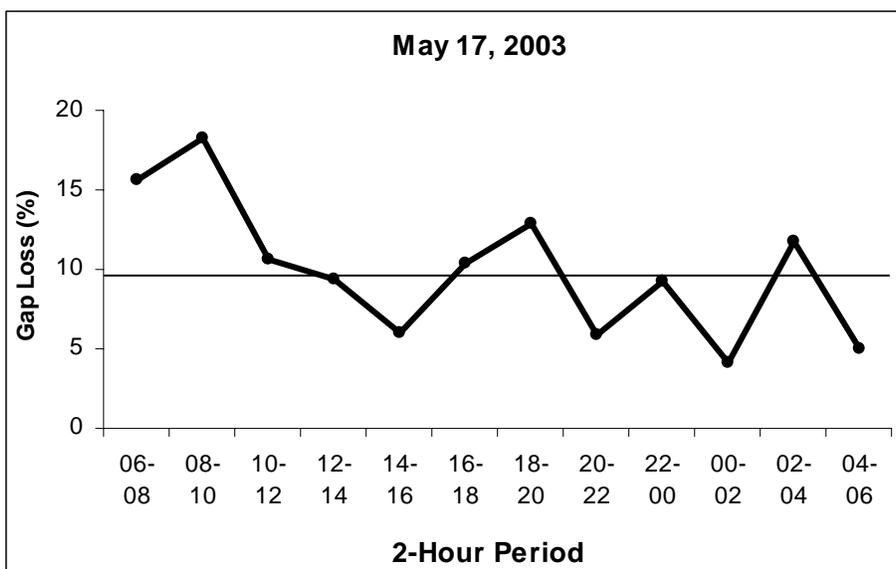
Figure 3.11. Plot of the diel trend in gap loss as a percent of gatewell and gap-loss passage at Intake 13B on May 17, 2003. The horizontal line is the average loss.

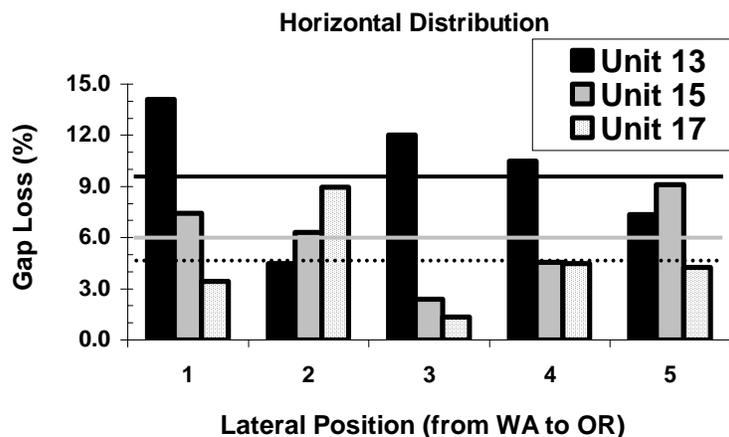
**Figure 3.12.** Bar chart of the horizontal distribution of gap loss as a percent of gatewell and gap passage among five equidistant position across the width of the gatewell slot at unmodified Unit 13 and modified Units 15 and 17 in 2003. The horizontal lines represent the mean gap loss for each unit.

The horizontal distribution of gap loss as a percent of gatewell and gap passage was not uniform at any of the units sampled, and the patterns varied among units (Figure 3.12).

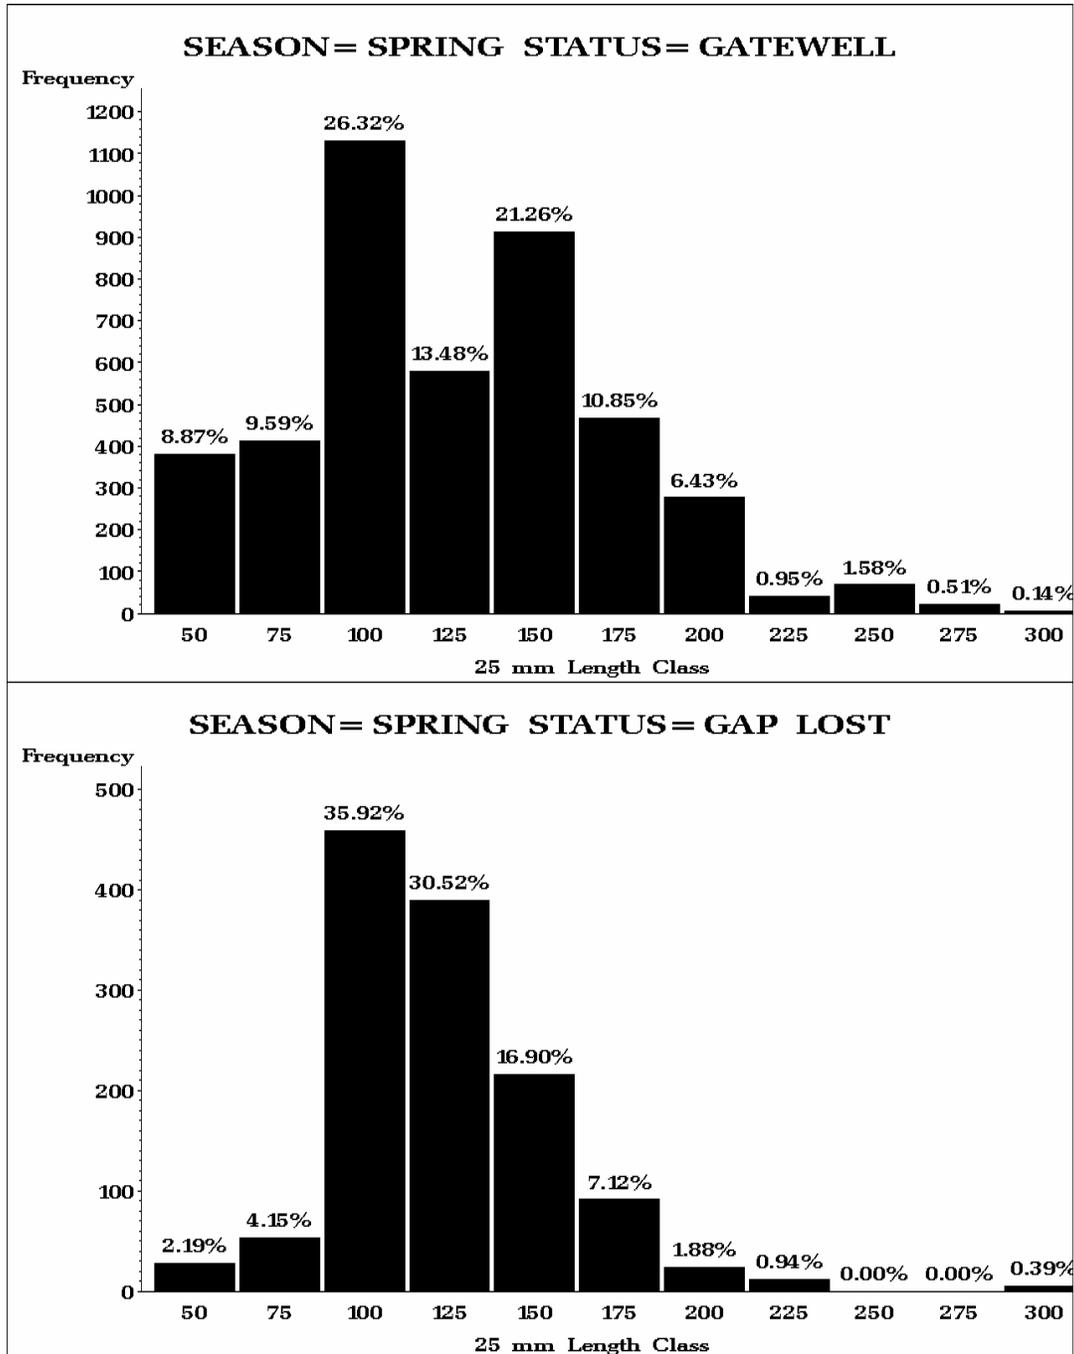
**Figure 3.13.** Length frequencies based on the number fish passing up into the gateway slots (upper chart) and through the gap between the top of the STS and the intake ceiling (lower chart) in spring 2003 based upon DIDSON data.

The length frequency distribution of fish passing through the gap and up into the gateway slots in spring were generally similar except that the gap claimed a higher percentage of fish in the 100- and 125-mm length classes and a lower percentage of fish in the 150-, 175-, and 200-mm length classes (Figure 3.13).

The length-frequency distributions of fish detected in the gatewell and STS gap were reasonable in spring (Figure 3.13) but not in summer (Figure 3.14), and differences in distributions of gatewell and gap-loss fish in summer likely resulted from differences in fish orientation upon detection. We could not discriminate reliably between small summer fish and bubbles in the gatewell fraction in summer. Not only were the summer fish smaller on average, but they usually were oriented upward as they entered the gatewell slot and presented head-aspect images that appeared smaller than would images from similar-sized fish oriented horizontally as they pass through the gap. The length-frequency distribution of fish detected in the gaps in summer was not as unreasonable as was that of summer fish detected in the gatewell slots (see Figure 3.14). We would expect sub-yearling smolts in summer to range from 50 to about 125 mm in length with the mean and mode around 100 mm. The length-frequency of targets classified as fish in the gatewell in summer was clearly biased toward 50 and 75 mm length class fish, and this likely reflects our inability to properly measure small fish in head aspect.

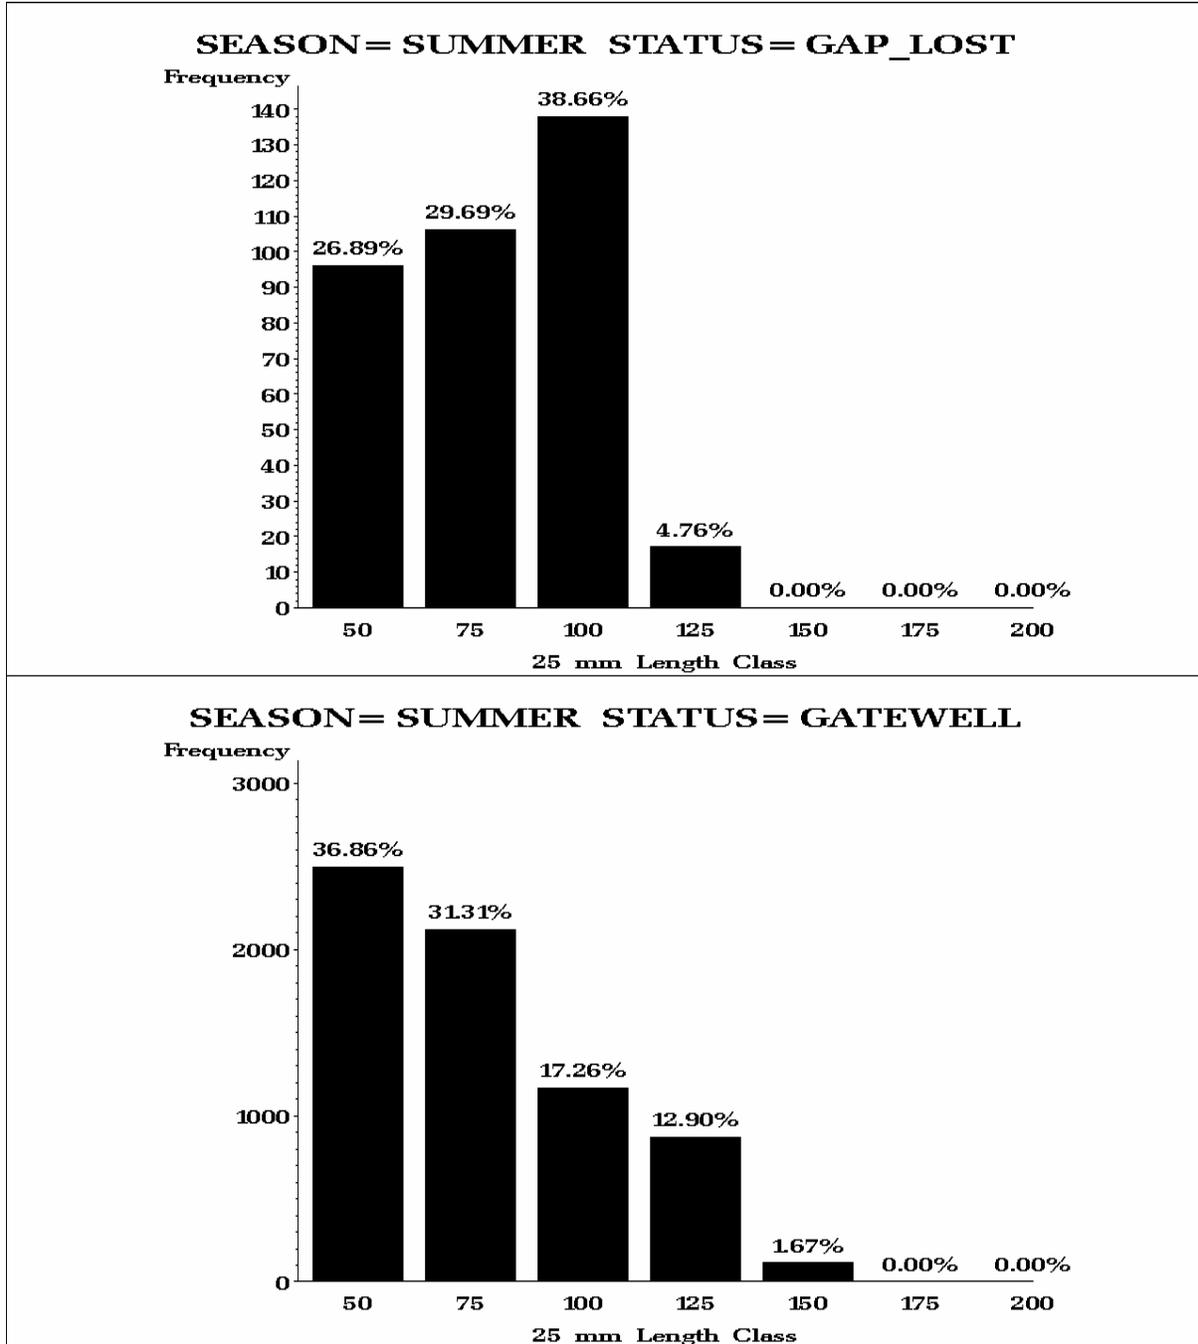
**Figure 3.14.** Length frequencies of fish passing up into the gateway slots (upper chart) and through the gap between the top of the STS and the intake ceiling (lower chart) in summer 2003 based upon DIDSON data.

The length frequency distribution of fish passing through the gap and up into the gateway slots in spring were very different, with the gateway fraction skewed toward smaller fish and the gap loss fraction skewed toward larger fish (Figure 3.14). Most sub-yearling fish were about 100 mm long according to data from the smolt-monitoring facility, but both length frequency distributions contained large percentages of fish in the 50- and 75-mm length classes.

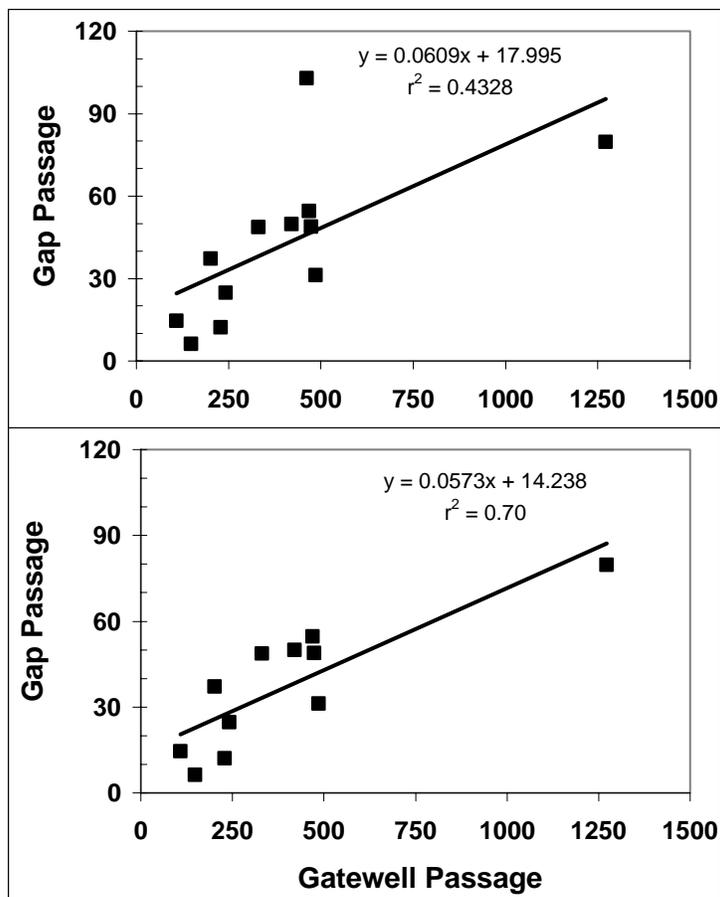
**Figure 4.1.** Plots of 2-hour rates of gap passage as a percent of gatewell and gap-loss passage at Intake 13B on May 17, 2003. The upper plot includes the point for 0800-1000 hours, whereas the bottom plot omits the 0800-1000 hour point.
