TID Environmental Performance Testing In Support of the Mayak Fissile Material Storage Facility

March 2002

Executive Summary

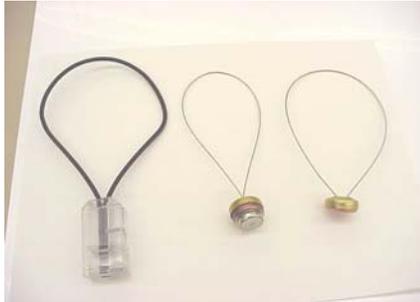
Figure 1. Loop Seal Candidates

Cobra E-Tag E-Cup

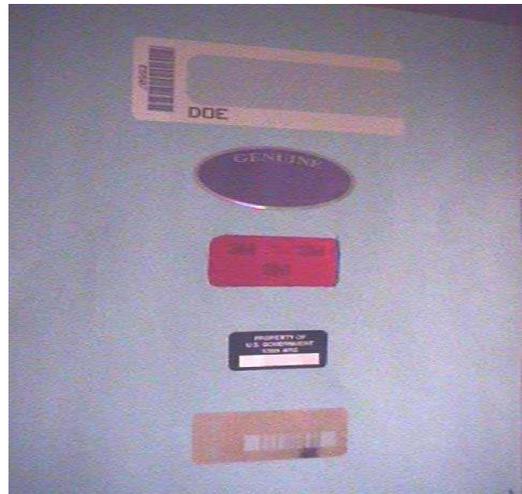
Figure 2. Adhesive Seal Candidates

3-M Confirm, ALCAN OTF, 3M TED, Koehler-Gibson, MIKOH SubScribe

The Koehler-Gibson tag is composed of duragraphic etched aluminum. This material consists of an aluminum substrate coated by an anodized layer that has been etched away to create a graphic image. Any graphic image can be transferred to the anodized aluminum. The substrate material is 1100 series aluminum, and a 3M adhesive backing is used for adhesive seals. The duragraph material is ideal for conditions requiring exposure to sunlight, excessive heat, and resistance to abrasives and chemicals.

The SubScribe adhesive seal employs a subsurface laser marking technology for variable marking of internal layers of laminated, metalized polyester/polypropylene. Removal of the seal by peeling causes delamination and reveals a previously hidden honeycomb pattern. The adhesive seals can be printed with graphics and text, including bar codes and serial numbers, for identification.

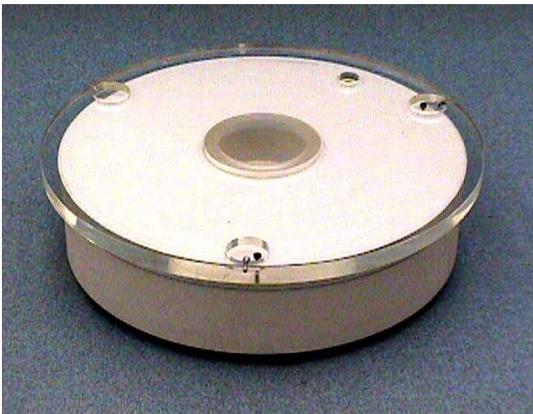
Figure 4. Plastic/Metal Mockup of Nest Cover and Top of Nest Tube

The TIDs tested as part of this project were thought to be compatible with the containers or items anticipated for application at the Mayak FMSF. To facilitate operational comparison of the seals and to provide demonstrations, a full-scale plastic mockup of the nest cover and top of the nest tube was constructed, utilizing drawings provided by the United States Army Corps of Engineers (USACE). The mockup, shown in Figure 4, proved very useful in demonstrating some serious shortcomings in the planned design with respect to the use of TIDs. A problem was found in the design that would not allow the nest cover to be effectively sealed with a loop-type TID. An E-Tag or E-Cup seal would fit in the recessed hole in the nest cover; however, it is quite possible that the lid could be lifted and returned to place without actually disturbing the seal. The Cobra loop seal would not fit in the existing design because the fiber-optic cable is too large, and the seal itself would protrude above the nest-cover surface. This problem could be corrected by a PNNL-recommended design change to the nest covers. The change calls for two additional holes to be drilled in the cover and a small hollow box welded to the outside of the top of the nest tube. A graphical representation of the proposed design concept is shown in Figure 5. These recommended changes would allow effective use of any approved loop-type seal.

- 2) **The Storage Nest Covers** – Significant operational issues with regard to TIDs on the storage nest covers were encountered. A mockup of the nest top and cover clearly showed that none of the tested loop seals could be effectively used for this application, given the initial nest cover and mating assembly design. Pacific Northwest National Laboratory research staff proposed design-modification recommendations that could provide for the secure use of IAEA standard loop-type seals on the nest cover. However, it is our understanding that these modifications cannot be made because of significant cost and schedule impacts with respect to the entire FMSF construction. It is our judgment at this time that no IAEA or internationally accepted TID will adequately work on the storage nest cover. This puts an additional burden on the entire facility-monitoring scheme. Because there is still a Mayak Transparency Protocol requirement for a TID on the storage nest cover, we believe this issue needs to be resolved by bringing together a DTRA and multi-laboratory team to explore all possible options, such as modifications of existing technologies or combining two or more technologies, or even evaluating non-standard technologies.

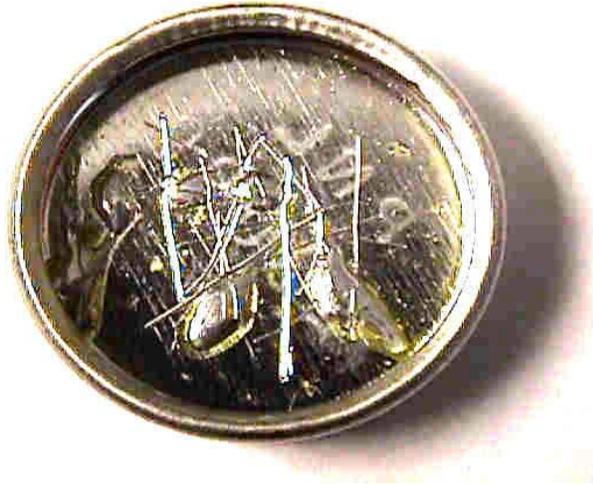
Figure 6. Bottom of a Prepared E-Type Cup Metal Seal

Preparation of the E-Cups is a multi-step process, requiring care and consistency. The E-Cups were prepared by taking approximately 30.5 cm (12 in.) of 49-strand stainless steel cable, inserting each cut end through one of the two holes in the top half of the E-Cup, and then threading the ends in opposite directions through either the single-holed metal sleeve/grommet or the double-holed metal sleeve/grommet. A crimping tool was used to crimp the metal grommet in such a way that the two ends of the wire were held firmly in place within the grommet. The bottom half of the E-Cup was prepared by heating it on a hotplate until a solder wire would melt when touched to the bottom of the cup on the

inside. The melted dots of solder created a random design on the bottom of each E-Cup. After removing the E-Cup from the hotplate, a scribing tool was used to scratch a random design in the melted solder to give a unique identifying pattern to each individual seal. An example of the bottom of a prepared E-Cup is shown in Figure 6. The bottom of each seal containing the design was then photographed to give a record of the seal for verification purposes. After this was accomplished, the tops (which had been prepared previously with the wire and grommet/sleeve) and the bottoms containing the solder design were snapped together to produce the tamper-indicating seal. Under normal procedures, of course, these seals are only snapped together when the container is actually sealed.

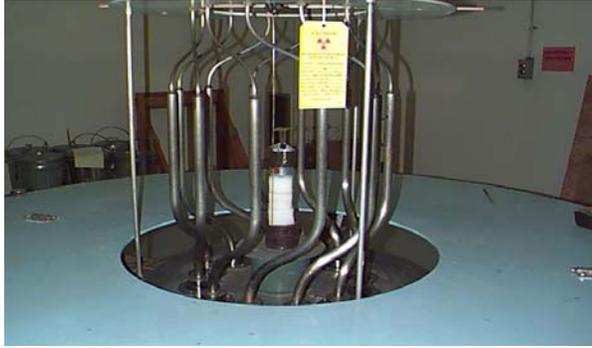
Figure 7. PNNL High Dose ⁶⁰Co Facility

Gamma irradiations were performed at the PNNL High Dose ^{60}Co Facility in the 331 Building. The gamma exposure rate is variable, depending on the number and proximity of ^{60}Co source tubes used and the location of the items during irradiation. The ^{60}Co source tubes and irradiation platform are shown in Figure 7. Due to space limitations on the irradiation platform, the gamma exposure was performed in two stages. During the first stage, 52 plates with adhesive seals were irradiated, and during the second stage, the remaining 18 plates and all the loop seals (Cobra, E-Cups, and E-Tags) were irradiated. The exposures lasted about 21 hours each and were completed during the last week in July.

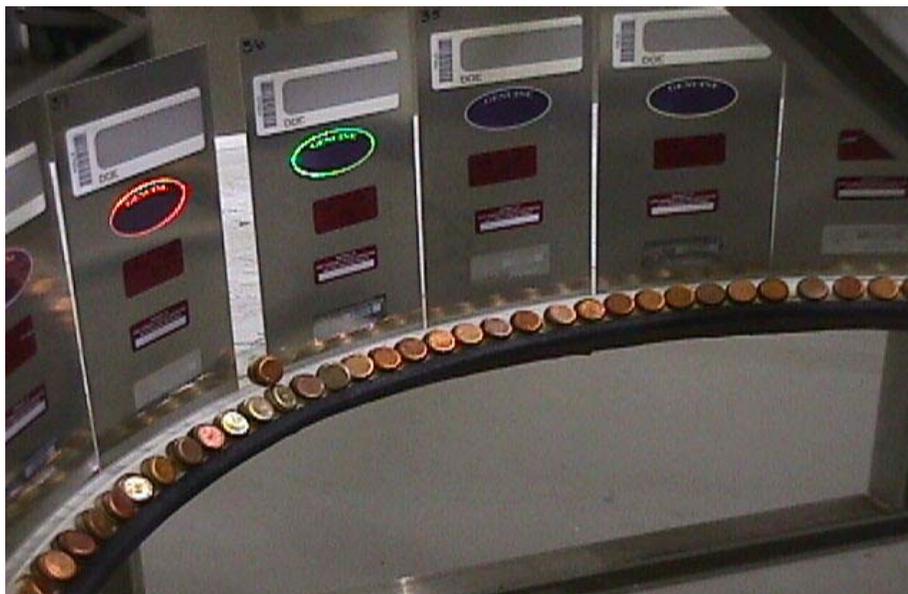
Figure 8. Adhesive Seals and E-Cups Around the South Exposure Station

All candidate TIDs were exposed to 130-rem neutron radiation from bare ²⁵²Cf in the Low Scatter Room of the 318 building. The south station in the Low Scatter Room was used since it had a Plexiglas ring holder for exposures at a 50-cm-radius reference distance. This Plexiglas ring allowed the stainless steel plates to be easily set up in a reproducible manner on the irradiation platform. However, only 24 plates could fit around the ring at one time; therefore, the irradiations had to be performed four times. The first and second irradiations exposed 24 stainless steel plates, the third irradiation exposed the remaining 22 plates, the E-Tags, and the E-Type Metal Cup seals (Figure 8), and the fourth irradiation exposed the sample population of Cobra Seals (Figure 9). Due to the neutron source strength at the time of testing, the exposures took about 42 hours at the reference distance of 50 cm. The neutron exposures were started during the first week of August and completed August 20, 2000.

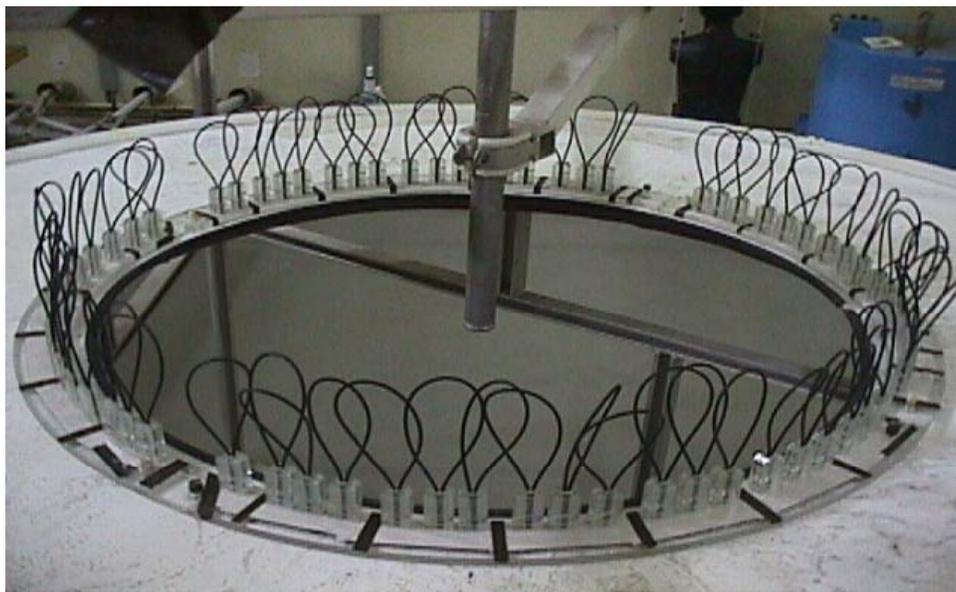
Figure 9. Cobra Seals Around the South Exposure Station

A special test was performed on six Cobra Seals to determine at which point they would fail under intense radiation conditions and what the failure mode would be. These six Cobra Seals were independent of the 70 units used in all the standard tests. Since the ⁶⁰Co High Dose Facility was the only facility capable of the extremely high exposure rates needed, it was used to conduct this special test. The Cobra Seals were exposed in increments up to a total of 2M-rads gamma radiation. The Cobra Seals were inspected and the images recorded after each incremental exposure. The total exposures after each increment were 10K, 30K, 50K, 100K, 150K, 200K, 300K, 500K, 1000K, and 2000K (2M) rads. The recorded images after 500K rads total exposure were sufficiently darkened to be considered failed since the image could not be used to compare against the reference image to determine a match. The progressive degradation in the seal image can be seen in Figure 10. The Cobra Seal body also turned

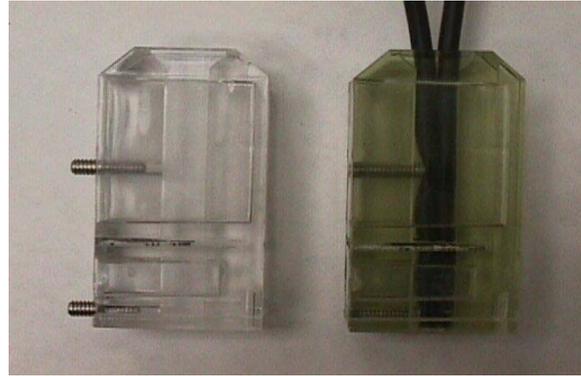
Figure 11. Cobra Seal Body Unexposed and Exposed to 500,000 Rads

color from clear to gold, although this did not detract from the ability to visually inspect the seal for signs of tampering. The color change of the seal body can be seen in Figure 11.

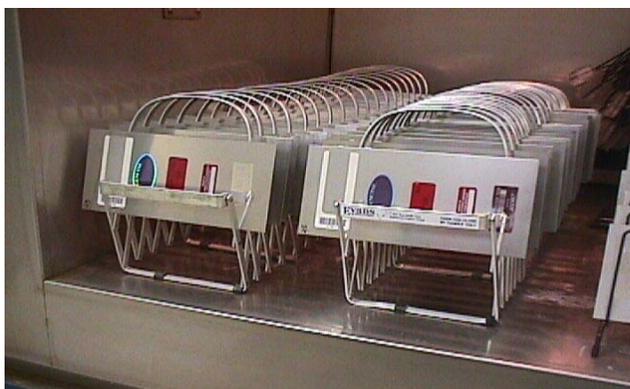
Figure 12. Adhesive Seals Inside Environmental Chamber

The TIDs to be tested thermally were initially placed in the Russell environmental chamber at ambient temperature for *cold temperature testing* (Figure 12). This test began at 15:20 on August 24th, 2000. The temperature was varied from ambient to -20°C in 1 hour. The temperature remained at $-20^{\circ}\text{C} \pm 3^{\circ}\text{C}$ for 96 hours. At 15:20 on August 28th, the chamber was returned to ambient temperature, and each specimen was removed and checked to determine its condition. All TIDs appeared to be in good condition following this first round of thermal testing. The E-Tags were all read with the reader to verify their continued readability. The Cobra Seals were all photographed. Each E-Cup was checked and found in good condition. All adhesive seals were also checked, and several exhibited a small amount of bubbling. None, however, appeared to have failed.

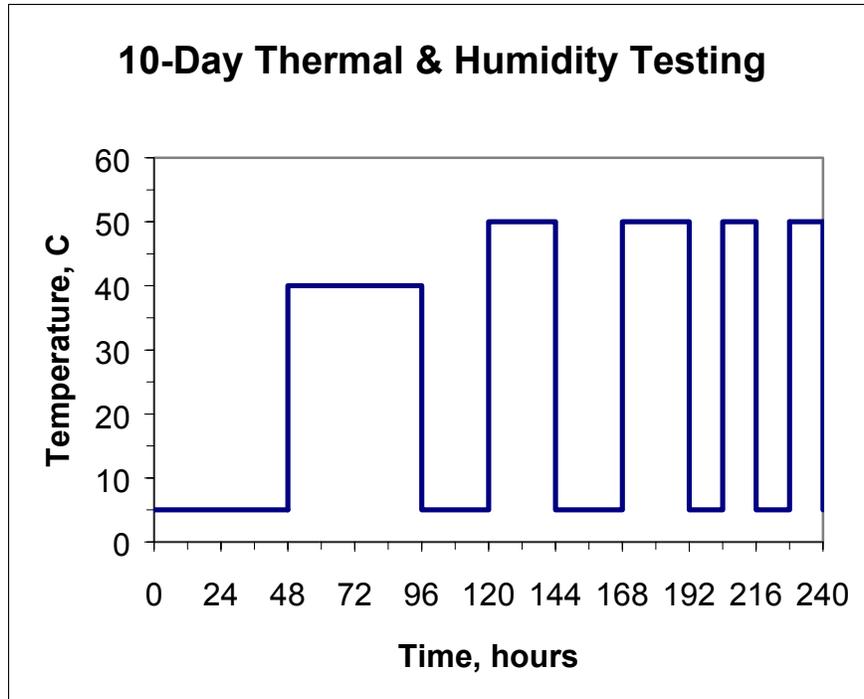
Figure 13. 10-Day Thermal and Humidity Testing

On September 14th at 12:00, the TIDs were returned to the environmental chamber to undergo *thermal and humidity stressing*. This test procedure is in conformity with the IEC 68-2-56 standard. Each specimen entered the chamber under ambient conditions. At that point, the temperature was lowered from ambient to $5^{\circ}\text{C} \pm 2^{\circ}\text{C}$, and the humidity was increased to $90\% \pm 5\%$ RH. After 48 hours on September 16th at 12:00 noon, the temperature was changed to $40^{\circ}\text{C} \pm 2^{\circ}\text{C}$, and the test continued at that temperature and RH for the next 48 hours. On September 18th at 12:20 pm, the temperature in the chamber was decreased to $5^{\circ}\text{C} \pm 2^{\circ}\text{C}$ again with the RH remaining at $90\% \pm 5\%$ and remained at that temperature and RH for the next 24 hours. On September 19th, the temperature was again changed back to $50^{\circ}\text{C} \pm 2^{\circ}\text{C}$ and $90\% \pm 5\%$ RH, remaining under those conditions for the next 24 hours. The test continued in this manner, changing between $5^{\circ}\text{C} \pm 2^{\circ}\text{C}$ and $50^{\circ}\text{C} \pm 2^{\circ}\text{C}$ for two more cycles, at which time the length of time between each cycle was reduced to 12 hours for the next 48 hours until the last low-temperature cycle. The total duration of this temperature and humidity test was 10 days, as illustrated in Figure 13. At the completion of the test, the chamber returned to ambient temperature and RH and the TIDs were removed from the chamber and inspected. All TIDs reacted very well to the temperature and humidity tests. There were no failures, and even the small amount of bubbling that had appeared in some of the adhesive seals previously had disappeared during this phase of the testing process. All of the Cobra seals were photographed, the E-Tags were read, and a visual assessment was given to the E-Cups and the adhesive seals.

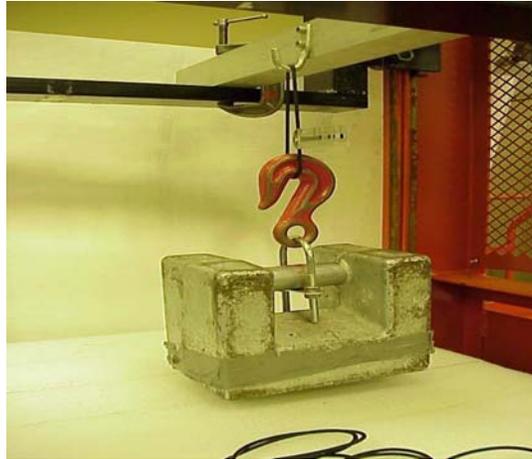
Figure 14. Loop Seal 50-lb Pull Test

Following the pull tests, the E-Cups and E-Tags were visually inspected. One E-Cup and one E-Tag failed this test due to the wire slipping out of the grommet inside the seal as the weight was initially applied.

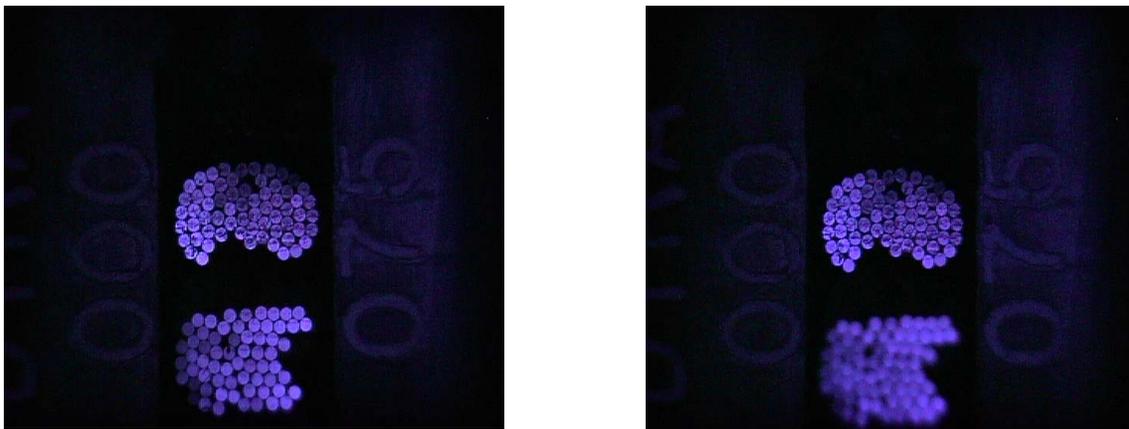
Figure 15. Cobra Seal # 75 Before and After Pull Test

The Cobra seals were imaged before and after and given a visual inspection following the pull testing. Initially, it was thought that all Cobras passed the pull test; however, after reviewing the images taken following the pull test, it was revealed that three Cobras failed this test due to the cable being retracted very slightly into the seal body (Figure 15).

It was noted earlier in this report that during the initial preparation of the Cobra seals for the test program, the manufacturer-supplied Monotool failed mechanically, resulting in only one of the two cutting blades being lowered onto the fiber-optic cable. (All three of the failed Cobras exhibited this anomaly, plus several of those that passed the pull test. This problem was not obvious until the before and after pull test images were compared.)

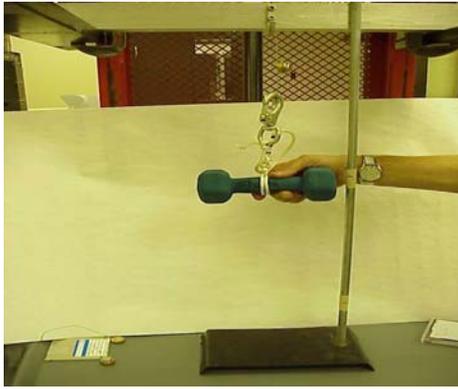
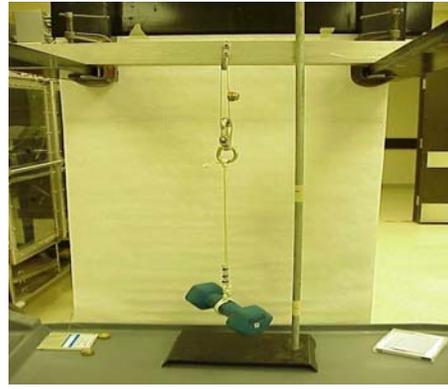
Figure 16. Loop Seal 5-lb Drop Test

For the drop testing, the loop seals were connected from above in the same manner as the pull test. The lower section of the loop was hooked to a cord that was attached to a 5-lb weight. The weight was raised 30.5 cm (12 in.), and then dropped, simulating a sudden jerk on the loop. This is illustrated in Figure 16.

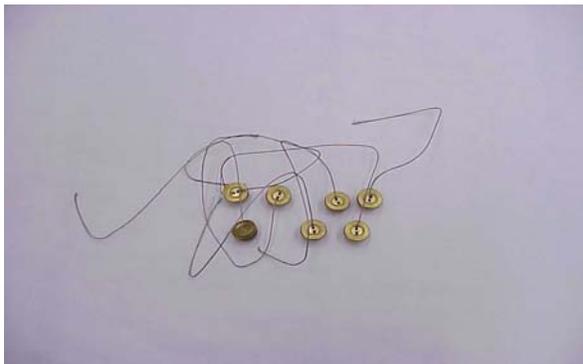
Figure 17. E-Tag Drop Test Failures

A substantial number of failures were encountered during this test phase. Seven E-Tags and nine E-Cups failed the test when the grommet inside the seal that connected the wires failed. The failed E-Tags are shown in Figure 17. In addition, almost all of the E-Cups and E-Tags showed evidence of tearing or elongation of the wire holes (Figure 18).

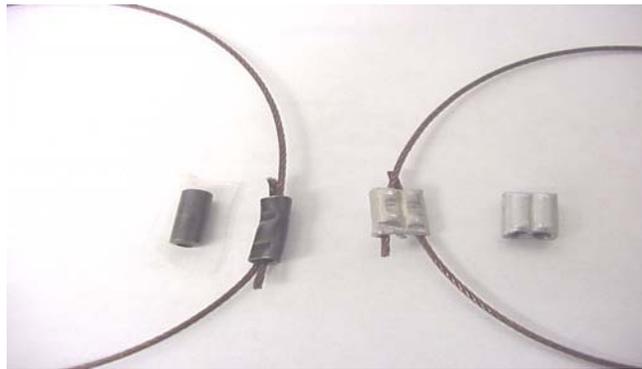
Figure 19. Single and Double-Holed Grommets

A post-test analysis of the E-Cups and E-Tags was conducted to determine the possible cause of the failures. The metal cups were cut open along the sides to facilitate photography of the E-Cups for comparison with photographs taken before the test program began. During the initial preparation of the E-Cups and E-Tags, two types of grommets were used; one type uses a single hole, and the other type uses two holes as shown in Figure 19. The single-hole grommets were measurably more difficult to crimp. All of the E-Cup and E-Tag failures had utilized the single-holed grommet.

The mechanical test program resulted in significant failures of the wire loop seals, primarily because of the type of grommet used to secure the wire. Three Cobra seals also failed in this test phase. The adhesive seals performed well as a group, with minor exceptions, and should be useable wherever they are not subjected to severe mechanical abrasion or shearing stress. Electromagnetic testing showed that

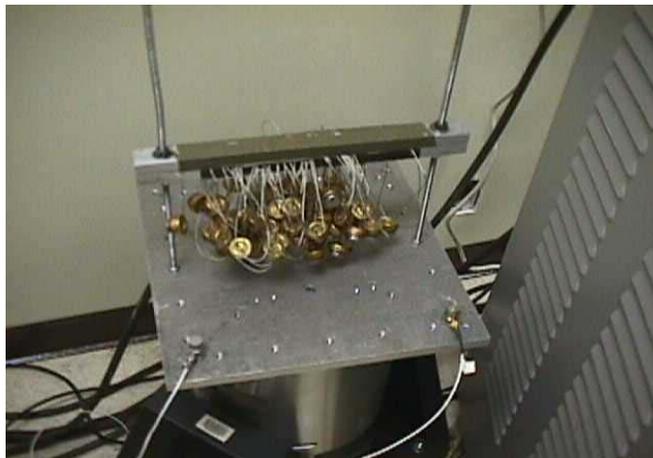
Figure 20. E-Cup Vibration Testing

The seals were attached to the test bench (Figure 20) and vibrated as a group for 20-minute periods at 10, 30, and 60 Hz. Ten Hz appeared to be a close simulation of what a container would experience on the back of a truck driving over unimproved roads. For example, 20 minutes of vibrations at 10 Hz represented 12,000 bounces at 4.4 g acceleration. Thirty Hz might represent the vibration that would be experienced during high-speed rail travel. Sixty Hz provided a buzz-type effect. The amplitude of the vibrations resulted in accelerations of 4.4 to 6.0 g.

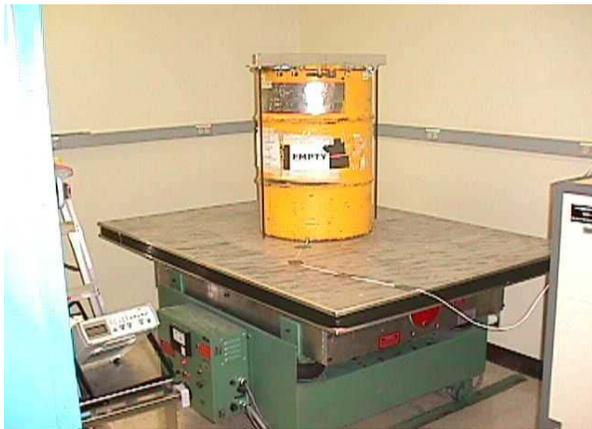
Figure 21. Vibration Test Platform

certified by the Department of Transportation for the transport and storage of fissile material in the United States. To replicate the inertia factor of a loaded AT-400R fissile material container, lead weights were added to the internal container to bring the weight to approximately 200 lb, the same weight that a loaded container would normally weigh. The container was sanded to remove some rust and corrosion. The seals were attached to the drum on the locking ring around the top. A minimum cure time of 72 hours was allowed for the adhesive seals. The drum was then securely fastened to a large 122 cm x 122 cm (48 in. x 48 in.) vibration test platform (Figure 21).

The test parameters were limited by the physical capabilities of the test platform. The initial vibration run was conducted for 30 minutes at 15 Hz and 1-g acceleration. The effect was very similar to that of a truck with very stiff springs. After the initial test period, the seals were inspected, paying close attention to the small gaps around the locking ring. All seals looked very good.

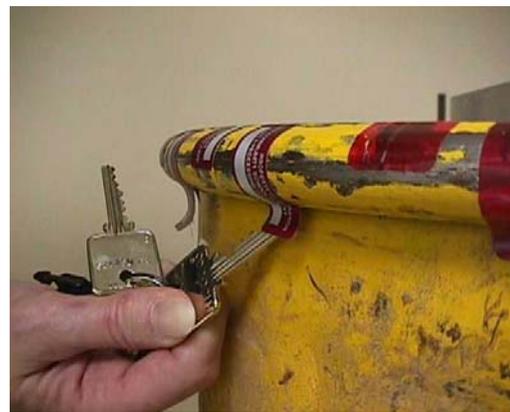
Figure 22. Koehler-Gibson Test Failures

The counter weights were changed on the vibration table, which allowed a small frequency change to 11.5 Hz at 1-g acceleration for another test period of 30 minutes. This small frequency change created a slightly rougher ride. Approximately 5 minutes into this second vibration run, it was noticed that one Koehler-Gibson seal came loose at the bottom. A second Koehler-Gibson failed approximately 20 minutes into this second run. Figure 22 is a close-up showing how the seals came loose on the drum surface.

Two of six Koehler-Gibson seals came loose at the drum-locking rim interface. All other adhesive seals showed no effect.

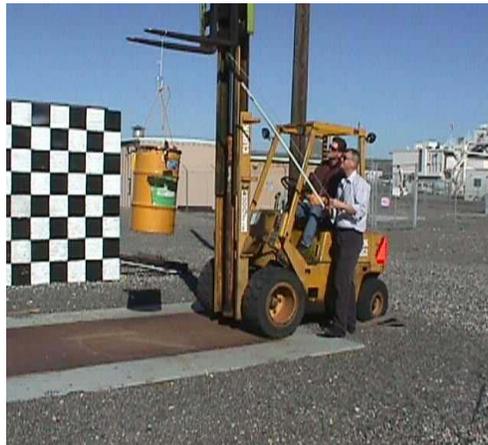
Figure 23. 113.56 L (30-Gal) Drum ready for Mechanical Shock Test

Mechanical shock testing was restricted to adhesive seals only since there are no scenarios for loop seals where shock testing is necessary. The mechanical shock test was specified to test the adhesive seals attached to a container dropped from a height of 1 meter to a hard surface as shown in Figure 23. For this test, the same 113.56-L (30-gal) drum configuration that was used in the adhesive seal vibration testing was utilized. The test drum was again weighted to 200 lb to duplicate the inertia effect of a loaded AT-

400R container. The barrel was dropped once onto a hard surface. Pre and post inspection of the adhesive seals indicated no failures.

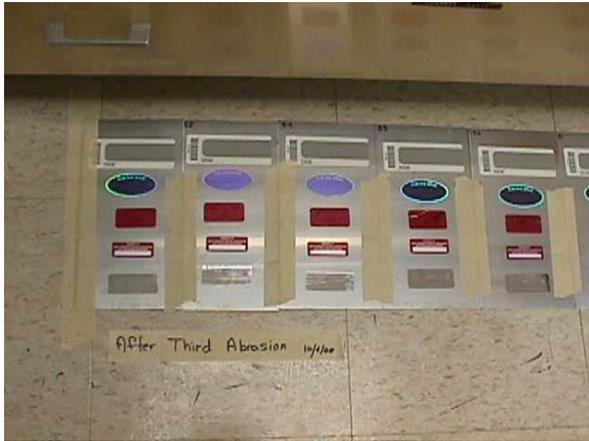
Figure 24. 113.56-L (30-Gal) Drum ready for Mechanical Shock Test

For the abrasion test, the metal plates containing the adhesive seals were secured to the floor with adhesive tape (Figure 24). Sandpaper was glued to the bottom of the outside of a box in which a 5-lb weight had been placed. A rope was secured to the box, and the box was slowly dragged over each portion of the plates three times. Each seal was then evaluated for abrasion. Some minor scuffing was noted on most of the MIKOH and Alcan seals. There was also some evidence of scuffing on a few of the 3M TED seals, but no scuffing was found on the Koehler-Gibson or 3M Confirm Tamper Tapes. None of the adhesive seals showed any evidence of tampering as a result of the abrasion test.

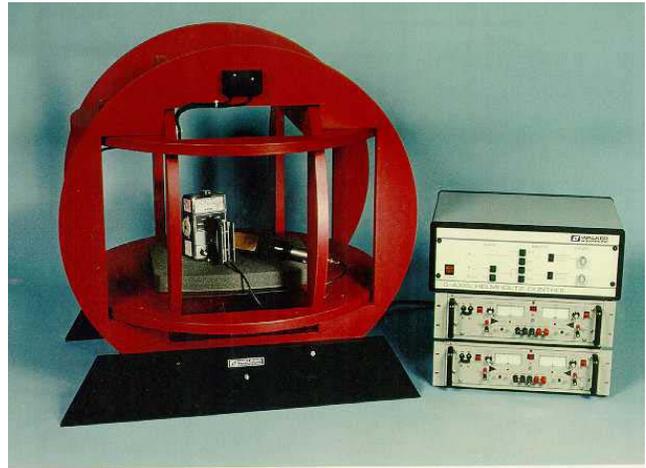
Figure 25. Magnetic Test Chamber

The E-Tag samples were tested using a Walker Scientific 3-axis Helmholtz coil apparatus. The tests were conducted using a 10-gauss AC magnetic field (Figure 25). The E-Tags were bundled together and

exposed to the magnetic field for 1 hour. All E-tags were successfully read electronically during and following this test.

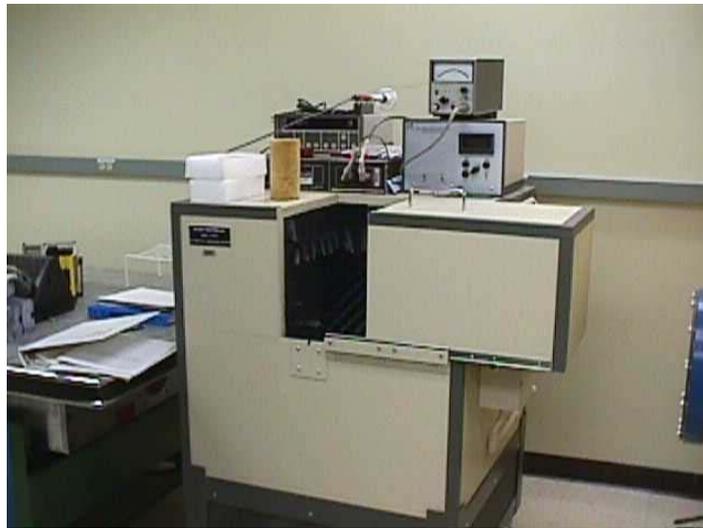
Figure 26. Microwave Test Chamber

The samples of E-Tags were exposed to microwave fields using a Holaday Industries microwave exposure chamber (Figure 26). The exposures were performed at 2450 MHz with a power density of 10 mW/cm^2 ($\sim 200 \text{ V/m}$ electric field strength). The exposure frequency is identical to the one used in commercial microwave ovens. The E-Tags were bundled together, placed in the chamber, and exposed to the microwave field for 1 hour; then they were read by the electronic reader. All E-Tags were read electronically with no observed failures.

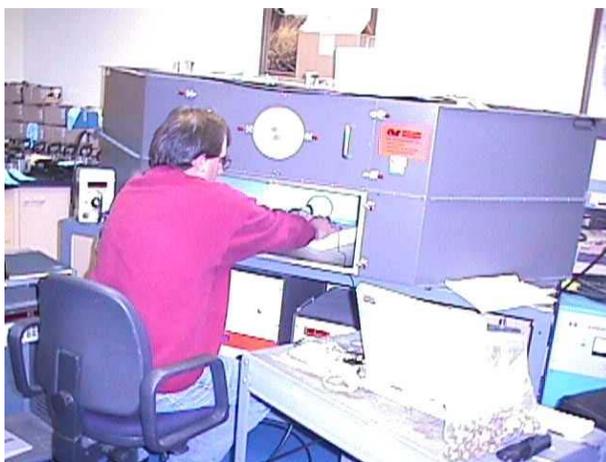
Figure 27. E-Tag Testing in RF Chamber

The samples were tested using a transverse electromagnetic (TEM) cell manufactured by Amplifier Research. The testing was conducted over a frequency range of 500 kHz to 375 MHz. The maximum electric-field strength available at any given frequency was used during the testing. The electric fields encountered in most “real-world” locations will be far below the levels used during this testing. Radio-frequency emitters found in this frequency range include:

In the initial test using one E-Tag, no radio-frequency interference was noted. The E-Tag was readable after radio-frequency exposure. The E-Tag was also read successfully when the E-Tag reader probe was inside the TEM cell. The subsequent test of the complete sample of E-Tags did not reveal any failed samples.

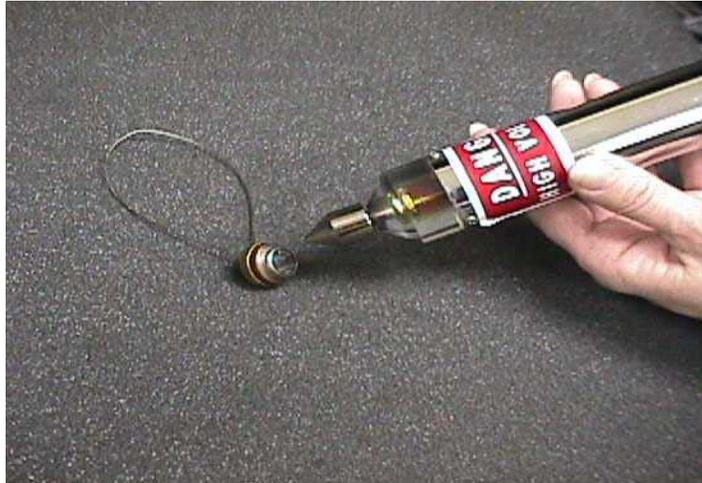
Figure 28. E-Tags During ESD Testing

The E-Tag samples were tested for sensitivity to electrostatic discharge (ESD) using an ESD generator manufactured by Andy Hish & Associates (Model ESD 255). The samples were exposed to discharges ranging from 2.5 kV to 25 kV as illustrated in Figure 28. The ESD generator was designed to produce controlled static-discharge events similar to those produced by a human touching a grounded surface with a metal object (such as a key).

A small sample of E-Tags was exposed from 2.5 kV to 25 kV in 2.5-kV intervals. A series of 50 discharges was delivered at each voltage. After a “failure threshold” was determined, a sample of 10 E-Tags was exposed at 17.5 kV. Again, 50 discharges were administered to each E-Tag.

During the initial testing, one E-Tag failed at 12.5 kV, two failed at 17.5 kV, and two did not fail. Of the 10 E-Tags exposed at 17.5 kV, 8 failed and 2 passed. A failure of the E-Tag simply means that the electronic reader was unable to interpret the serial number. There was no observed physical damage to the E-Tags, and the serial numbers could be easily read visually. Because of the high failure rate for the electrostatic discharge testing, it was elected to preserve the remaining samples and conclude that the E-Tags are susceptible to failure after exposure to nominal electrostatic discharges.
