PNNL-19018

# An Evaluation of Ultrasonic Phased Array Testing for Reactor Piping System Components Containing Dissimilar Metal Welds

JCN N6398, Task 2A

November 2009

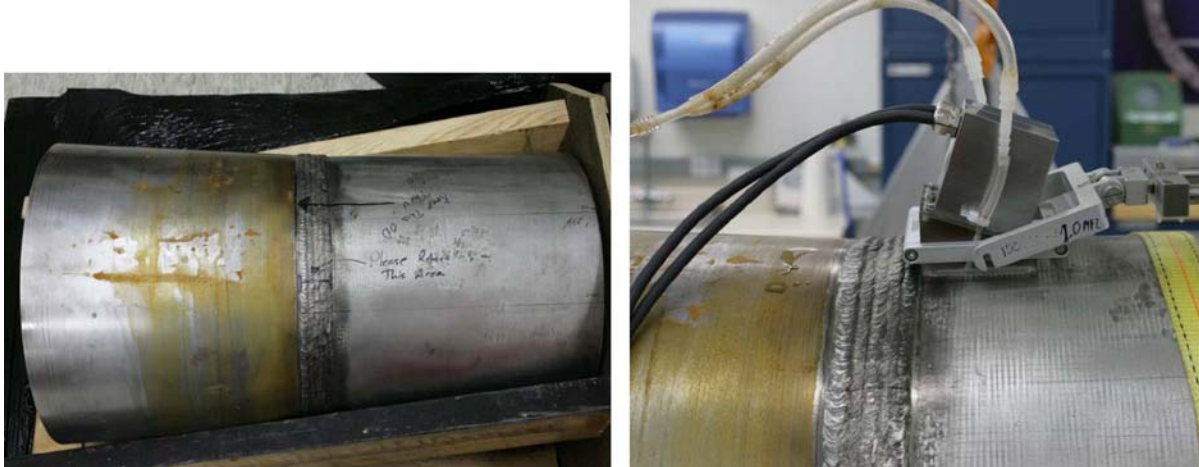
approximately 584.2 mm (23.00 in.) in length, with approximately 34.8-mm (1.37-in.) wall thickness at the flaw location within the DMW. Digital photographs of the mock-up are provided in Figure 7.10 and Figure 7.11. These photos show a significant difference in surface condition and subsequent access and transducer coupling efficiency between the specimen with and without the weld crown.

**Figure 7.10.** Photographs of the Original OD Surface of DMW Mock-up Specimen 9C-034

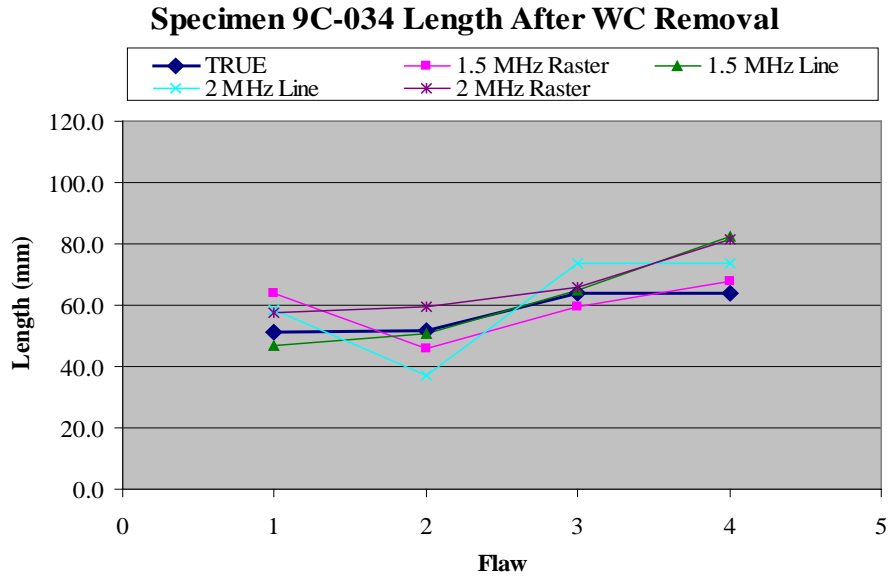
A sizing comparison of the data acquired after weld crown removal is displayed in Figure 8.21 for length and Figure 8.22 for depth. Both line and raster data are displayed for 1.5 and 2 MHz. The length sizing is worst for flaw 4 at 1.5-MHz line scan data and 2-MHz raster data. The error is 19 and 18 mm, respectively. Depth sizing in the raster data is good and within 2.2 mm at both frequencies.

**Figure 8.21.** Length Sizing Results on Specimen 9C-034
